S-SMA-3.72

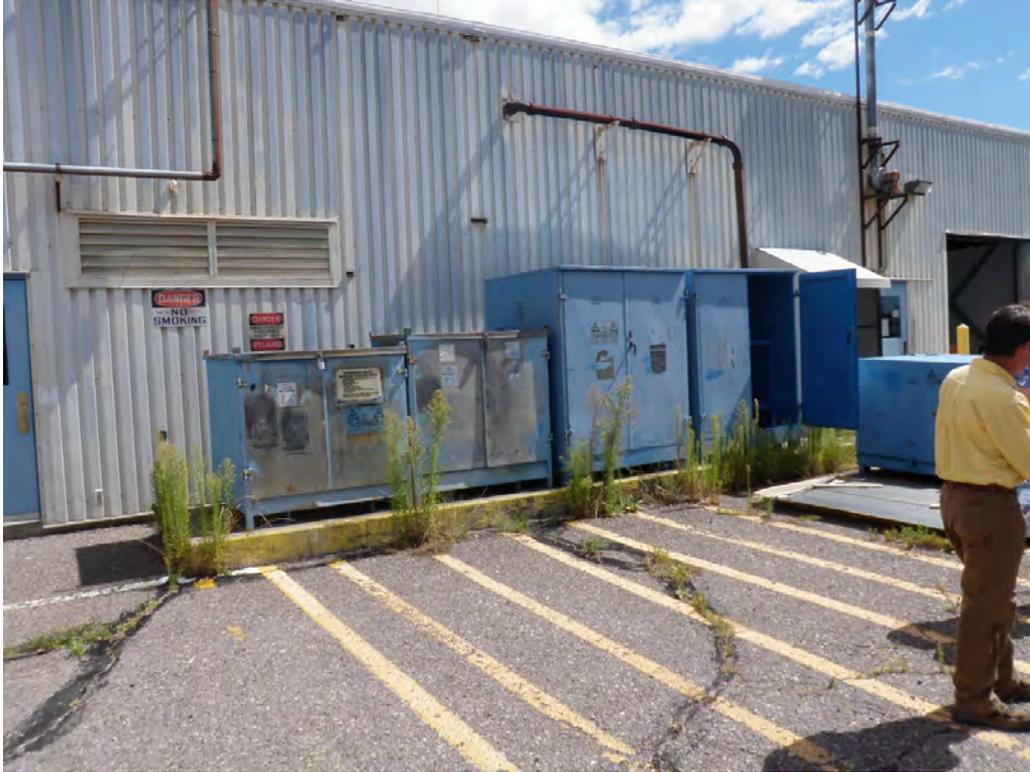
Photo 1: SWMU 53-001(b) former storage area

SWMU boundary is shown as a very small point and may not be reflective of actual affected area.

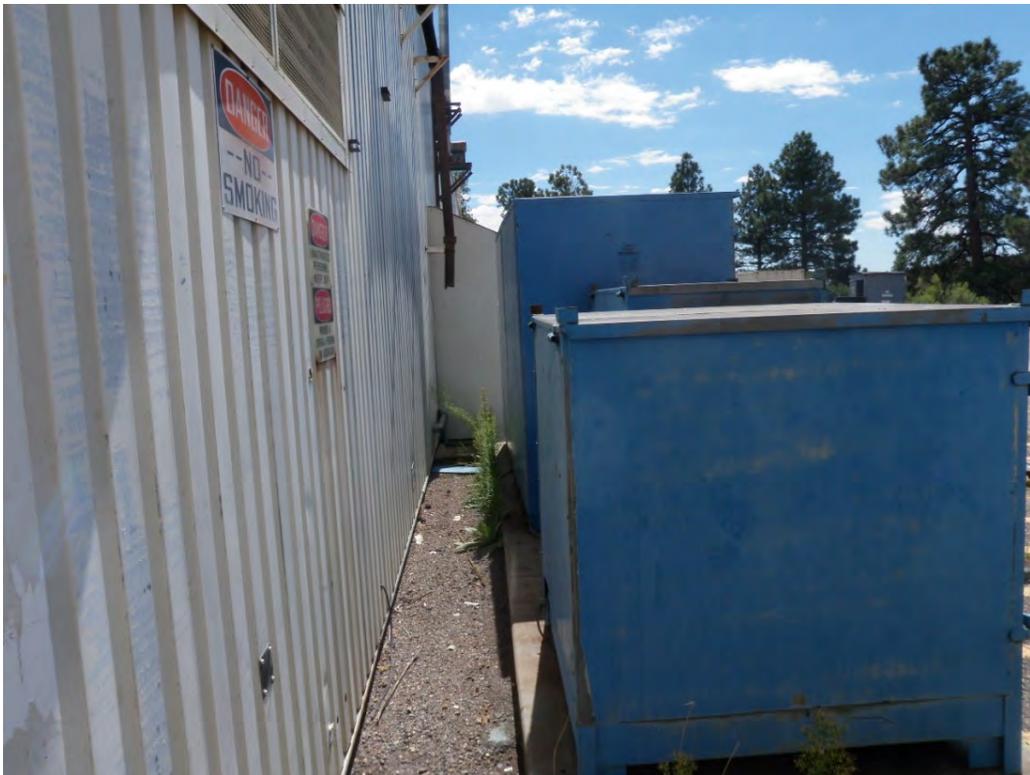
Photo 2: View behind storage area

Roof drains are directed onto the SWMU area.
