NEW MEXICO  
ENVIRONMENT DEPARTMENT

**Re: Major Industrial, SIC 4941, NPDES Compliance Evaluation Inspection, Buckman Direct Diversion Project, NM0030848, April 14, 2011**

### NPDES Compliance Inspection Report

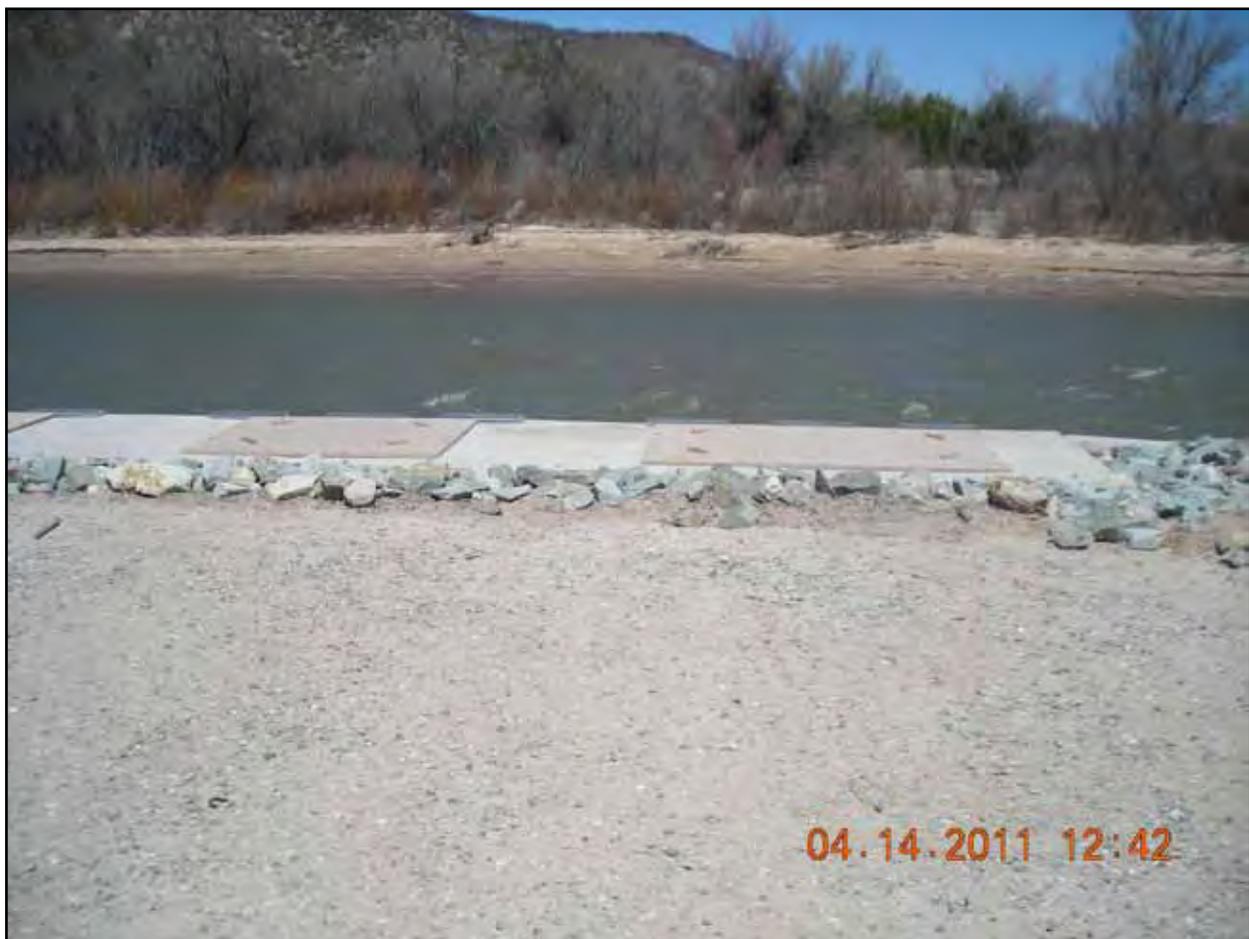
Photo # 1

Photographer: Sarah Holcomb	Date: 4-14-2011	Time: 1242 hours
City/County: Santa Fe/Santa Fe County		
Location: Buckman Direct Diversion Project intake structure		
Subject: Diversion point bringing Rio Grande water into the treatment facility.

Water is diverted from the river through a large intake structure located eleven miles away from the drinking water treatment plant itself. (Please see photo #1.) Diversion usually takes place between 8pm-8am to take advantage of cheaper electricity during this low demand period of the day. The intake structure is composed of five diversion compartments which are encased in cement with fine mesh screens. There is a pump in each compartment, and all pumps are alternated. The facility will stop diversion from the river in three instances: 1) Due to the consideration for the endangered silvery minnow, when the river flow is low (below 150 cfs), the facility will stop pumping water, 2) when there is high turbidity in the river because sand and sediments cause problems with the water treatment membranes, and 3) when the facility receives early notification from Los Alamos National Labs regarding a storm event carrying pollutants down Pueblo Canyon toward the facility. With respect to storm flows, when the flow is above five cubic feet per second at the bottom of Pueblo Canyon (at the convergence with the Rio Grande), BDD will shut down diversion. In February, BDD pumped 99.63 million gallons of water up to the treatment plant and sent 2.932 million gallons back to the river.

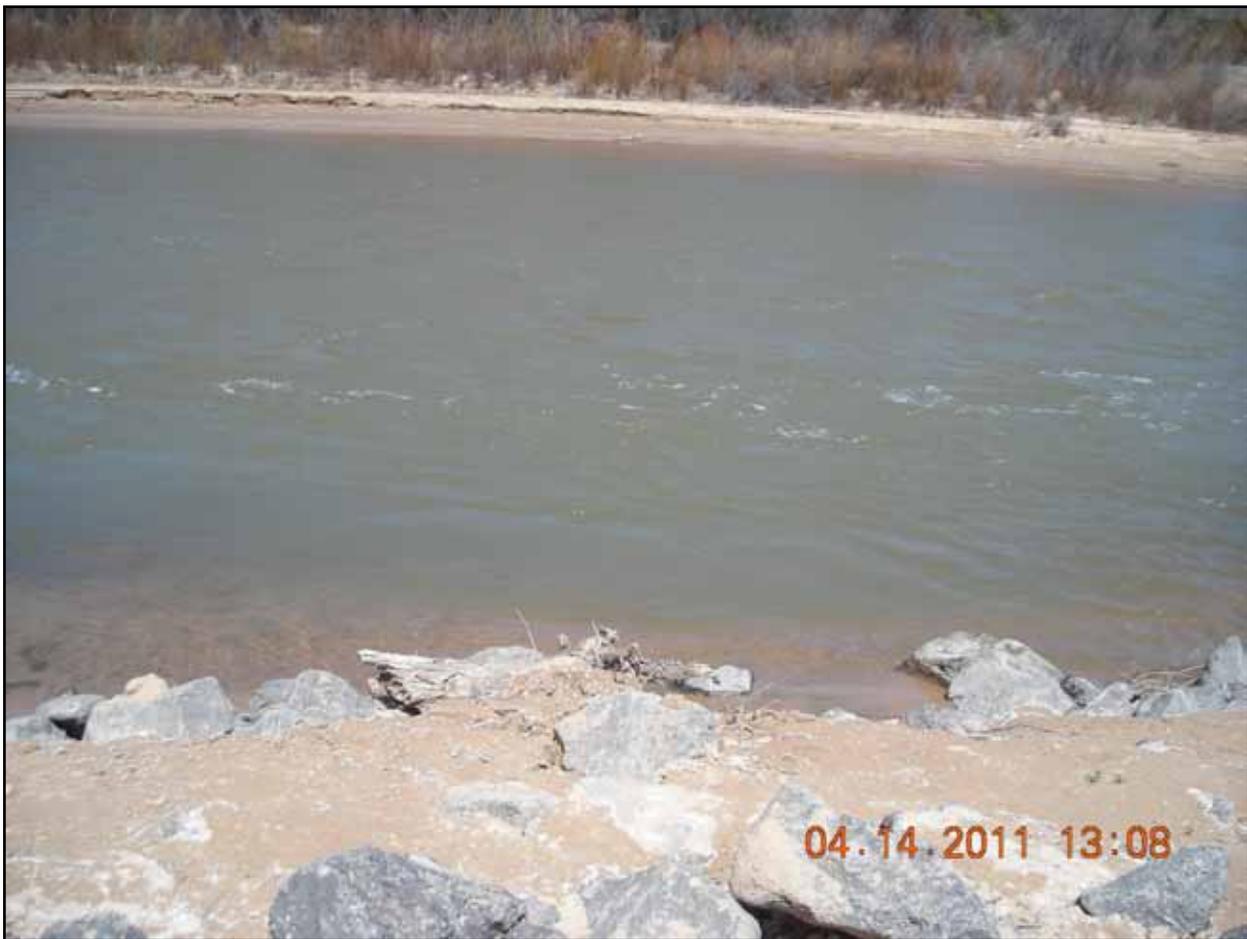
Photo # 2

Photographer: Sarah Holcomb	Date: 4-14-2011	Time: 1308 hours
City/County: Santa Fe/Santa Fe County		
Location: Buckman Direct Diversion Project		
Subject: Approximate location of the effluent pipe from the sediment removal process. The pipe is located beneath the surface of the Rio Grande. This is just south of the diversion structure.

The facility's effluent pipe is located beneath the surface of the Rio Grande, directly downstream of the diversion intake structure. (Please see Photo # 2.) Because the pipe is underwater, it is difficult to observe the effluent flow to determine whether the permittee is compliant with visual discharge requirements.

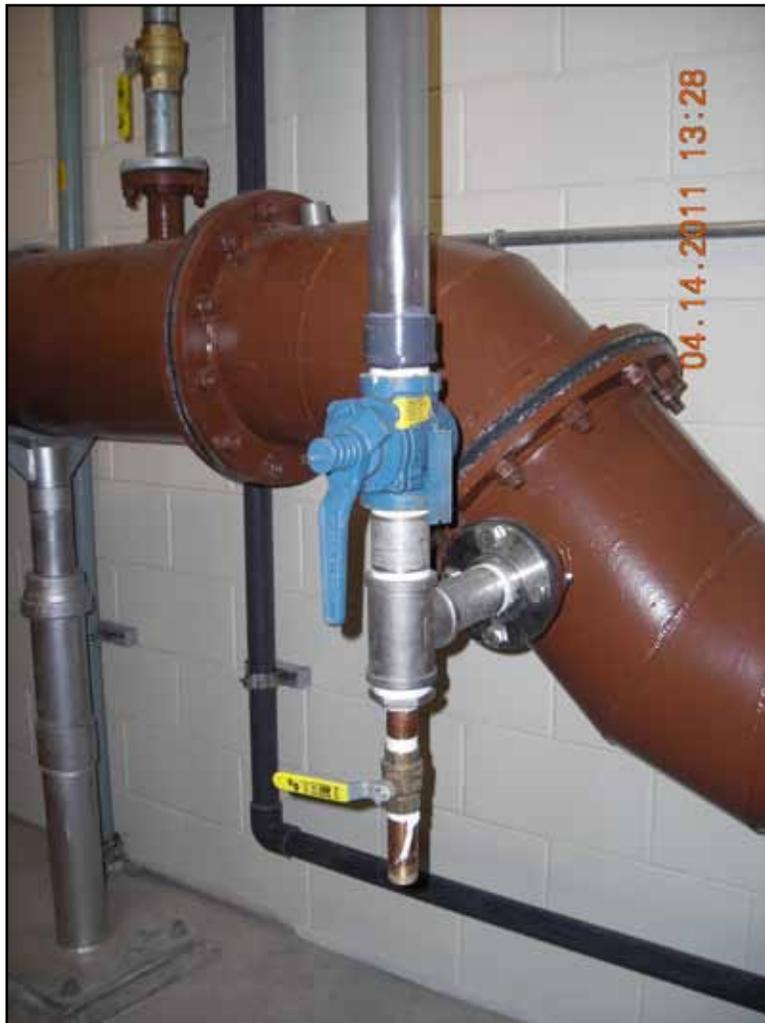
Photo # 3

Photographer: Sarah Holcomb	Date: 4-14-2011	Time: 1328 hours
City/County: Santa Fe/Santa Fe County		
Location: Buckman Direct Diversion Project		
Subject: Effluent sampling location – valve is located on discharge pipe prior to outfall.
