**Re: City of Las Cruces, East Mesa Water Reclamation Plant; Major; Individual Permit;
SIC 4952; Compliance Evaluation Inspection; NPDES Permit NM0030872;
August 26, 2014**

NPDES Compliance Inspection Report

City of Las Cruces
East Mesa Water Reclamation Facility
NPDES Permit No. NM0030872
Compliance Evaluation Inspection
August 26, 2014

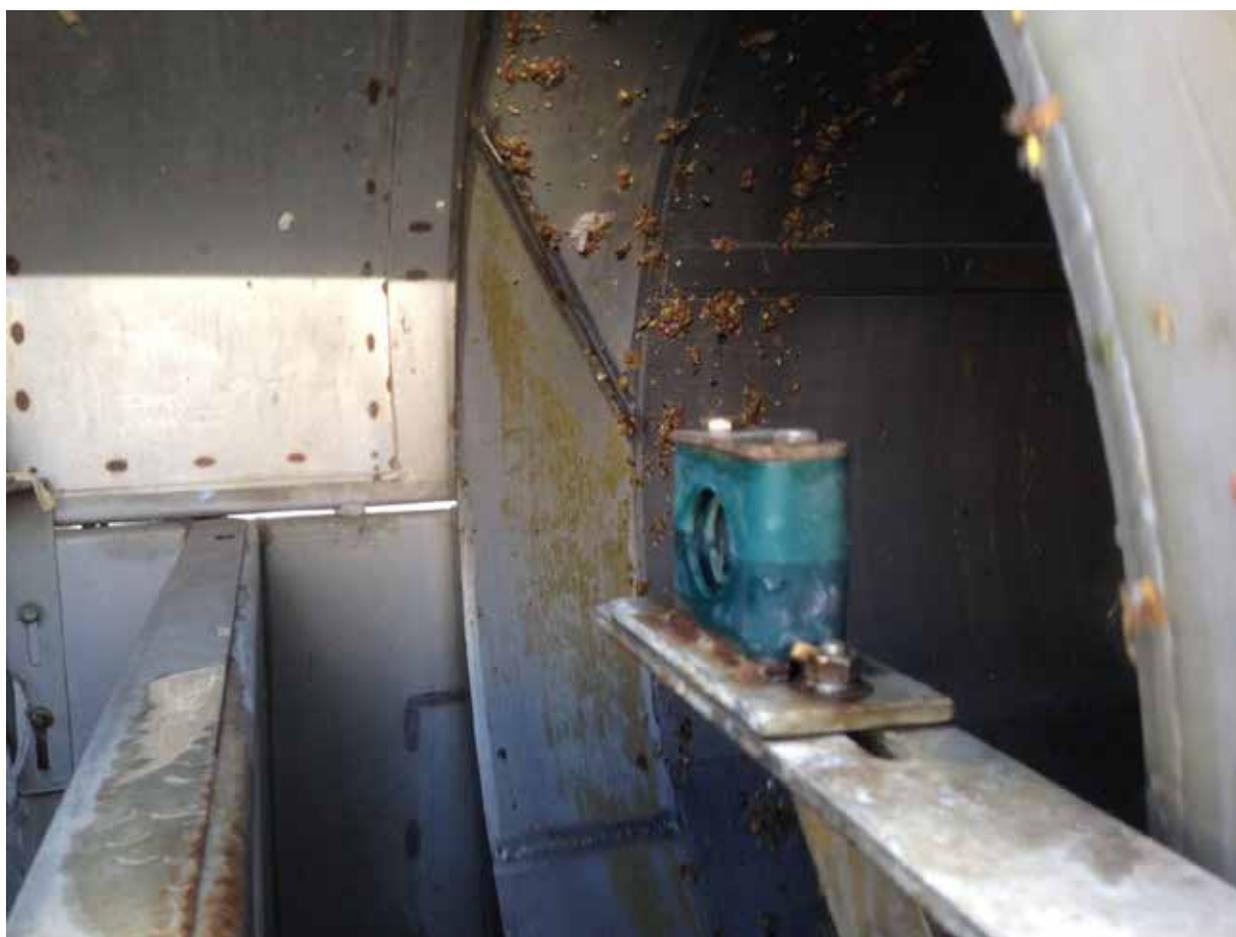
NMED/SWQB
Official Photograph Log
Photo # 1

Photographer: Sandra Gabaldón	Date: August 26, 2014	Time: 1403 hours
City/County: Las Cruces / Dona Ana		State: New Mexico
Location: City of Las Cruces East Mesa Water Reclamation Facility		
Subject: Close up view of enclosed disc filter

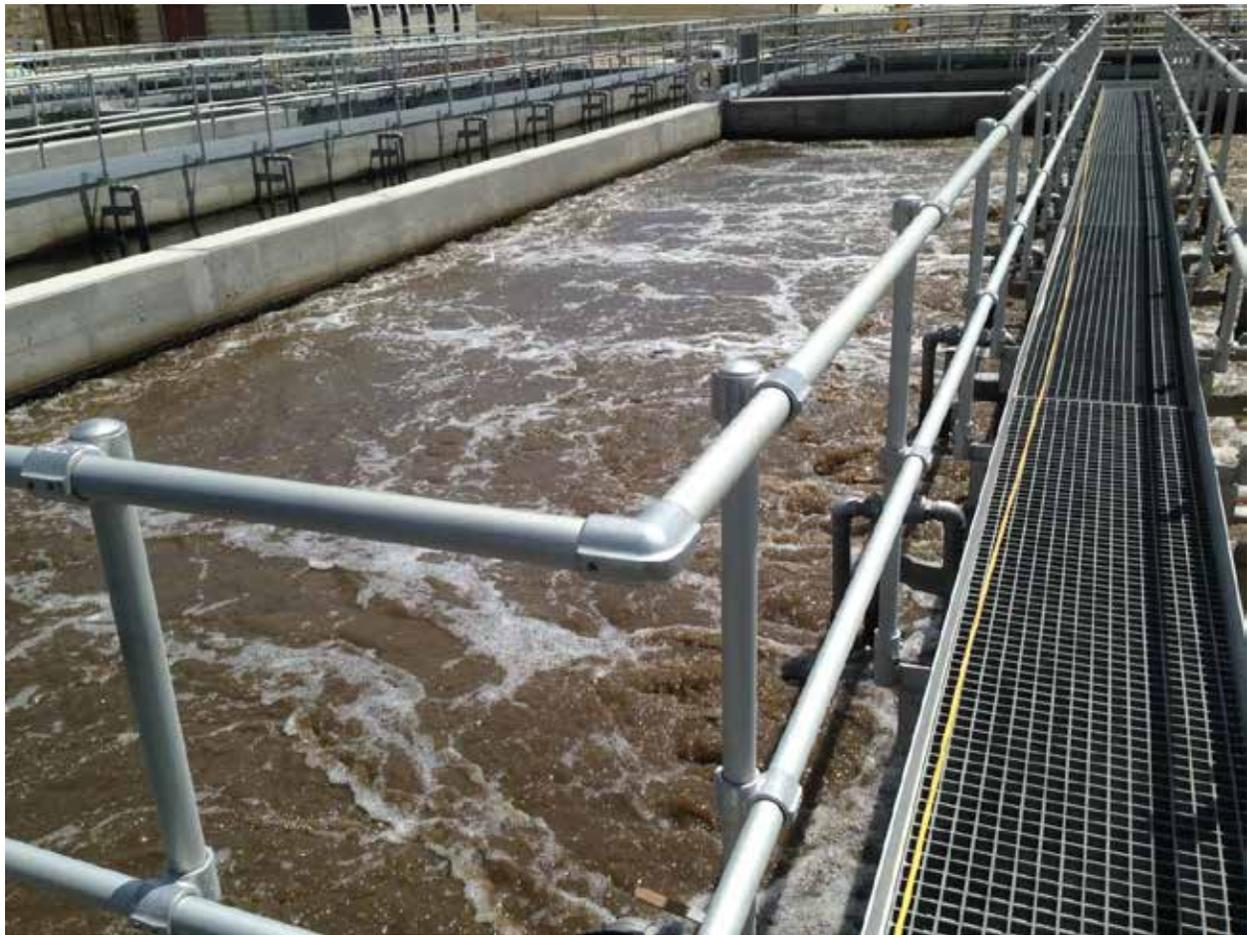
NMED/SWQB
Official Photograph Log
Photo # 2

Photographer: Sandra Gabaldón	Date: August 26, 2014	Time: 1424 hours
City/County: Las Cruces / Dona Ana		State: New Mexico
Location: City of Las Cruces East Mesa Water Reclamation Facility		
Subject: West aeration basin

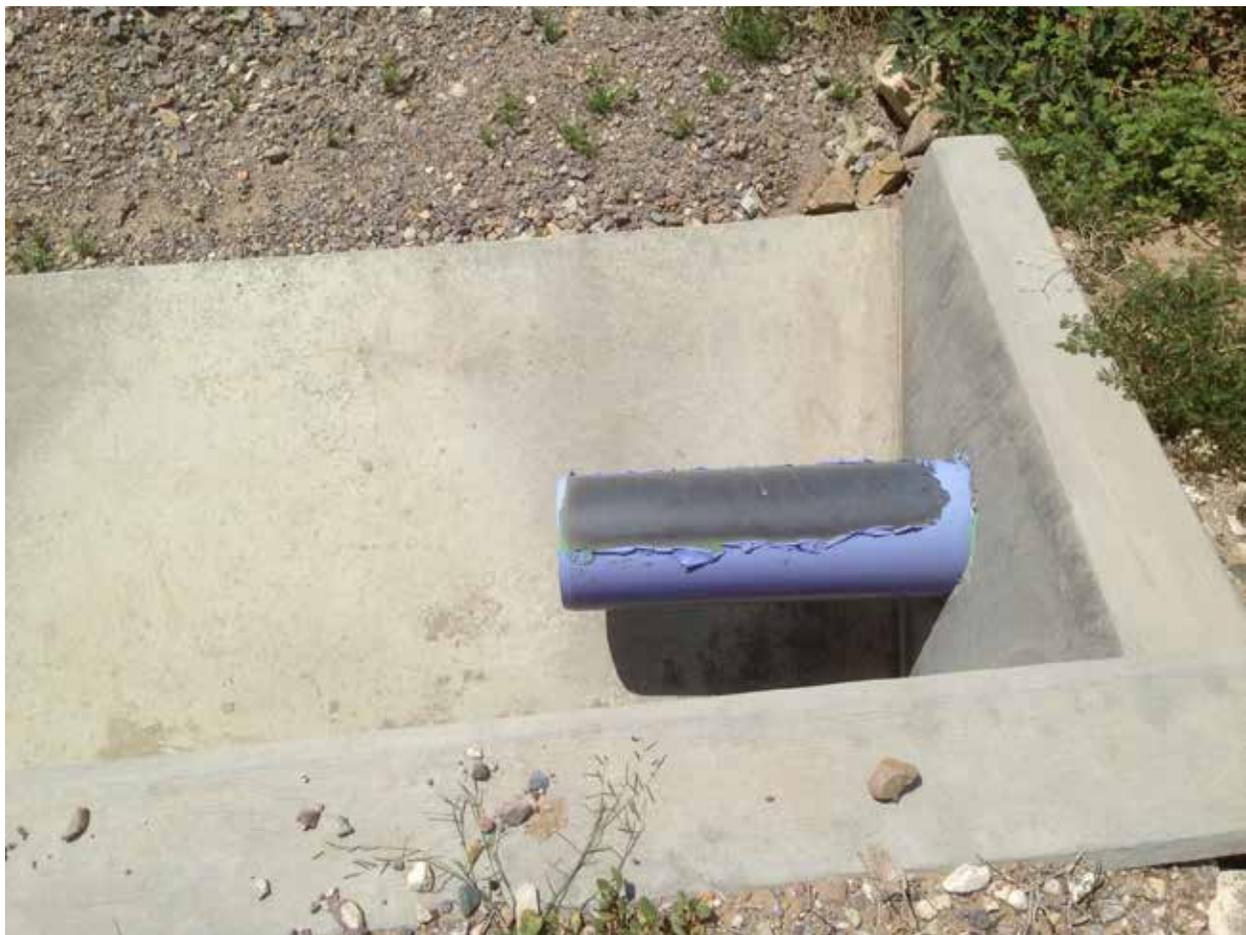
NMED/SWQB
Official Photograph Log
Photo # 3

Photographer: Sandra Gabaldón	Date: August 26, 2014	Time: 1424 hours
City/County: Las Cruces / Dona Ana		State: New Mexico
Location: City of Las Cruces East Mesa Water Reclamation Facility		
Subject: Discharge pipe
