**Re: GCC Rio Grande, Inc.; Tijeras Plant; MSGP; SIC 3241; NPDES Compliance Evaluation Inspection; NMR05GD23; March 18 & 19, 2015**

### NPDES Compliance Inspection Report

**GCC Rio Grande, Inc. - Tijeras Plant  
Compliance Evaluation Inspection  
NPDES Tracking No. NMR05GD23  
March 18 and 19, 2015**

**RE: Compliance Evaluation Inspection, Industrial Stormwater Multi-Sector General Permit, GCC Rio Grande, Inc. – Tijeras Plant (NPDES Tracking Number #NMR05GD23), January 5, 2010**

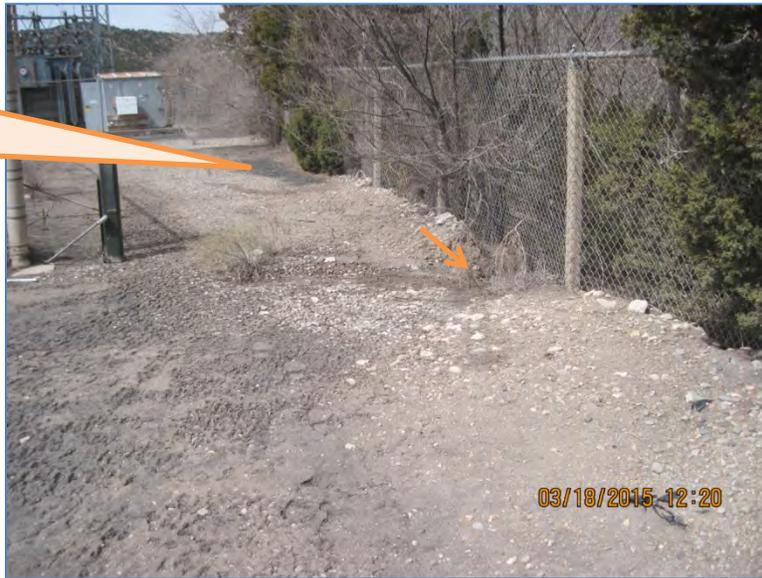
<b>NMED/SWQB            Official Photograph Log            Photo # 1</b>		
Photographer: Erin S. Trujillo	Date: 03/18/2015	Time: 1220 hours
City/County: Tijeras / Bernalillo County		State: New Mexico
Location: GCC Rio Grande, Inc. / Tijeras Plant / NPDES Tracking No. NMR05GD23		
Subject: Looking generally west-northwest, arrow points to channel (conveyance) starting at north facility fence.

Example of dark soils along north facility fence

- The plant site map (attached) did not include the following from Part 5.1.2 Site Description, SWPPP, Site Map of the 2008 Permit:
  - directions of stormwater flow (use arrows) north of the coal silo and PNM substation, including the access road from northwest of the PNM Station toward #1 Well House (see Photos #1, 2 and 3).

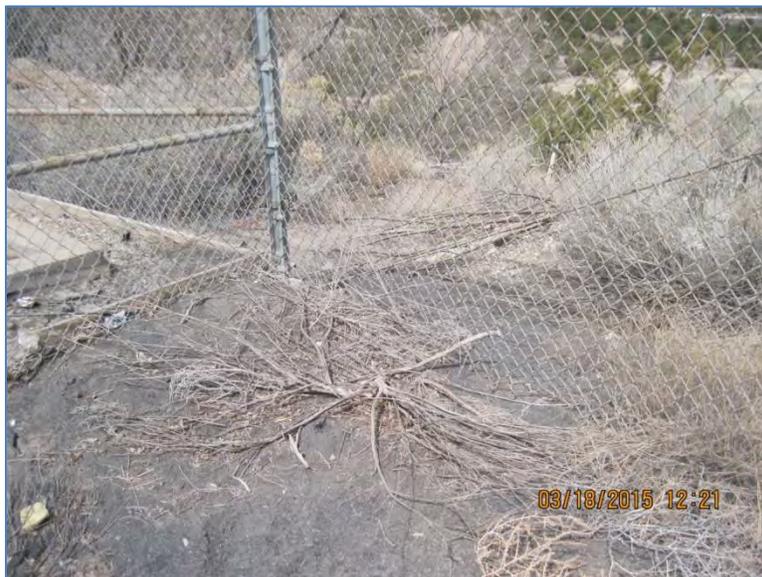
<b>NMED/SWQB            Official Photograph Log            Photo # 2</b>		
Photographer: Erin S. Trujillo	Date: 03/18/2015	Time: 1221 hours
City/County: Tijeras / Bernalillo County		State: New Mexico
Location: GCC Rio Grande, Inc. / Tijeras Plant / NPDES Tracking No. NMR05GD23		
Subject: Example of darker soils (similar to observed coal dust or solids) near PNM substation along (both within and outside) the north facility fence.

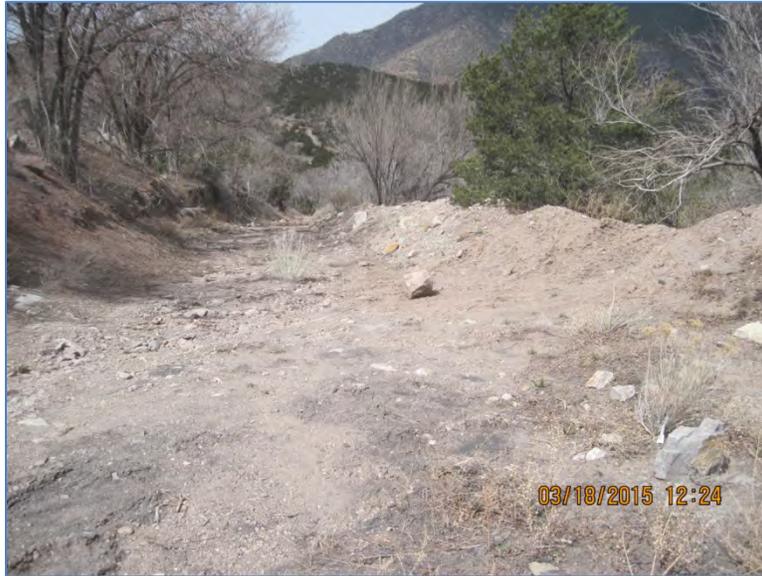
<b>NMED/SWQB            Official Photograph Log            Photo # 3</b>		
Photographer: Erin S. Trujillo	Date: 03/18/2015	Time: 1224 hours
City/County: Tijeras / Bernalillo County		State: New Mexico
Location: GCC Rio Grande, Inc. / Tijeras Plant / NPDES Tracking No. NMR05GD23		
Subject: Access road north and west of PNM substation.

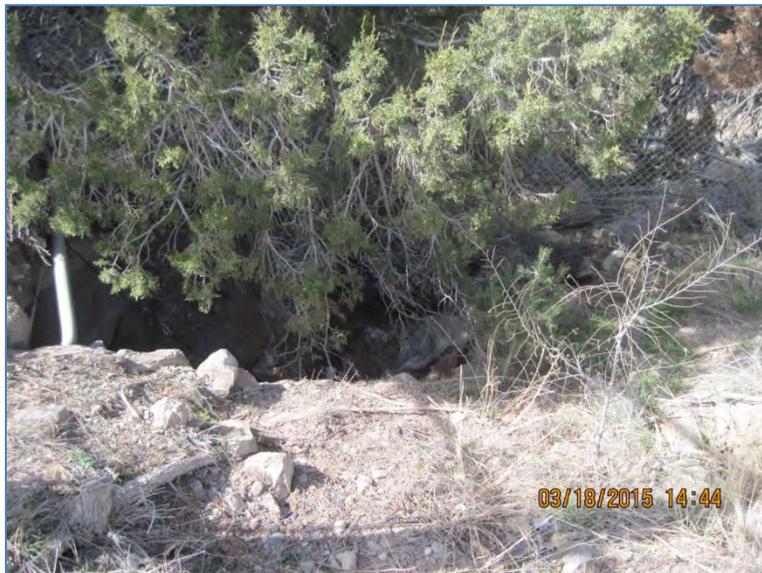
<b>NMED/SWQB            Official Photograph Log            Photo # 4</b>		
Photographer: Erin S. Trujillo	Date: 03/18/2015	Time: 1444 hours
City/County: Tijeras / Bernalillo County		State: New Mexico
Location: GCC Rio Grande, Inc. / Tijeras Plant / NPDES Tracking No. NMR05GD23		
Subject: Location of outlet of culvert inlet Outfall 002 that is outside the facility fence. This photo is provided to compare with Photo #7 in previous 2010 CEI report when it had recently snowed.

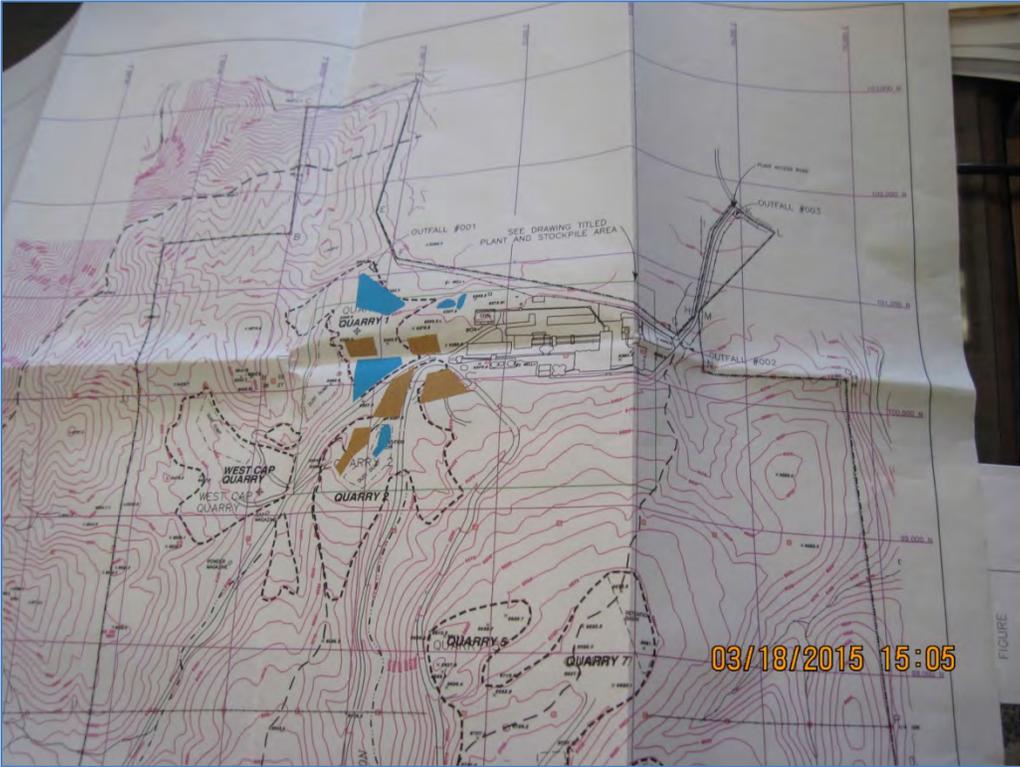
<b>NMED/SWQB</b> <b>Official Photograph Log</b> <b>Photo # 5</b>		
Photographer: Erin S. Trujillo	Date: 03/18/2015	Time: 1505 hours
City/County: Tijeras / Bernalillo County		State: New Mexico
Location: GCC Rio Grande, Inc. / Tijeras Plant / NPDES Tracking No. NMR05GD23		
Subject: Larger map provided by on-site permittee representatives during this CEI has additional information than the map available during previous 2010 CEI (e.g., notation to see drawing titled plant and stockpile area).

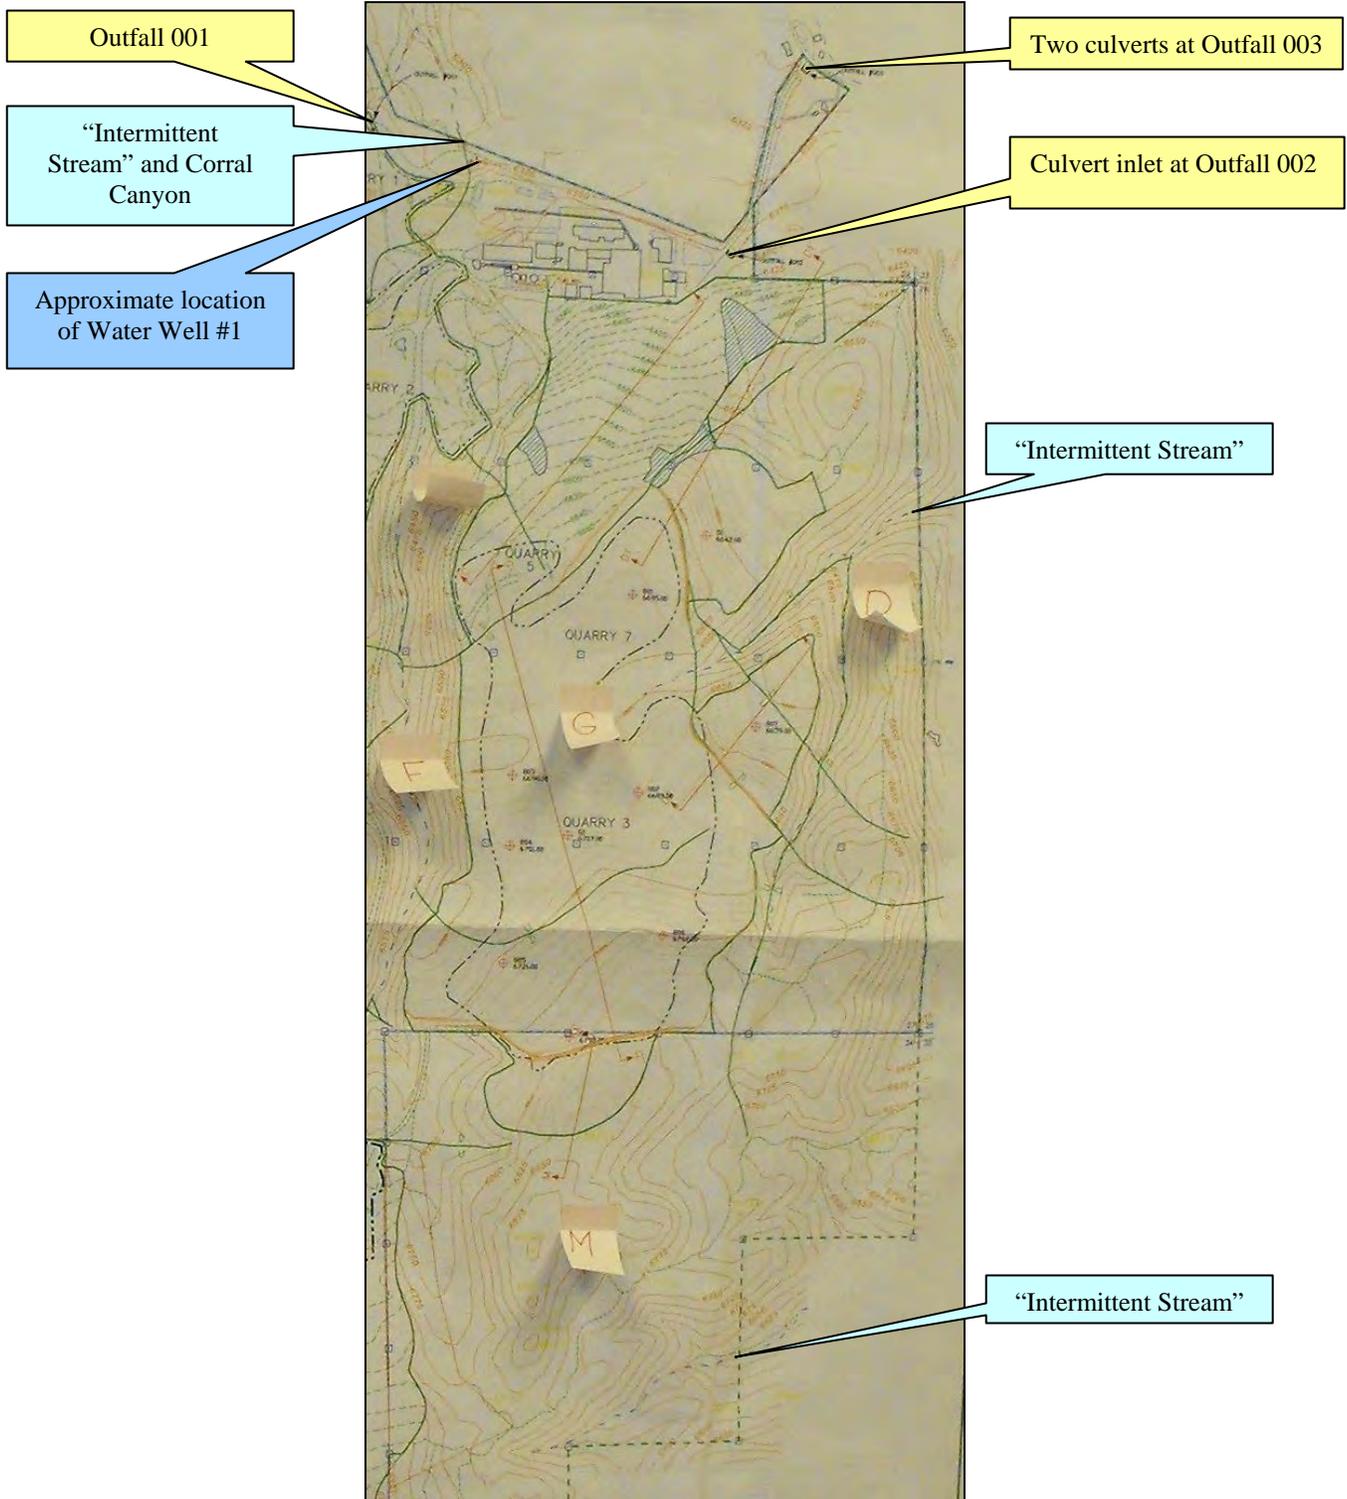
**NMED/SWQB  
Official Photograph Log  
Photo # 1**

Photographer: Daniel Valenta	Date: 01/05/2010	Time: 0936 hours
City/County: Tijeras/Bernalillo County		State: New Mexico
Location: GCC Rio Grande, Inc. – Tijeras Plant		
Subject: Portion of facility wall map (GCC's Design Limits of Quarry Units dated 11/29/95) showing outfalls and intermittent streams. The original photo has been cropped for this report.

Industrial activities at the GCC meet the descriptions in both Sector E - Glass, Clay, Cement, Concrete, and Gypsum Product Facilities (Standard Industrial Code or SIC 3241) and Sector J - Non-Metallic Mineral Mining and Dressing Activities (SIC 1499) of the 2008 MSGP. Drainage along the northern property boundary and unpaved access road to water well #1 is not toward Quarry #1 Pond and Outfall 001, but is contained by earth berms. East of the cement silo storage and truck scale house, drainage of the paved areas is to the southeast toward a ditch open to culvert inlet Outfall 002 with an outlet outside the facility fence (Photos 1, 3, 4 and 7). Stormwater of the mining claim area south of the plant would also flow toward culvert inlet identified as Outfall 002. Along the entrance paved access road, drainage is to two culverts at identified as Outfall 003 that cross east under NM 377 (Photos 1 and 5). North of the facility

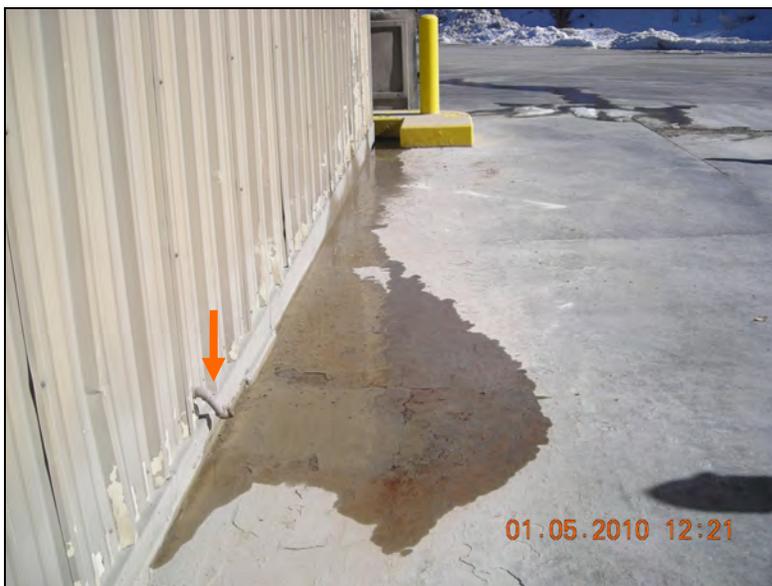
**NMED/SWQB  
Official Photograph Log  
Photo # 2**

Photographer: Erin Trujillo	Date: 01/05/2010	Time: 1221 hours
City/County: Tijeras/Bernalillo County	State: New Mexico	
Location: GCC Rio Grande, Inc. – Tijeras Plant		
Subject: Arrow points to pipe that is used to dewater cement storage silos/truck scale house outside onto paved area.

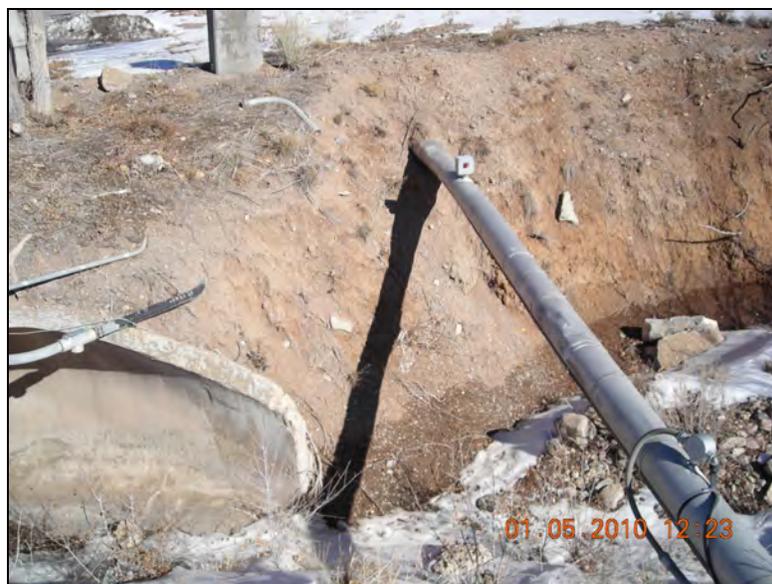
**NMED/SWQB  
Official Photograph Log  
Photo # 3**

Photographer: Erin Trujillo	Date: 01/05/2010	Time: 1223 hours
City/County: Tijeras/Bernalillo County	State: New Mexico	
Location: GCC Rio Grande, Inc. – Tijeras Plant		
Subject: Location of culvert inlet Outfall 002

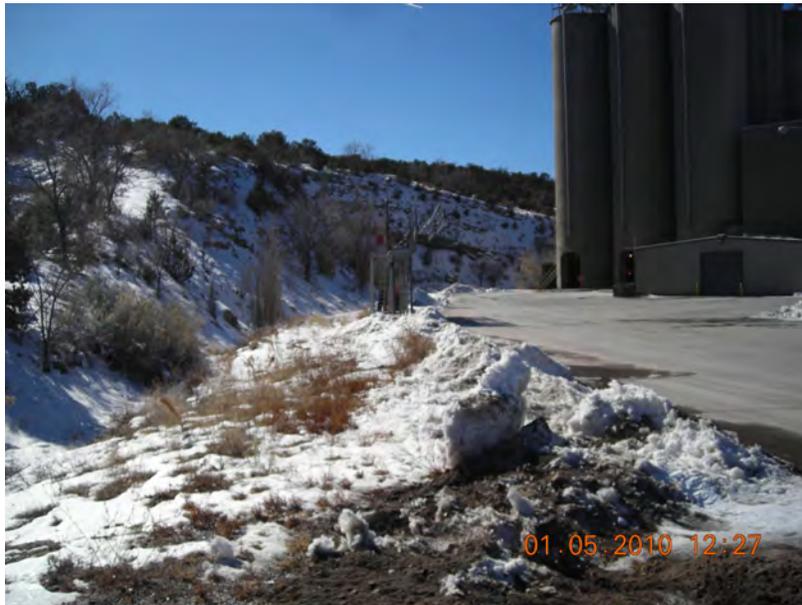
**NMED/SWQB  
Official Photograph Log  
Photo # 4**

Photographer: Erin Trujillo	Date: 01/05/2010	Time: 1227 hours
City/County: Tijeras/Bernalillo County		State: New Mexico
Location: GCC Rio Grande, Inc. – Tijeras Plant		
Subject: Ditch south of plant that is open to Outfall 002

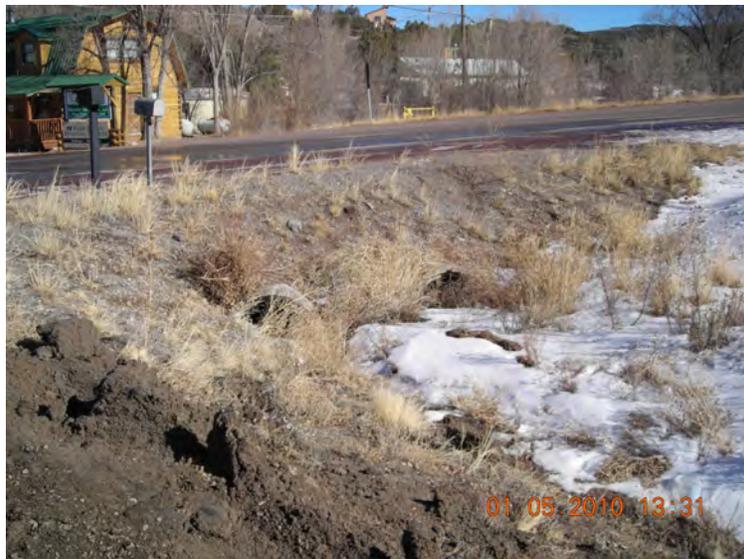
**NMED/SWQB  
Official Photograph Log  
Photo # 5**

Photographer: Erin Trujillo	Date: 01/05/2010	Time: 1331 hours
City/County: Tijeras/Bernalillo County		State: New Mexico
Location: GCC Rio Grande, Inc. – Tijeras Plant		
Subject: Two culverts crossing NM 377 at Outfall 003 south of entrance

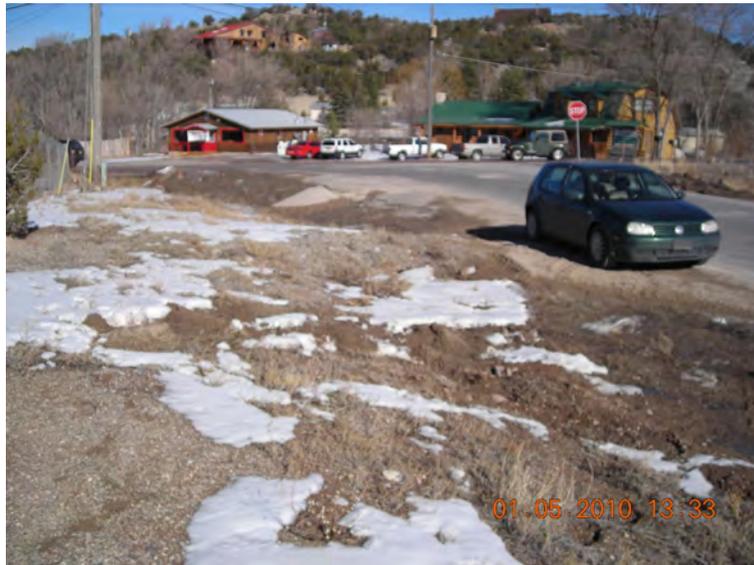
**NMED/SWQB  
Official Photograph Log  
Photo # 6**

Photographer: Erin Trujillo	Date: 01/05/2010	Time: 1333 hours
City/County: Tijeras/Bernalillo County	State: New Mexico	
Location: GCC Rio Grande, Inc. – Tijeras Plant		
Subject: Area along NM 377 north of entrance

entrance, drainage would be north toward ditches along NM 377 (Photo 6). Based on information from the permittee's on-site representative and review of available topography and aerial photography maps, exploration to determine the financial viability of a site and land disturbance activities have occurred through out the facility's mining claim area. Unpaved roads are shown on USGS topography maps and on the facility wall maps in areas labeled D and M (Photo 1). Topography shown on the facility wall map indicate that drainage from portions of area D is toward the culvert inlet Outfall 002. Also, drainage from portions of area D and M is toward two unnamed intermittent streams that both flow to the eastern property boundary of the facility and offsite.

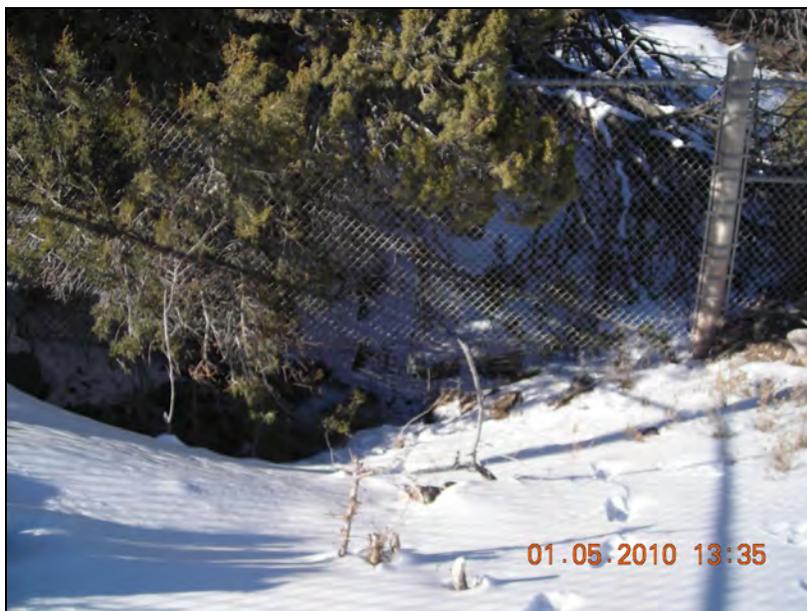
**NMED/SWQB  
Official Photograph Log  
Photo # 7**

Photographer: Erin Trujillo	Date: 01/05/2010	Time: 1335 hours
City/County: Tijeras/Bernalillo County	State: New Mexico	
Location: GCC Rio Grande, Inc. – Tijeras Plant		
Subject: Location of outlet of culvert inlet Outfall 002 that is outside the facility fence

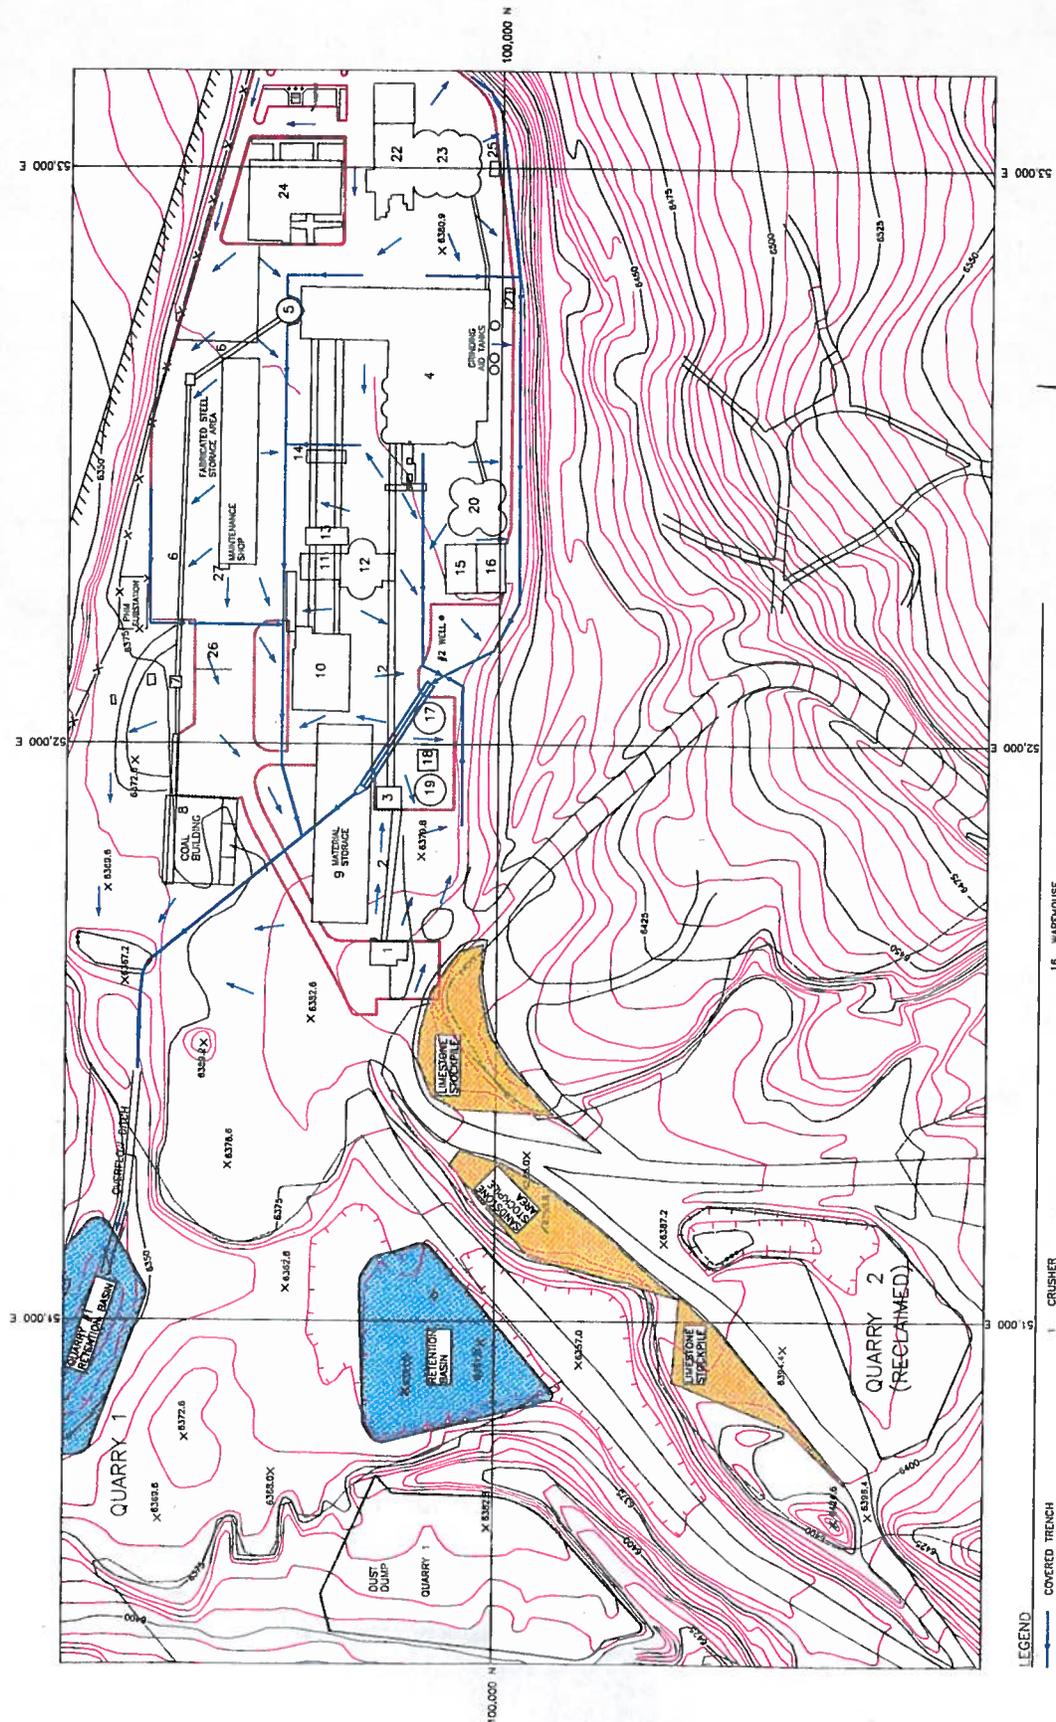
**GCC Rio Grande, Inc. Plant Site Map**

- locations of all stormwater conveyances along the north fence and possibly along the access road from northwest of the PNM Station toward #1 Well House. These conveyances may be additional stormwater monitoring points/outfalls.
