Re: Parkhill Estates Subdivision Phase 3B1, Construction Storm Water, SIC 1541, NPDES Compliance
Evaluation Inspection, NPDES Permit NMR12B162, August 3, 2015

NPDES Compliance Inspection Report

Official Photograph Log

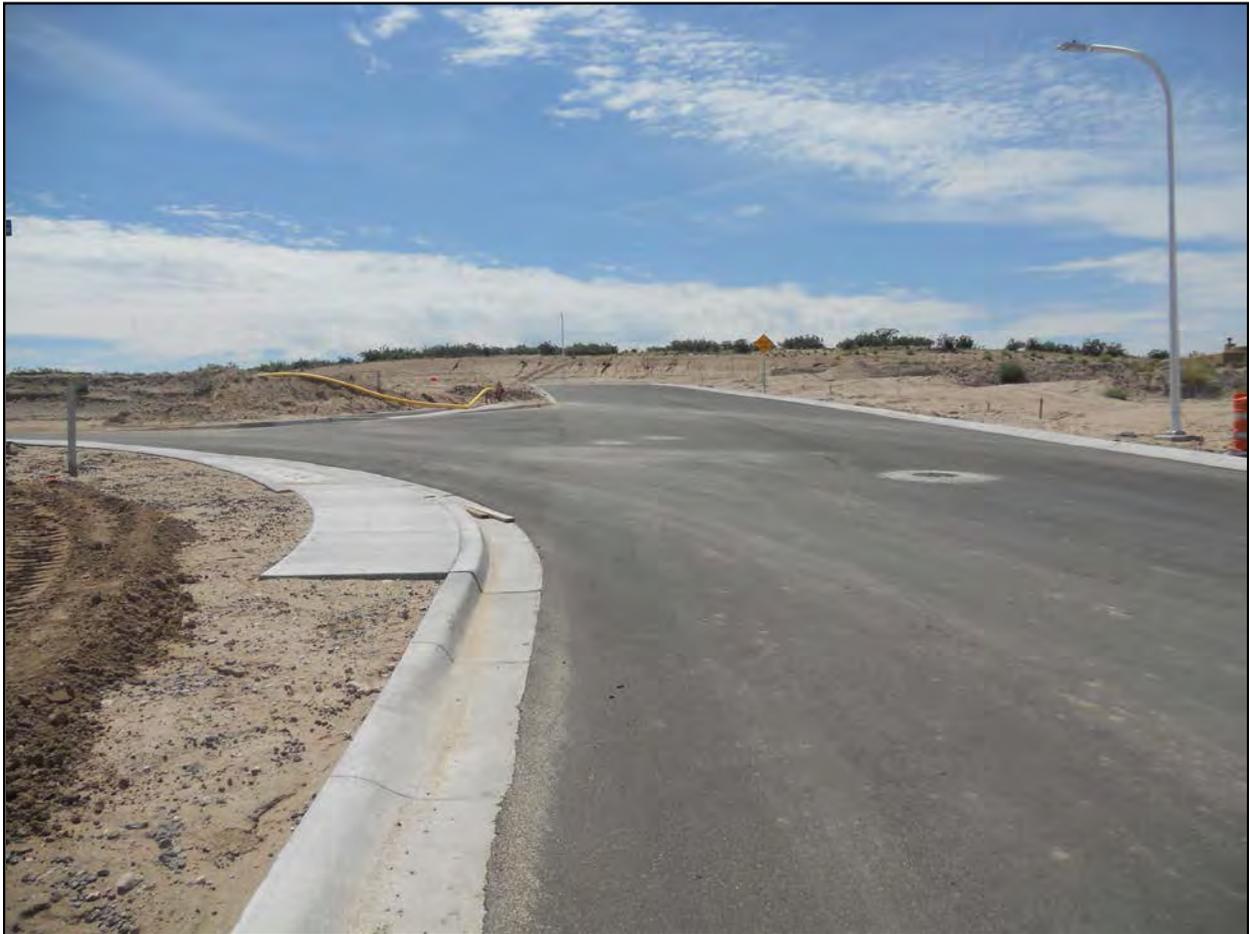
Photo # 1

Photographer: Sarah Holcomb	Date: 8-3-2015	Time: 1133 hours
City/County: Las Cruces, Dona Ana County		
Location: Parkhill Estates Subdivision, Phase 3B1		
Subject: General lack of BMPs on site. Facing South. At the far end of the street, there is an unstabilized slope with evident rilling.

<p>Describes erosion and sediment control maintenance requirements?</p> <ul style="list-style-type: none"> ➤ Initiates fix immediately and completed by close of next work day (routine maintenance) Y/N ➤ Installs new measure/significant repair no later than 7 calendar days or document why infeasible Y/N <p><i>Part 2.1.1.4</i></p>	Y	<input type="checkbox"/> N	
<p>Installs perimeter controls and describes maintenance (removes sediment before it has accumulated to 1/2 of the above-ground height)?</p> <p><i>Part 2.1.2.2</i></p>	<input type="checkbox"/> Y	N	
<p>Minimizes sediment track-out?</p> <ul style="list-style-type: none"> ➤ Restricts vehicle use to properly designated exit points? Y/N ➤ Uses appropriate stabilization techniques at all points that exit onto paved roads? Y/N ➤ Where necessary, uses additional measures to remove sediment prior to exit? Y/N/NA ➤ Removes tracked out sediment prior to the end of the same work day or if occurs on non-work day the next work day? Y/N <p><i>Part 2.1.2.3</i></p>	Y	<input type="checkbox"/> N	There were no perimeter BMPs located on site. Please see Photo #1

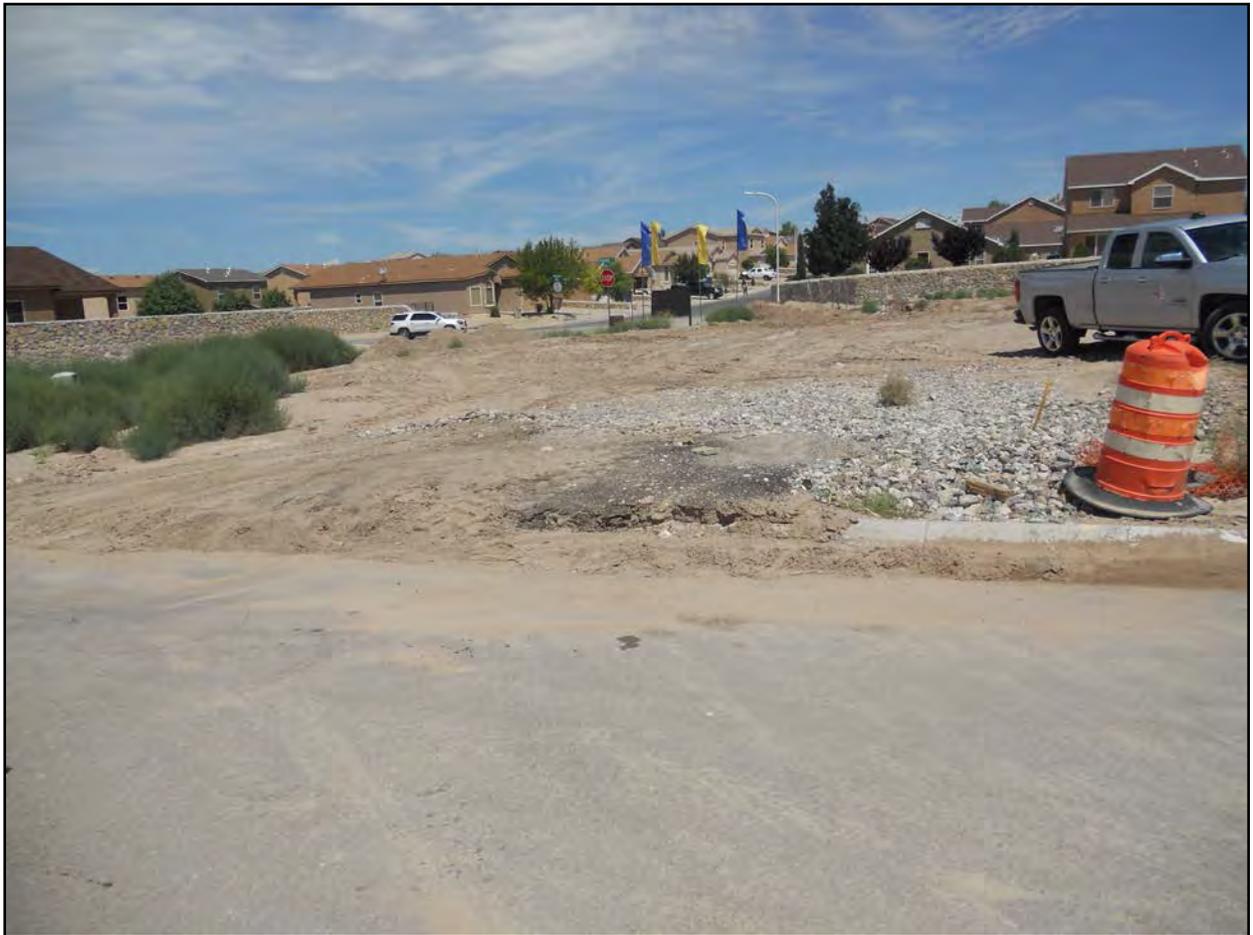
Photo # 2

Photographer: Sarah Holcomb	Date: 8-3-2015	Time: 1142 hours
City/County: Las Cruces, Dona Ana County		
Location: Parkhill Estates Subdivision, Phase 3B1		
Subject: Stabilized entrance. Note the amount of dirt covering the entrance, which needed replacement.

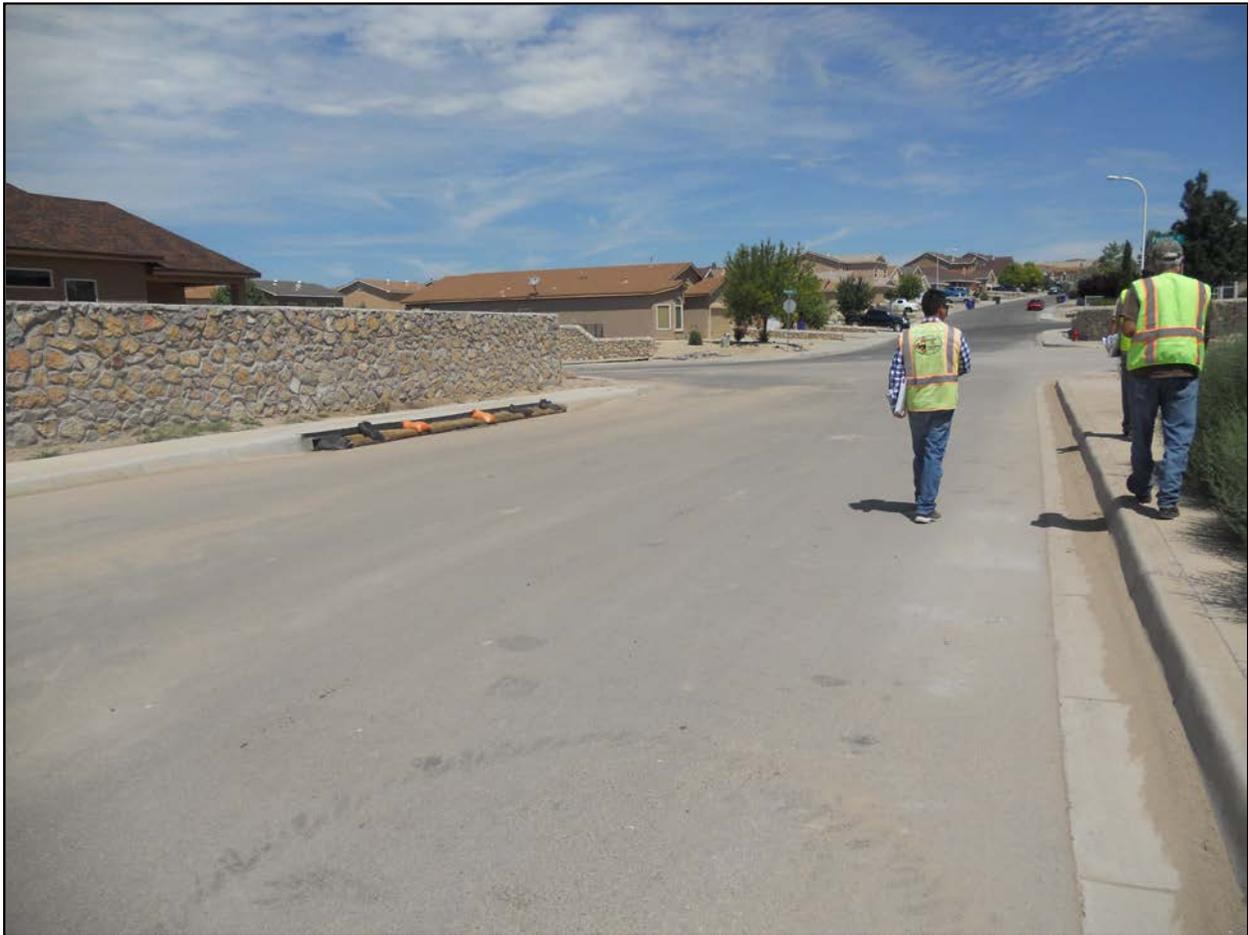
Photo # 3

Photographer: Sarah Holcomb	Date: 8-3-2015	Time: 1143 hours
City/County: Las Cruces, Dona Ana County		
Location: Parkhill Estates Subdivision, Phase 3B1		
Subject: Sediment tracked out from the site onto adjacent streets, then flowing down onto Parkhill Drive. Note the amount of sediment in the gutter on the right.

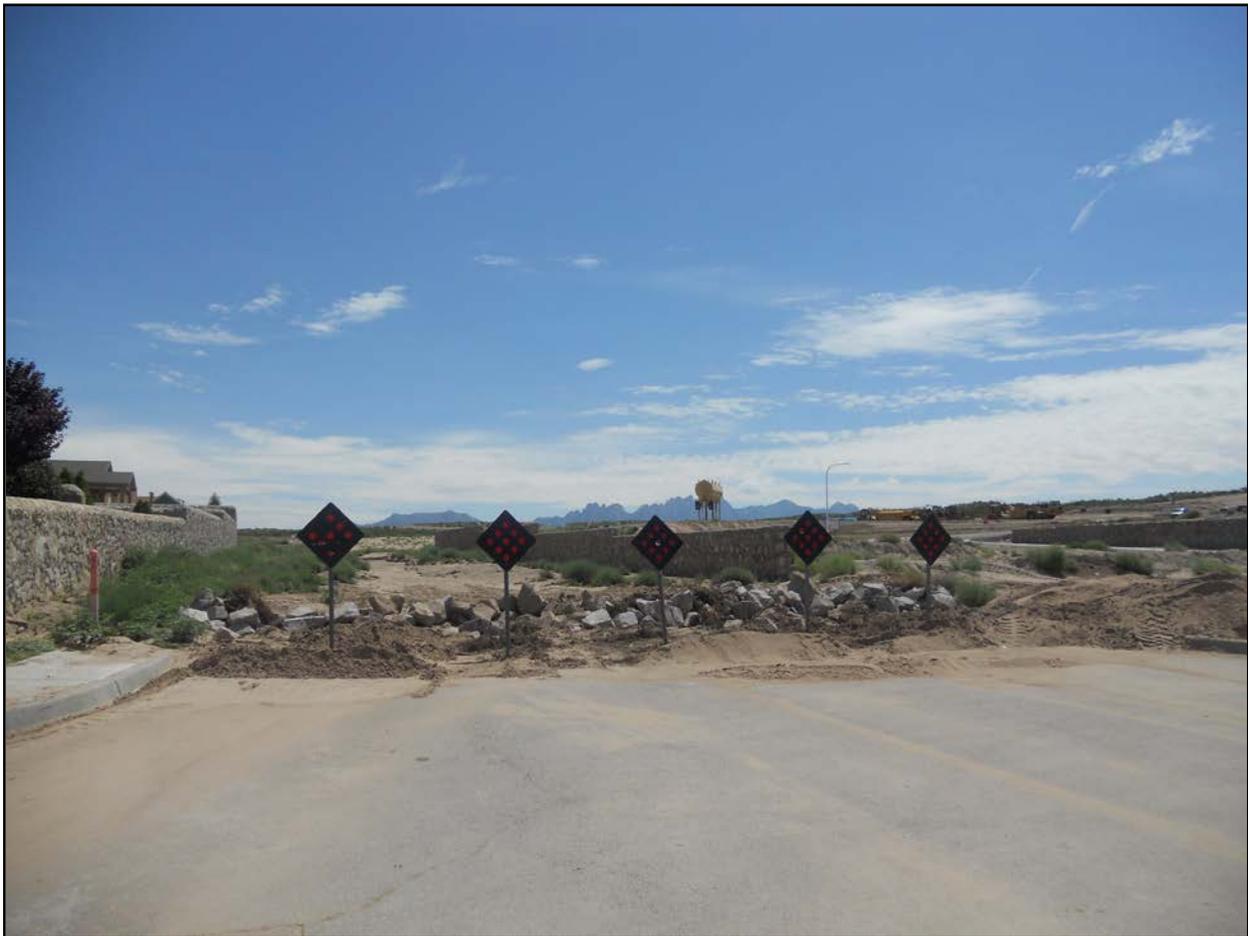
Photo # 4

Photographer: Sarah Holcomb	Date: 8-3-2015	Time: 1147 hours
City/County: Las Cruces, Dona Ana County		
Location: Parkhill Estates Subdivision, Phase 3B1		
Subject: Area where Parkhill Drive abuts the Moreno Arroyo. There is a small section of rock wall on the right that separates the construction project from the arroyo but does not continue all the way east to the end of the project. The plans specify that Parkhill Drive will be continued east to connect with Rinconada Blvd.

<p>Properly maintains and protects all pollution prevention controls?</p> <p><i>Part 2.3.2</i></p>	Y	<input type="checkbox"/> N	The only BMP noted on site was the rockered entrance, which needed replacement. Please see Photo #4.
<p>Complies with pollution prevention standards for certain activities?</p> <ul style="list-style-type: none"> ➤ Fueling/maintenance of equipment or vehicles <input checked="" type="checkbox"/> Y/N/NA ➤ Washing of equipment and vehicles Y/N/<input checked="" type="checkbox"/> NA ➤ Storage, handling, disposal of materials, products and waste <input checked="" type="checkbox"/> Y/N/NA ➤ Washing applicators/containers Y/N/<input checked="" type="checkbox"/> NA <p><i>Part 2.3.3</i></p>	<input checked="" type="checkbox"/> Y	N	
<p>Minimizes discharge/complies with restrictions of <u>fertilizer application</u>?</p> <p><i>Part 2.3.5</i></p>	Y	N	NA

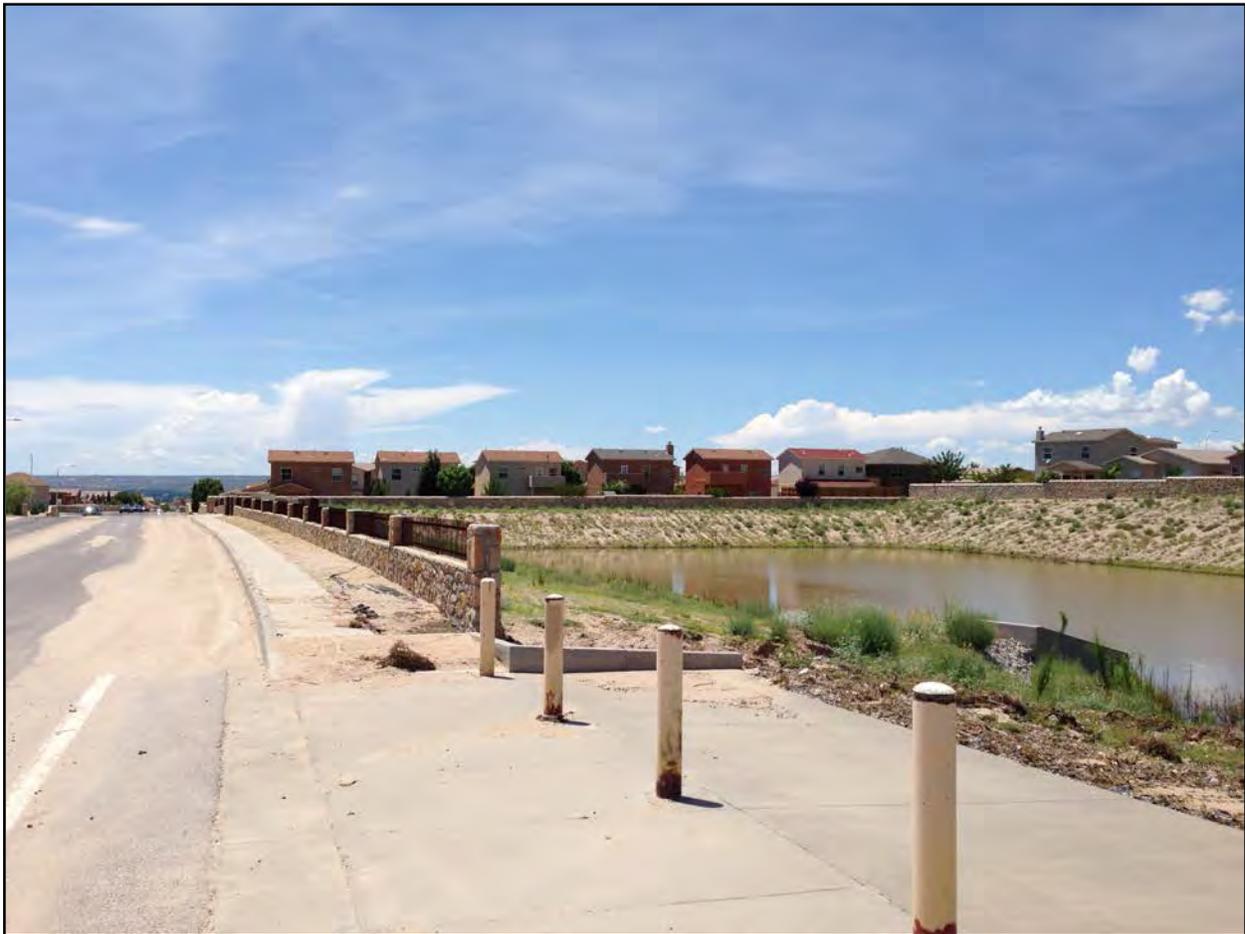
Photo # 5

Photographer: Peter Bennett	Date: 8-4-2015	Time: 1345 hours
City/County: Las Cruces, Dona Ana County		
Location: Parkhill Estates Subdivision, Phase 3B1		
Subject: Overview of Parkhill Estates Pond, which is approximately 0.5 miles downstream from the construction site. Note the sediment in the road, which also may be from the Moreno Arroyo above.
