**Re: Galles and Davis Motor Company Illicit Discharge; Major; MS4; SIC 5201; NPDES Compliance Evaluation Inspection; NMS000101; March 12, 2014**

### NPDES Compliance Inspection Report

**Galles and Davis Motor Company, Inc.**  
**Compliance Evaluation Inspection**  
**NPDES Permit No. NMS000101**  
**March 12, 2014**

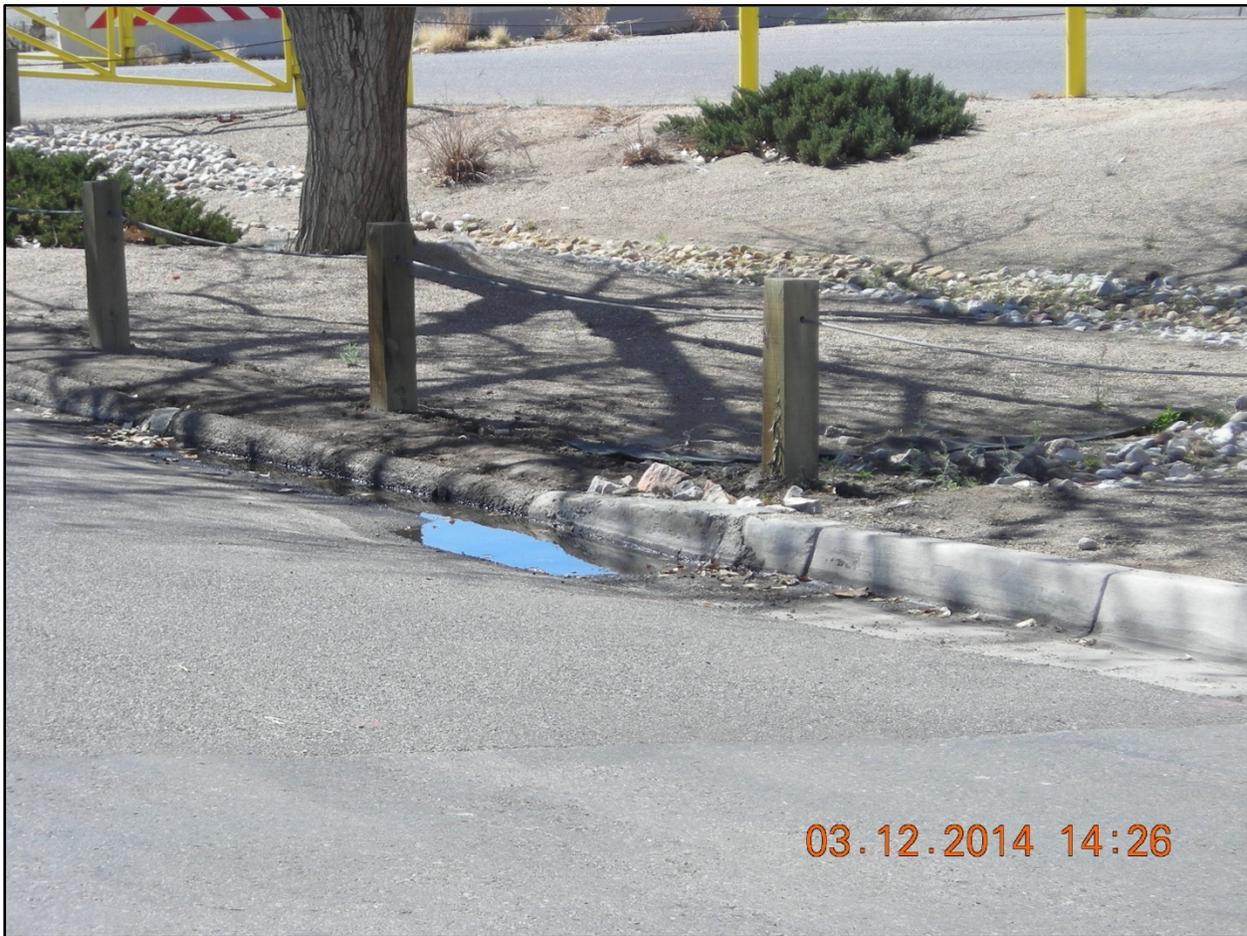
**NMED/SWQB  
Official Photograph Log  
Photo # 1**

During the onsite inspection, Mr. Davis informed the inspectors that engine washing is no longer occurring outdoors. The facility has a specific enclosed washing area with its own sump, which is pumped on a routine basis by a contract hauler. The car wash area's discharge consists primarily of water. Mr. Davis thought that at one time a biodegradable soap had been utilized in the operation of the car wash, but was informed by his employees that this is no longer the case. The vehicles are washed only with water, which mostly stays in the wash bay. There is some water that escapes the bay and travels to the discharge area, but Mr. Davis showed the inspectors where he had eliminated the possibility of a routine discharge by building up the concrete berm in that area. (Please see photo #1.)

Photographer: Sarah Holcomb	Date: 3-11-2014	Time: 1426 hours
City/County: Albuquerque, Bernalillo County		
Location: Galles and Davis Motor Company on San Mateo		
Subject: The curbing was built up at the facility to prevent a discharge of water from the car wash into NMDOT's right of way.

Based on these observations, the NMED inspectors were satisfied that with the cessation of the engine washing and the elimination of the potential to discharge from the vehicle wash bay that NMDOT's concerns were mitigated.
