**RE: NPDES Construction Storm Water, SIC 1542, NPDES Compliance Evaluation Inspection,  
The Brott Corporation / A-1 Self Storage, Rio Rancho, NMU001693, November 12, 2010**

**NPDES Construction Storm Water Compliance Evaluation Inspection**  
**A-1 Self Storage Expansion, Rio Rancho**  
**The Brott Corporation (NMU001693) and DKM Construction, Inc. (NMU001694)**  
**November 12, 2010**

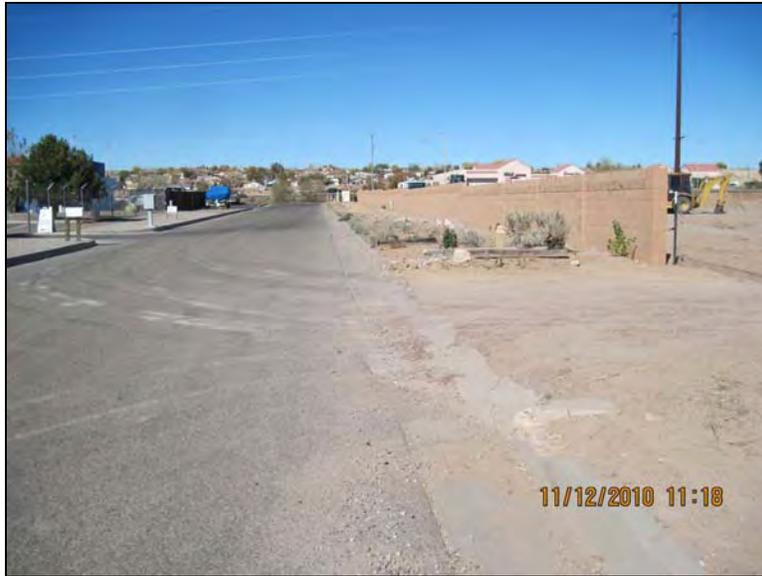
| <b>NMED/SWQB<br/> Official Photograph Log<br/> Photo # 3</b> | | |

| <b>NMED/SWQB<br/> Official Photograph Log<br/> Photo # 3</b> | | |
|---|---|---|
| Subject: Off-site accumulated sediment from vehicle tracking at construction site entrance shown in previous photo. | | |

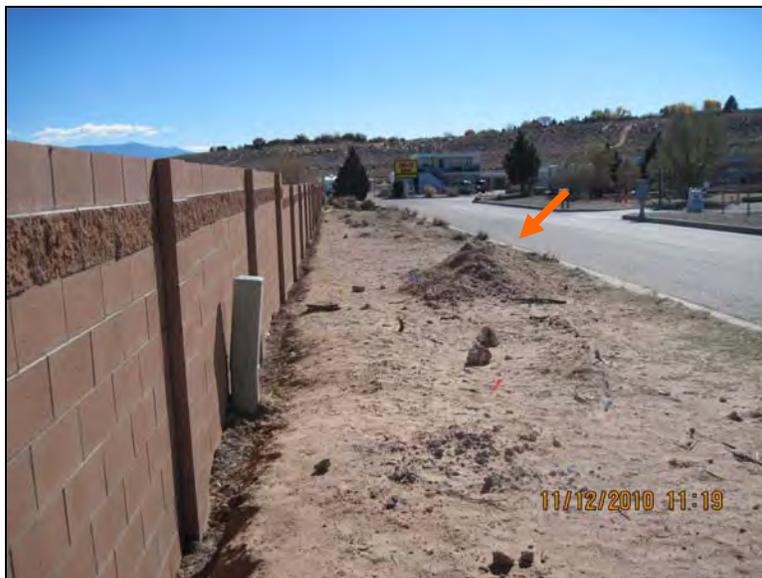
| <b>NMED/SWQB<br/> Official Photograph Log<br/> Photo # 4</b> | | |

| <b>NMED/SWQB<br/> Official Photograph Log<br/> Photo # 4</b> | | |
|---|---|---|
| Subject: Soil disturbance south of wall. Arrow points to soil stockpile that appears to be from trenching activities. | | |

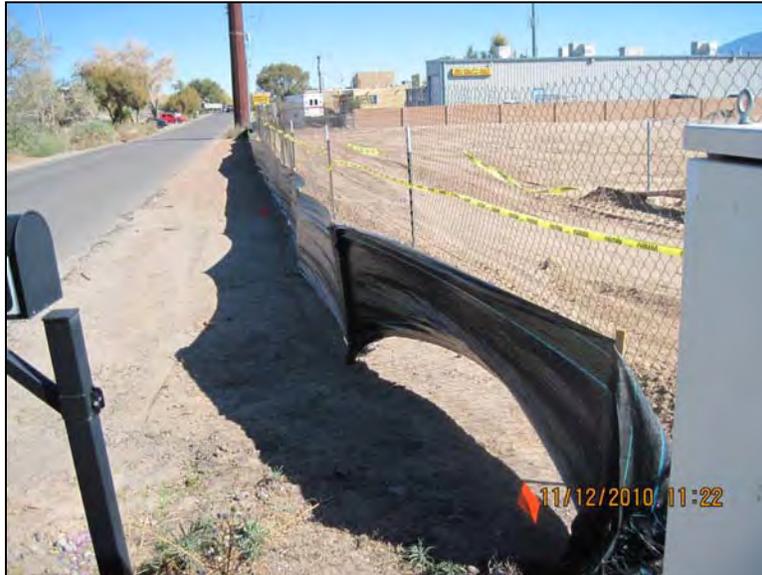
| <b>NMED/SWQB<br/>Official Photograph Log<br/>Photo # 5</b> | | |

| Subject: Silt fence along western property boundary that is not trenched. There is also a gap at white electrical box (right side of photo). | | |

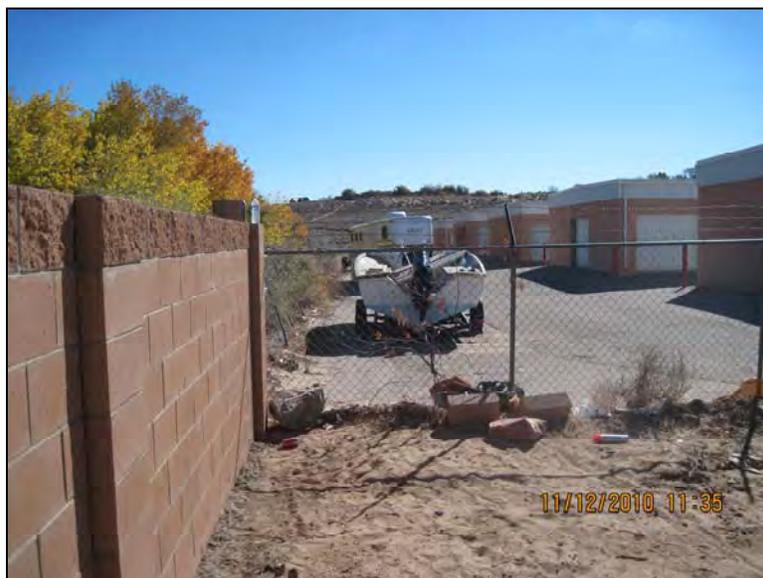
| <b>NMED/SWQB</b><br><b>Official Photograph Log</b><br><b>Photo # 7</b> | | |

Construction materials stored in an on-site metal building were protected from rain and precipitation. But, some windblown construction trash and debris was at the fence in the northeast corner of the construction site. Some accumulated sediment from vehicle tracking was also observed off-site. There were also no erosion or sediment control, or stabilization measures for stockpiles. There were no erosion or sediment control measures along the eastern property boundary where discharges would be off-site toward a tributary and a sediment retention pond on the owner’s adjacent storage facility property, thence to Arroyo de los Montoyas. Silt fence along the west site boundary was not trenched and contained gaps; therefore, this measure would not provide erosion or sediment control for the construction site. It is possible that the silt fence along the western boundary was intended to serve other purposes (e.g., wind block, additional site access control), but there was no SWPPP to document the selection, design, installation, and implementation of control measures. If not properly managed or minimized in accordance with the USEPA’s NPDES CGP, pollutants in stormwater and allowable non-stormwater discharges from this construction activity, would be a potential threat to water quality.

| <b>NMED/SWQB</b><br><b>Official Photograph Log</b><br><b>Photo # 7</b> | | |
|---|---|---|
| Subject: Accumulated trash (paint can, water bottle, cardboard boxes and bags) in northeast corner of site. Most site drainage appears toward this corner, thence off-site toward tributary along northern property boundary and sedimentation pond in owner's adjacent property, thence to Arroyo de los Montoyas. | | |

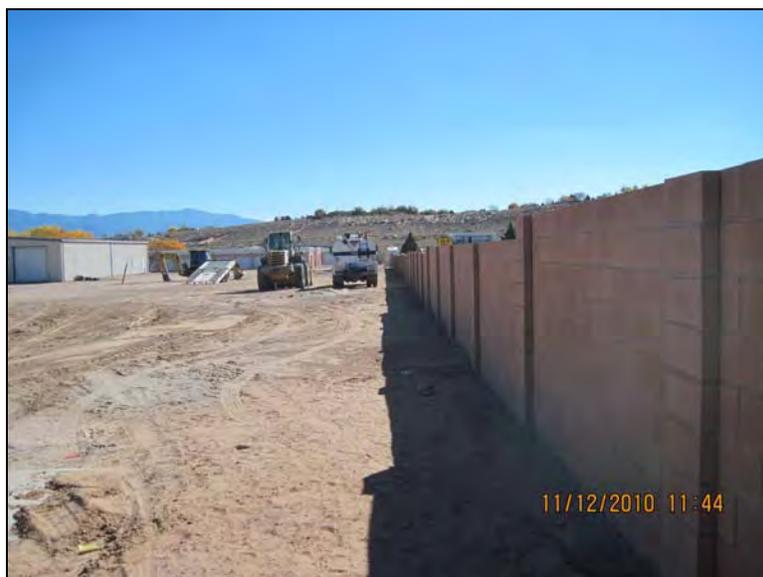
| <b>NMED/SWQB</b><br><b>Official Photograph Log</b><br><b>Photo # 8</b> | | |

| <b>NMED/SWQB</b><br><b>Official Photograph Log</b><br><b>Photo # 8</b> | | |
|--|---|---|
| Subject: Overall photo showing wall, equipment staging/storage, and soil disturbance visible from southwest corner of construction site. | | |
