NEW MEXICO
ENVIRONMENT DEPARTMENT

RE: NPDES Construction Storm Water, SIC 1542, NPDES Compliance Evaluation Inspection, DKM Construction, Inc. / A-1 Self Storage, Rio Rancho, NMU001694, November 12, 2010

NPDES Compliance Inspection Report

NPDES Construction Storm Water Compliance Evaluation Inspection
A-1 Self Storage Expansion, Rio Rancho
The Brott Corporation (NMU001693) and DKM Construction, Inc. (NMU001694)
November 12, 2010

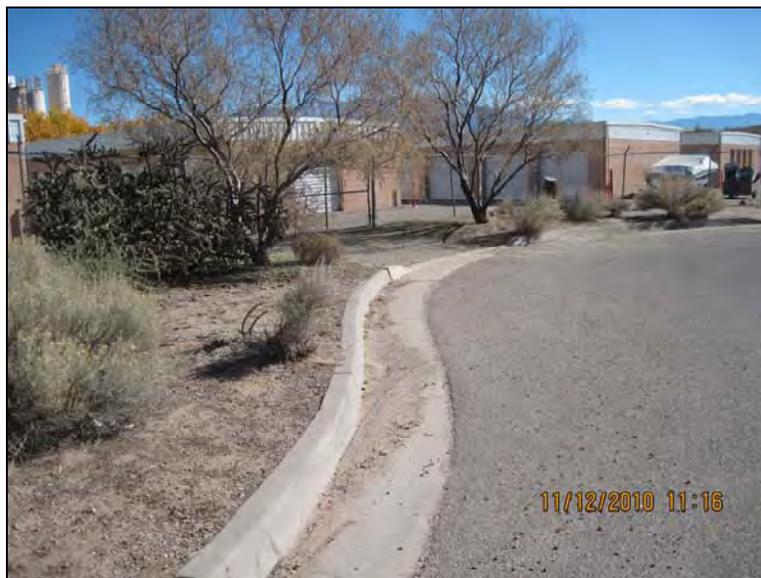
NMED/SWQB Official Photograph Log Photo # 1		
Photographer: Erin Trujillo	Date: 11/12/2010	Time: 1116 hours
City/County: Rio Rancho / Sandoval County		State: New Mexico
Location: A-1 Self Storage Expansion, Industrial Park Place, Rio Rancho		
Subject: Off-site accumulated sediment and gravel in off-site cul-de-sac near construction entrance. Discharge from cul-de-sac is towards a stormwater drain inlet not shown in photo.

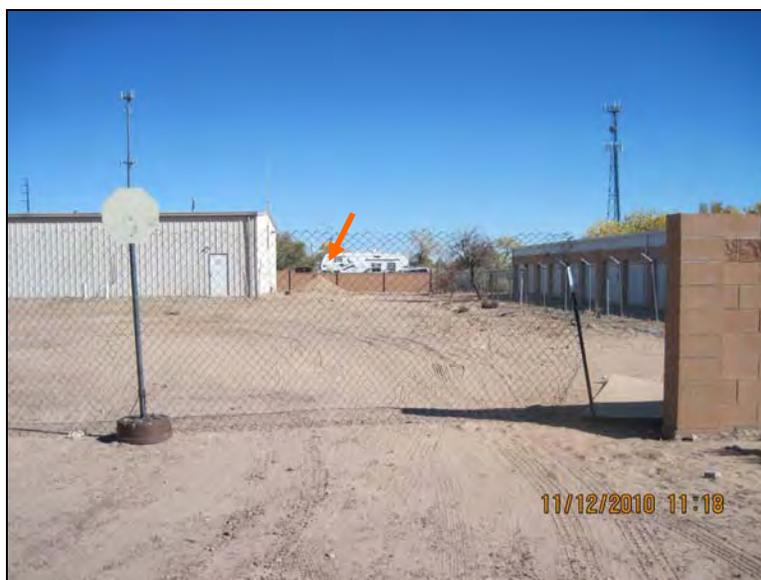
NMED/SWQB Official Photograph Log Photo # 2		
Photographer: Erin Trujillo	Date: 11/12/2010	Time: 1118 hours
City/County: Rio Rancho / Sandoval County		State: New Mexico
Location: A-1 Self Storage Expansion, Industrial Park Place, Rio Rancho		
Subject: Arrow points to stockpile in northeast corner of construction site. Operator on-site representative stated that initial clearing and preliminary grading occurred along this eastern boundary. Site entrance did not have track out control measures.

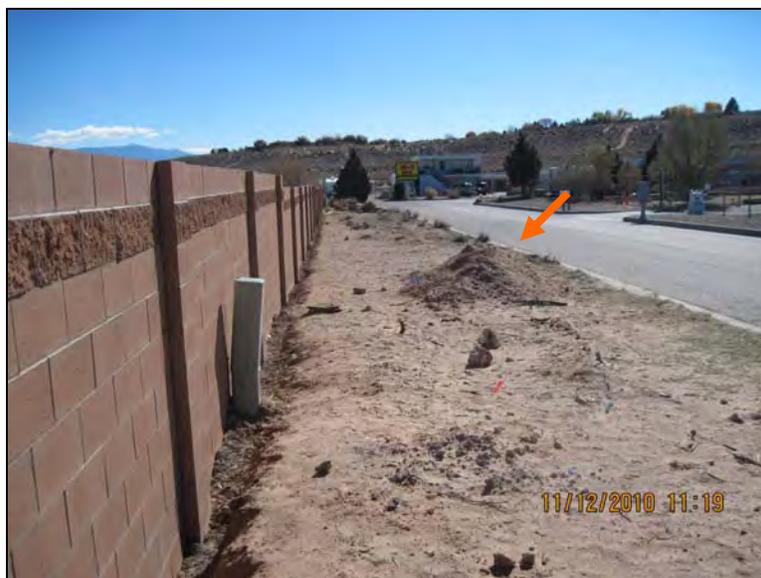
NMED/SWQB Official Photograph Log Photo # 4		
Photographer: Erin Trujillo	Date: 11/12/2010	Time: 1119 hours
City/County: Rio Rancho / Sandoval County		State: New Mexico
Location: A-1 Self Storage Expansion, Industrial Park Place, Rio Rancho		
Subject: Soil disturbance south of wall. Arrow points to soil stockpile that appears to be from trenching activities.

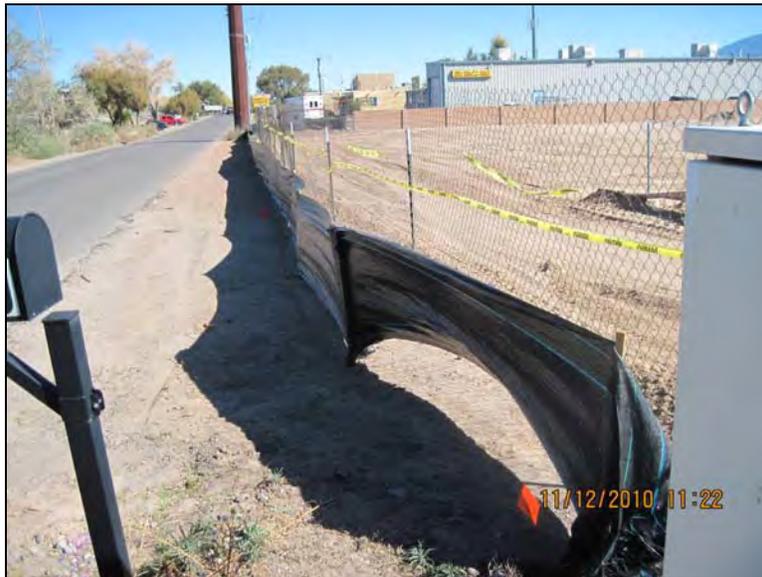
NMED/SWQB Official Photograph Log Photo # 5		
Photographer: Erin Trujillo	Date: 11/12/2010	Time: 1122 hours
City/County: Rio Rancho / Sandoval County		State: New Mexico
Location: A-1 Self Storage Expansion, Industrial Park Place, Rio Rancho		
Subject: Silt fence along western property boundary that is not trenched. There is also a gap at white electrical box (right side of photo).

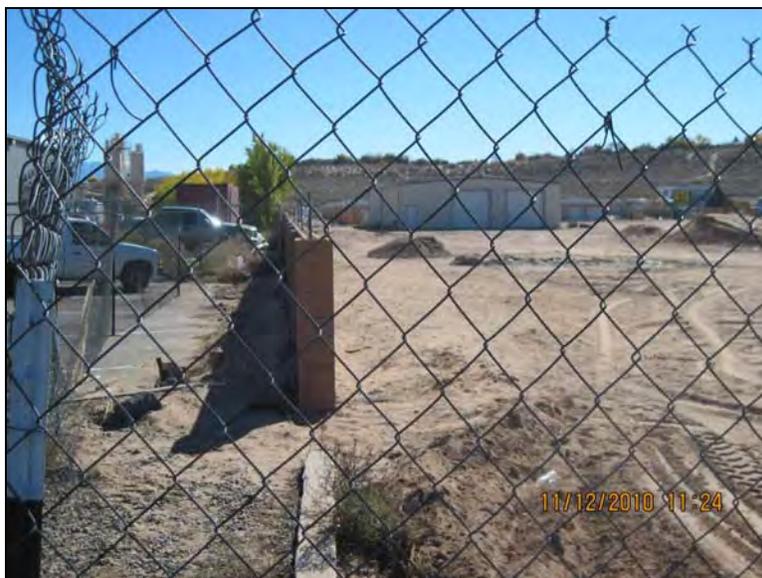
NMED/SWQB Official Photograph Log Photo # 6		
Photographer: Erin Trujillo	Date: 11/12/2010	Time: 1124 hours
City/County: Rio Rancho / Sandoval County		State: New Mexico
Location: A-1 Self Storage Expansion, Industrial Park Place, Rio Rancho		
Subject: Overall photo showing unfinished wall along northern property boundary, on-site stockpiles and soil disturbance visible from northwest corner of construction site.

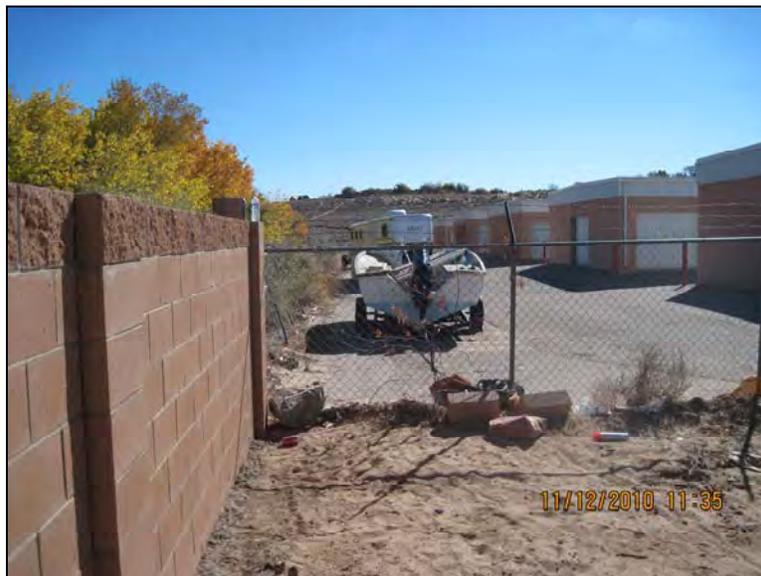
Construction materials stored in an on-site metal building were protected from rain and precipitation. But, some windblown construction trash and debris was at the fence in the northeast corner of the construction site. Some accumulated sediment from vehicle tracking was also observed off-site. There were also no erosion or sediment control, or stabilization measures for stockpiles. There were no erosion or sediment control measures along the eastern property boundary where discharges would be off-site toward a tributary and a sediment retention pond on the owner’s adjacent storage facility property, thence to Arroyo de los Montoyas. Silt fence along the west site boundary was not trenched and contained gaps; therefore, this measure would not provide erosion or sediment control for the construction site. It is possible that the silt fence along the western boundary was intended to serve other purposes (e.g., wind block, additional site access control), but there was no SWPPP to document the selection, design, installation, and implementation of control measures. If not properly managed or minimized in accordance with the USEPA’s NPDES CGP, pollutants in stormwater and allowable non-stormwater discharges from this construction activity, would be a potential threat to water quality.

NMED/SWQB Official Photograph Log Photo # 7		
Photographer: Erin Trujillo	Date: 11/12/2010	Time: 1135 hours
City/County: Rio Rancho / Sandoval County		State: New Mexico
Location: A-1 Self Storage Expansion, Industrial Park Place, Rio Rancho		
Subject: Accumulated trash (paint can, water bottle, cardboard boxes and bags) in northeast corner of site. Most site drainage appears toward this corner, thence off-site toward tributary along northern property boundary and sedimentation pond in owner's adjacent property, thence to Arroyo de los Montoyas.

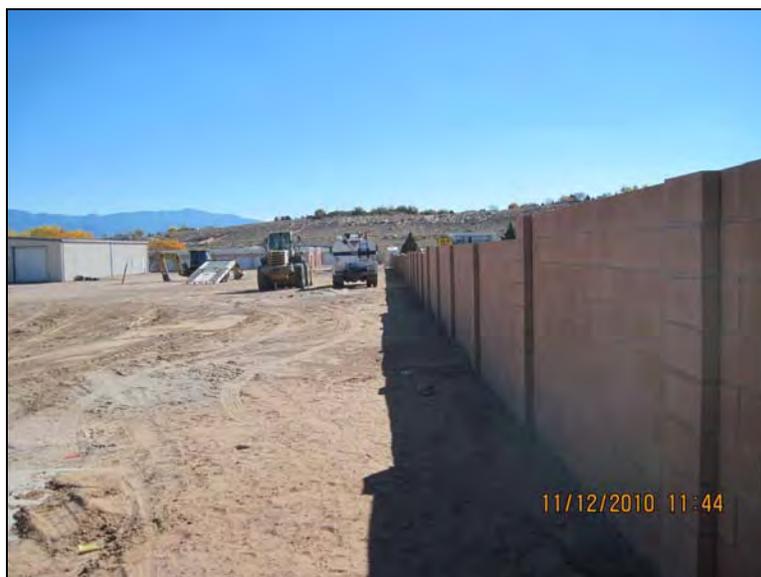
NMED/SWQB Official Photograph Log Photo # 8		
Photographer: Erin Trujillo	Date: 11/12/2010	Time: 1144 hours
City/County: Rio Rancho / Sandoval County		State: New Mexico
Location: A-1 Self Storage Expansion, Industrial Park Place, Rio Rancho		
Subject: Overall photo showing wall, equipment staging/storage, and soil disturbance visible from southwest corner of construction site.
