**Re: Storm Water Compliance Inspection; SIC 3273; NPDES Multi-Sector General Permit
#NMU001708; January 27, 2011**

NPDES Compliance Inspection Report

Compliance Evaluation Inspection
B.T.U. Block & Concrete, Inc.
January 27, 2011
NMU001708

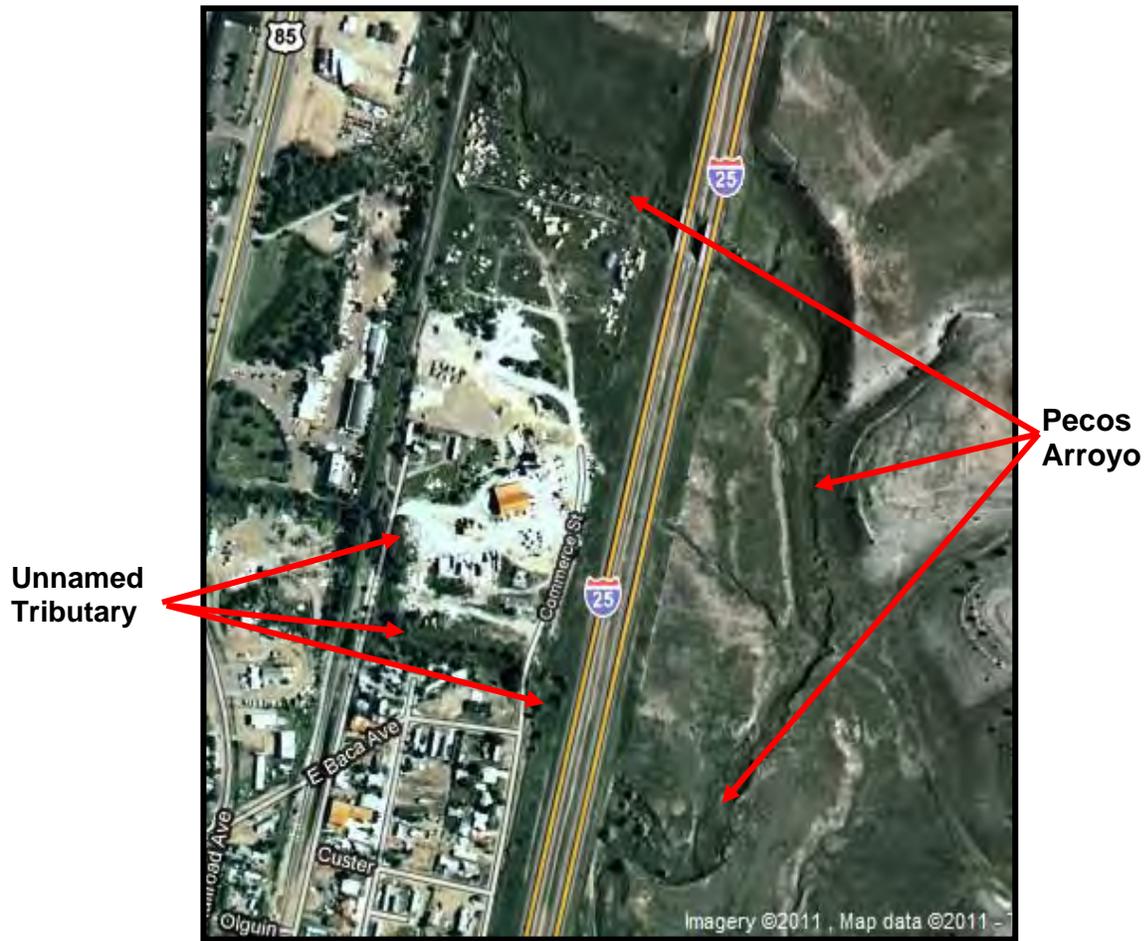
Satellite Overview

City/County: Las Vegas/San Miguel
Subject: Las Vegas operation of B.T.U. Block & Concrete, Inc. Unnamed tributary joins the Pecos Arroyo which joins Gallinas creek approximately 3miles south of site.

The active portion of the property is estimated to be 17 acres, the site borders on the north with a scrap/storage area, (see site overview). The majority of the north and east side of the property are bermed or high in elevation. There is a small containment pond at the northwest corner and a discharge point to the Pecos Arroyo at the northeast corner, (see photo 1). According to the SWPPP this is the only outfall from the site although the south side of the site slopes to the south. The discharge outfall is to the Pecos Arroyo in Water Quality Segment 20.6.4.221 NMAC (*State of New Mexico Standards for Interstate and Intrastate Surface Water*) and not to the Gallinas River as described in the SWPPP. The designated uses for this segment are: warm water aquatic life, secondary contact, livestock watering, and wildlife habitat.

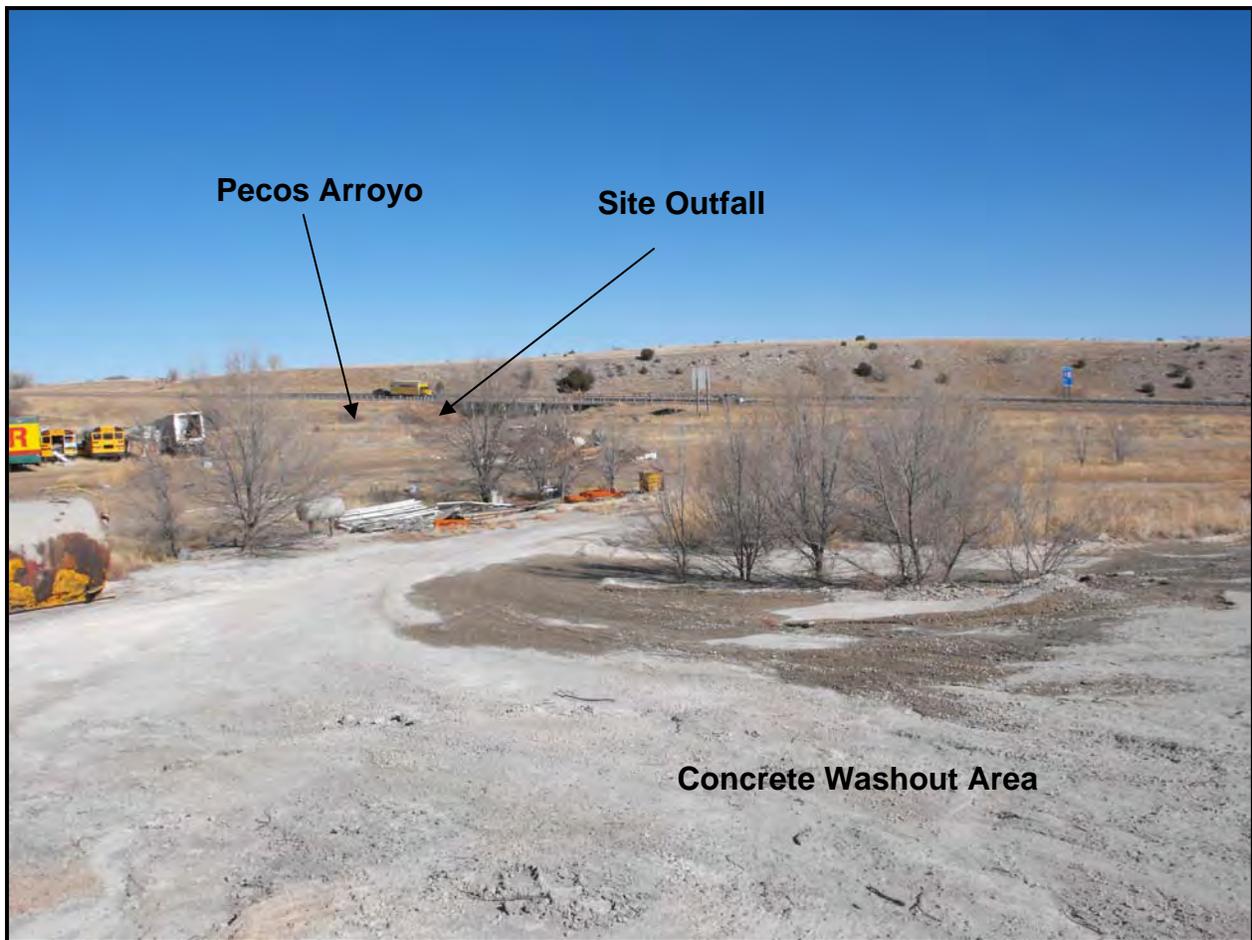
Photo # 1

Photographer: Daniel Valenta	Date: 1/27/2011	Time: 1338 hours
City/County: Las Vegas/San Miguel County		
Location:	1500 North Commerce, Las Vegas, New Mexico, B.T. U. Block & Concrete, Inc. northeast corner of property, facing northeast.	
Subject:	On the north side of the property trucks are washed out. The site outfall as described in the SWPPP is located here as it enters the Pecos Arroyo.

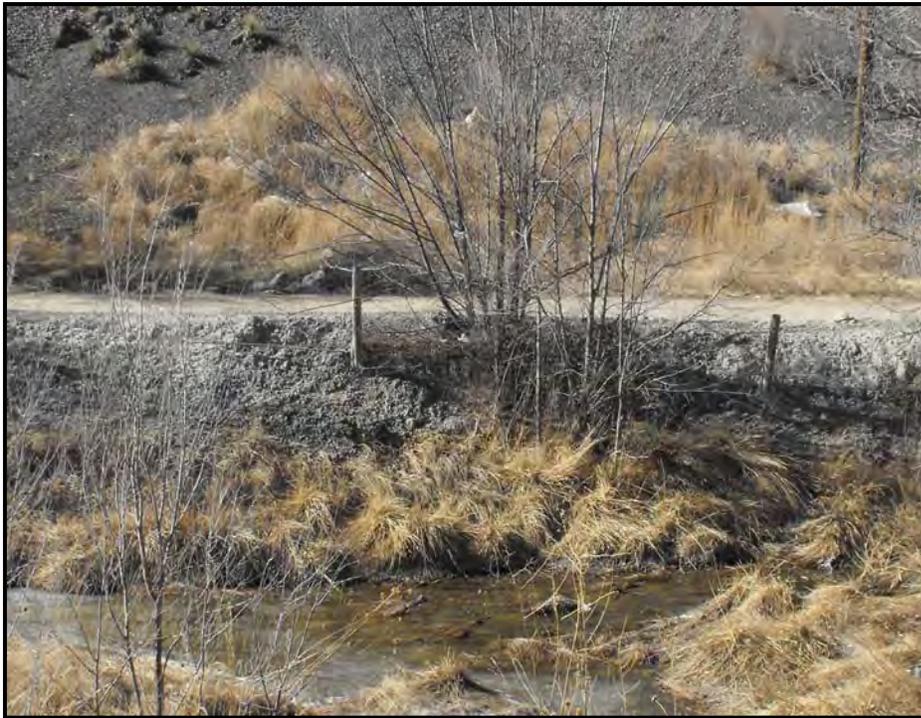
Photo # 2

Photographer: Daniel Valenta	Date: 1/27/2011	Time: 1357 hours
City/County: Las Vegas/San Miguel County		
Location: North end of Garfield Ave, Las Vegas, New Mexico, B.T. U. Block & Concrete, Inc. main entrance to site, west side of property, facing west.		
Subject: Along the sides of the north end of Garfield Ave. before entering the BTU main gate, cement appears to be poured or discarded along the edges of the road.

There is an unnamed tributary to the Pecos Arroyo that comes in from the west, crosses under Garfield Ave., runs parallel to the road for a short distance (see photo 2) and then forms a small wetland (see photo 3) before crossing under I-25 to join the Pecos Arroyo. It is unknown at the present time if this stream is supplied by groundwater or springs, it was flowing on the day of the inspection. Mr. Sonchar stated the road belonged to the city and they maintain it. The sides of the road appeared to be covered with concrete, (see photo 2). The south side of the site was bermed at one time but has not been maintained. Mixed piles of concrete/sediment have been dumped at the south west corner and pushed towards the unnamed tributary, (see photo 3). The main entrance/exit road is Garfield Ave. The road is not paved and dead ends at the entrance to BTU, (see photo 4).

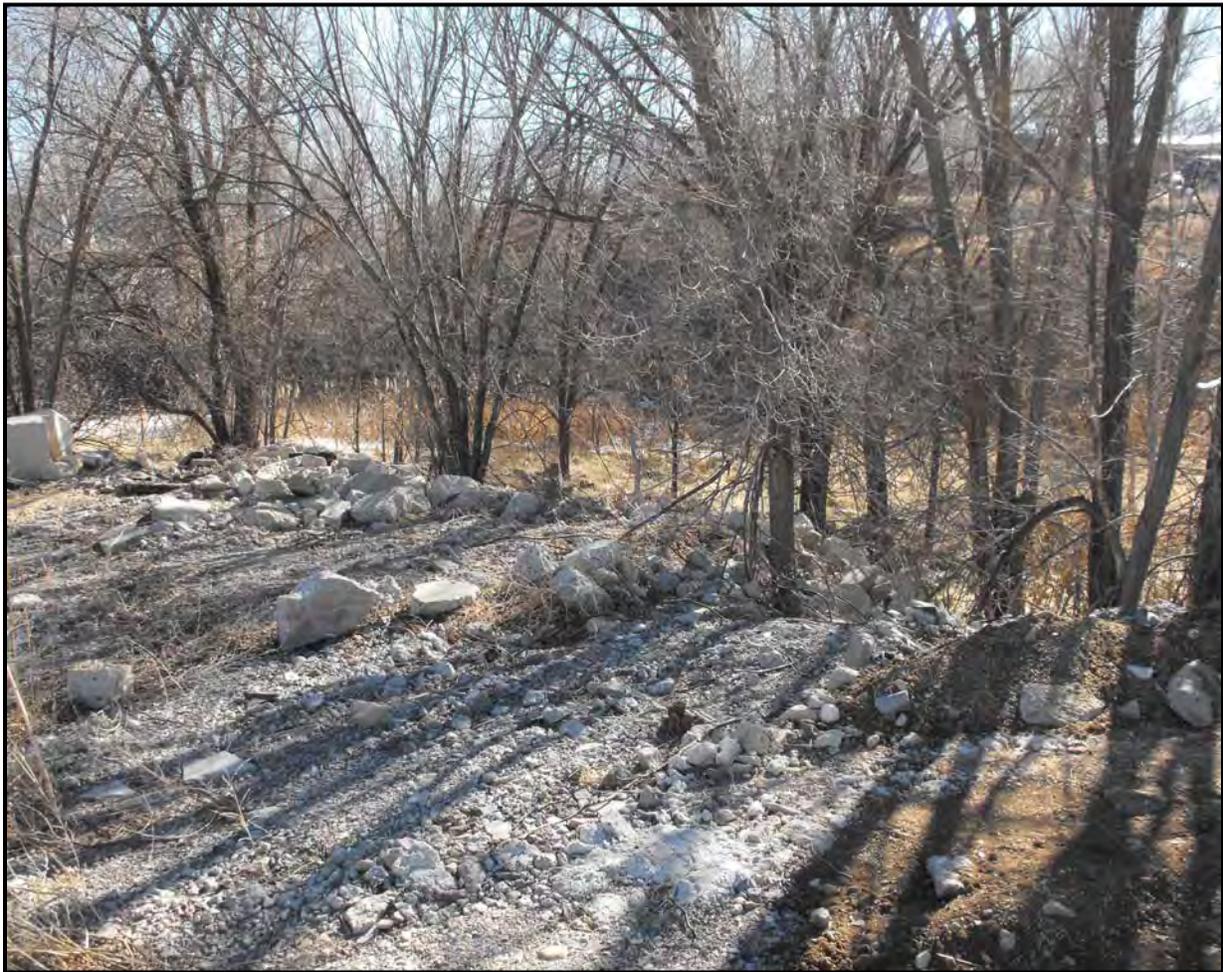
Photo # 3

Photographer: Daniel Valenta	Date: 1/27/2011	Time: 1358 hours
City/County: Las Vegas/San Miguel County		
Location: 1500 North Commerce, Las Vegas, New Mexico, B.T. U. Block & Concrete, Inc. southwest corner of property, facing south.		
Subject: Concrete/dirt dumped and pushed towards the unnamed tributary.

- Potential site discharge locations found in photos 3 & 4 have not been addressed in the SWPPP.
- Site may discharge to the Pecos Arroyo and the unnamed tributary not to the Gallinas River.

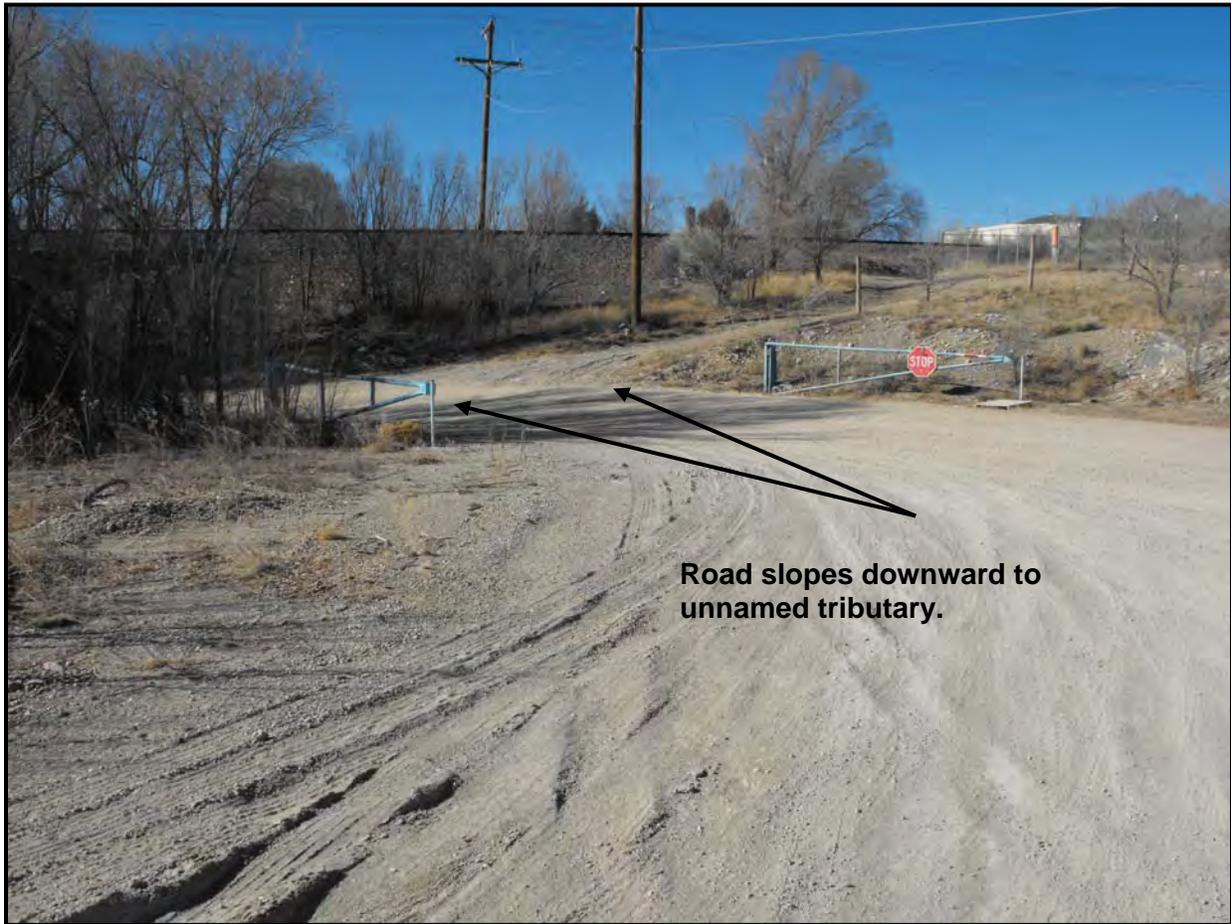
Photo # 4

Photographer: Daniel Valenta	Date: 12/8/2010	Time: 1350 hours
City/County: Las Vegas/San Miguel County		
Location: 1500 North Commerce, Las Vegas, New Mexico, B.T. U. Block & Concrete, Inc. main entrance to site, west side of property, facing west.		
Subject: Exit from site onto Garfield Ave., downward slope along road to unnamed tributary.
