NEW MEXICO  
ENVIRONMENT DEPARTMENT

*Surface Water Quality Bureau*

RE: Industrial Storm Water; SIC 5093; NPDES Compliance Evaluation Inspection; Village of Angel Fire;  
NPDES Permit No. NMU001760; August 8, 2011

### NPDES Compliance Inspection Report

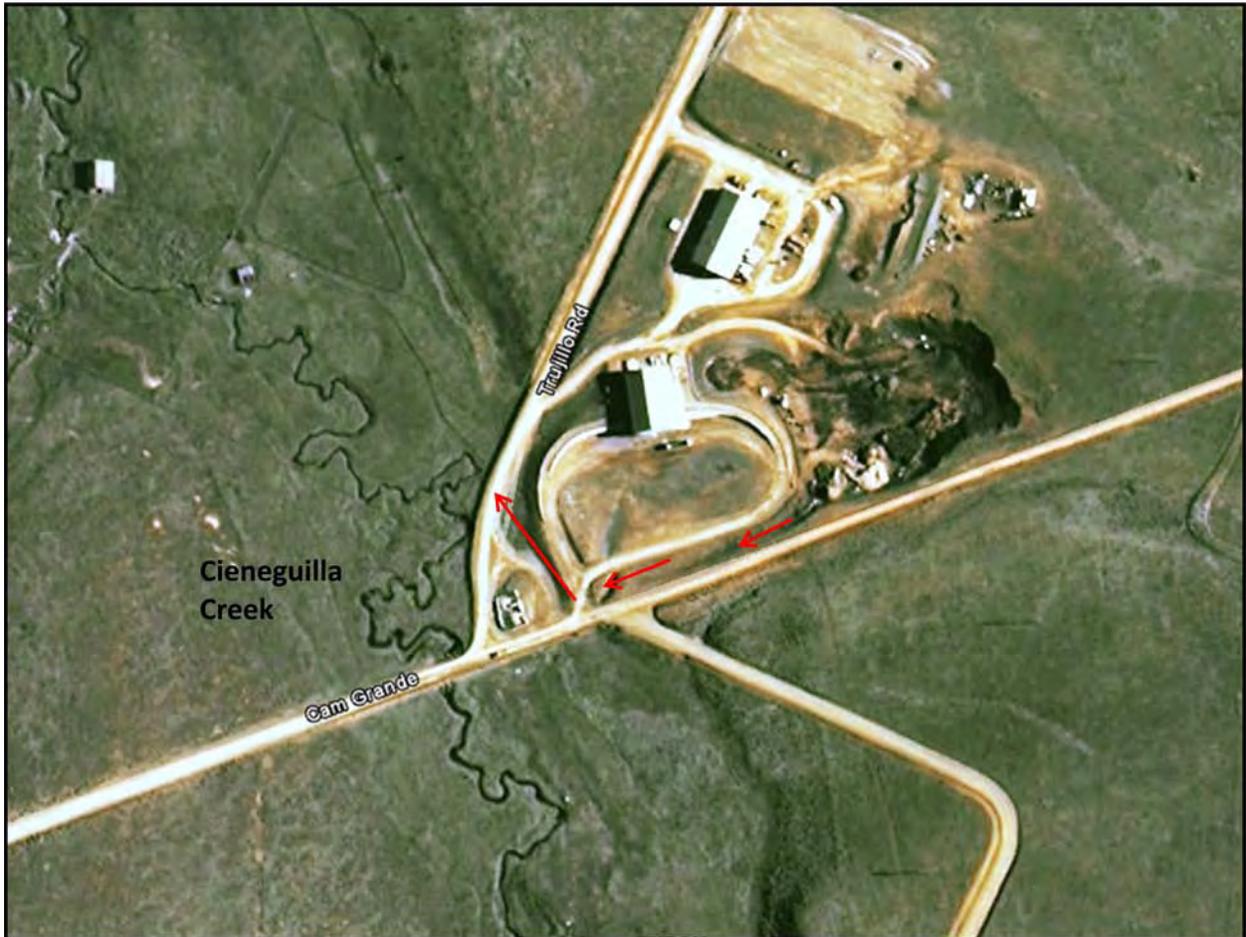
**NMED/SWQB  
Site Overview**

City/County: Angel Fire, New Mexico /Colfax County	
Location: One mile south of intersection Hwy 64 and Hwy 434.	
Subject: Overview of Village of Angel Fire Collection Center along Cieneguilla Creek, taken 7/1/2005. Bar ditch from Collection Center that may discharge storm water to creek in red.

**The Village of Angel Fire Recycling Center does not have permit coverage and has not prepared the required documents to file for and receive a permit or conducted the required inspections. Storm Water may drain from the facility and slash area into Cienguilla Creek by an existing bar ditch.**

Wood chips and other debris could be seen along the ditch most of its length. However before any storm water may discharge to the Cienguilla Creek it would have to go through a grassy area that may reduce the flow and rate of runoff. The site appeared well managed and ordered. Bailed material was stored under a shed; truck unloading area is in covered building.

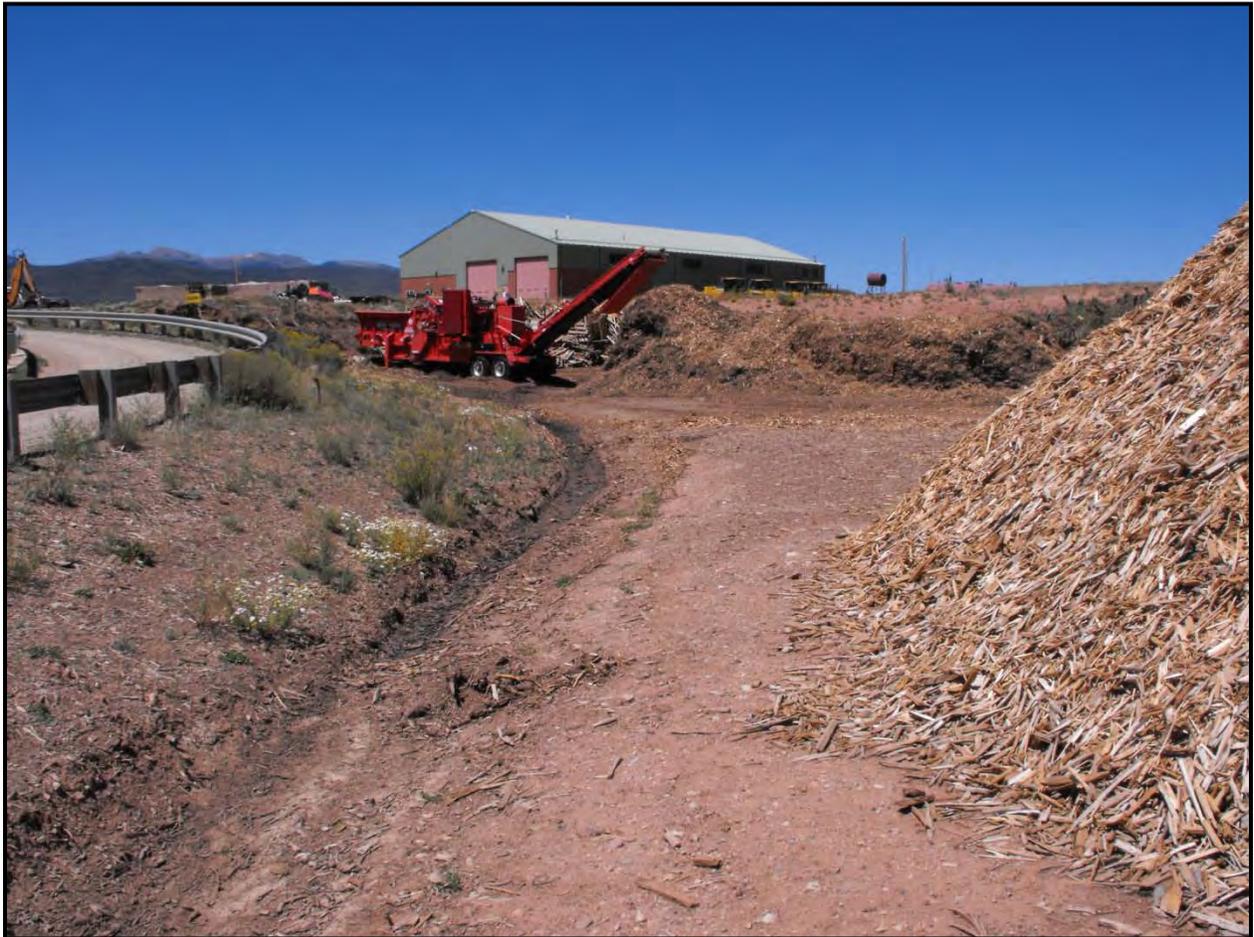
Photo # 1

Photographer: Daniel Valenta	Date: 8/8/2011	Time: 1406 hours
City/County: Angel Fire, New Mexico /Colfax County		
Location: Village of Angel Fire Collection Center, 55 Camino Grande, one mile south of intersection Hwy 64 and Hwy 434, facing north.		
Subject: Bar ditch that runs along the road and through the recycling facility. A blackish stain was left in the bottom of the ditch in this area.
