RE: Industrial Storm Water, SIC 1442, NPDES Compliance Evaluation Inspection, A. Montaña & Associates, Inc. /
 Albert Montaña Sand & Gravel and Albert Montaña Septic Tanks, NMU001800, August 7, 2012

NPDES Compliance Inspection Report

A. Montañó & Associates, Inc.
Compliance Evaluation Inspection – Industrial Stormwater
NPDES Tracking No. NMU001800
August 7, 2012

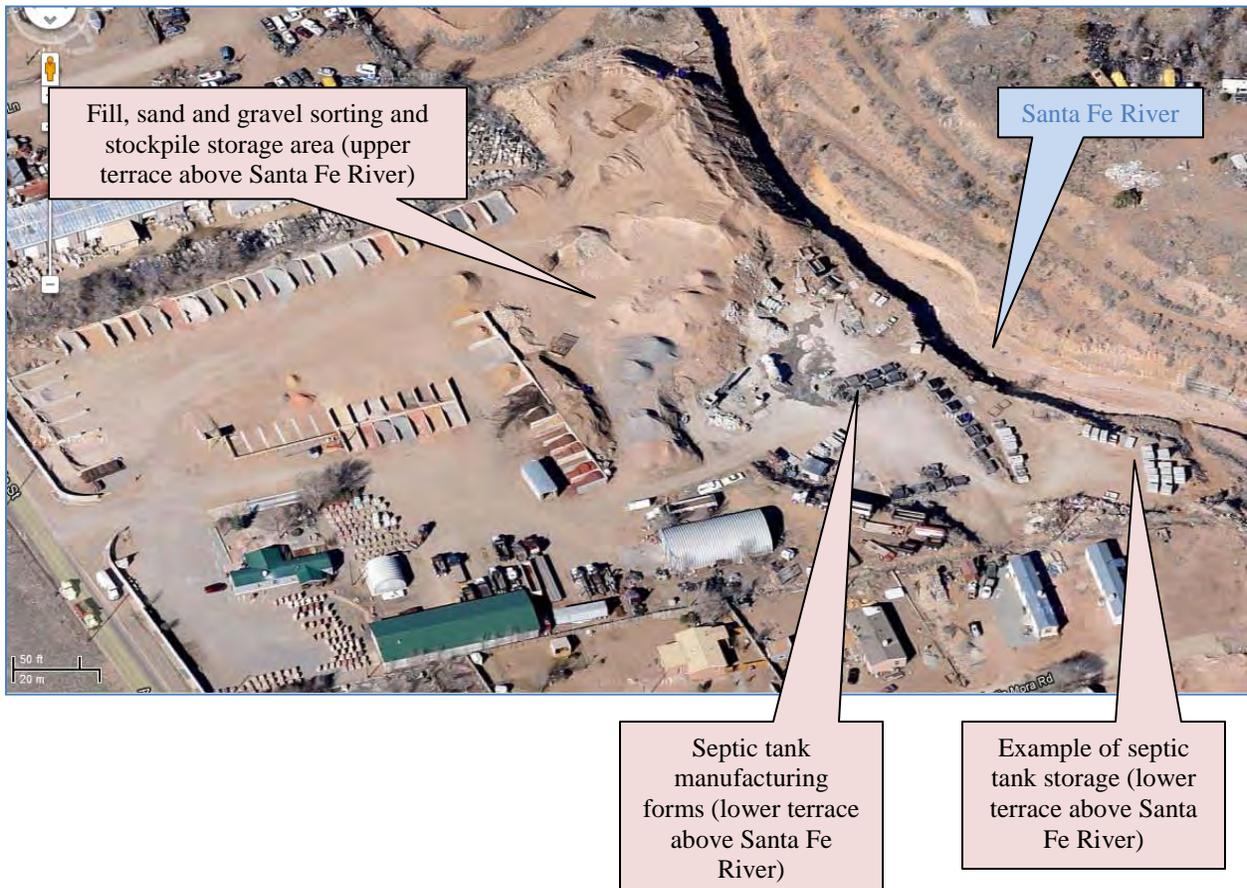
Figure 1
Imagery Viewed Looking North-Northwest

Subject: Readily available Google Map 2012 image viewed on-line looking north-northwest at the site. Exact date of this image is not shown on the web site.

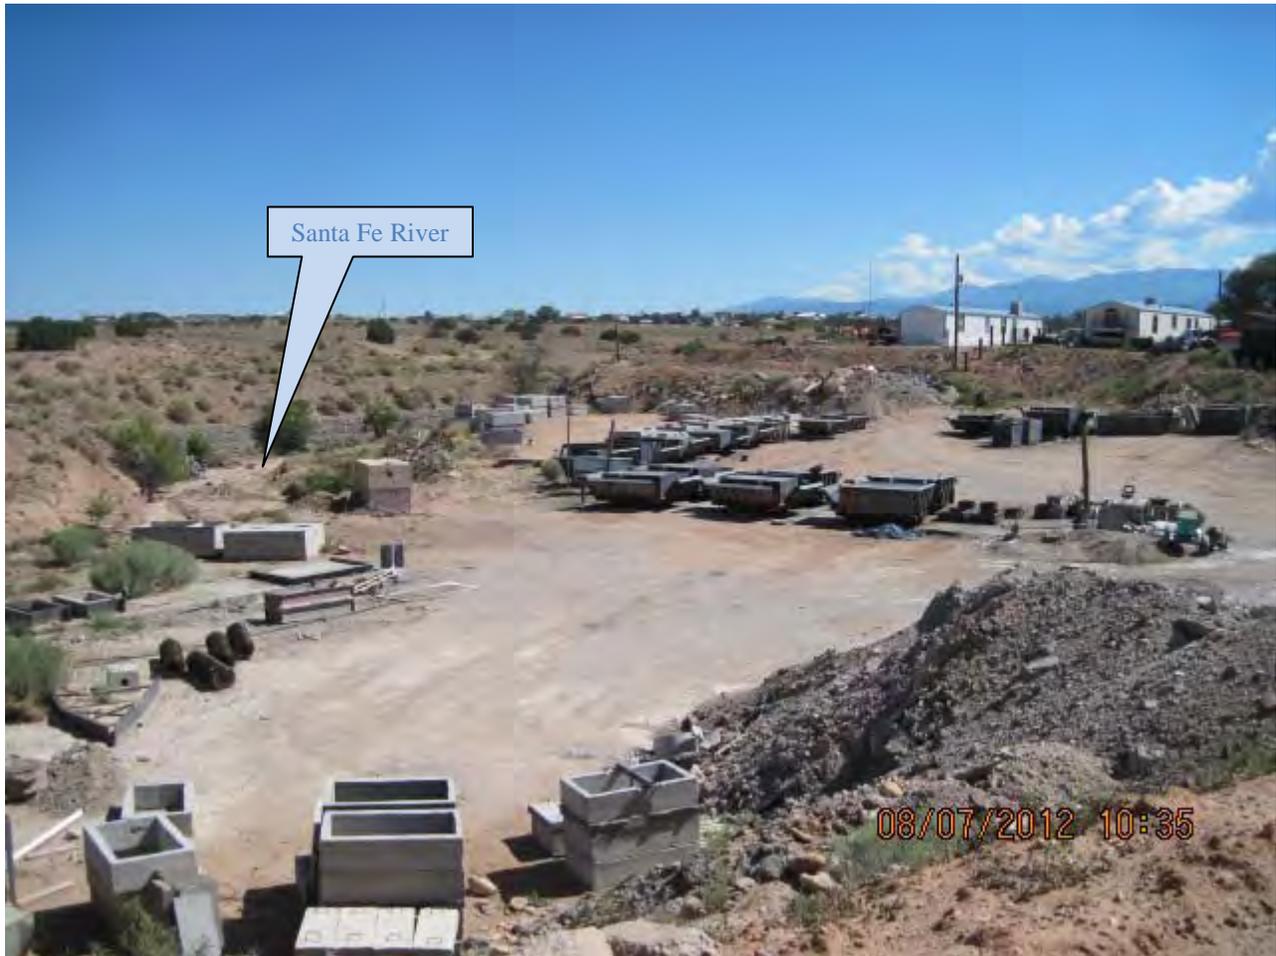
NMED/SWQB Official Photograph Log Photo # 1		
Photographer: Erin S. Trujillo	Date: 08/07/2012	Time: 1035 hours
City/County: Santa Fe / Santa Fe		State: New Mexico
Location: 4519 Agua Fria Street, Santa Fe, New Mexico		
Subject: Overview of concrete septic tank manufacturing area

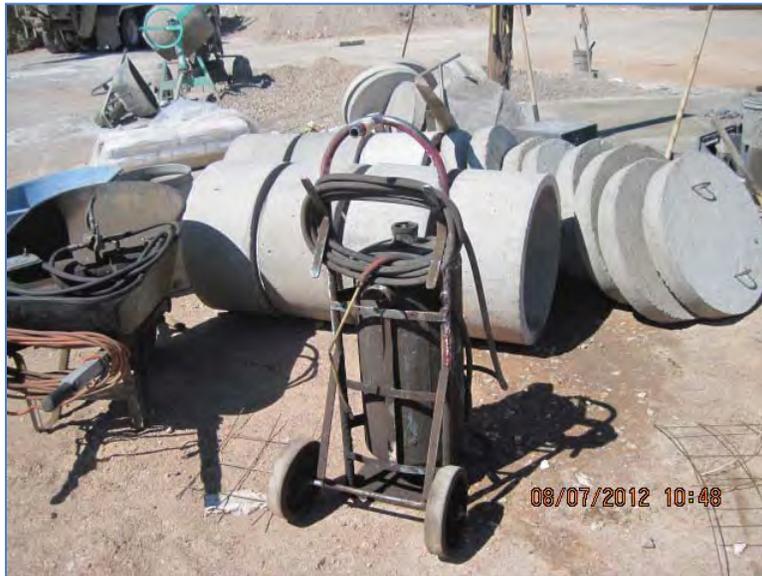
Used oil from on-site fleet maintenance is sprayed on the concrete septic tank forms as a lubricant according to Albert Montaña. Oil stains observed below the septic tank forms on the concrete footing and ground surface were potential pollutant sources. The ground surface of the septic tank manufacturing area had light grey solids which appeared to be cement, and/or crushed or broken concrete. Use of non-stormwater (e.g., wash waters) was not observed during this inspection.

NMED/SWQB Official Photograph Log Photo # 2		
Photographer: Erin S. Trujillo	Date: 08/07/2012	Time: 1046 hours
City/County: Santa Fe / Santa Fe		State: New Mexico
Location: 4519 Agua Fria Street, Santa Fe, New Mexico		
Subject: Equipment used to spray used oil on concrete septic tank cast forms according to on-site representative

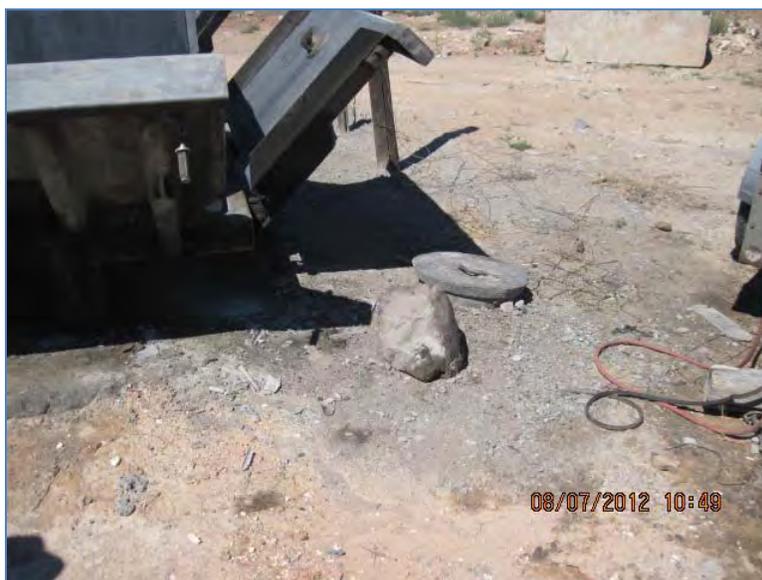
NMED/SWQB Official Photograph Log Photo # 3		
Photographer: Erin S. Trujillo	Date: 08/07/2012	Time: 1049 hours
City/County: Santa Fe / Santa Fe		State: New Mexico
Location: 4519 Agua Fria Street, Santa Fe, New Mexico		
Subject: Oil stains and grey solids on ground surface around concrete cast forms

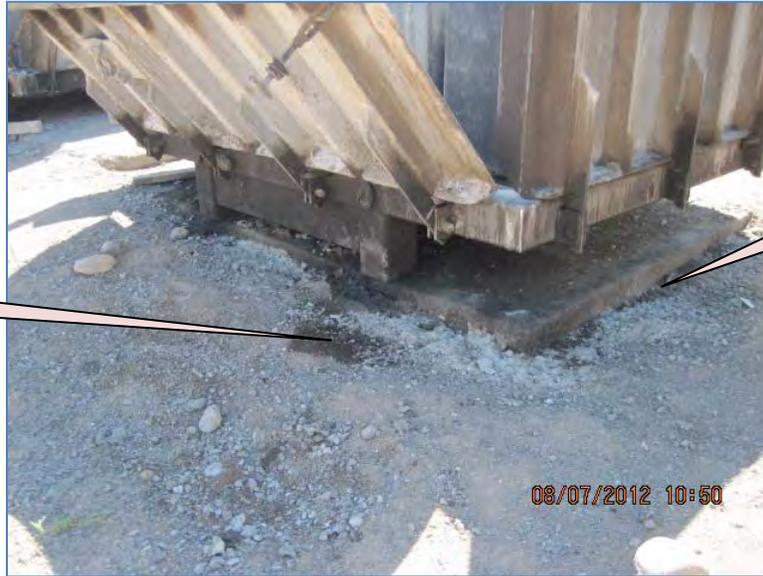
NMED/SWQB Official Photograph Log Photo # 4		
Photographer: Erin S. Trujillo	Date: 08/07/2012	Time: 1050 hours
City/County: Santa Fe / Santa Fe	State: New Mexico	
Location: 4519 Agua Fria Street, Santa Fe, New Mexico		
Subject: Examples of oil staining on ground below concrete cast form

Used Oil Stains

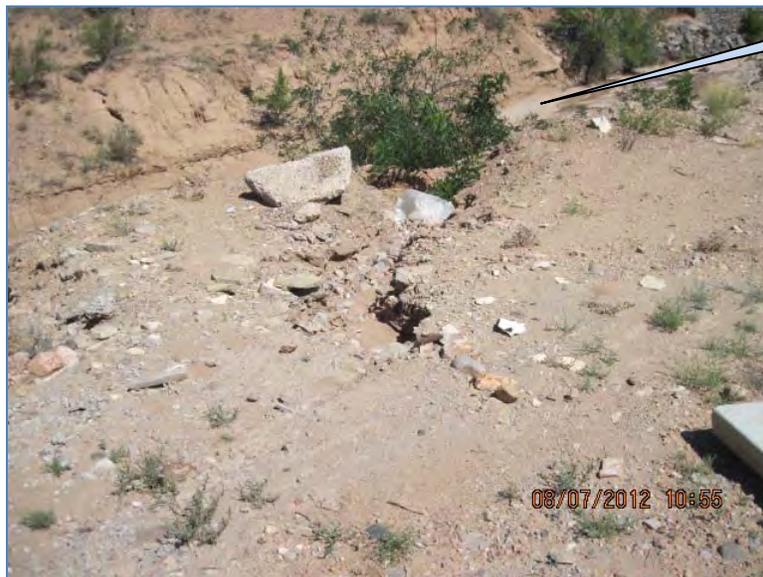
In the area of the site where dirt fill, sand and gravel stockpiles existed, the embankment was steep above the Santa Fe River. Coarse material and some vegetation was observed on the side slope of the steep embankment on the day of this inspection. The topography of the concrete manufacturing area is to the north toward the Santa Fe River. Two erosion rills or shallow gullies were observed at the edge of the lower terrace. Some vegetation was observed along the lower terrace edge. No other erosion and sediment controls or management of runoff measures (e.g., seeding, mulching, silt fences, sediment ponds, check dams, stabilization, diversions, etc.) was observed. There was no other barrier to prevent runoff over the lower terrace edge.

NMED/SWQB Official Photograph Log Photo # 5		
Photographer: Erin S. Trujillo	Date: 08/07/2012	Time: 1055 hours
City/County: Santa Fe / Santa Fe	State: New Mexico	
Location: 4519 Agua Fria Street, Santa Fe, New Mexico		
Subject: Example of erosion at lower terrace edge

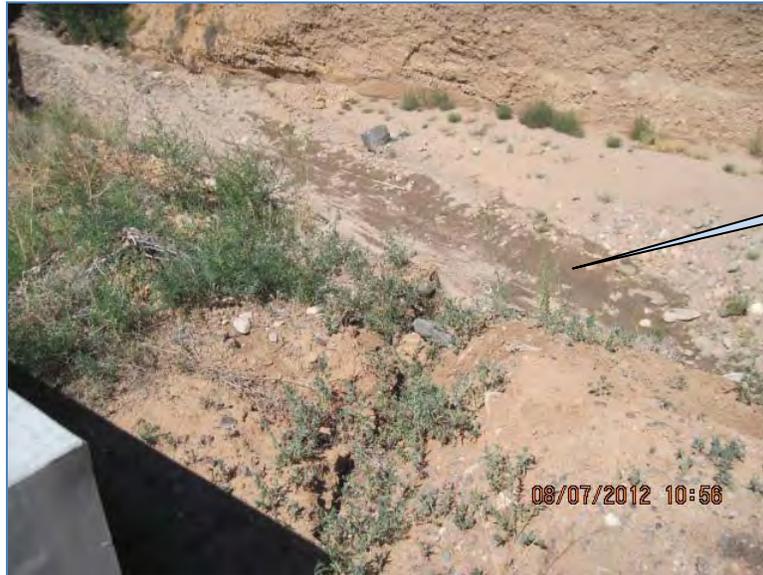
NMED/SWQB Official Photograph Log Photo # 6		
Photographer: Erin S. Trujillo	Date: 08/07/2012	Time: 1058 hours
City/County: Santa Fe / Santa Fe		State: New Mexico
Location: 4519 Agua Fria Street, Santa Fe, New Mexico		
Subject: Example at erosion at lower terrace edge

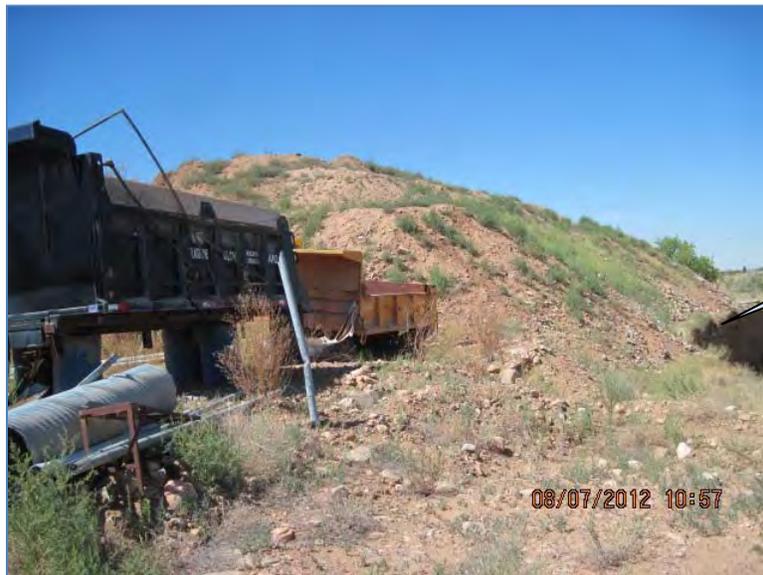
NMED/SWQB Official Photograph Log Photo # 7		
Photographer: Erin S. Trujillo	Date: 08/07/2012	Time: 1057 hours
City/County: Santa Fe / Santa Fe		State: New Mexico
Location: 4519 Agua Fria Street, Santa Fe, New Mexico		
Subject: Equipment storage and steep embankment above the Santa Fe River

Terrace edge above Santa Fe River

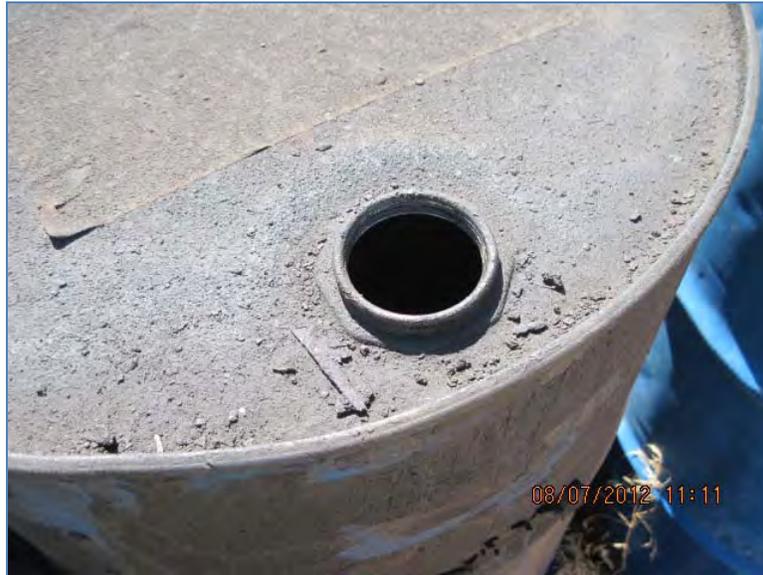
In the concrete septic tank manufacturing area of the site, storage and stockpiling of materials, included Black Jack® 5527 Roof-Gard 700 Elastomeric Roof Coating, asphalt emulsion, motor oil, used oil, battery, gasoline, and 55-gallon drums. Housekeeping in the septic tank manufacturing area was not orderly. Collected aluminum cans and other trash were in containers, but not covered. A plastic bucket was observed near the Santa Fe River stream bed edge immediately below this site. Trash was observed along the bed and banks of the river, but not all debris could be attributed to this facility. Drum storage was not in a manner to allow access to all drums to inspect for spills or leaks. Some drums were not labeled as to contents (or the labels were not readily visible) and had open bungs.

NMED/SWQB Official Photograph Log Photo # 8		
Photographer: Erin S. Trujillo	Date: 08/07/2012	Time: 1111 hours
City/County: Santa Fe / Santa Fe		State: New Mexico
Location: 4519 Agua Fria Street, Santa Fe, New Mexico		
Subject: Example of open bung of drum

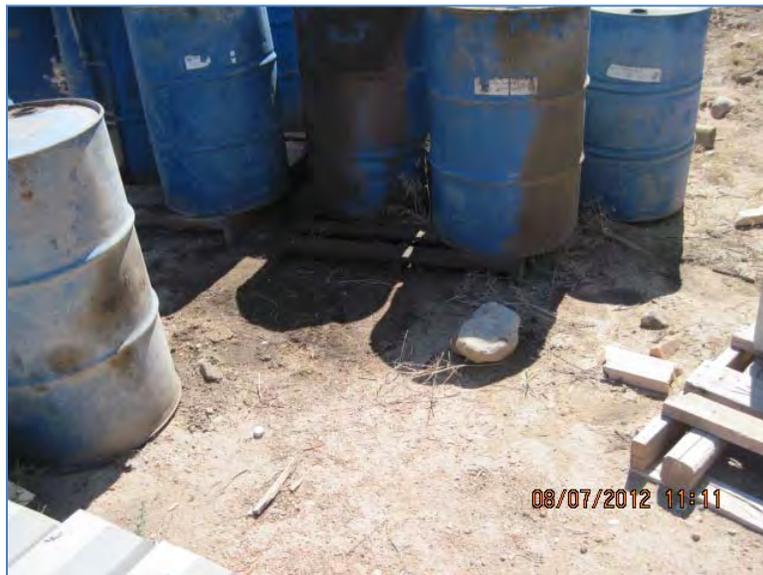
NMED/SWQB Official Photograph Log Photo # 9		
Photographer: Erin S. Trujillo	Date: 08/07/2012	Time: 1111 hours
City/County: Santa Fe / Santa Fe		State: New Mexico
Location: 4519 Agua Fria Street, Santa Fe, New Mexico		
Subject: On site drum storage.

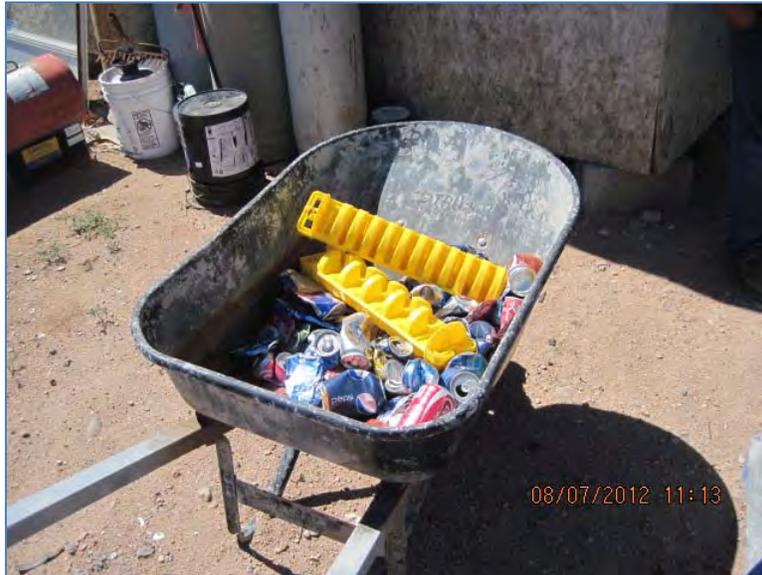
NMED/SWQB Official Photograph Log Photo # 10		
Photographer: Erin S. Trujillo	Date: 08/07/2012	Time: 1113 hours
City/County: Santa Fe / Santa Fe		State: New Mexico
Location: 4519 Agua Fria Street, Santa Fe, New Mexico		
Subject: Collected plastic and aluminum cans in open container

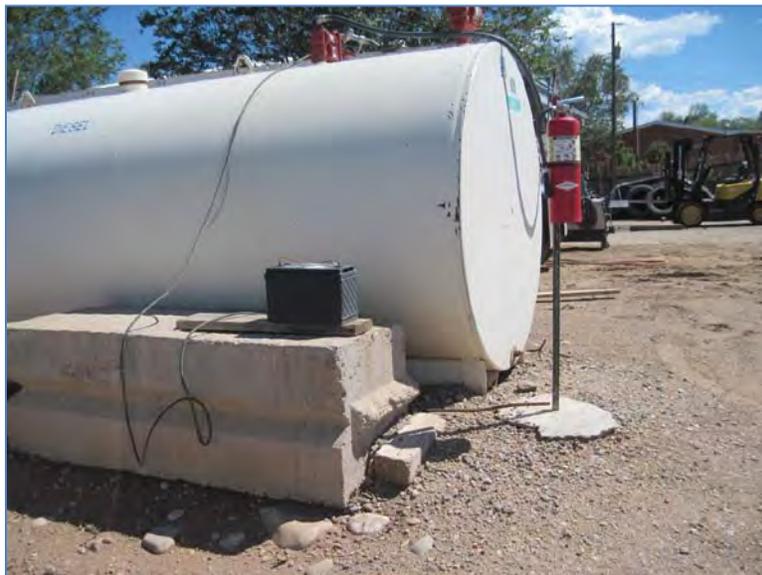
Material storage and material handling for both the preparation of construction sand and gravel; and septic tank manufacturing, were outside and not sheltered from exposure from stormwater run on and runoff. A diesel fuel tank on the upper terrace above the Santa Fe River did not appear to have additional containment or surrounding barriers to protect the tank from vehicle traffic. Examples of potential pollutant sources and associated pollutants at concrete product manufacturing facilities and for mineral processing activities is listed in Table 1 and 2 below.

NMED/SWQB Official Photograph Log Photo # 11		
Photographer: Erin S. Trujillo	Date: 08/07/2012	Time: 1117 hours
City/County: Santa Fe / Santa Fe		State: New Mexico
Location: 4519 Agua Fria Street, Santa Fe, New Mexico		
Subject: On site fuel storage and battery
