RE: Industrial Storm Water; SIC 5093; NPDES Compliance Evaluation Inspection; Bio Pappel International; NPDES Permit NMU001812; October 31, 2012

NPDES Compliance Inspection Report

Bio Pappel International
October 31, 2012
NMU001812

Further Explanation

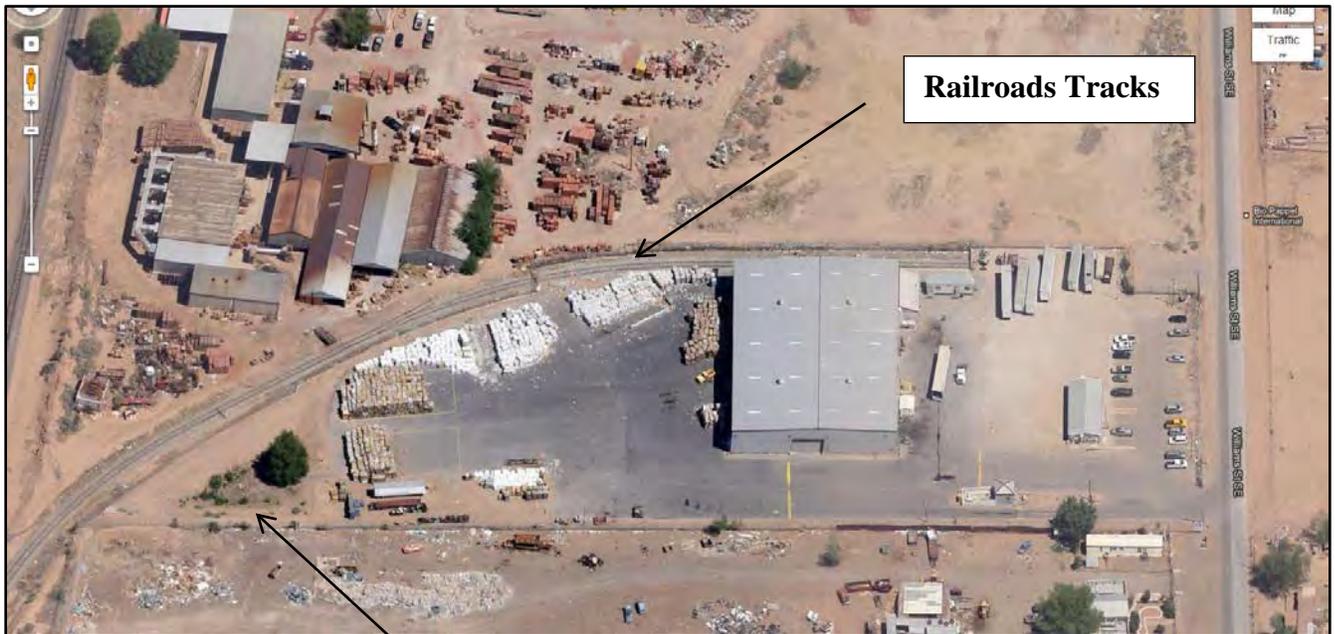
**NMED/SWQB
Site Overview**

City/County:	Albuquerque/Bernalillo	
Location:	4600 Williams SE, Albuquerque, New Mexico.	
Subject:	Overview of Bio Pappel Recycling facility in Albuquerque, New Mexico.

Railroads Tracks

Stormwater Containment Pond

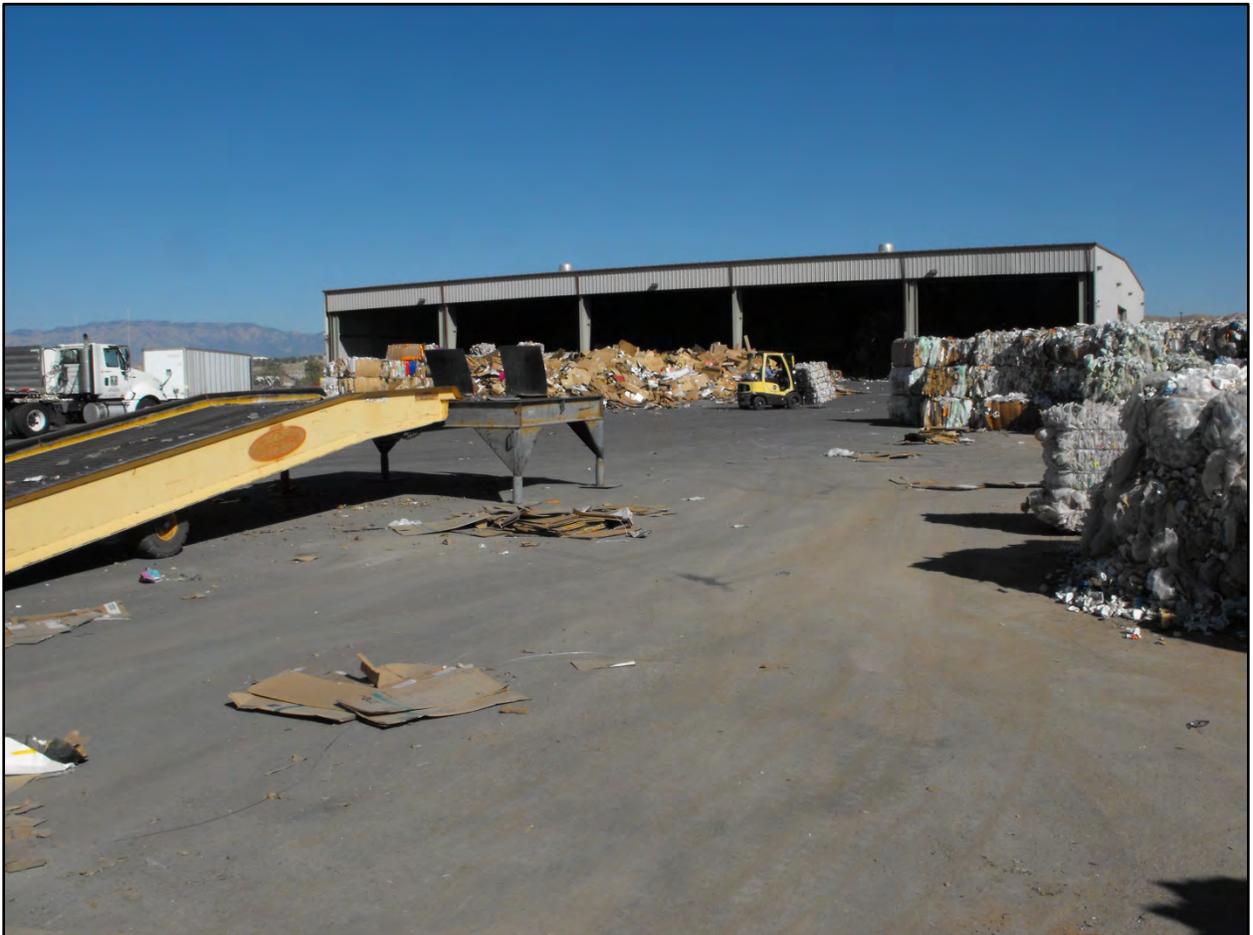
Photo # 1

Photographer: Daniel Valenta	Date: 10/31/2012	Time: 1437 hours
City/County: Albuquerque/Bernalillo		
Location: 4600 Williams SE, Albuquerque, New Mexico, facing east.		
Subject: Loading/unloading area of facility, compaction, bailing completed under shed.

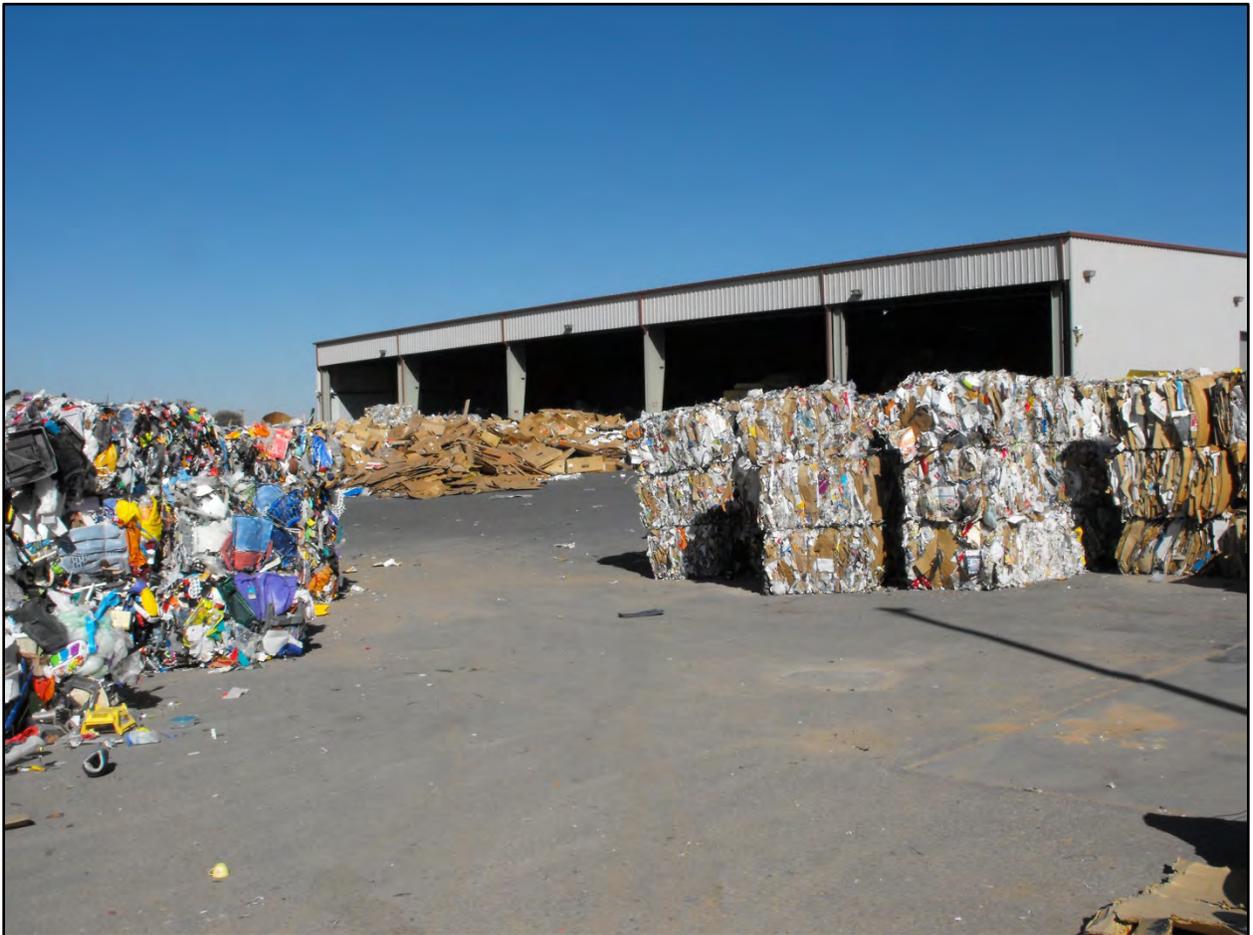
Photo # 2

Photographer: Daniel Valenta	Date: 10/31/2012	Time: 1436 hours
City/County: Albuquerque/Bernalillo		
Location: 4600 Williams SE, Albuquerque, New Mexico, facing northeast.		
Subject: Loading/unloading area of facility, compaction, bailing completed under shed.
