**Re: Russell Sand & Gravel Co., Minor, Unpermitted Discharge, SIC 1442, NPDES
Reconnaissance Inspection, NPDES# NMU001831, August 7, 2014**

Reconnaissance Inspection
Russell Sand & Gravel Company, Inc.
NPDES Permit No. NMU001831
August 7, 2014

**Compliance Evaluation Inspection
Russell Sand & Gravel Company, Inc.
NPDES Permit No. NMU001831
December 6, 2012**

Re: Russell Sand & Gravel Co., Inc. Reconnaissance Inspection-Minor, Unpermitted Discharge, SIC
1442 NPDES Permit Number: NMU001831, August 7, 2014

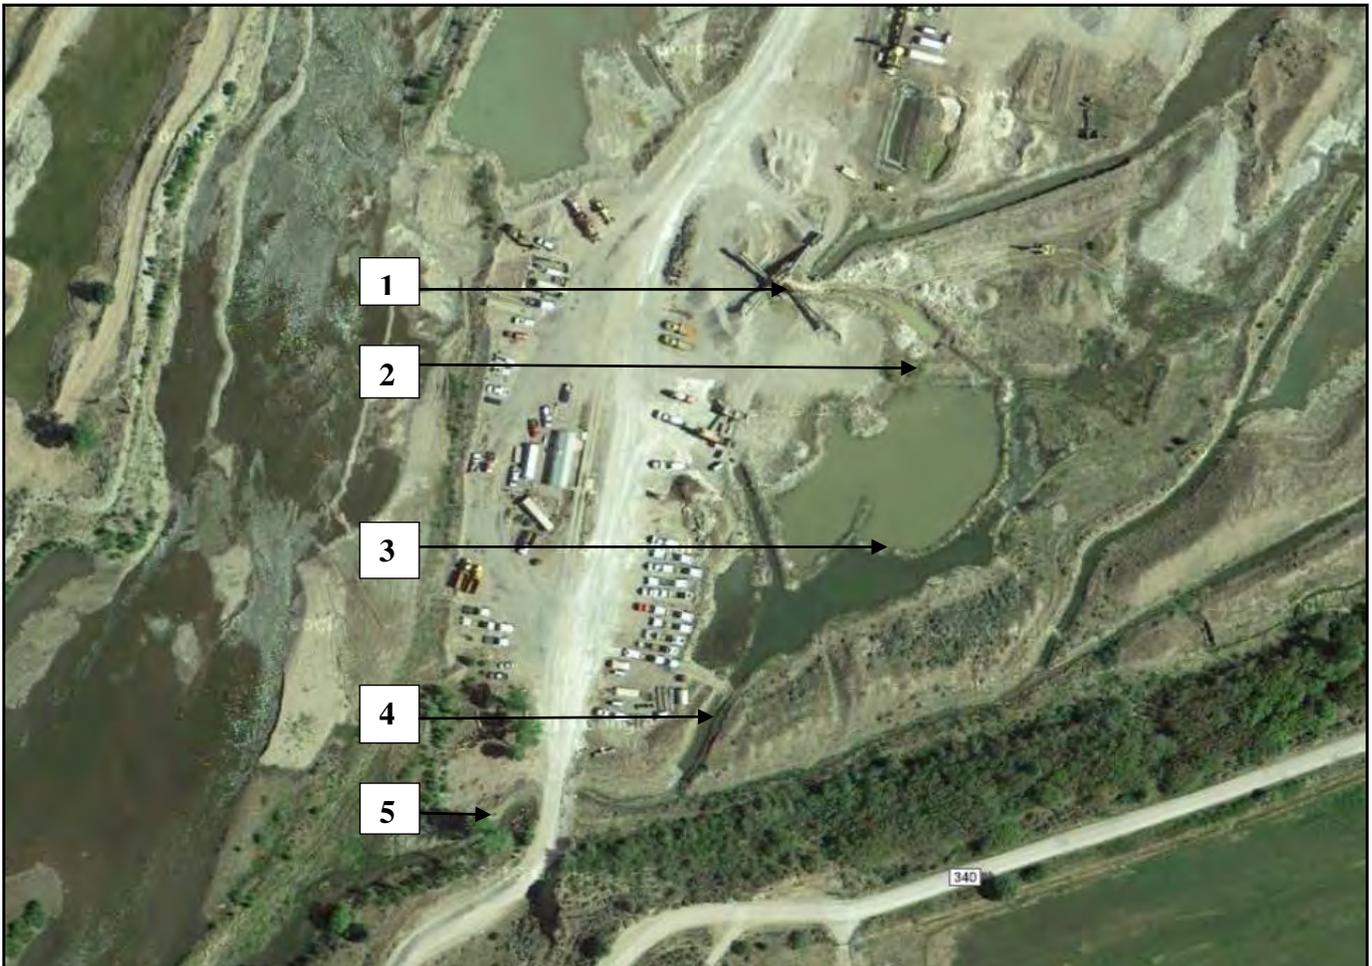
Site Overview

City/County: Outside of Los Ojos, New Mexico/ Rio Arriba County		
Location: Russell Sand & Gravel Company, 150 CR 340, Los Ojos, New Mexico, 87551		
Subject: Overview of process to contain and release process water.

1. Sand wash area discharges to ditch leading to a small pond.
2. Ditch discharges to pond.
3. Pond has a exit breach at far side to allow water out.
4. Rock check dam slows and filters water.
5. Water comingles with irrigation ditch water and exits site to a heavily vegetated side of the river.

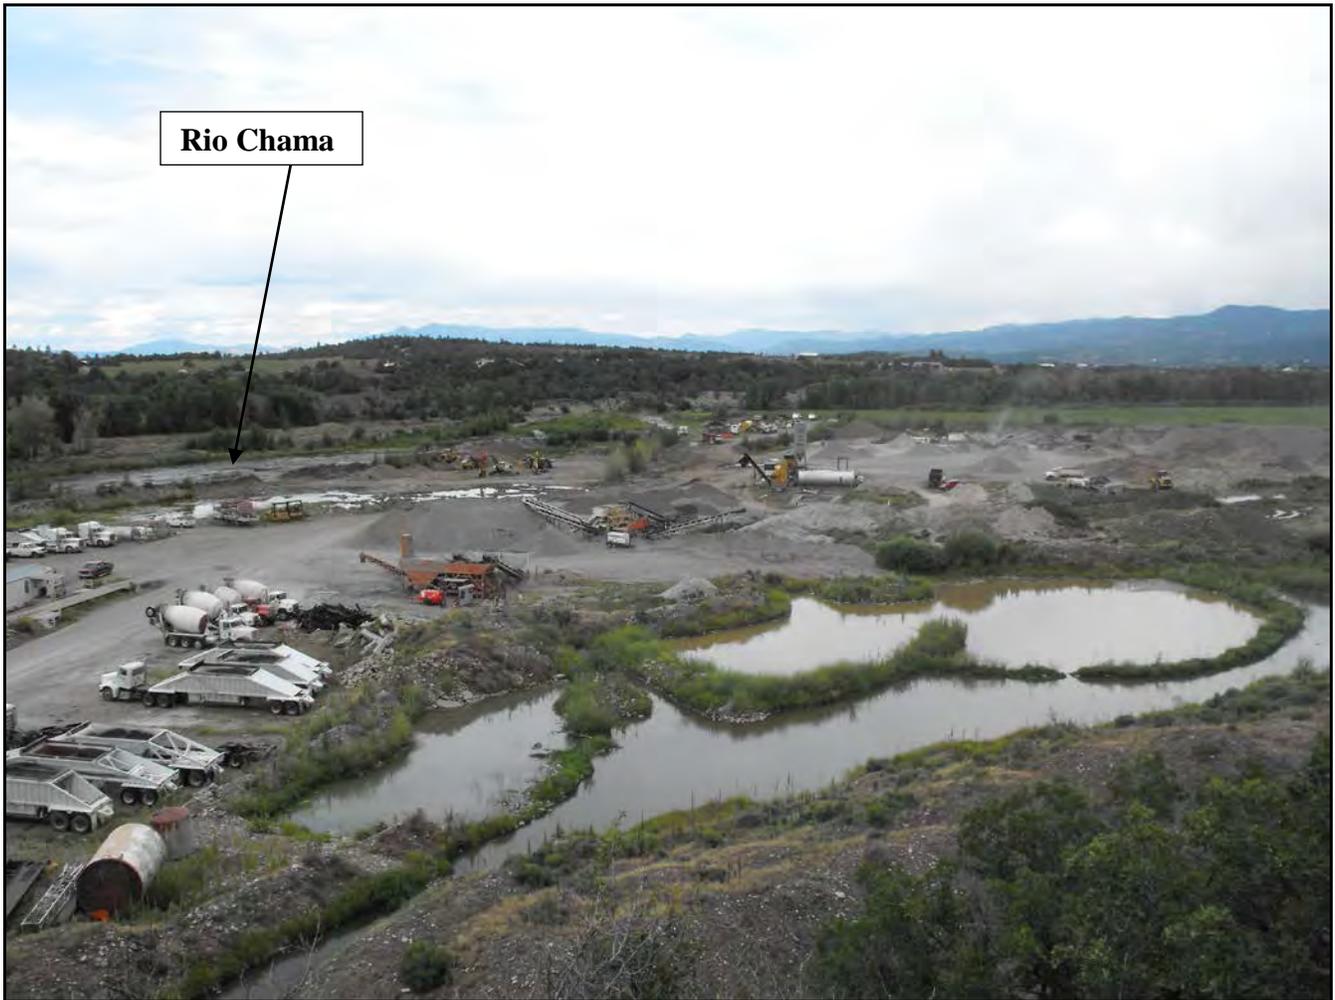
Photo # 1

Photographer: Daniel Valenta	Date: August 7, 2014	Time: 1237 hours
City/County: Outside of Los Ojos, New Mexico/ Rio Arriba County		
Location: Russell Sand & Gravel Company, 150 CR 340, Los Ojos, New Mexico, 87551		
Subject: Overview of working area of Russell Sand & Gravel Company Los Ojos site, facing north.

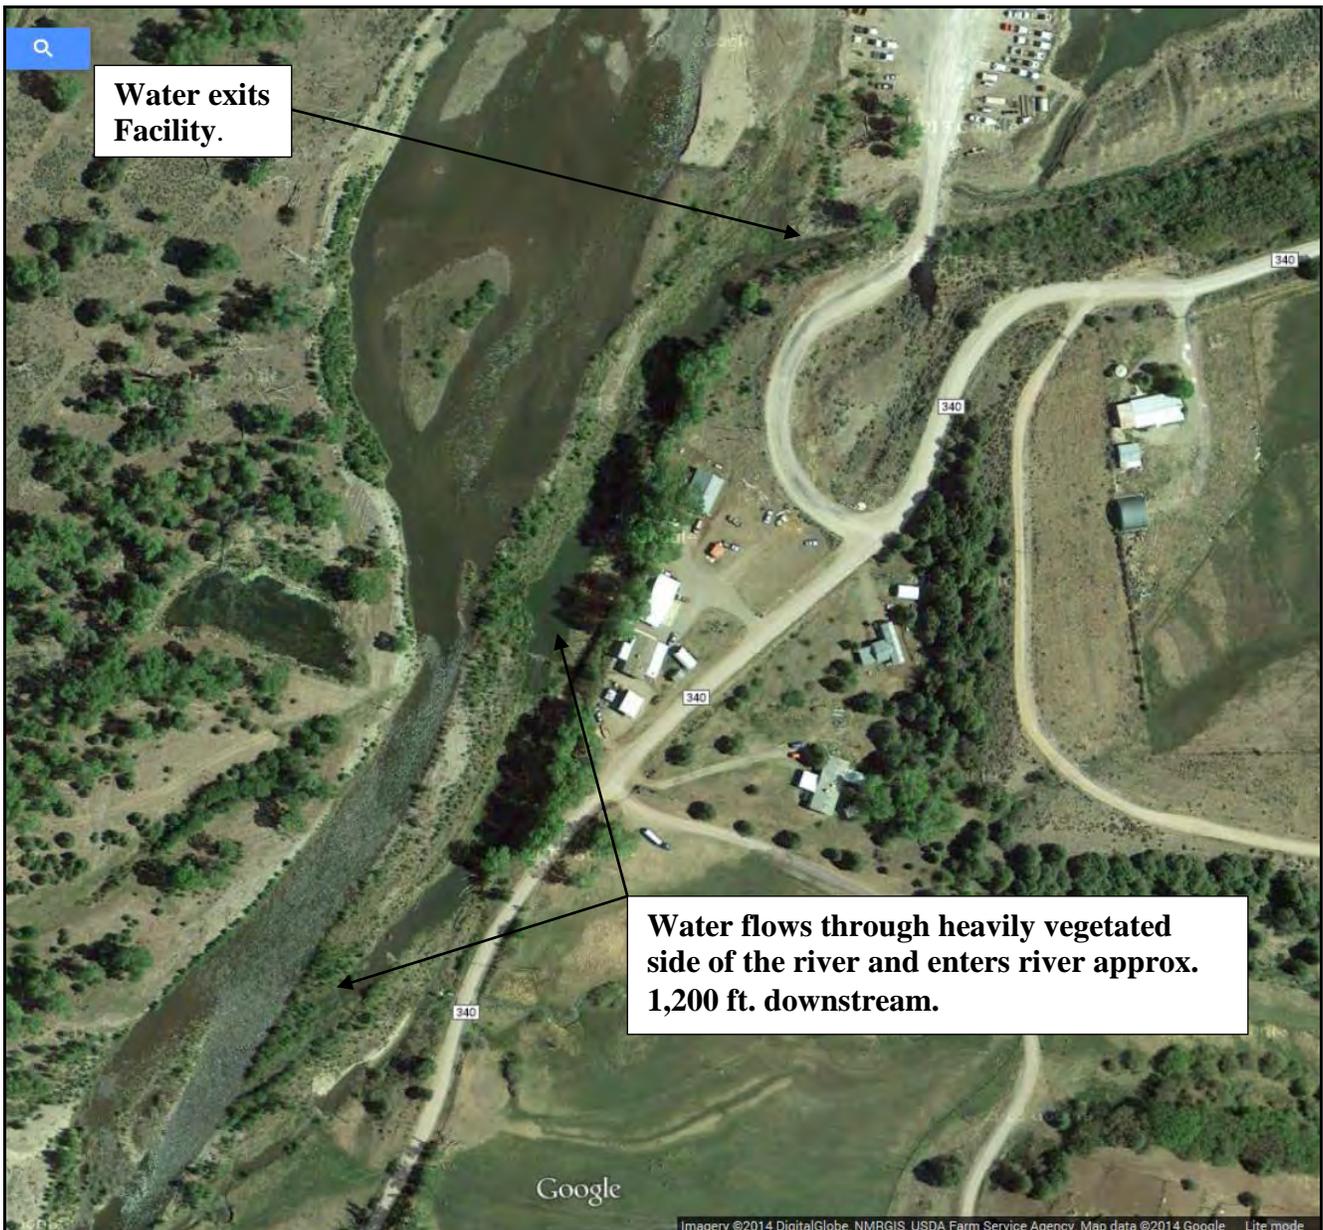
Site Overview

City/County: Outside of Los Ojos, New Mexico/ Rio Arriba County		
Location: Russell Sand & Gravel, 150 CR 340, Los Ojos, New Mexico, 87551		
Subject: Overview of outfall at Russell Sand & Gravel facility.

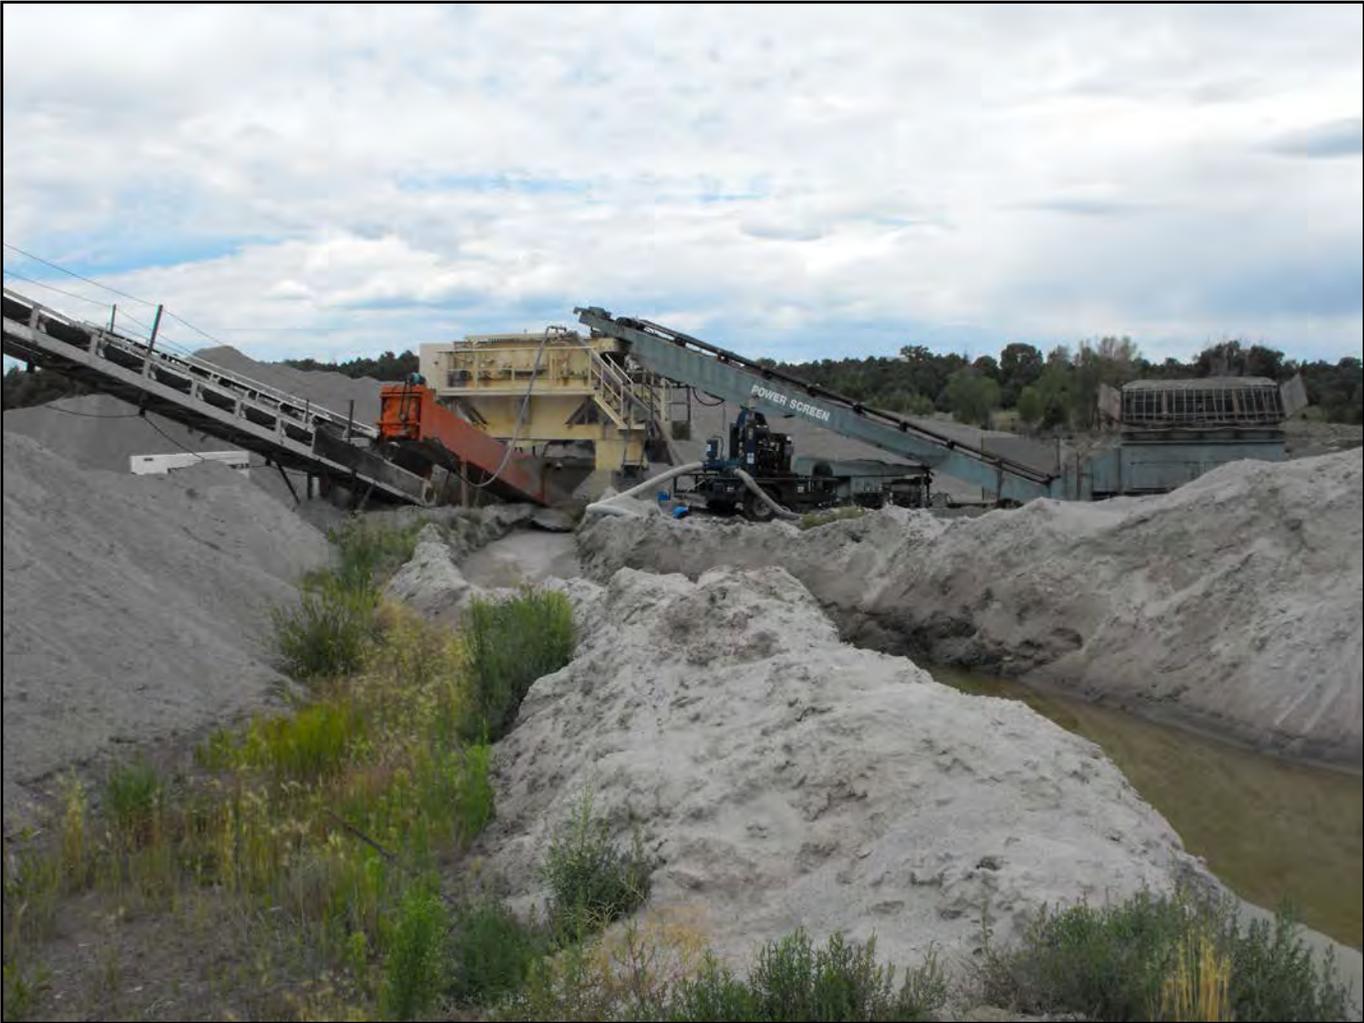
Photo # 2

Photographer: Daniel Valenta	Date: August 7, 2014	Time: 1316 hours
City/County: Outside of Los Ojos, New Mexico/ Rio Arriba County		
Location: Russell Sand & Gravel Company, 150 CR 340, Los Ojos, New Mexico, 87551		
Subject: Sand wash area, discharged ditch has been cleaned and enlarged, facing west.

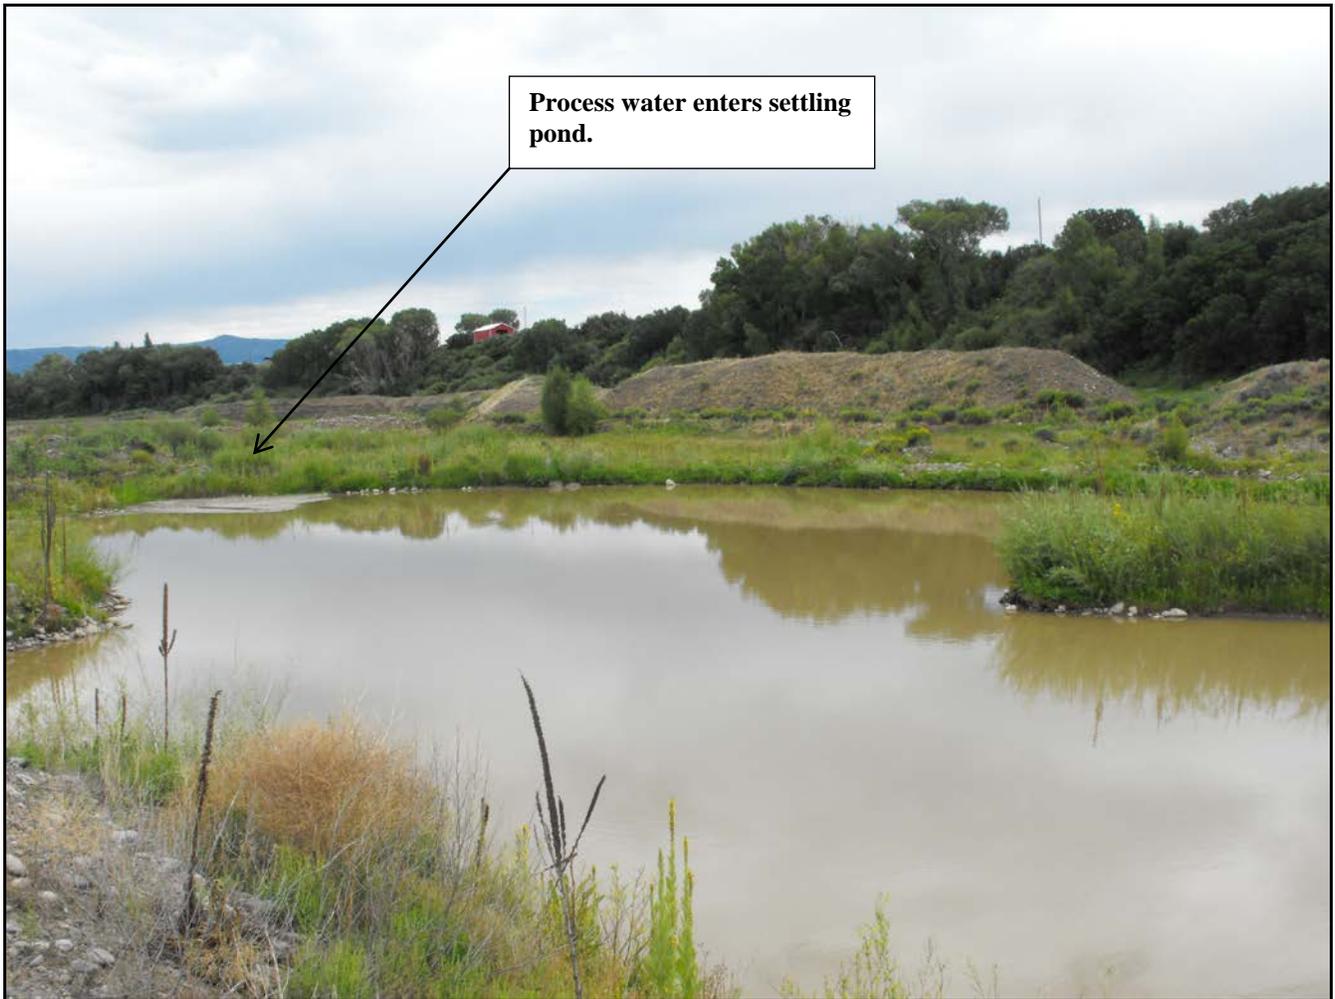
Photo # 3

Photographer: Daniel Valenta	Date: August 7, 2014	Time: 1313 hours
City/County: Outside of Los Ojos, New Mexico/ Rio Arriba County		
Location: Russell Sand & Gravel Company, 150 CR 340, Los Ojos, New Mexico, 87551		
Subject: Discharge ditch flows to pond, facing northeast.

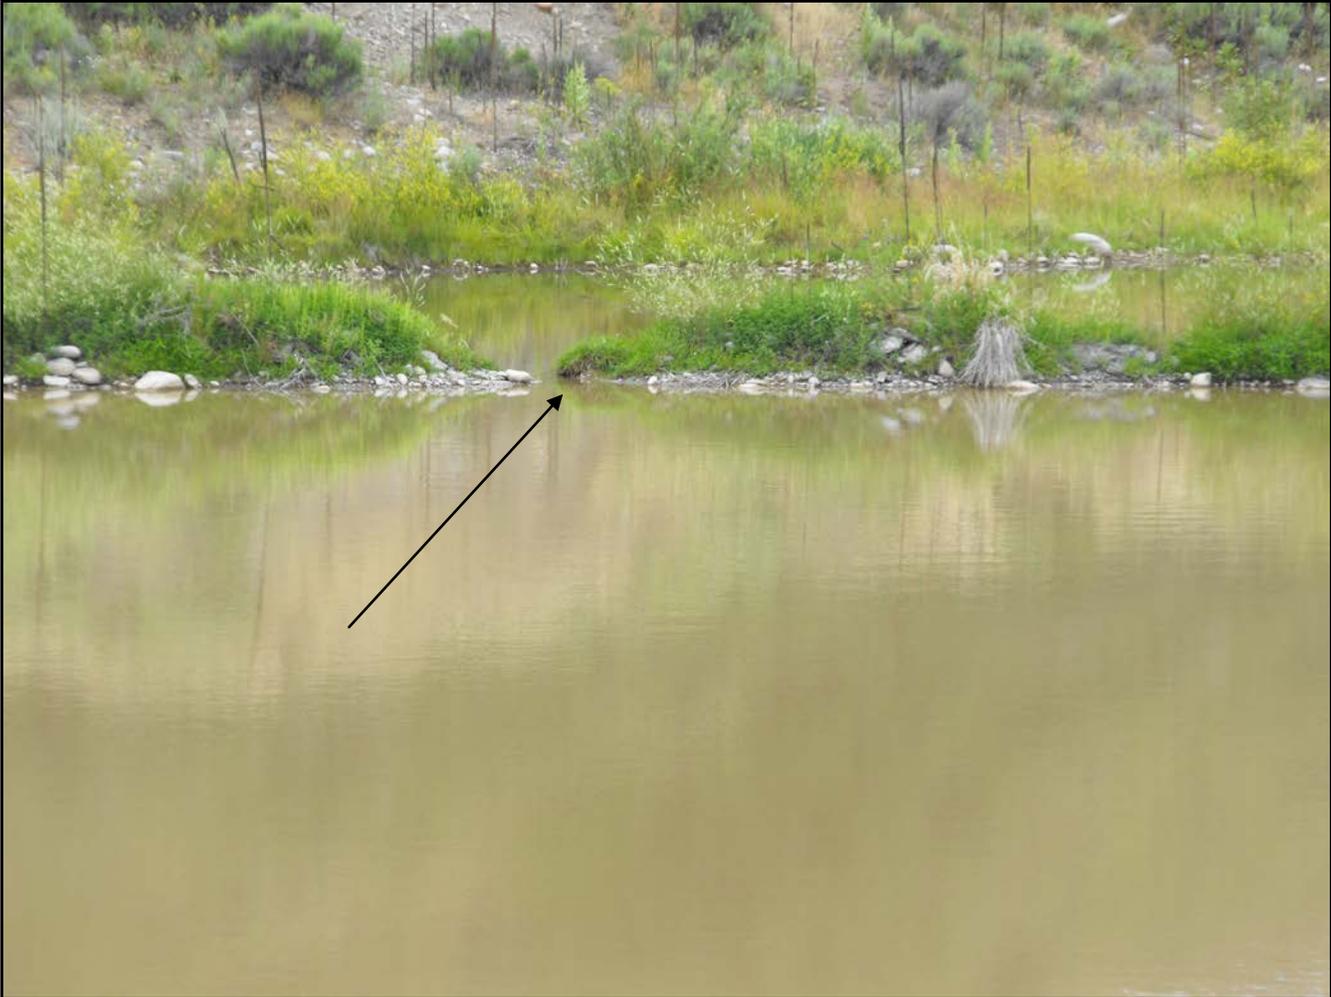
Photo # 4

Photographer: Daniel Valenta	Date: August 7, 2014	Time: 1318 hours
City/County: Outside of Los Ojos, New Mexico/ Rio Arriba County		
Location: Russell Sand & Gravel Company, 150 CR 340, Los Ojos, New Mexico, 87551		
Subject: Water flows from settling pond through a breach in the berm, facing southeast.

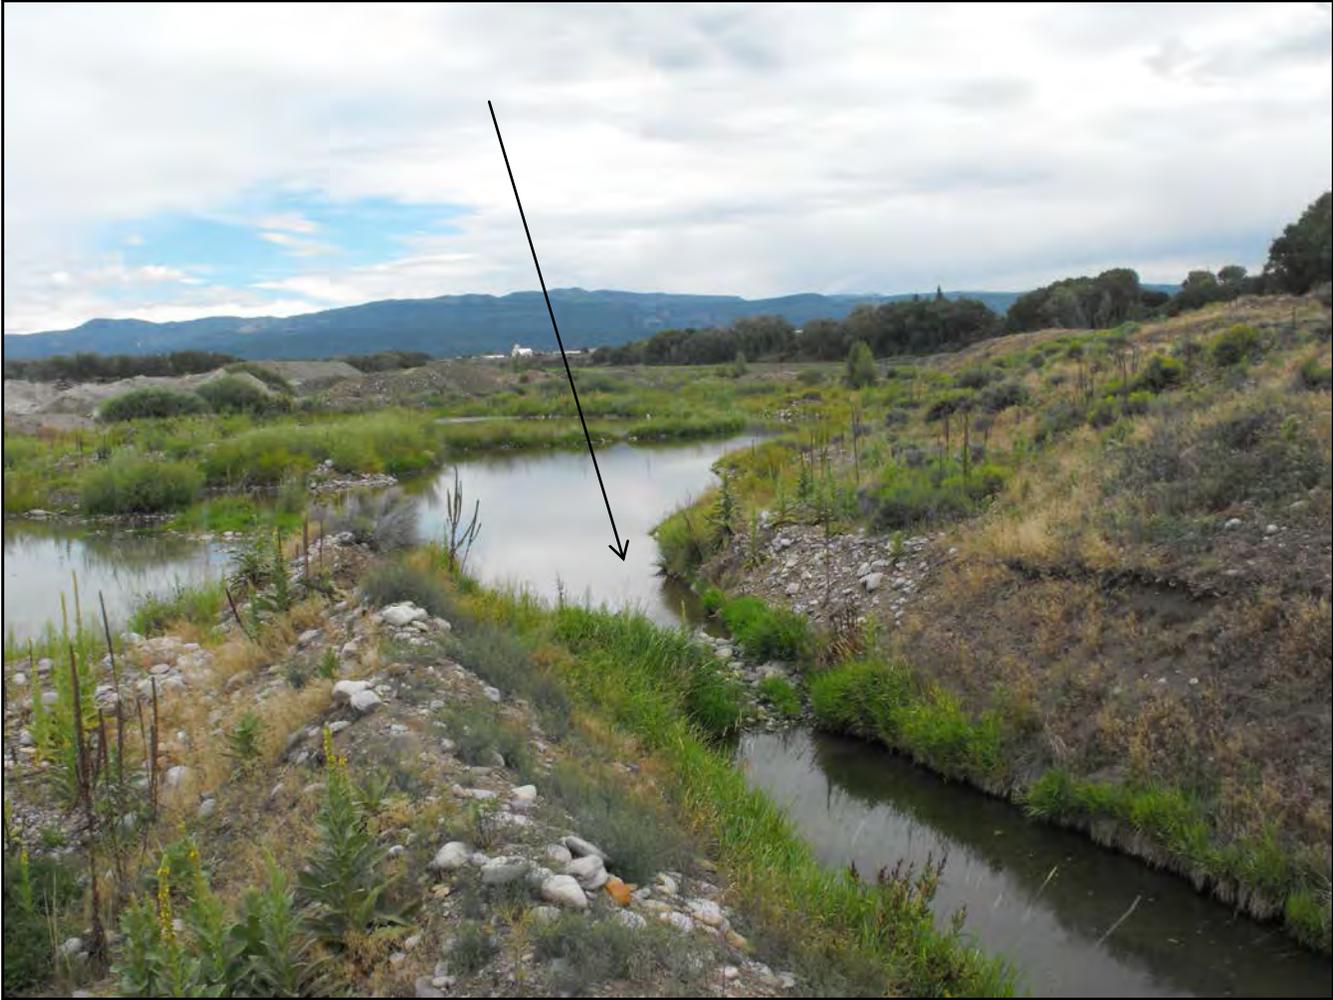
Photo # 5

Photographer: Daniel Valenta	Date: August 7, 2014	Time: 1327 hours
City/County: Outside of Los Ojos, New Mexico/ Rio Arriba County		
Location: Russell Sand & Gravel Company, 150 CR 340, Los Ojos, New Mexico, 87551		
Subject: Rock check dam retains and slows water from settling ponds before it comingles with water from irrigation channel, facing northeast.

Nevertheless to address the concerns of the NMED-SWQB, RSG has filled in the overflow channel that is between the secondary containment pond and the irrigation ditch as indicated by the attached photos. This work was completed on September 30th, 2014. If you have any further questions in this regard, please contact me at (575) 588-7933, or by email at rsg gravel@hotmail.com.

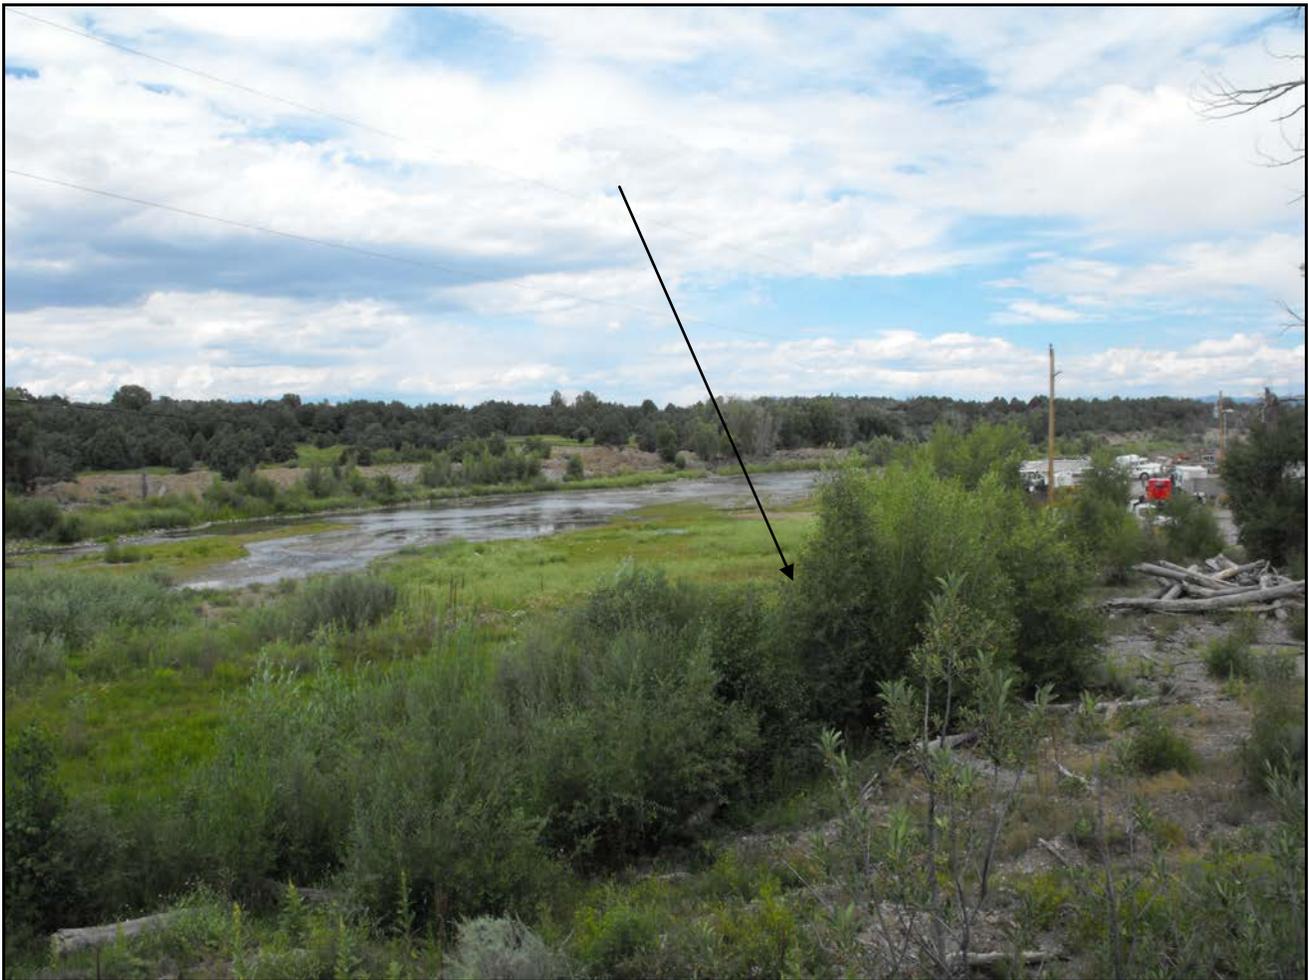
Photo # 6

Photographer: Daniel Valenta	Date: August 7, 2014	Time: 1354 hours
City/County: Outside of Los Ojos, New Mexico/ Rio Arriba County		
Location: Russell Sand & Gravel Company, 150 CR 340, Los Ojos, New Mexico, 87551		
Subject: Facility discharges process water and irrigation water to the Rio Chama in a heavily vegetated area, facing north.

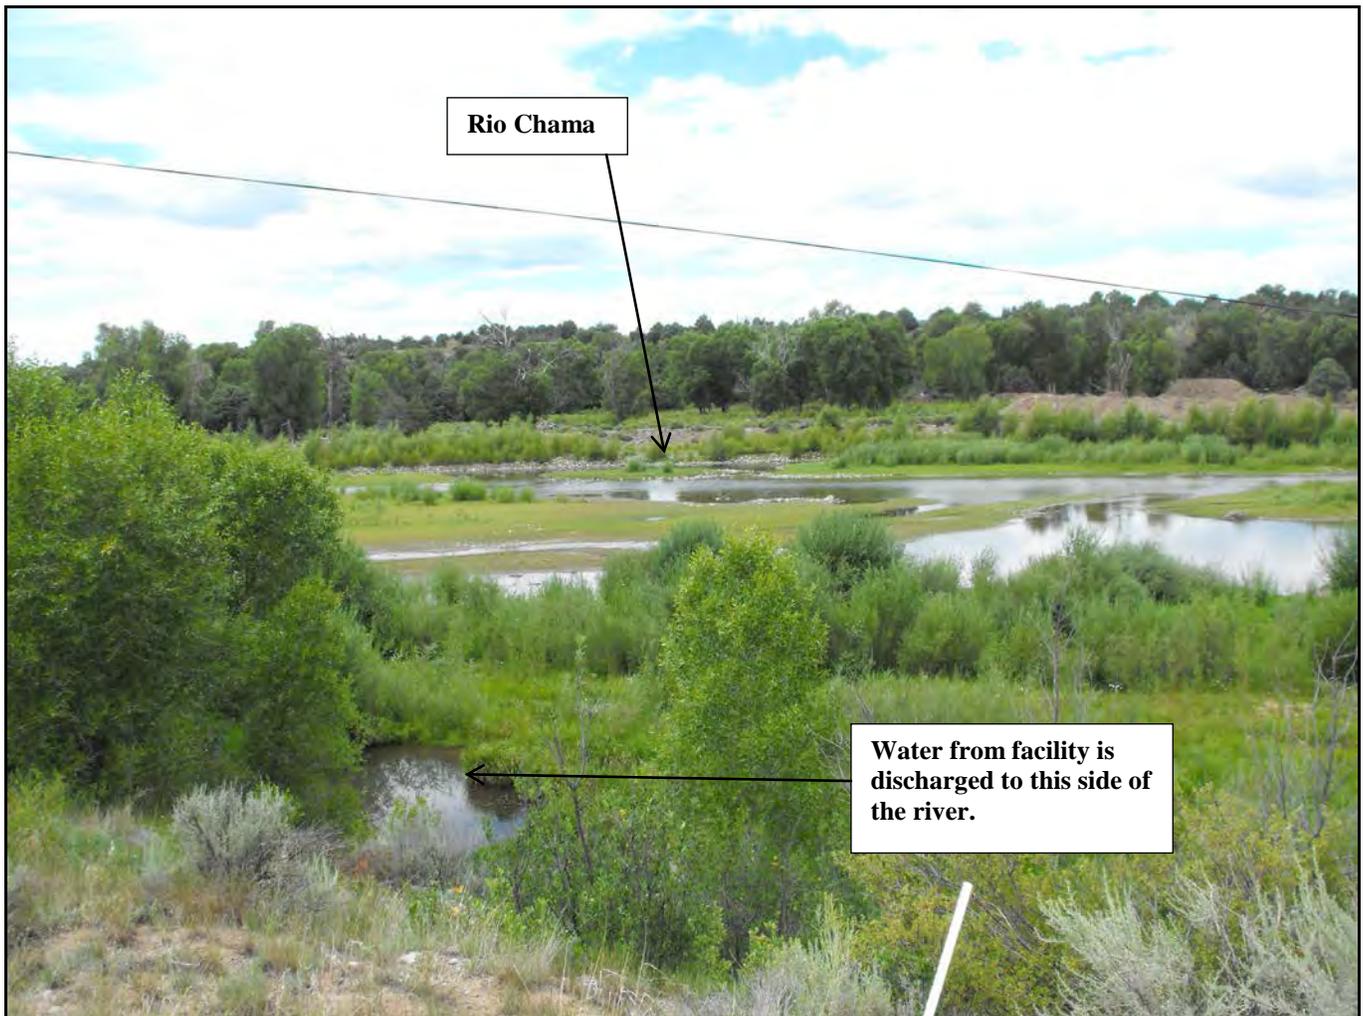
Photo # 7

Photographer: Daniel Valenta	Date: August 7, 2014	Time: 1353 hours
City/County: Outside of Los Ojos, New Mexico/ Rio Arriba County		
Location: Russell Sand & Gravel Company, 150 CR 340, Los Ojos, New Mexico, 87551		
Subject: Facility discharges process water and irrigation water to the Rio Chama in a heavily vegetated area, facing west.

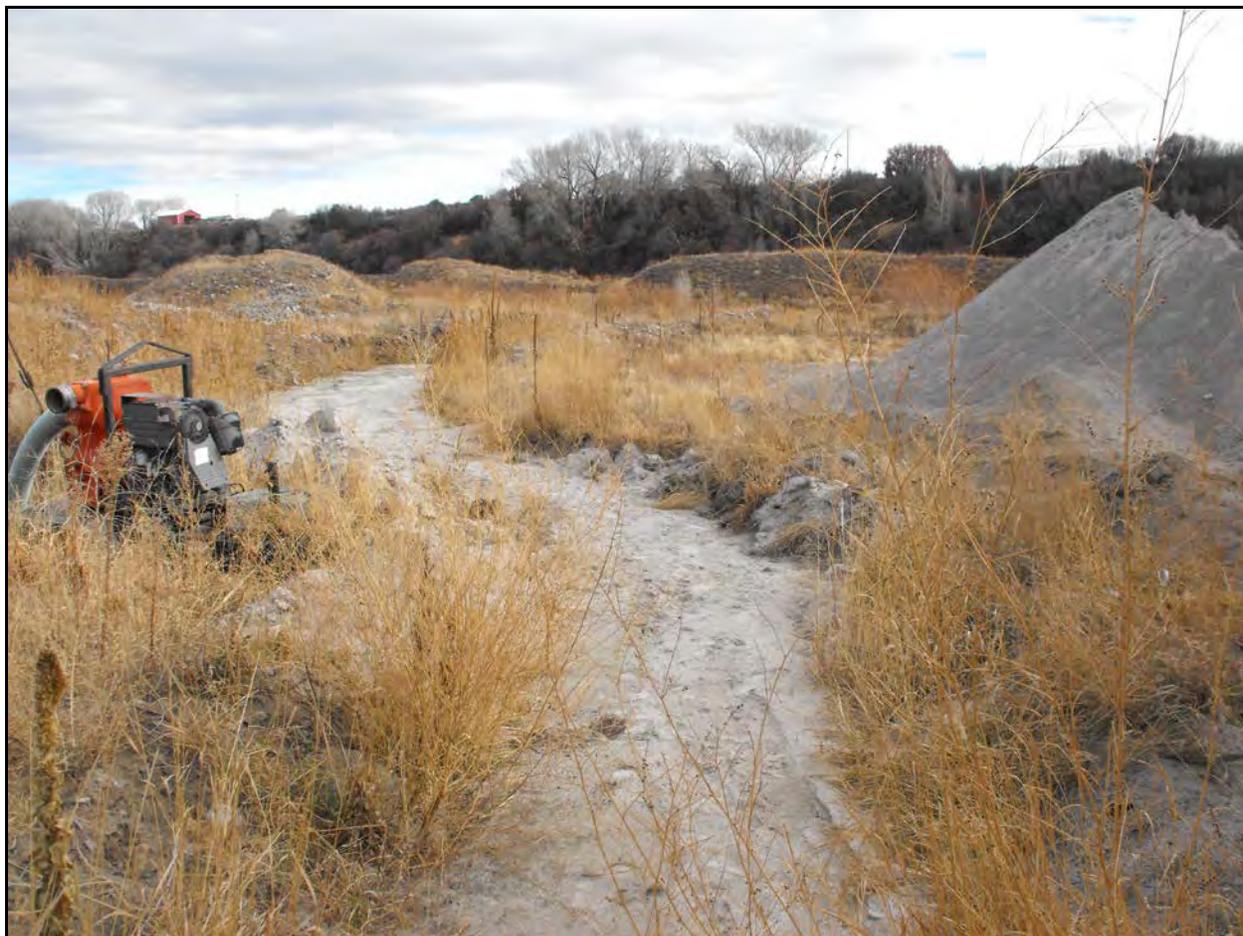
Photo # 2

Photographer: Daniel Valenta	Date: 12/6/2012	Time: 1252
City/County: Los Ojos/Rio Arriba County		
Location: Russell Sand & Gravel, Company, 150 County Rd. 340, Los Ojos, NM, facing southeast.		
Subject: Channel to pond.

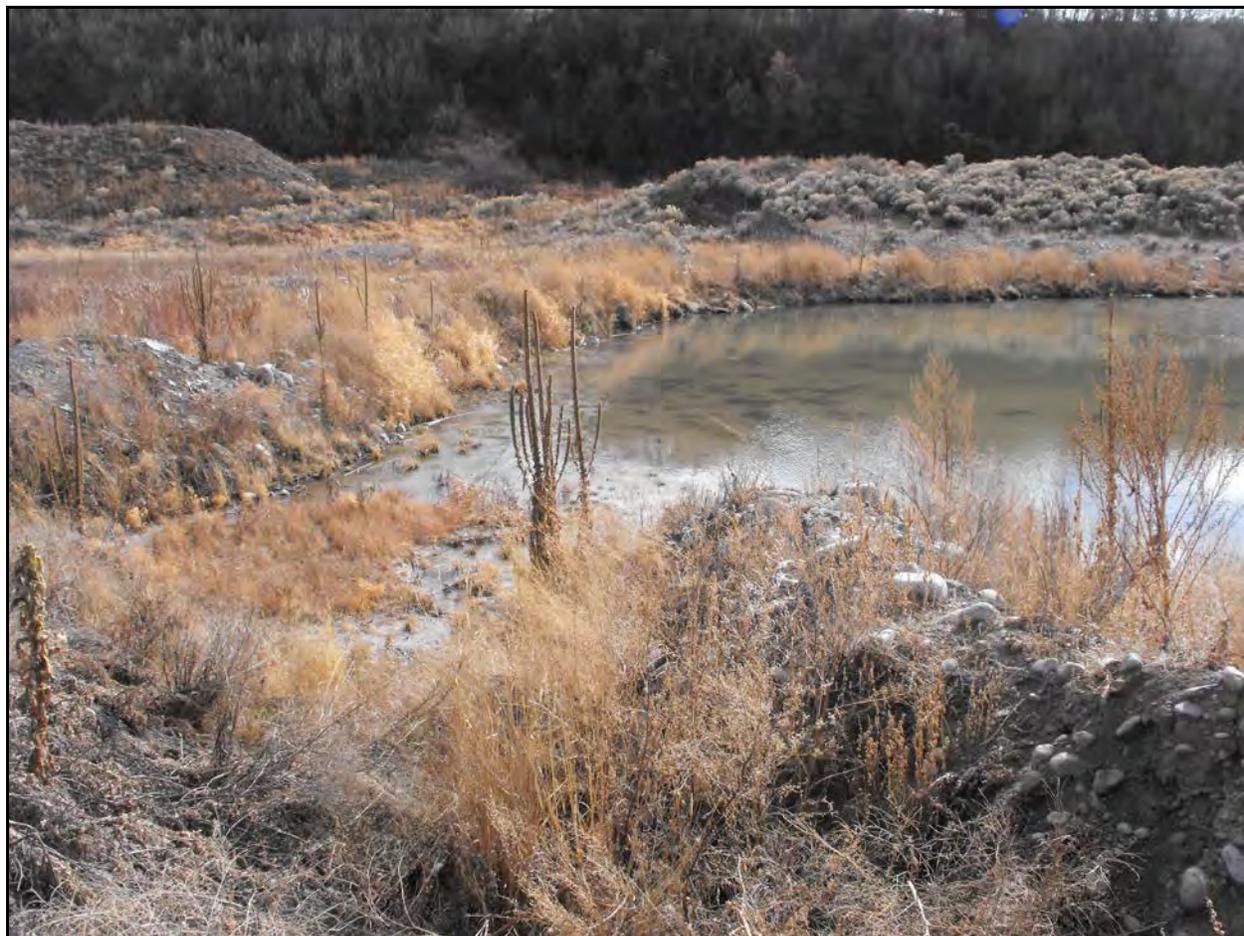
Photo # 3

Photographer: Daniel Valenta	Date: 12/6/2012	Time: 1255
City/County: Los Ojos/Rio Arriba County		
Location: Russell Sand & Gravel, Company, 150 County Rd. 340, Los Ojos, NM, facing southeast.		
Subject: Discharge from channel to pond

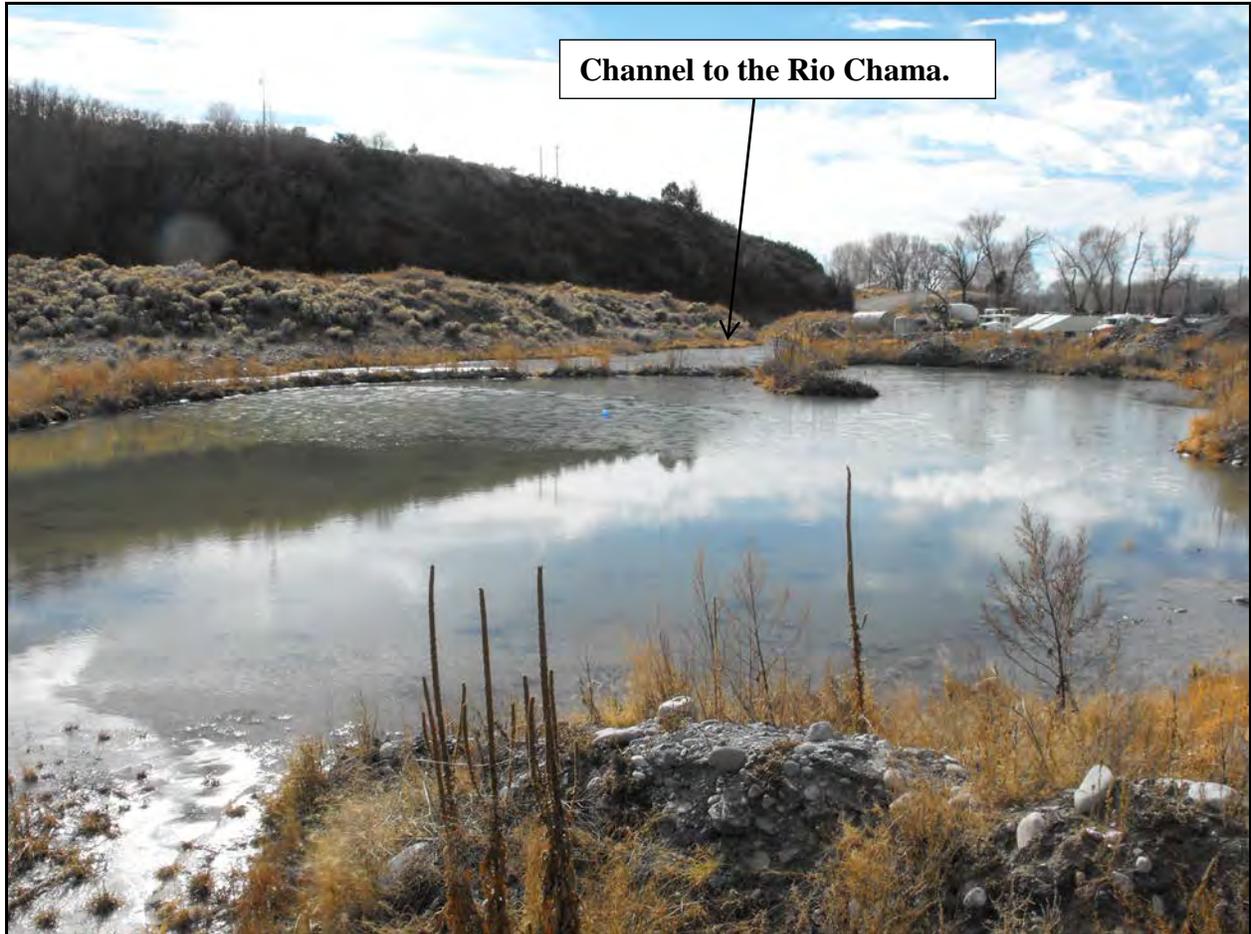
Photo # 4

Photographer: Daniel Valenta	Date: 12/6/2012	Time: 1255
City/County: Los Ojos/Rio Arriba County		
Location: Russell Sand & Gravel, Company, 150 County Rd. 340, Los Ojos, NM, facing southwest.		
Subject: Sediment pond is alongside discharge channel to river.

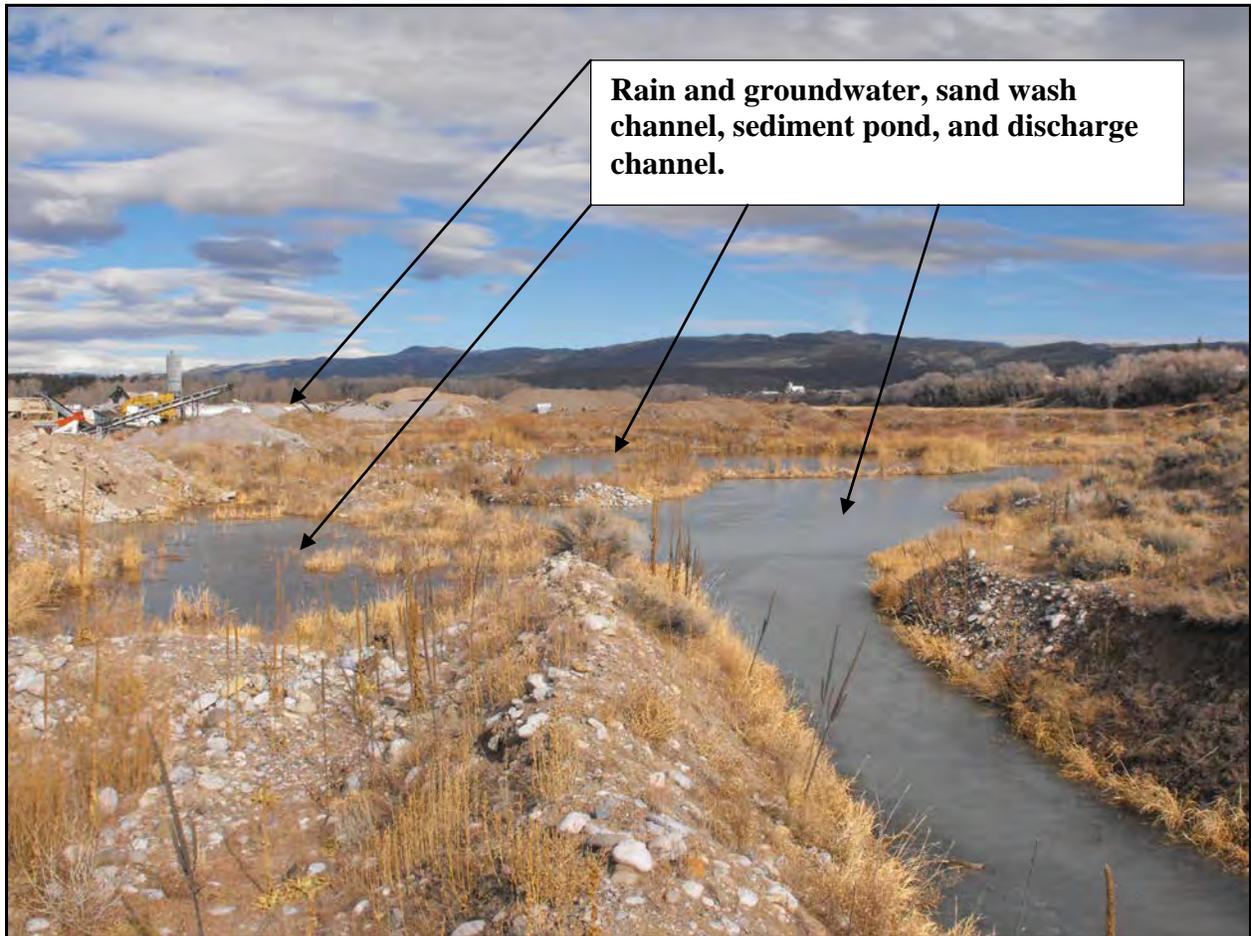
Photo # 6

Photographer: Daniel Valenta	Date: 12/6/2012	Time: 1231
City/County: Los Ojos/Rio Arriba County		
Location: Russell Sand & Gravel, Company, 150 County Rd. 340, Los Ojos, NM, facing southeast.		
Subject: View of area before flowing to discharge point.

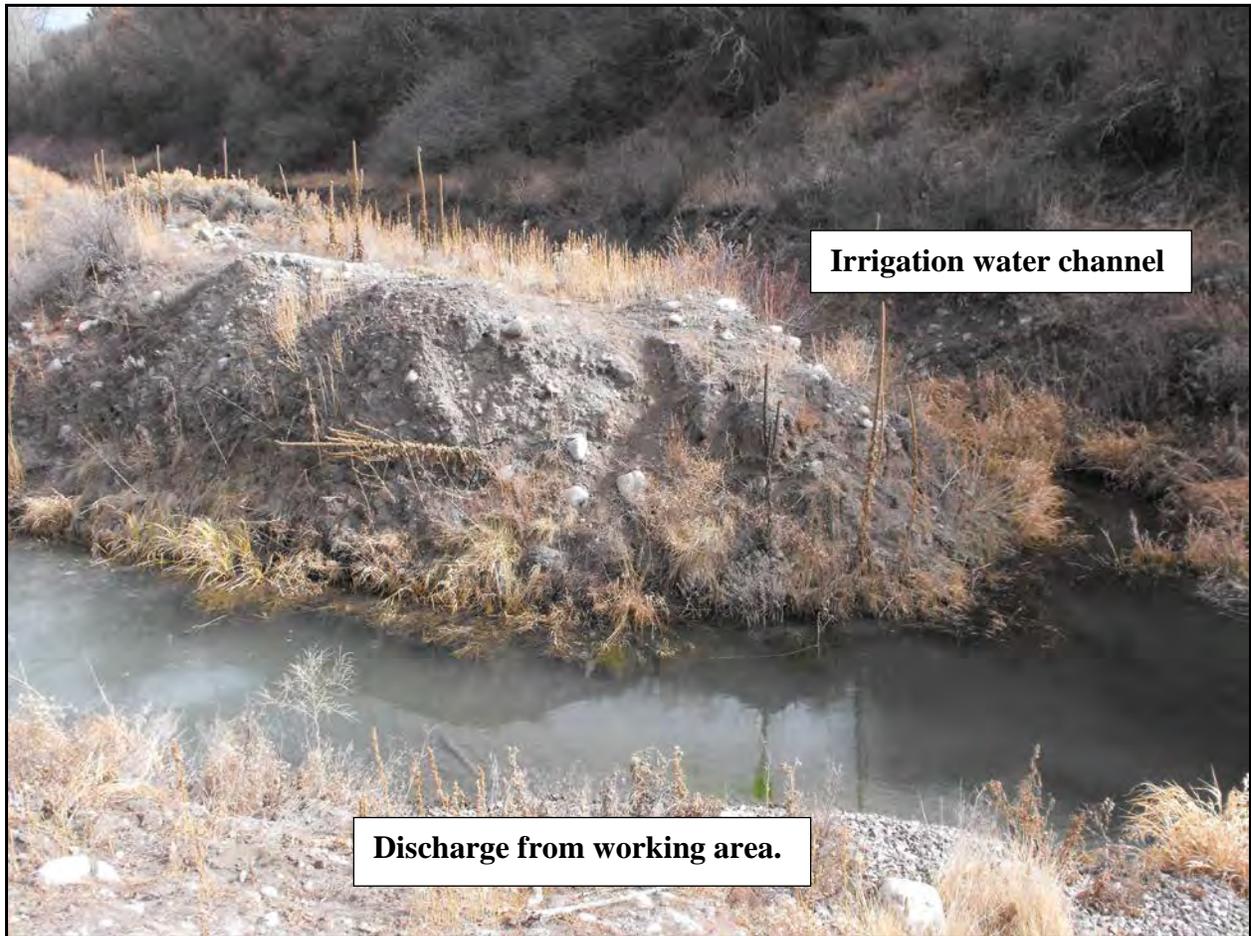
Photo # 7

Photographer: Daniel Valenta	Date: 12/6/2012	Time: 1228
City/County: Los Ojos/Rio Arriba County		
Location: Russell Sand & Gravel, Company, 150 County Rd. 340, Los Ojos, NM, facing southeast.		
Subject: The irrigation bypass channel joins the channel that drains the above working area.

Irrigation water channel

Discharge from working area.

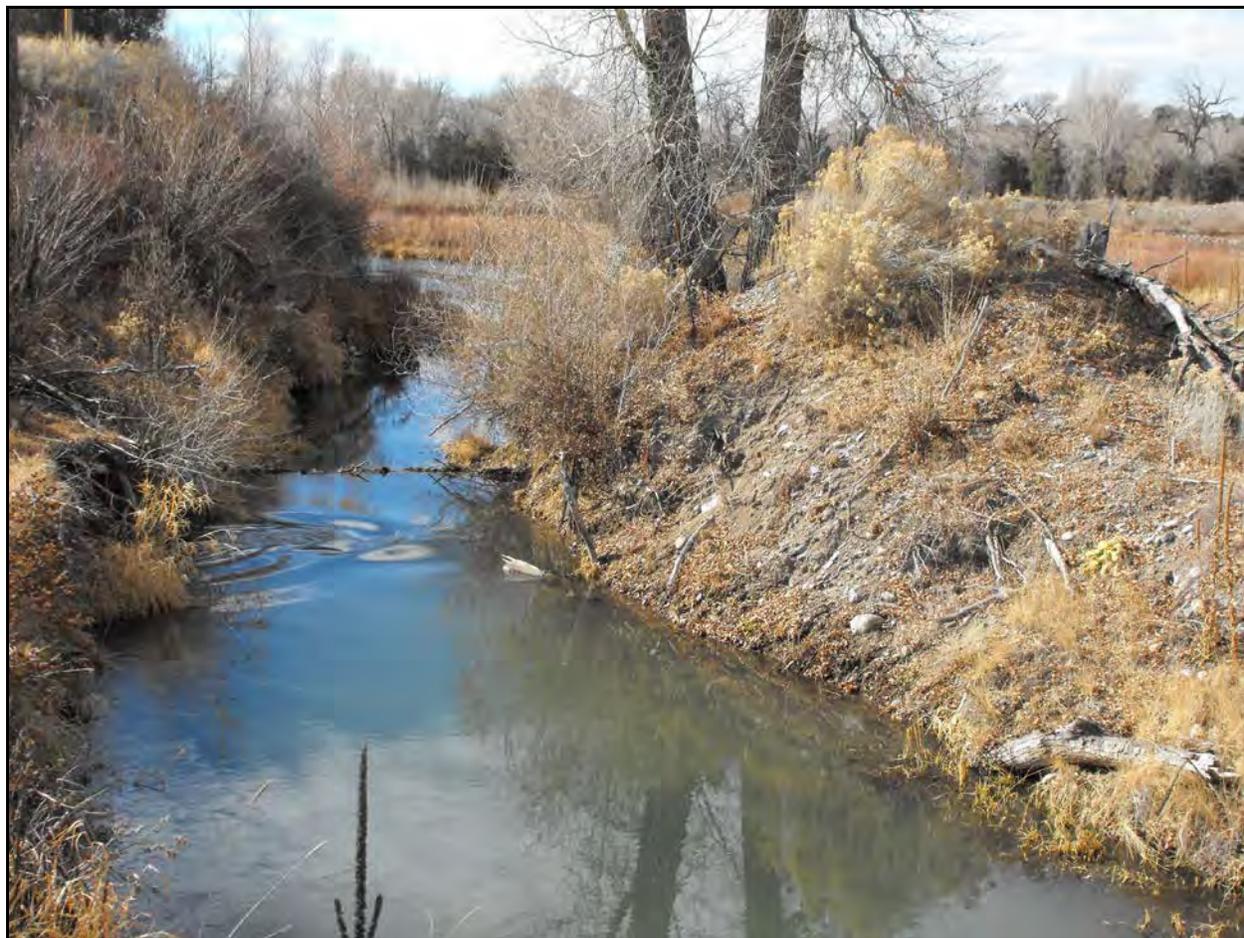
Photo # 8

Photographer: Daniel Valenta	Date: 12/6/2012	Time: 1217
City/County: Los Ojos/Rio Arriba County		
Location: Russell Sand & Gravel, Company, 150 County Rd. 340, Los Ojos, NM, facing west.		
Subject: Channel discharges to the Rio Chama, see overview.

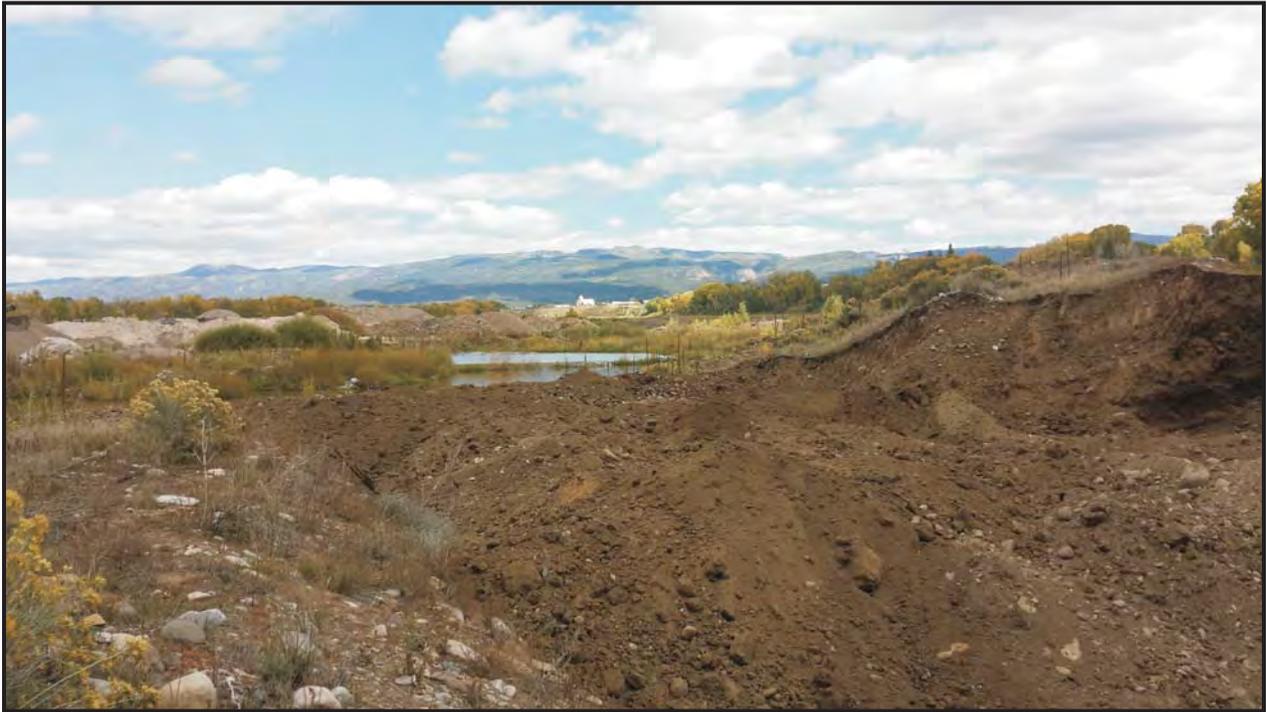
View to northeast

Clean fill placed in channel to prevent discharge from site

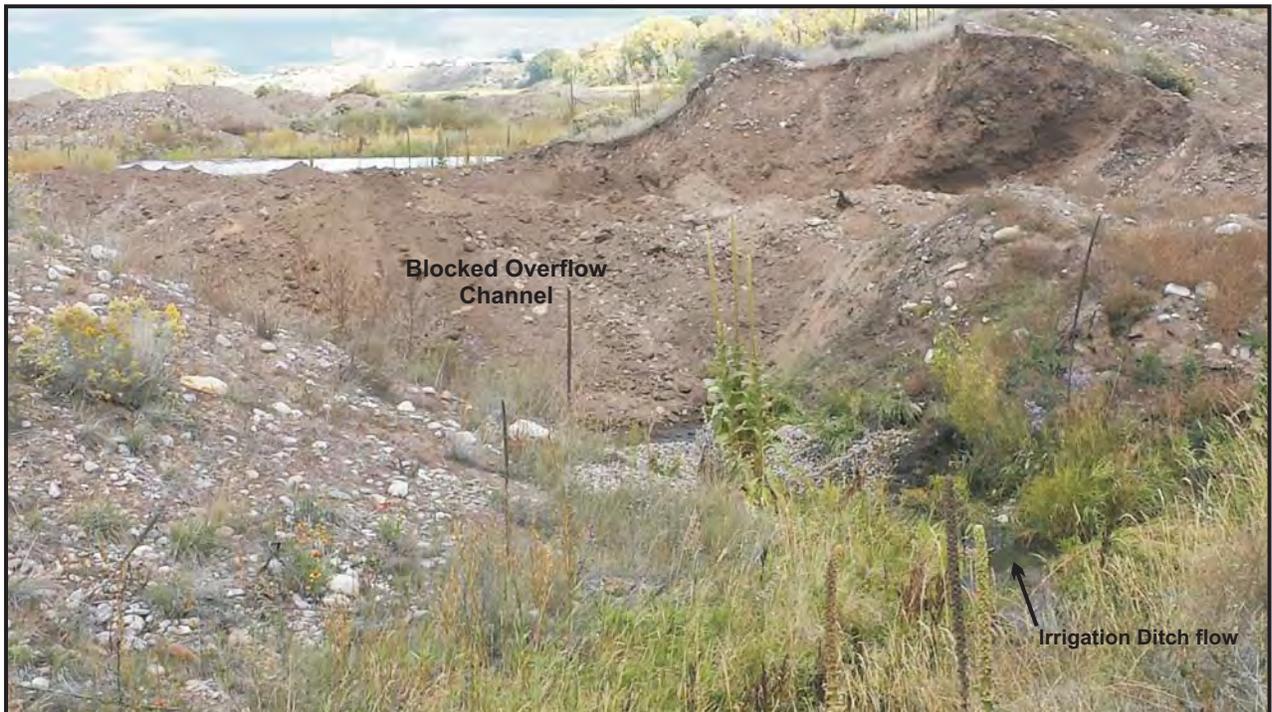
Overflow channel and rock check dam identified in photo #5, NMED Reconnaissance Report, 9/3/2014

View to northeast

Russell Sand & Gravel Co. NPDES# NMU001831
Los Ojos, New Mexico
Corrective action
Photo date: September 30, 2014
