**RE: Industrial Storm Water; SIC 3441; NPDES Compliance Evaluation Inspection; Amfabsteel, Inc.;
NPDES Permit NMU001837; January 9, 2013**

NPDES Compliance Inspection Report

Amfabsteel Inc.
NPDES Compliance Evaluation
Inspection NMU001837
January 9, 2013

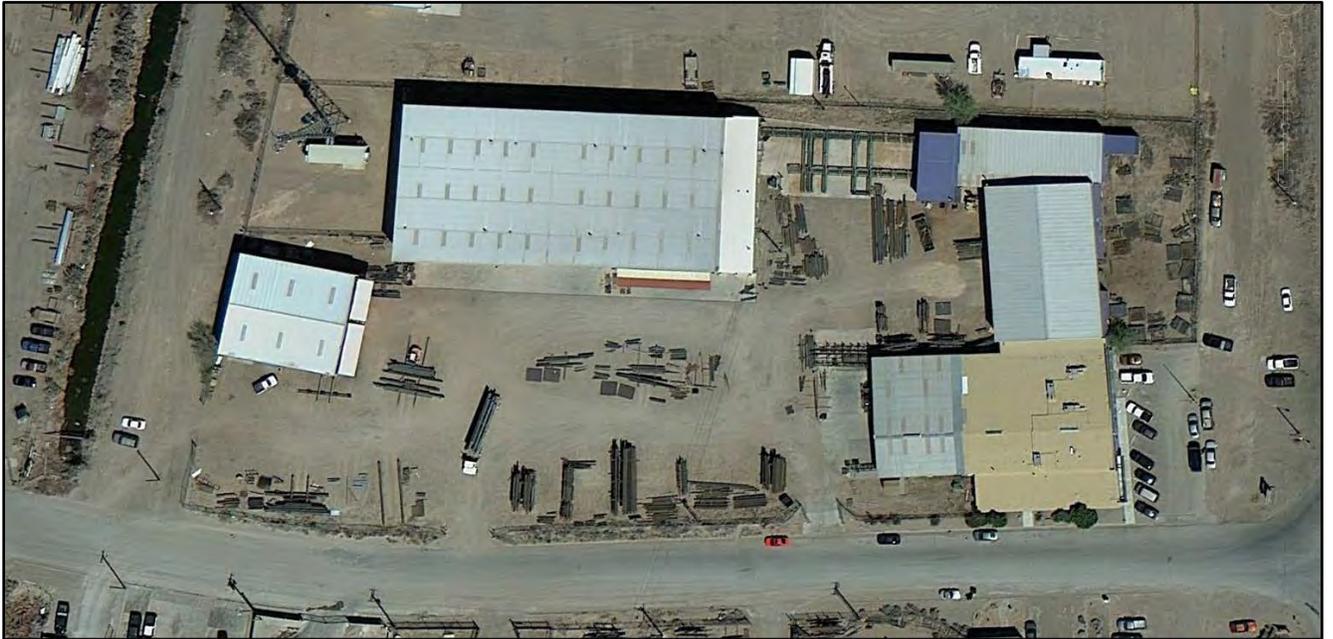
Photo # 1

Storm water may discharge from the facility into the stormwater inlets on the south side of the property (see photo 1) or into the Bernalillo stormwater system. This area discharges to the Rio Grande in the Rio Grande Basin in Segment 20.6.4.106 of the State of New Mexico Standards for Interstate and Intrastate Surface Waters, New Mexico Administrative Code (NMAC). Designated uses are irrigation, marginal warmwater aquatic life, livestock watering, wildlife habitat and primary contact; and public water supply on the Rio Grande.

Amfabsteel is a private company in business at this location since 1984 and has 34 employees. The site appeared to be fairly level with no discernible slope except at the entrance/exit. There are storm drains just outside the facility on the street (see photo 1). These were reported to be plugged and not working. The condition of the drains is unknown at this time. There were no containment berms or other BMPs in place at this time. The area appeared clean and organized except for metal cutting and trash around the dumpster (see photo 2) and what appeared to be used motor oil left in an open 5 gallon container. There was no lid on the dumpster to prevent contact with rainwater. The majority of industrial processes/activities, grinding, cutting, painting, welding, shaving, and metal treating, are performed under covered sheds (see photo 3). These areas are swept and the waste placed in containers to be landfilled.

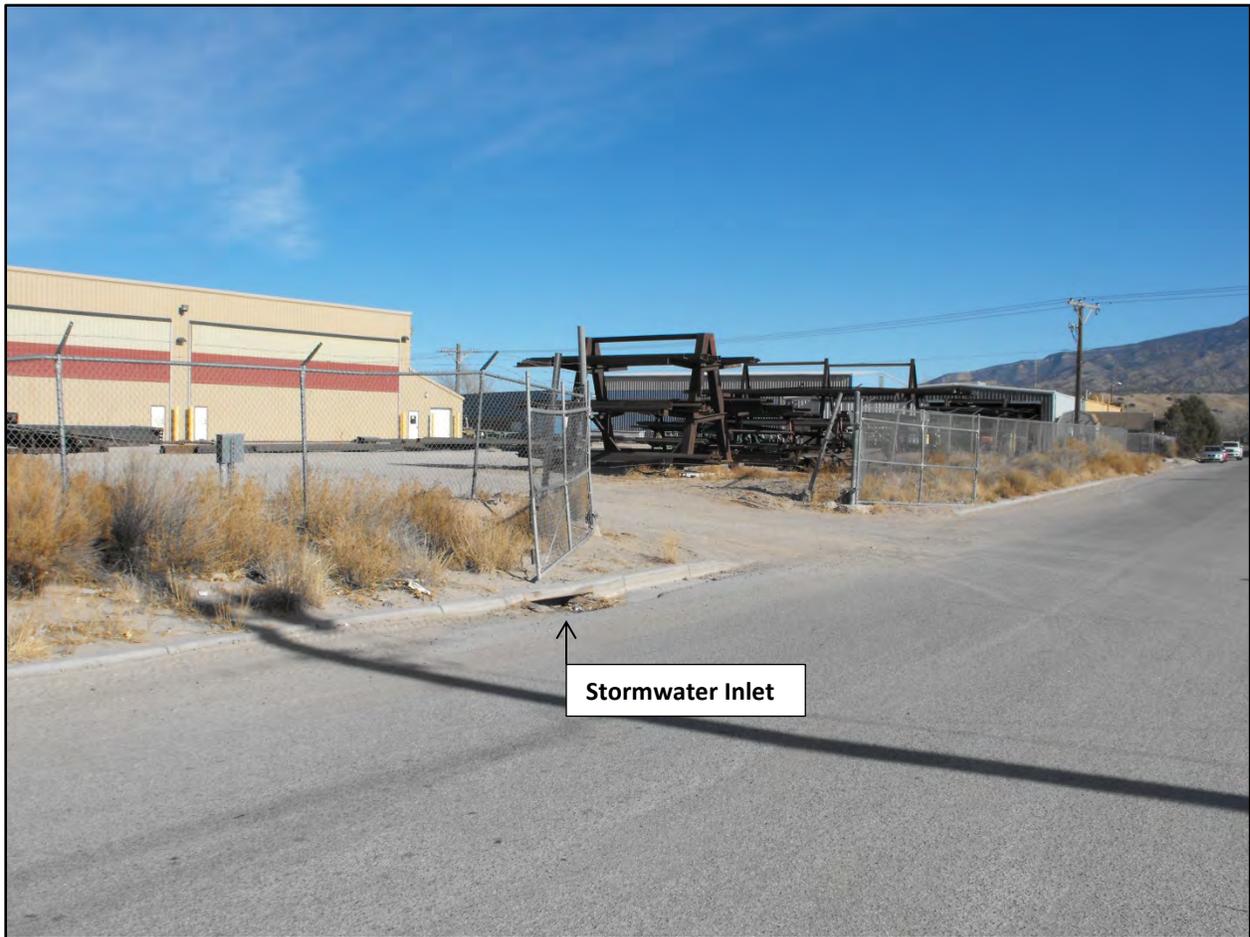
Photographer: Daniel Valenta	Date: 1/9/2013	Time: 1340 hours
City/County: Bernalillo/ Sandoval County		
Location: 100 Calle Industrial, Bernalillo, New Mexico, facing northeast.		
Subject: Amfabsteel storage yard of raw steel materials and finished items.

Your facility does not have permit coverage for the industrial activities associated with Sector AA. You are strongly encouraged to review the permit, complete your SWPPP and apply for coverage under the eNOI system.

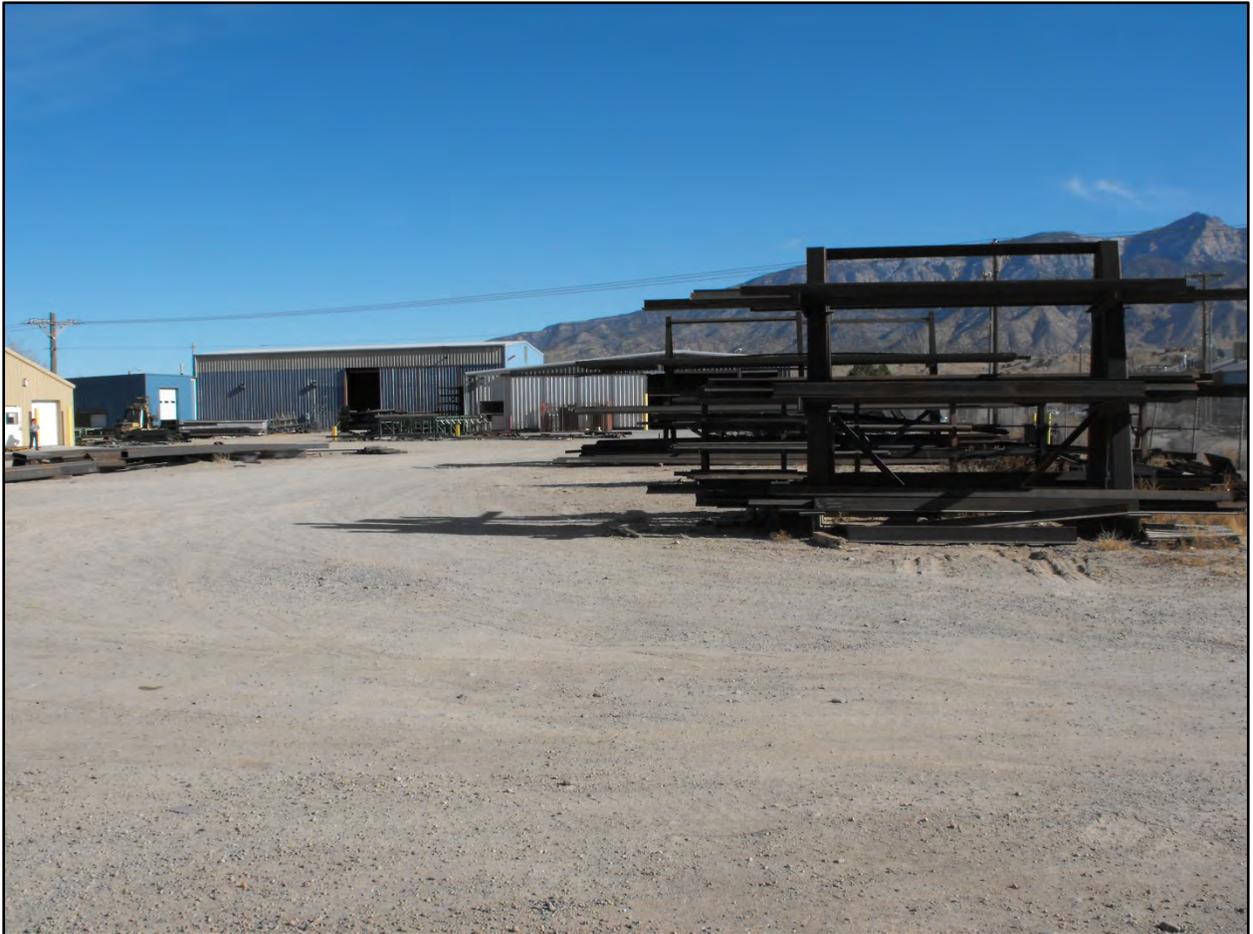
Photo # 2

Photographer: Daniel Valenta	Date: 1/9/2013	Time: 1316 hours
City/County: Bernalillo/ Sandoval County		
Location: 100 Calle Industrial, Bernalillo, New Mexico, facing east.		
Subject: Amfabsteel storage yard of raw steel materials and finished items.

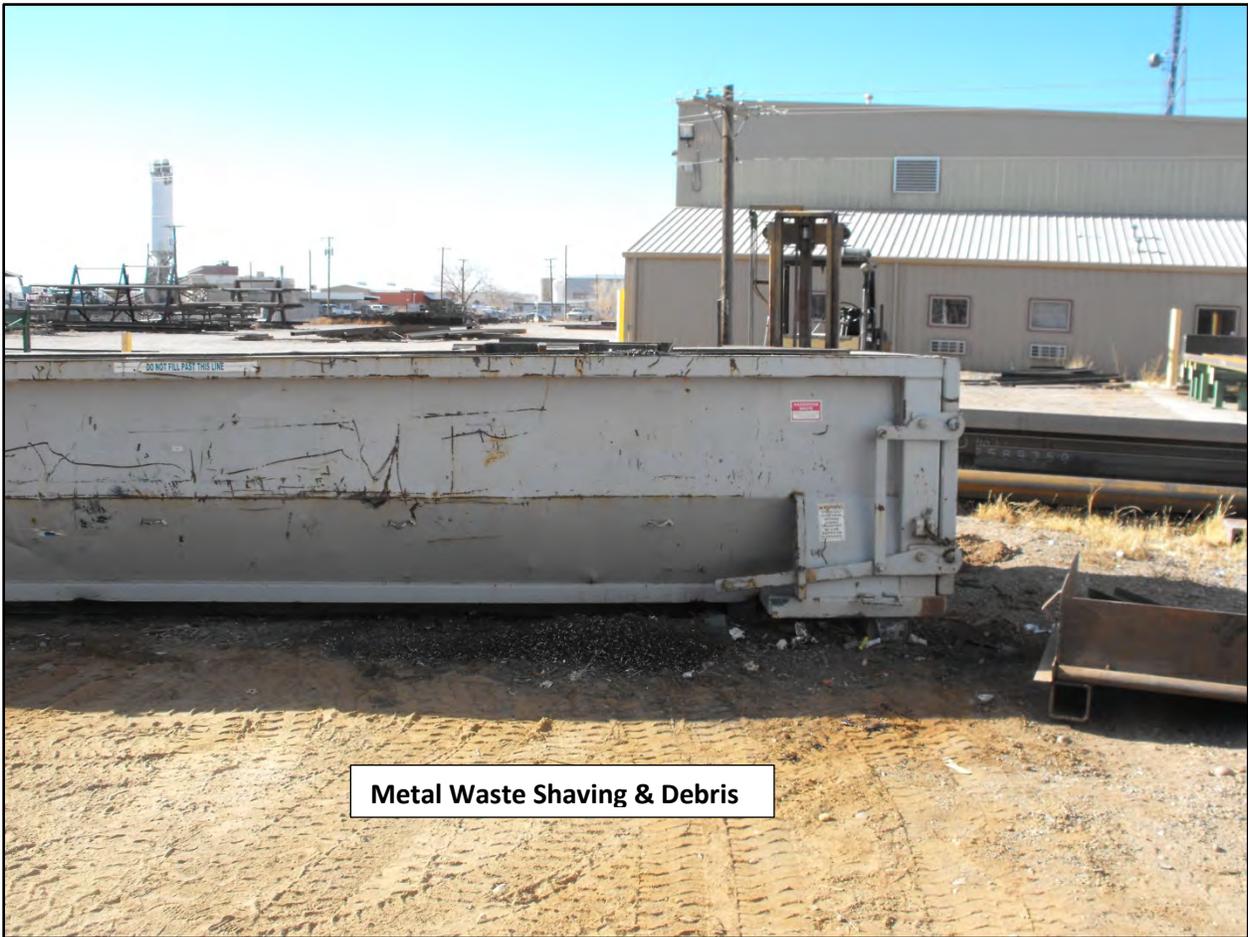
Photo # 3

Photographer: Daniel Valenta	Date: 1/9/2013	Time: 1350 hours
City/County: Bernalillo/ Sandoval County		
Location: 100 Calle Industrial, Bernalillo, New Mexico, facing east.		
Subject: Amfabsteel facility, oily metal shaving scattered around the waste dumpster.

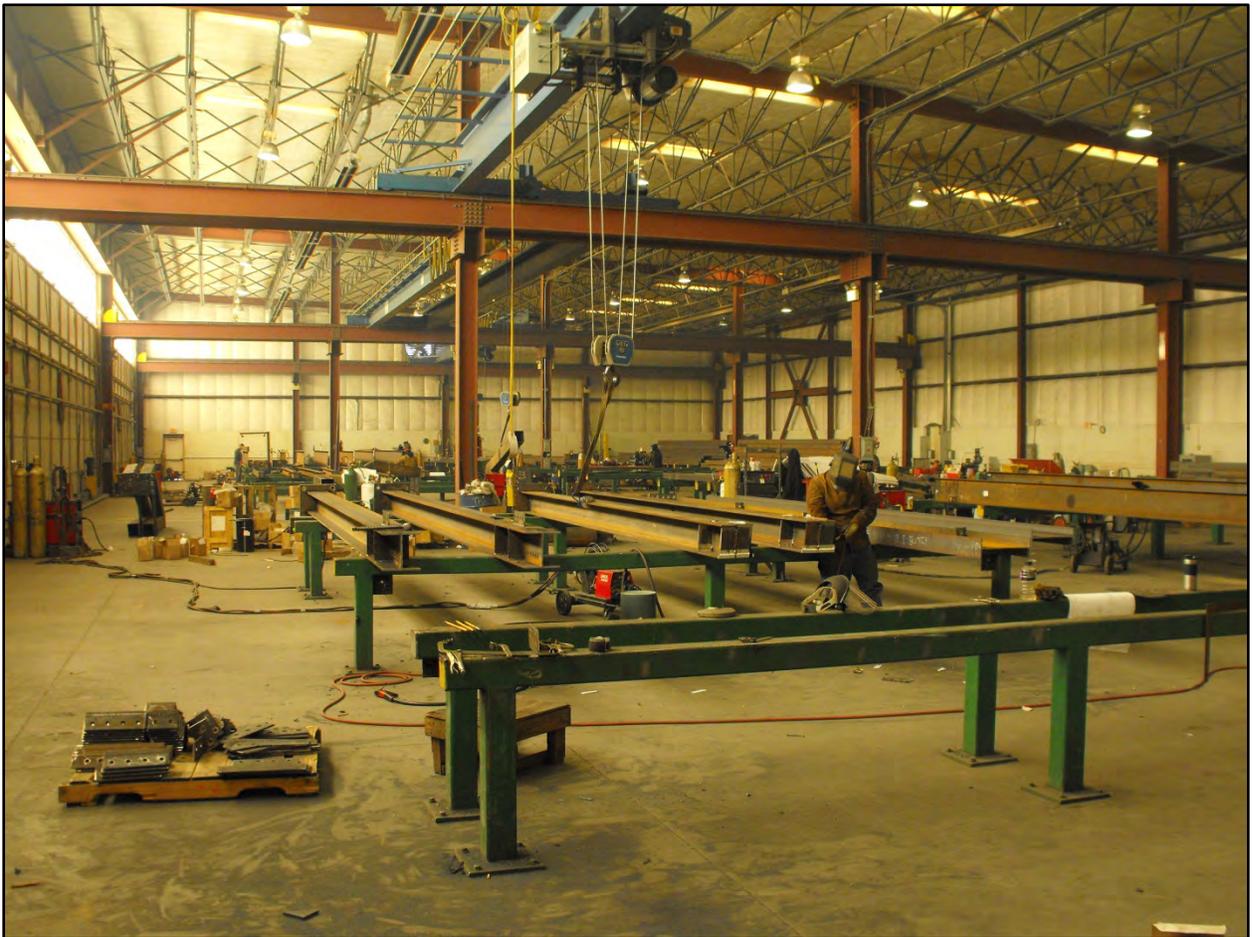
Photo # 4

Photographer: Daniel Valenta	Date: 1/9/2013	Time: 1347 hours
City/County: Bernalillo/ Sandoval County		
Location: 100 Calle Industrial, Bernalillo, New Mexico, facing east.		
Subject: Amfabsteel facility, majority of the industrial processing of metal is completed under cover.
