**NEW MEXICO  
ENVIRONMENT DEPARTMENT**

**RE: Construction Storm Water; SIC 1611; NPDES Compliance Evaluation Inspection; Albuquerque Metal Recycling Inc.; NMU001840; January 16, 2013**

### NPDES Compliance Inspection Report

**Albuquerque Metal Recycling**  
**January 16, 2013**  
**NMU001840**

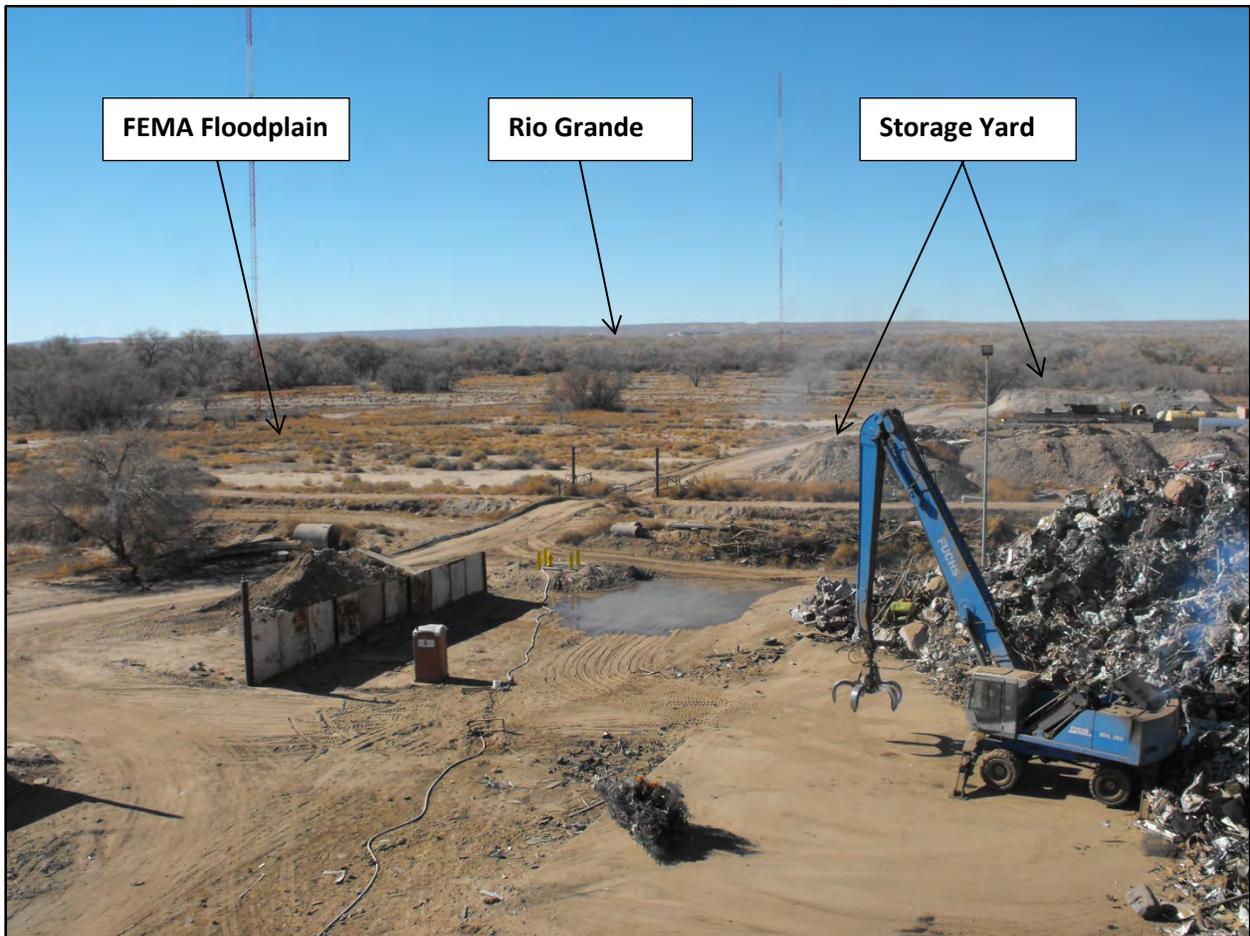
Photo # 3

The facility does not have the required coverage under the Construction General Permit (CGP) for the disturbance of one acre or more. The footprint of the disturbance includes the storage site for sediment removed in the construction of the detainment pond and the re-contouring of the facility. A recycling facility has been in operation at this site since 1960. As the top layers of sediment are removed from the site they are being stored on a property west of the site. No Best Management Practices (BMP's) have been installed to contain any run off from this area, (see photos 2-5).

Photographer: Daniel Valenta	Date: 1/16/2013	Time: 1246 hours
City/County: Albuquerque/Bernalillo		
Location: Albuquerque Metal Recycling, 3339 2 <sup>nd</sup> Street SW, Albuquerque, New Mexico, facing west.		
Subject: Storage yard on west side of facility.

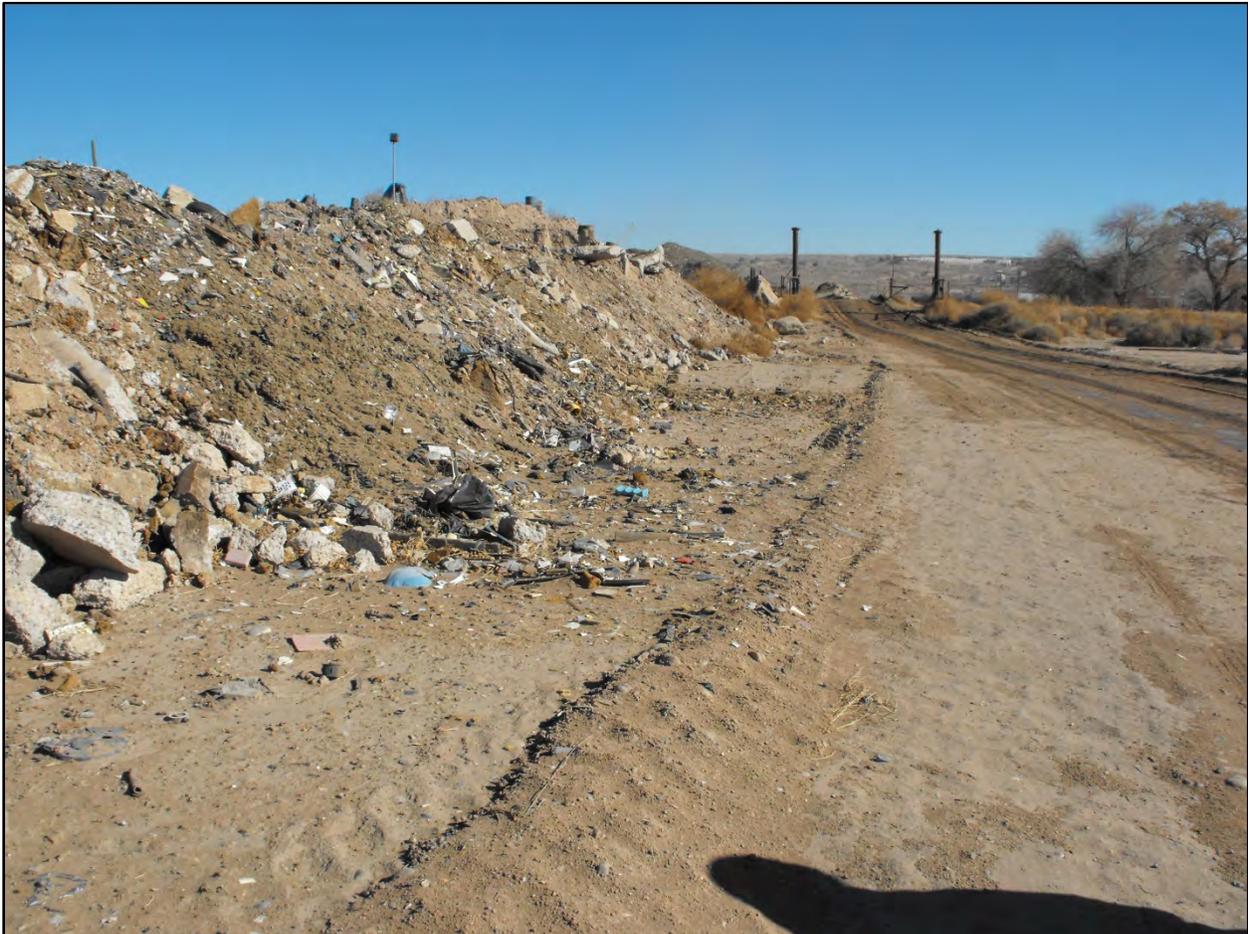
Photo # 4

Photographer: Daniel Valenta	Date: 1/16/2013	Time: 1319 hours
City/County: Albuquerque/Bernalillo		
Location: Albuquerque Metal Recycling, 3339 2 <sup>nd</sup> Street SW, Albuquerque, New Mexico, facing east.		
Subject: One of the uncontained piles of dirt stored at the west side of the facility.
