Re: Industrial Storm Water, SIC 4173, NPDES Compliance Evaluation Inspection, City of Albuquerque Pino Yards Maintenance Yard, NMU001861, August 2, 2013

**NPDES Compliance Inspection Report**

Compliance Evaluation Inspection  
City of Albuquerque Pino Yards, Sector P  
NPDES Permit #NMU001861, August 2, 2013

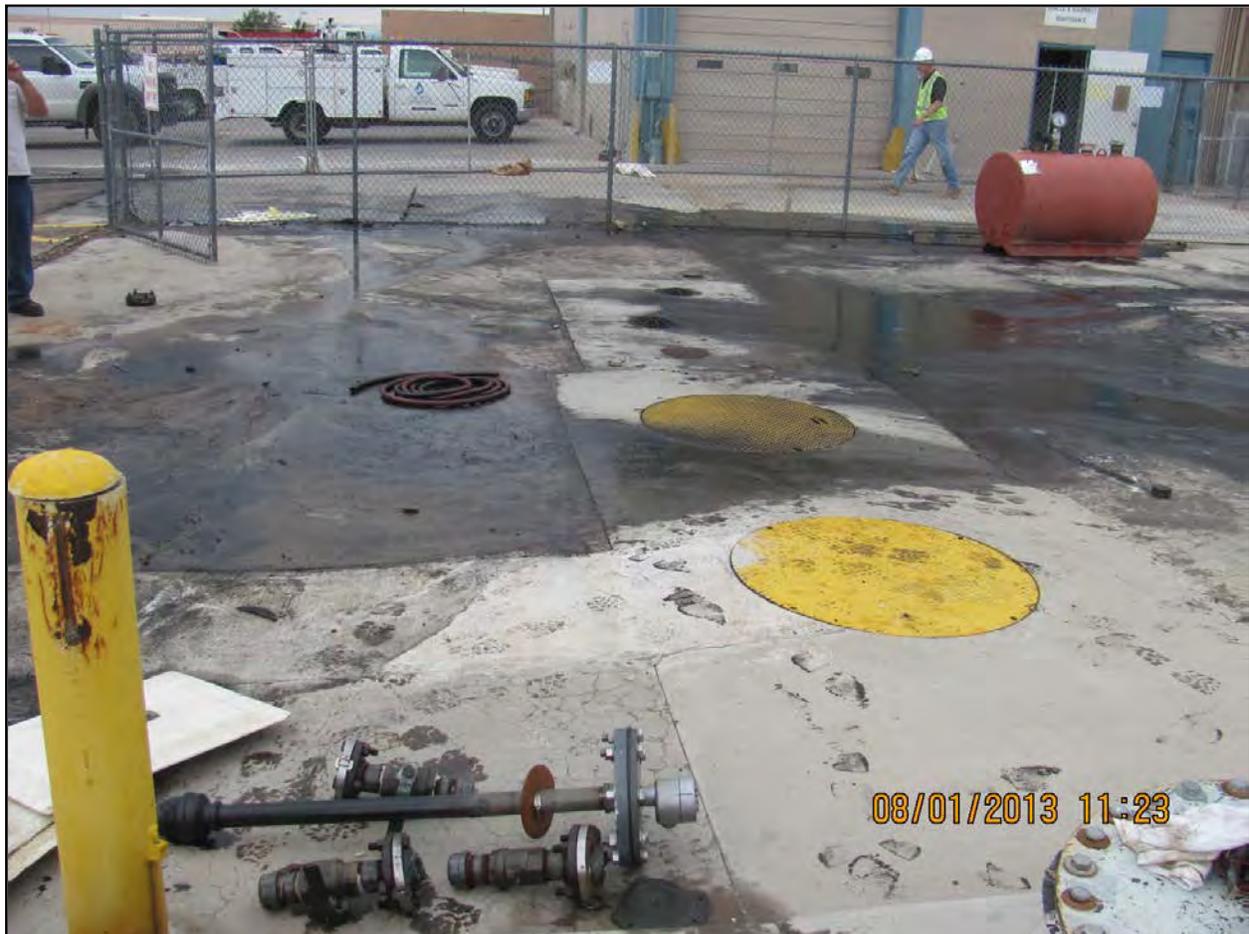
Photo # 1

Photographer: Bart Butler	Date: 8-1-2013	Time: 1123 hours
City/County: Albuquerque, Bernalillo County		
Location: City of Albuquerque Pino Yards near I-25 and Paseo del Norte, Albuquerque, NM		
Subject: Area where the spill originated by removal of an underground oil/water separator.

The City of Albuquerque has hired a subcontractor, RMCI, Inc. who is performing maintenance activities at the Pino Yards site, and was in the process of removing an old oil/water separator. According to facility representatives, RMCI staff attempted to pump out the materials in the separator, but were not successful in removing all of the material. When pulling the separator out of the ground, the gaskets on the separator broke, spilling the residual oil/water mixture that the staff were not successful in removing. Notification was made to the NMED Emergency Hotline, and Mr. Bart Butler of the NMED Petroleum Storage Tank Bureau (PSTB) initially responded to the report and documented the spill, as well as cleanup efforts later in the afternoon on August 1.

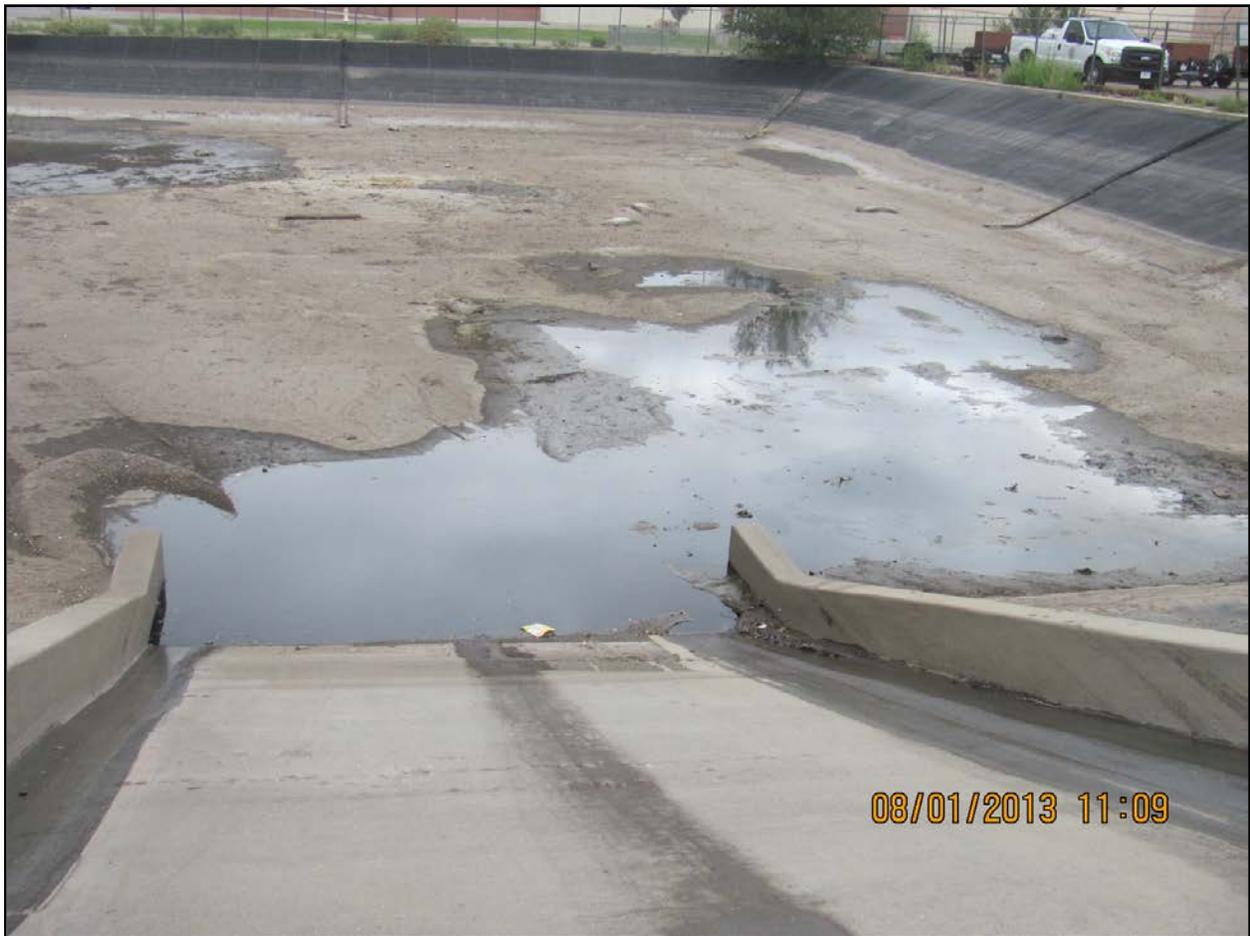
Photo # 2

Photographer: Bart Butler	Date: 8-1-2013	Time: 1109 hours
City/County: Albuquerque, Bernalillo County		
Location: City of Albuquerque Pino Yards near I-25 and Paseo del Norte, Albuquerque, NM		
Subject: Amount of oil that initially made it to the on-site retention pond. Outlet of the pond (which goes directly to the North Pino Arroyo via a non-functioning (according to facility representatives) oil/water separator.

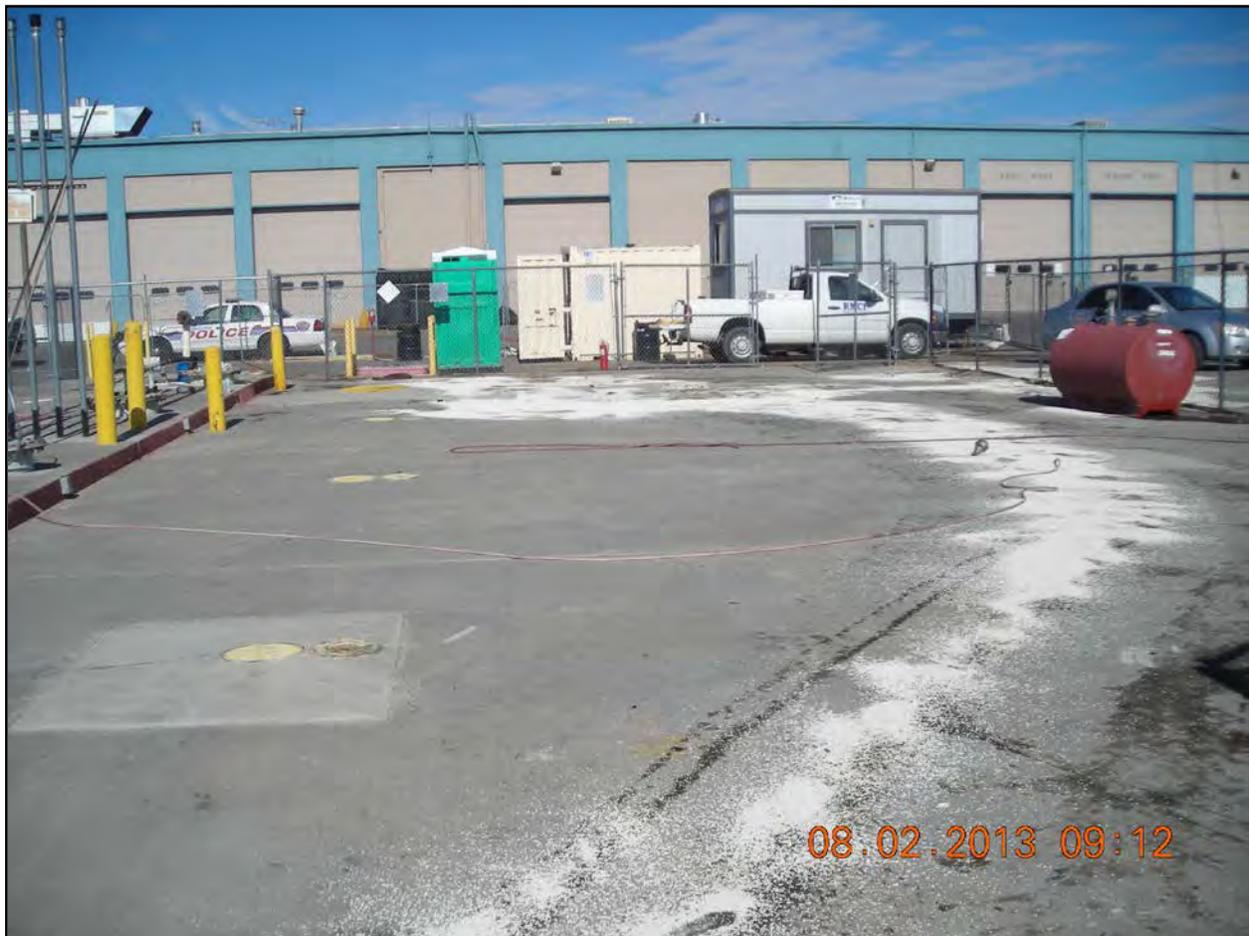
Photo # 3

Photographer: Sarah Holcomb	Date: 8-2-2013	Time: 0912 hours
City/County: Albuquerque, Bernalillo County		
Location: City of Albuquerque Pino Yards near I-25 and Paseo del Norte, Albuquerque, NM		
Subject: Area where the spill originated. Oil had been absorbed with kitty litter/absorbent material and swept for most of the spill. Inspector instructed the yards staff that the absorbent material should also be removed promptly to avoid being transported to the MS4 in the event of rain.

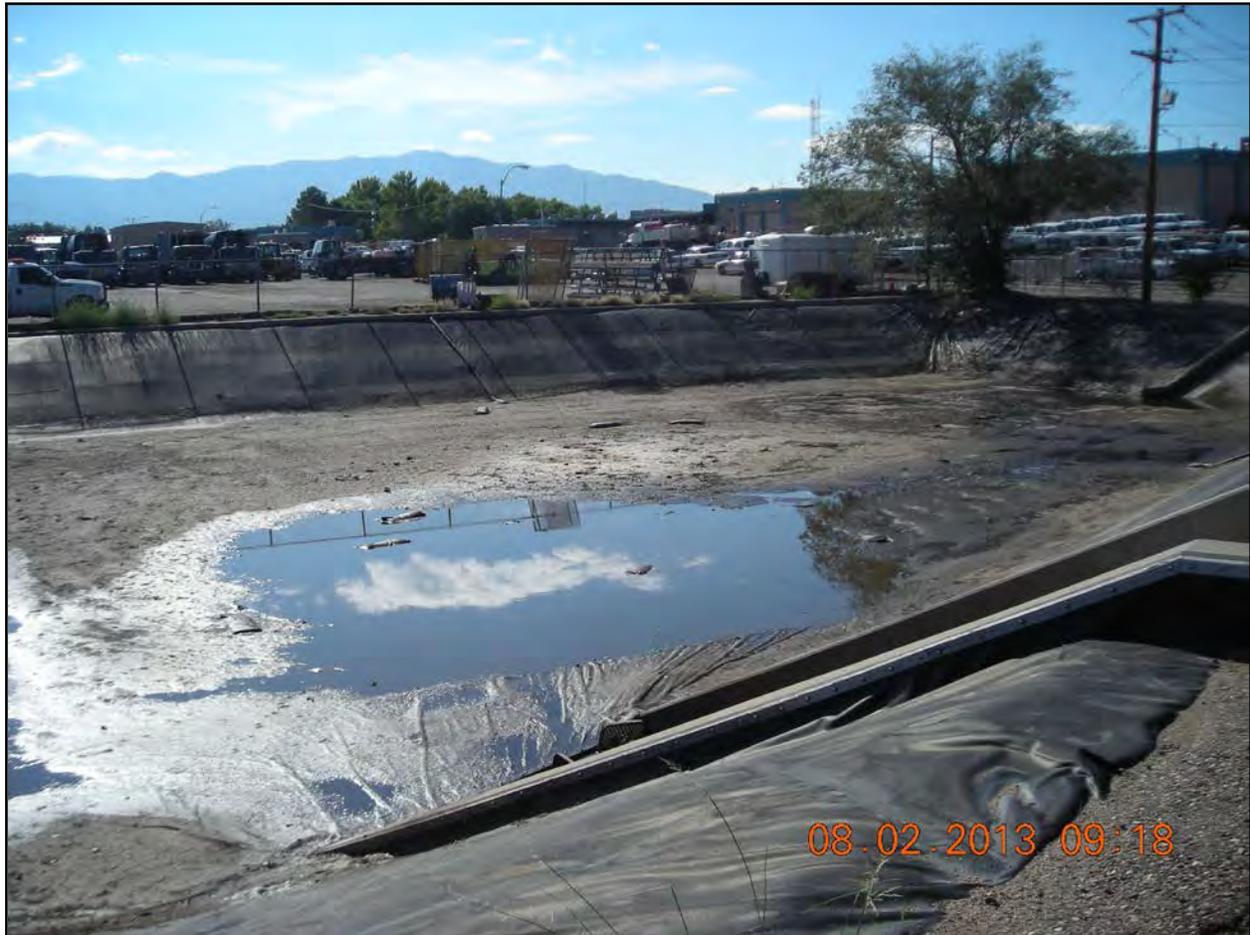
Photo # 4

Photographer: Sarah Holcomb	Date: 8-2-2013	Time: 0918 hours
City/County: Albuquerque, Bernalillo County		
Location: City of Albuquerque Pino Yards near I-25 and Paseo del Norte, Albuquerque, NM		
Subject: On-site retention pond on the day of the inspection. Oil that flowed to the pond had been captured and soils that were contaminated were removed and were awaiting proper disposal in a dumpster located on the property.
