Re: New Natural Gas Pipeline Hydrostatic Testing Wastewater Discharge at County Road (CR) 57A, Santa Fe County, New Mexico; Enterprise Mid-America Natural Gas Pipeline WEP III Project, Segment 3; Minor; Unpermitted Discharge; SIC 4923; NPDES Reconnaissance; NMU001866; November 8, 2013

NPDES Compliance Inspection Report

**Enterprise Products Operating, LLC
New Natural Gas Pipeline Hydrostatic Testing Wastewater Discharge
at County Road (CR) 57A, Santa Fe County, New Mexico
Enterprise Mid-America Natural Gas Pipeline WEP III Project, Segment 3
NPDES Tracking No. NMU001866
Reconnaissance
November 8, 2013**

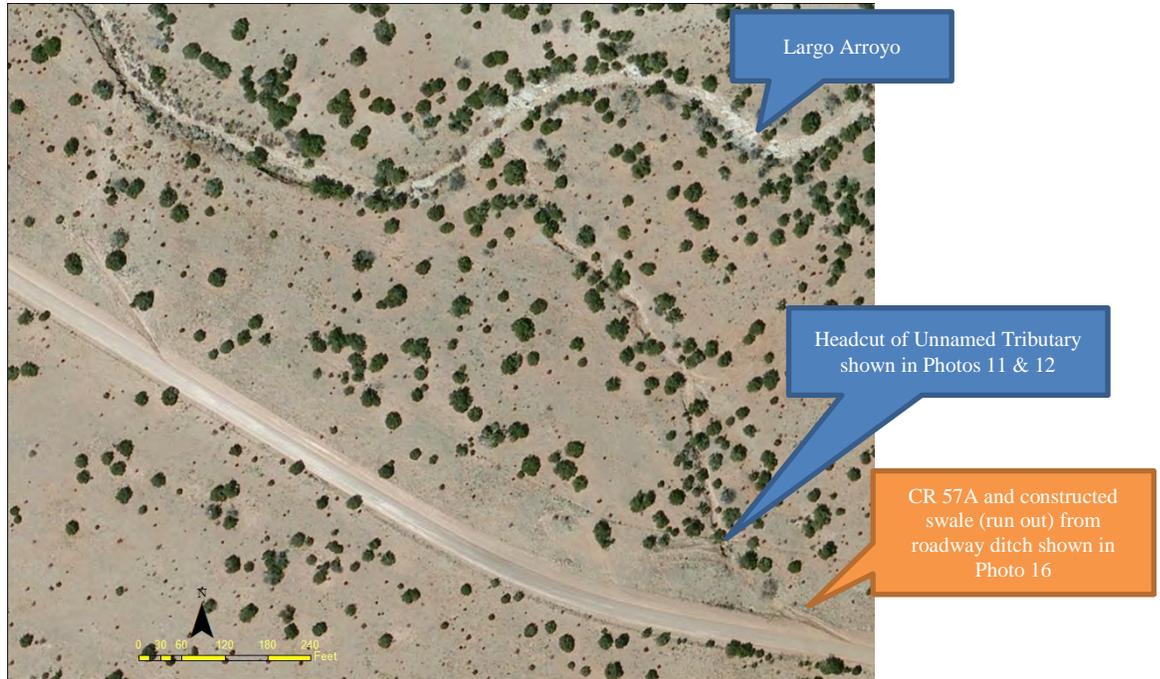
NMED/SWQB
Aerial Photograph

Location: Santa Fe County Road 57A, Approximately 1,500 Feet Northwest of Intersection of NM 14 and CR 57A

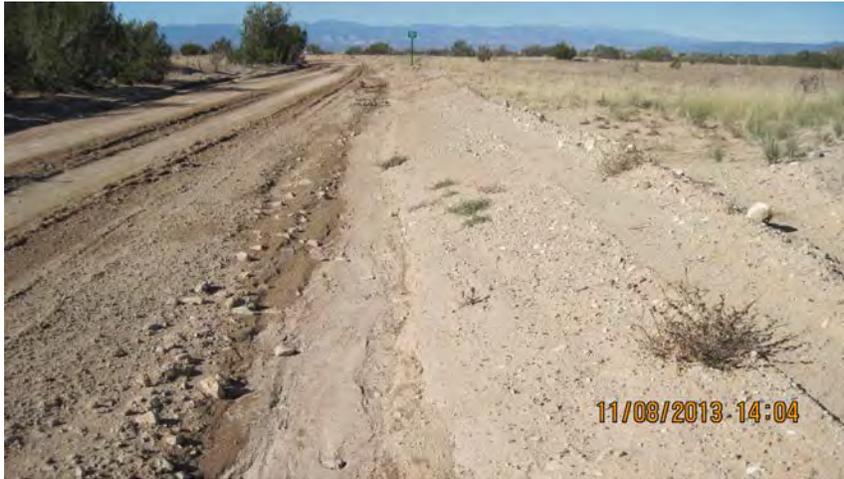
NMED/SWQB Official Photograph Log Photo # 1		
Photographer: Erin S. Trujillo, NMED SWQB	Date: 11/8/2013	Time: 1404 hours
City/County: North of Golden / Santa Fe		State: New Mexico
Location: Santa Fe County Road 57A Right of Way, Approx. 3.4 miles west of NM 14		
Subject: Looking generally west, wet soils existed on road and along roadway ditch east of county road maintenance sign.

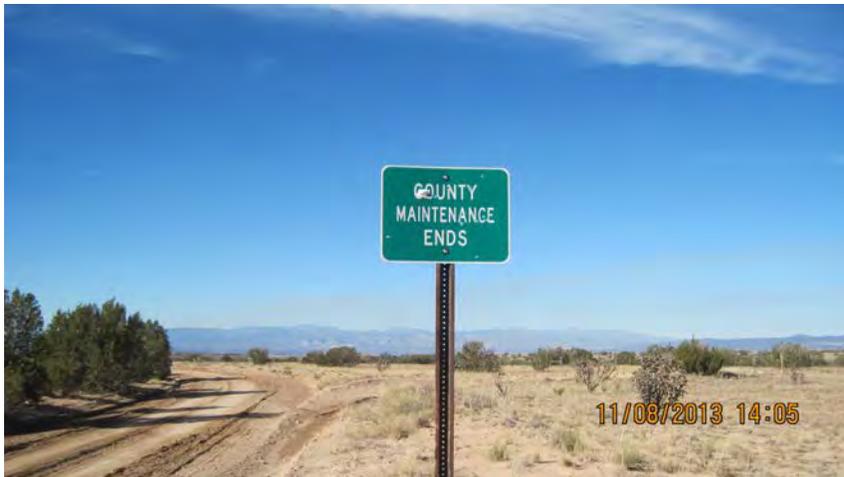
NMED/SWQB Official Photograph Log Photo # 2		
Photographer: Erin S. Trujillo	Date: 11/8/2013	Time: 1405 hours
City/County: North of Golden / Santa Fe		State: New Mexico
Location: Santa Fe County Road 57A Right of Way, Approx. 3.4 miles west of NM 14		
Subject: County road maintenance sign shown in previous photo is approximately 3.4 miles west of NM 14. Wet soils existed in constructed swale (run out) visible in background of photo.

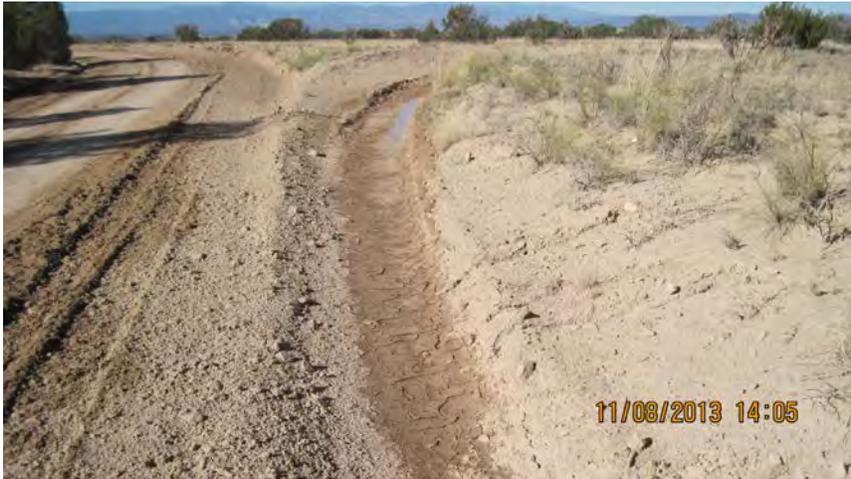
NMED/SWQB Official Photograph Log Photo # 3		
Photographer: Erin S. Trujillo	Date: 11/8/2013	Time: 1405 hours
City/County: North of Golden / Santa Fe		State: New Mexico
Location: Santa Fe County Road 57A Right of Way, Approx. 3.4 miles west of NM 14		
Subject: Looking north-northwest, wet soils and ponded water in constructed swale (run out) shown in previous photo.

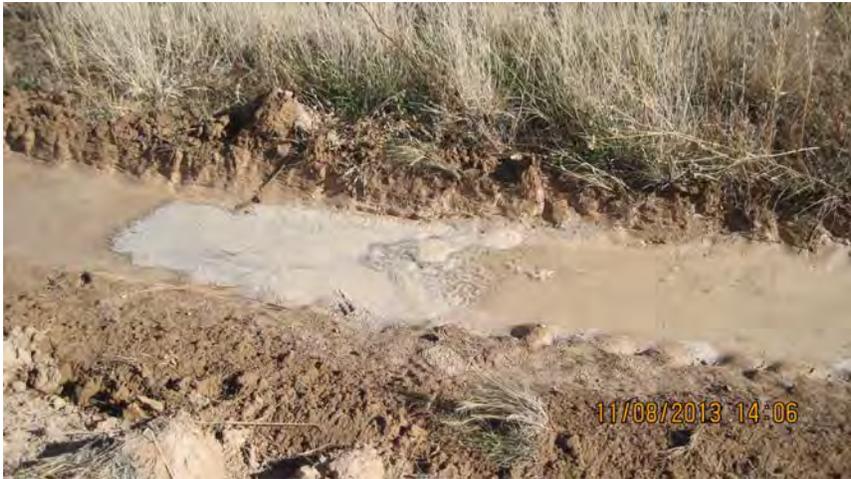
NMED/SWQB Official Photograph Log Photo # 4		
Photographer: Erin S. Trujillo	Date: 11/8/2013	Time: 1406 hours
City/County: North of Golden / Santa Fe		State: New Mexico
Location: Santa Fe County Road 57A Right of Way, Approx. 3.4 miles west of NM 14		
Subject: Wet soils and ponded water continued in constructed swale (run out). Soils outside constructed swale were dry.

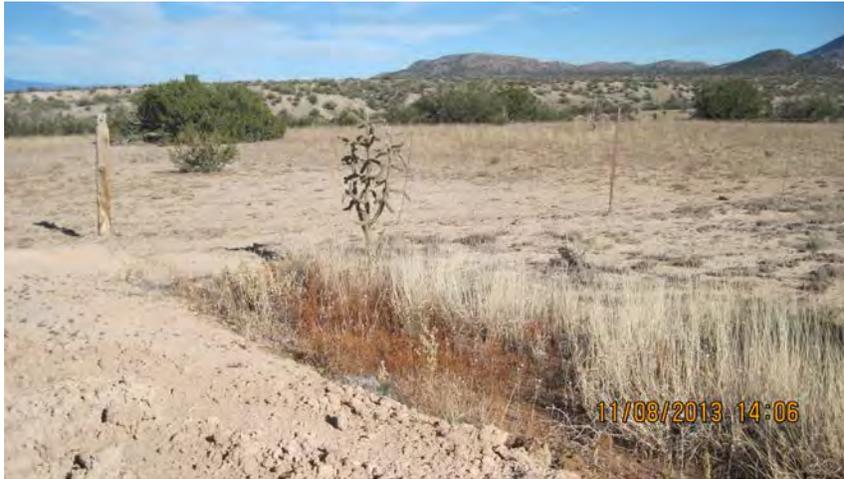
NMED/SWQB Official Photograph Log Photo # 5		
Photographer: Erin S. Trujillo	Date: 11/8/2013	Time: 1406 hours
City/County: North of Golden / Santa Fe		State: New Mexico
Location: Santa Fe County Road 57A Right of Way, Approx. 3.4 miles west of NM 14		
Subject: Looking north-northeast, constructed swale and ponded water shown in previous photos did not continue off the right of way line

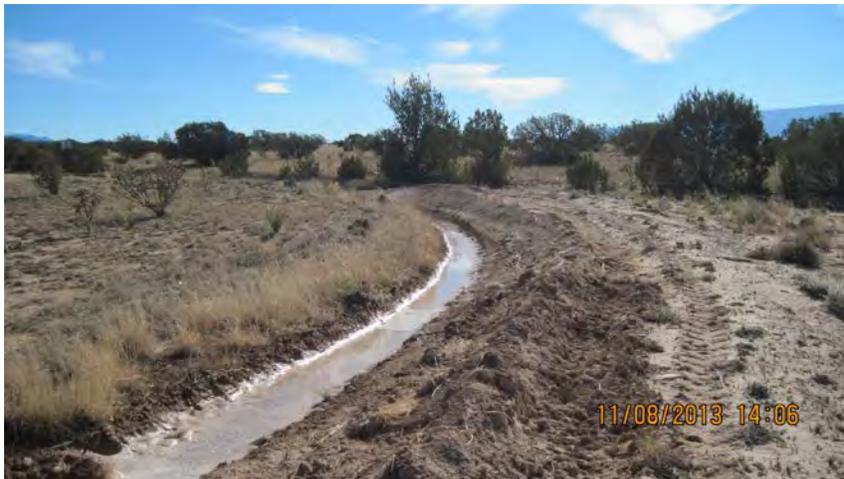
NMED/SWQB Official Photograph Log Photo # 6		
Photographer: Erin S. Trujillo	Date: 11/8/2013	Time: 1406 hours
City/County: North of Golden / Santa Fe		State: New Mexico
Location: Santa Fe County Road 57A Right of Way, Approx. 3.4 miles west of NM 14		
Subject: Looking south toward CR57A, ponded water in constructed swale shown in previous photos.

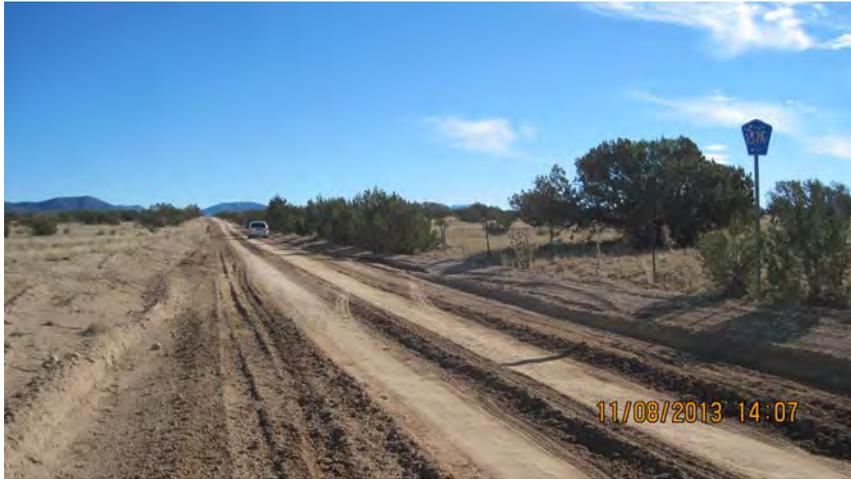
NMED/SWQB Official Photograph Log Photo # 7		
Photographer: Erin S. Trujillo	Date: 11/8/2013	Time: 1407 hours
City/County: North of Golden / Santa Fe		State: New Mexico
Location: Santa Fe County Road 57A Right of Way, Approx. 3.4 miles west of NM 14		
Subject: Looking east-southeast at CR 57A from Santa Fe County Line. Soils outside roadway and ditches appeared dry.

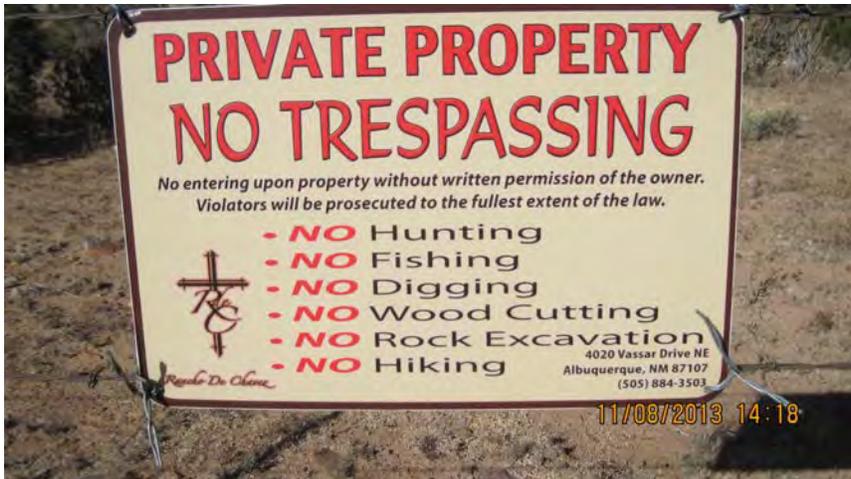
NMED/SWQB Official Photograph Log Photo # 8		
Photographer: Erin S. Trujillo	Date: 11/8/2013	Time: 1418 hours
City/County: North of Golden / Santa Fe		State: New Mexico
Location: Santa Fe County Road 57A Right of Way, Northwest corner of Intersection of NM 14 and CR 57A		
Subject: Looking north, example of no trespassing/private property sign (Rancho De Chavez, 4020 Vassar Drive NE, Albuquerque, NM 87107; 505-884-3503) on right of way fence along CR 57A.

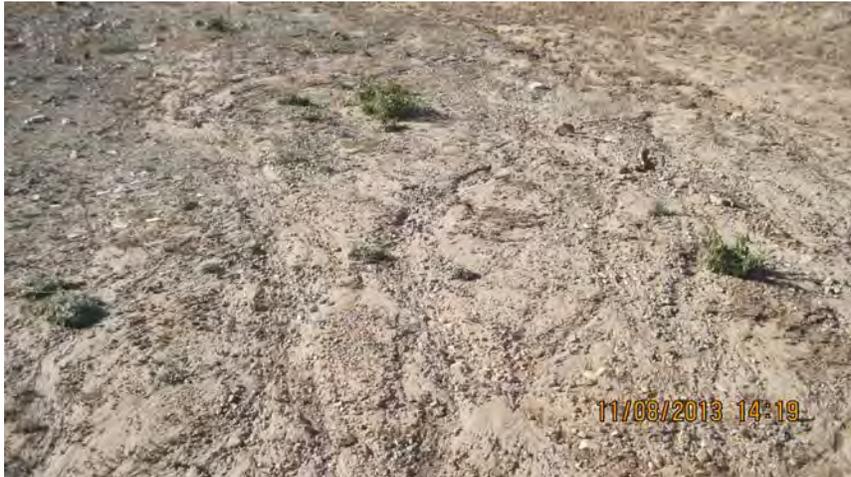
NMED/SWQB Official Photograph Log Photo # 9		
Photographer: Erin S. Trujillo	Date: 11/8/2013	Time: 1419 hours
City/County: North of Golden / Santa Fe		State: New Mexico
Location: Santa Fe County Road 57A Right of Way, Northwest corner of Intersection of NM 14 and CR 57A		
Subject: Looking north-northwest, evidence of previous sheet flow disturbance of the soils at pull out (staging area) near NM 14. Surface soils appeared relatively dry in this location.

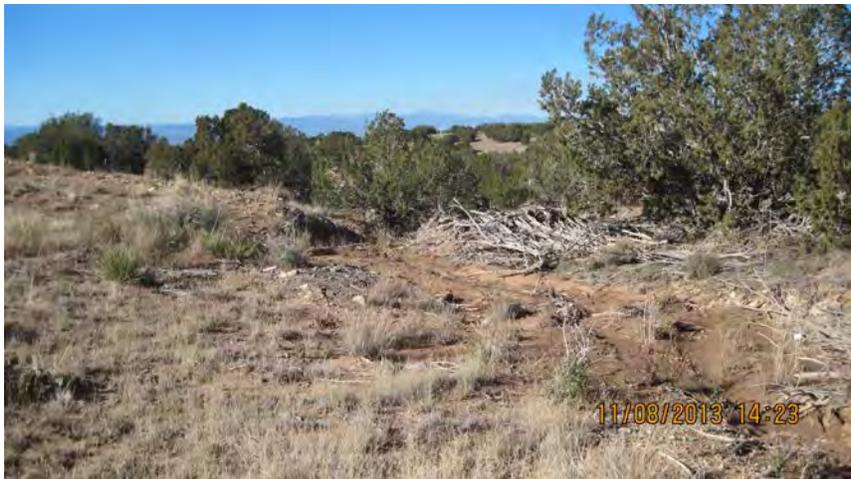
Any reported over application of hydrostatic testing wastewater for dust control on CR 57A had the potential to enter a tributary to the Rio Grande in at least one observed location (Photos 10-16). An NPDES permit was not obtained for hydrostatic test wastewater discharges. Discharges from hydrostatic testing, in this case from using a groundwater source in a new pipeline, have potential pollutants from natural deposits in the source well. If not managed or monitored in accordance with an NPDES permit, hydrostatic test discharge may be a potential source of contaminants to surface water quality.

NMED/SWQB Official Photograph Log Photo # 10		
Photographer: Erin S. Trujillo	Date: 11/8/2013	Time: 1423 hours
City/County: North of Golden / Santa Fe		State: New Mexico
Location: Santa Fe County Road 57A Right of Way, Approximately 1,500 Feet Northwest of Intersection of NM 14 and CR 57A		
Subject: Looking north, north of Photo 16 at CR57A, wet soils continued in shallow channel to right of way line fence.

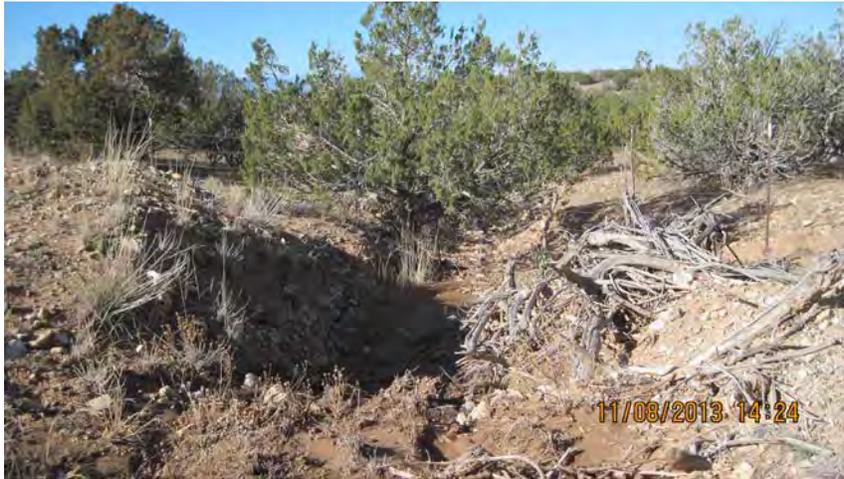
NMED/SWQB Official Photograph Log Photo # 11		
Photographer: Erin S. Trujillo	Date: 11/8/2013	Time: 1424 hours
City/County: North of Golden / Santa Fe		State: New Mexico
Location: Santa Fe County Road 57A Right of Way, Approximately 1,500 Feet Northwest of Intersection of NM 14 and CR 57A		
Subject: Looking north, wet soils continued in head cut of tributary (watercourse) at right of way line fence.

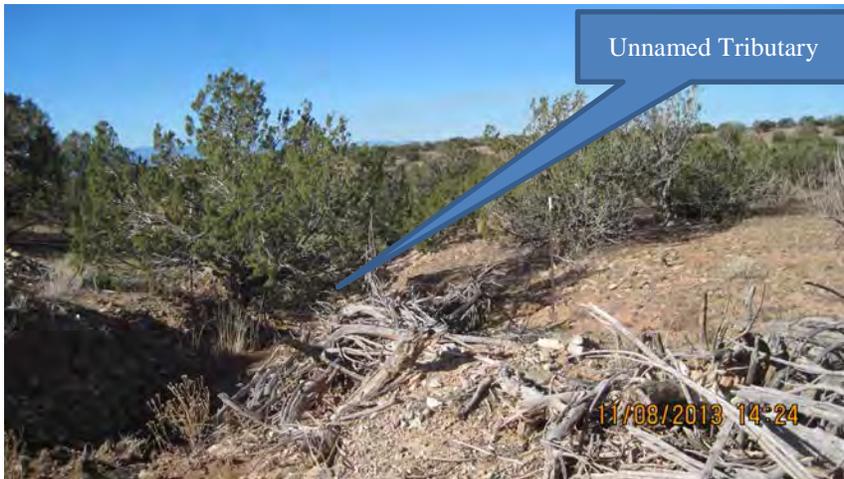
NMED/SWQB Official Photograph Log Photo # 12		
Photographer: Erin S. Trujillo	Date: 11/8/2013	Time: 1424 hours
City/County: North of Golden / Santa Fe		State: New Mexico
Location: Santa Fe County Road 57A Right of Way, Approximately 1,500 Feet Northwest of Intersection of NM 14 and CR 57A		
Subject: Looking north, tributary (watercourse) continues north of right of way fence.

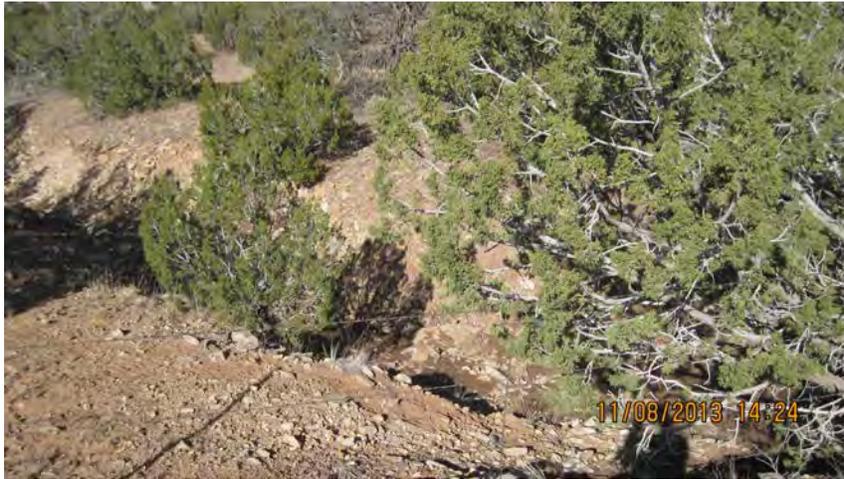
NMED/SWQB Official Photograph Log Photo # 13		
Photographer: Erin S. Trujillo	Date: 11/8/2013	Time: 1424 hours
City/County: North of Golden / Santa Fe		State: New Mexico
Location: Santa Fe County Road 57A Right of Way, Approximately 1,500 Feet Northwest of Intersection of NM 14 and CR 57A		
Subject: Looking north-northeast, darker soils appearing wet existed in tributary (watercourse) north of right of way fence on private property.

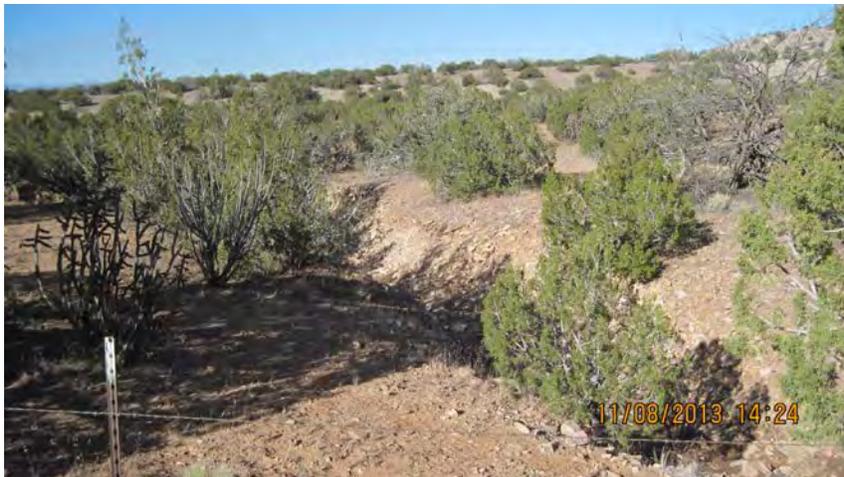
NMED/SWQB Official Photograph Log Photo # 14		
Photographer: Erin S. Trujillo	Date: 11/8/2013	Time: 1424 hours
City/County: North of Golden / Santa Fe		State: New Mexico
Location: Santa Fe County Road 57A Right of Way, Approximately 1,500 Feet Northwest of Intersection of NM 14 and CR 57A		
Subject: Looking north, tributary (watercourse) north of right of way fence continued north on private property.

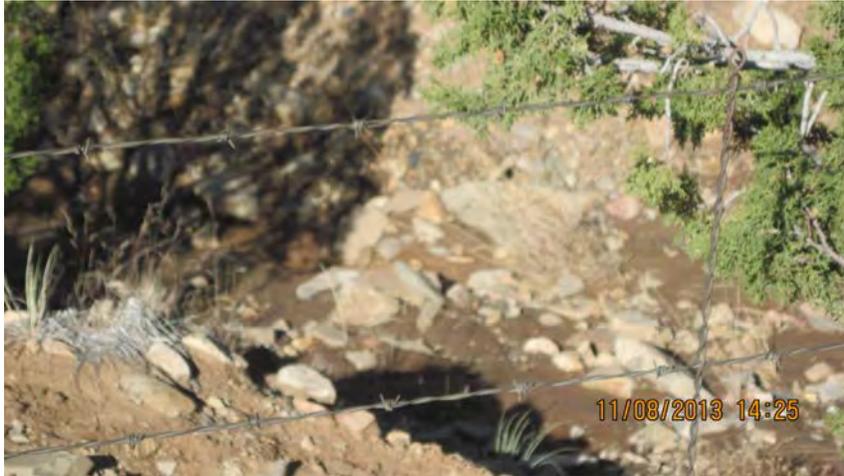
NMED/SWQB Official Photograph Log Photo # 15		
Photographer: Erin S. Trujillo	Date: 11/8/2013	Time: 1425 hours
City/County: North of Golden / Santa Fe		State: New Mexico
Location: Santa Fe County Road 57A Right of Way, Approximately 1,500 Feet Northwest of Intersection of NM 14 and CR 57A		
Subject: Looking north-northeast, darker wet soils existed in tributary (watercourse) north of right of way fence on private property shown in previous photo.

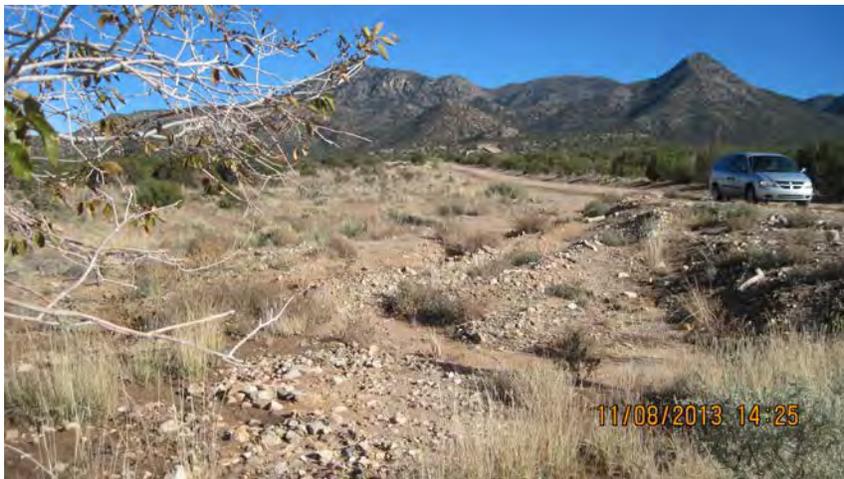
NMED/SWQB Official Photograph Log Photo # 16		
Photographer: Erin S. Trujillo	Date: 11/8/2013	Time: 1425 hours
City/County: North of Golden / Santa Fe		State: New Mexico
Location: Santa Fe County Road 57A Right of Way, Approximately 1,500 Feet Northwest of Intersection of NM 14 and CR 57A		
Subject: Looking east, wet soils north of County Road 57A (location of vehicle) existed in constructed swale continued to area where the channel is less defined. Wet soils continued north as shown in Photos 10 thru 14.
