Re: New Natural Gas Pipeline Hydrostatic Testing Water Discharge at County Road (CR) 57A, Santa Fe County, New Mexico; Enterprise Mid-America Natural Gas Pipeline WEP III Project, Segment 3; Minor; Unpermitted Discharge; SIC 1623; NPDES Reconnaissance; NMU001867; November 8, 2013

NPDES Compliance Inspection Report

**Price Gregory International
New Natural Gas Pipeline Hydrostatic Testing Water Discharge
at County Road (CR) 57A, Santa Fe County, New Mexico
Enterprise Mid-America Natural Gas Pipeline WEP III Project, Segment 3
NPDES Tracking No. NMU001867
Reconnaissance
November 8, 2013**

Further Explanations

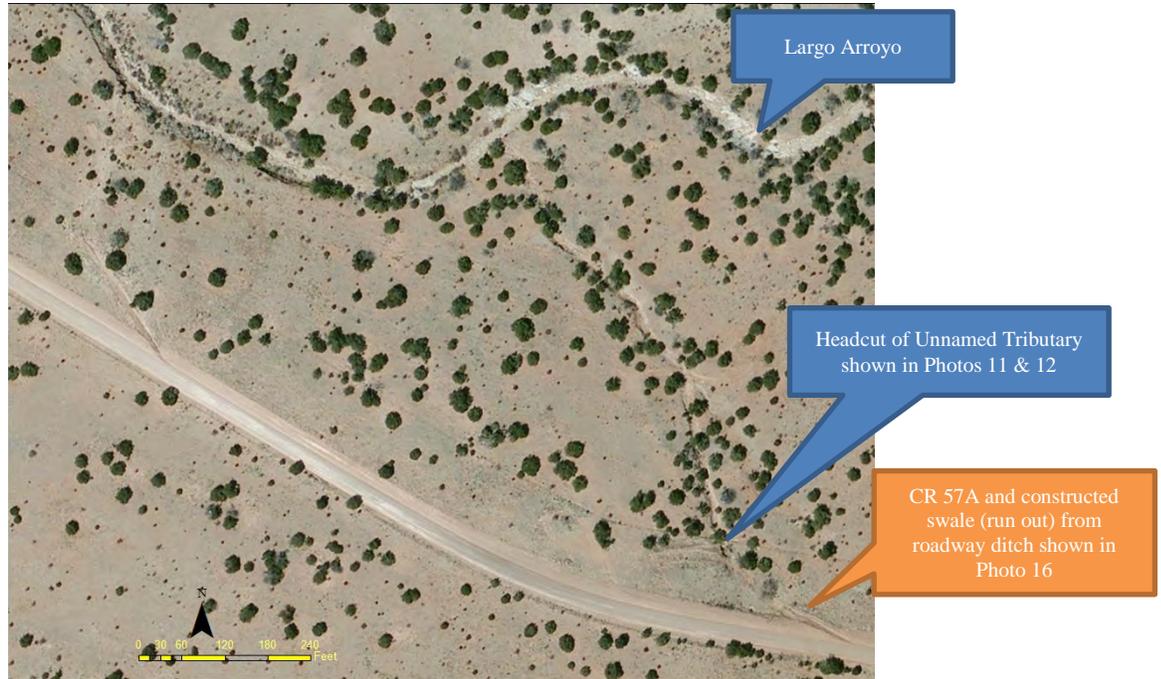
NMED/SWQB
Aerial Photograph

Location: Santa Fe County Road 57A, Approximately 1,500 Feet Northwest of Intersection of NM 14 and CR 57A

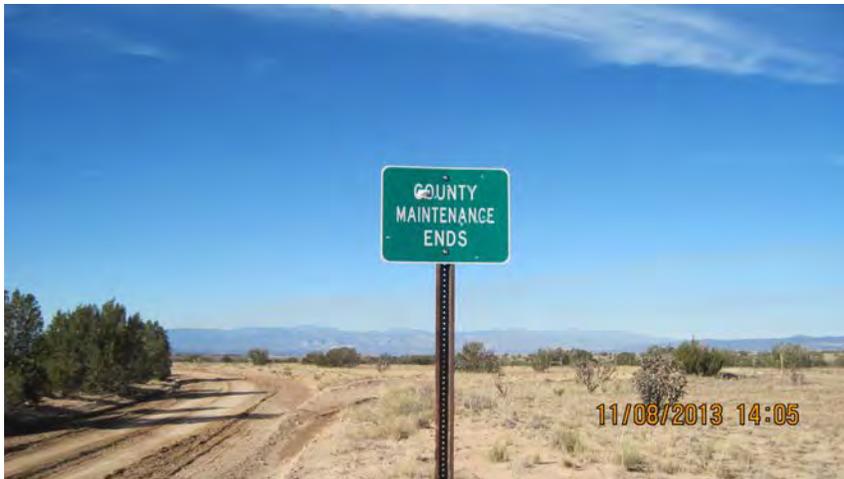
NMED/SWQB Official Photograph Log Photo # 2		
Photographer: Erin S. Trujillo	Date: 11/8/2013	Time: 1405 hours
City/County: North of Golden / Santa Fe		State: New Mexico
Location: Santa Fe County Road 57A Right of Way, Approx. 3.4 miles west of NM 14		
Subject: County road maintenance sign shown in previous photo is approximately 3.4 miles west of NM 14. Wet soils existed in constructed swale (run out) visible in background of photo.

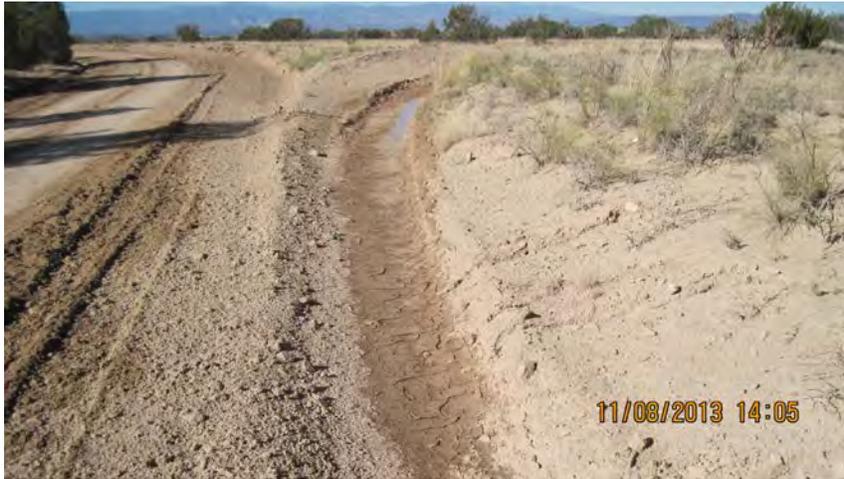
NMED/SWQB Official Photograph Log Photo # 3		
Photographer: Erin S. Trujillo	Date: 11/8/2013	Time: 1405 hours
City/County: North of Golden / Santa Fe		State: New Mexico
Location: Santa Fe County Road 57A Right of Way, Approx. 3.4 miles west of NM 14		
Subject: Looking north-northwest, wet soils and ponded water in constructed swale (run out) shown in previous photo.

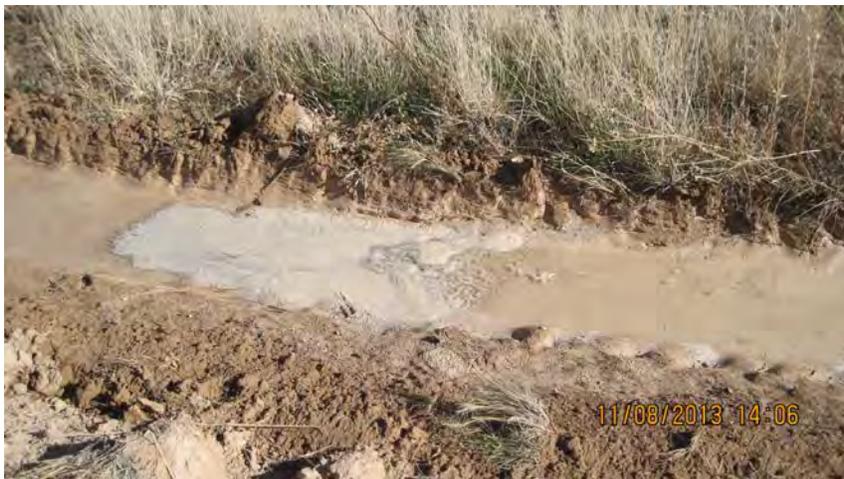
NMED/SWQB Official Photograph Log Photo # 4		
Photographer: Erin S. Trujillo	Date: 11/8/2013	Time: 1406 hours
City/County: North of Golden / Santa Fe		State: New Mexico
Location: Santa Fe County Road 57A Right of Way, Approx. 3.4 miles west of NM 14		
Subject: Wet soils and ponded water continued in constructed swale (run out). Soils outside constructed swale were dry.

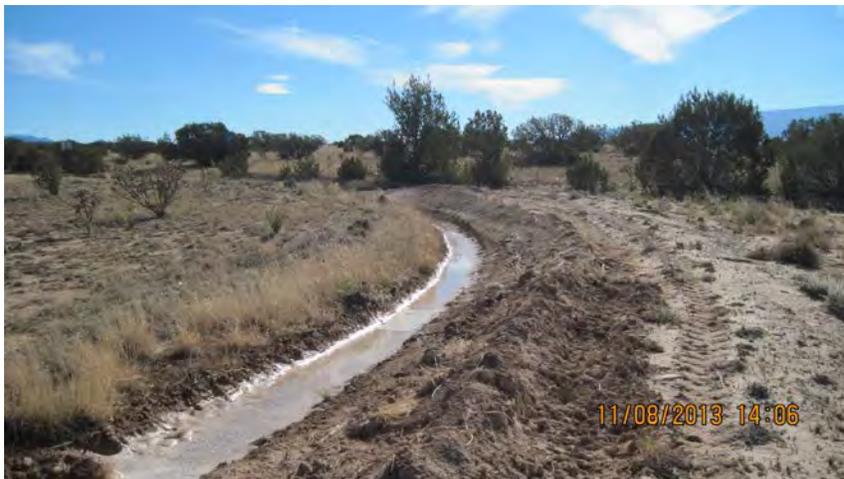
NMED/SWQB Official Photograph Log Photo # 6		
Photographer: Erin S. Trujillo	Date: 11/8/2013	Time: 1406 hours
City/County: North of Golden / Santa Fe		State: New Mexico
Location: Santa Fe County Road 57A Right of Way, Approx. 3.4 miles west of NM 14		
Subject: Looking south toward CR57A, ponded water in constructed swale shown in previous photos.

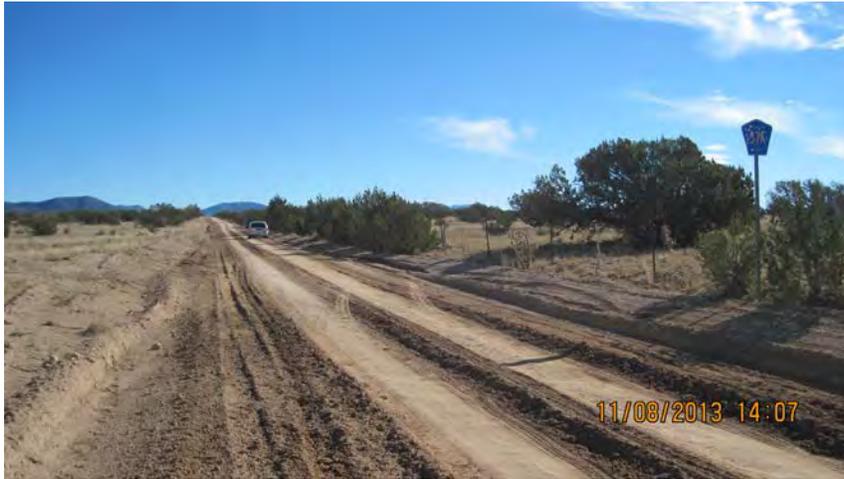
NMED/SWQB Official Photograph Log Photo # 7		
Photographer: Erin S. Trujillo	Date: 11/8/2013	Time: 1407 hours
City/County: North of Golden / Santa Fe		State: New Mexico
Location: Santa Fe County Road 57A Right of Way, Approx. 3.4 miles west of NM 14		
Subject: Looking east-southeast at CR 57A from Santa Fe County Line. Soils outside roadway and ditches appeared dry.

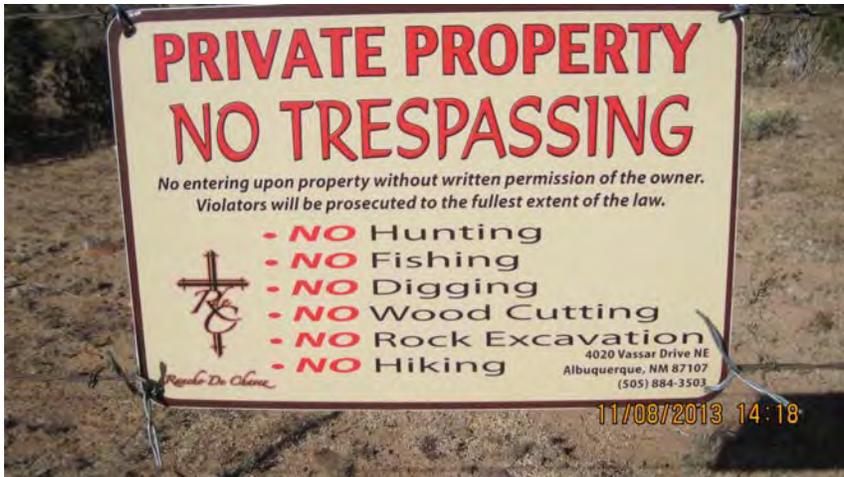
NMED/SWQB Official Photograph Log Photo # 8		
Photographer: Erin S. Trujillo	Date: 11/8/2013	Time: 1418 hours
City/County: North of Golden / Santa Fe		State: New Mexico
Location: Santa Fe County Road 57A Right of Way, Northwest corner of Intersection of NM 14 and CR 57A		
Subject: Looking north, example of no trespassing/private property sign (Rancho De Chavez, 4020 Vassar Drive NE, Albuquerque, NM 87107; 505-884-3503) on right of way fence along CR 57A.

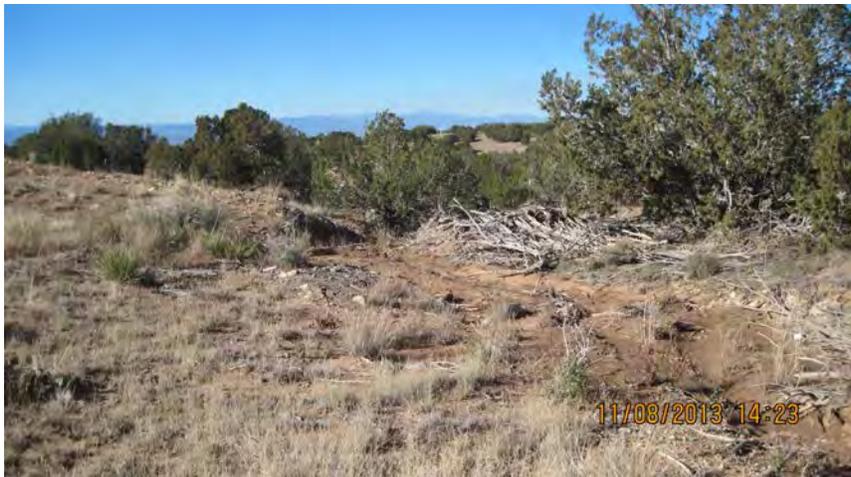
Any reported over application of hydrostatic testing wastewater for dust control on CR 57A had the potential to enter a tributary to the Rio Grande in at least one observed location (Photos 10-16). An NPDES permit was not obtained for hydrostatic test wastewater discharges. Discharges from hydrostatic testing, in this case from using a groundwater source in a new pipeline, have potential pollutants from natural deposits in the source well. If not managed or monitored in accordance with an NPDES permit, hydrostatic test discharge may be a potential source of contaminants to surface water quality.

NMED/SWQB Official Photograph Log Photo # 10		
Photographer: Erin S. Trujillo	Date: 11/8/2013	Time: 1423 hours
City/County: North of Golden / Santa Fe		State: New Mexico
Location: Santa Fe County Road 57A Right of Way, Approximately 1,500 Feet Northwest of Intersection of NM 14 and CR 57A		
Subject: Looking north, north of Photo 16 at CR57A, wet soils continued in shallow channel to right of way line fence.

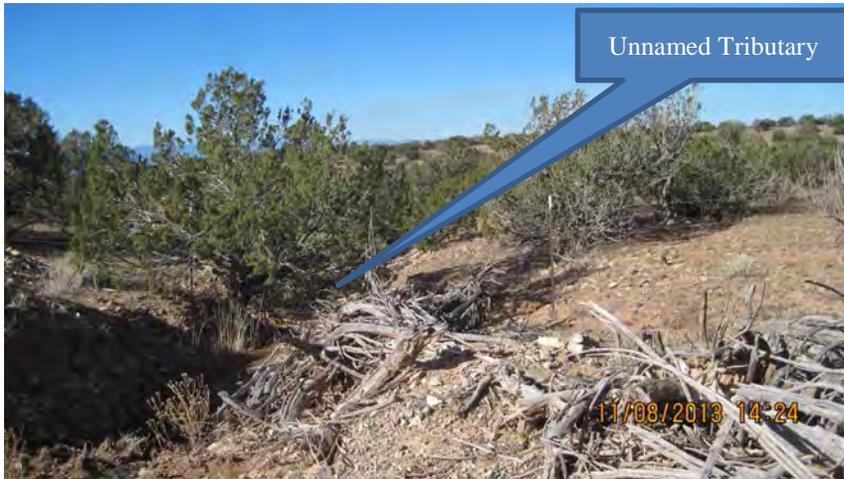
NMED/SWQB Official Photograph Log Photo # 12		
Photographer: Erin S. Trujillo	Date: 11/8/2013	Time: 1424 hours
City/County: North of Golden / Santa Fe		State: New Mexico
Location: Santa Fe County Road 57A Right of Way, Approximately 1,500 Feet Northwest of Intersection of NM 14 and CR 57A		
Subject: Looking north, tributary (watercourse) continues north of right of way fence.

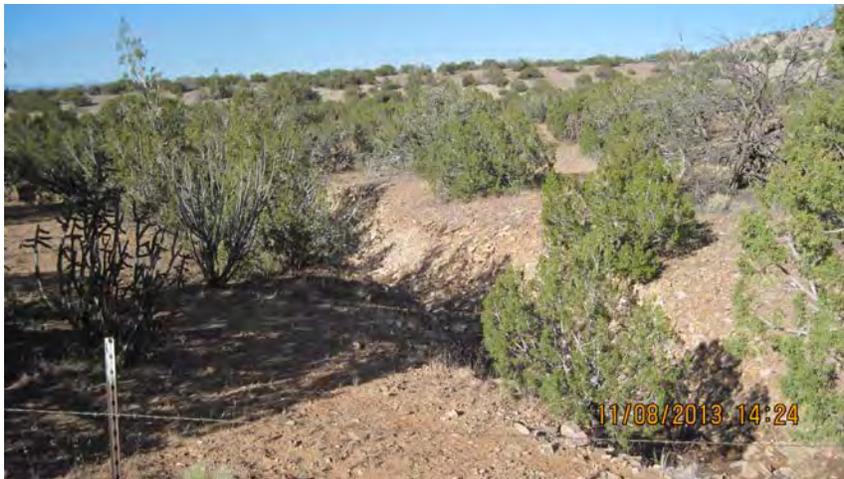
NMED/SWQB Official Photograph Log Photo # 14		
Photographer: Erin S. Trujillo	Date: 11/8/2013	Time: 1424 hours
City/County: North of Golden / Santa Fe		State: New Mexico
Location: Santa Fe County Road 57A Right of Way, Approximately 1,500 Feet Northwest of Intersection of NM 14 and CR 57A		
Subject: Looking north, tributary (watercourse) north of right of way fence continued north on private property.

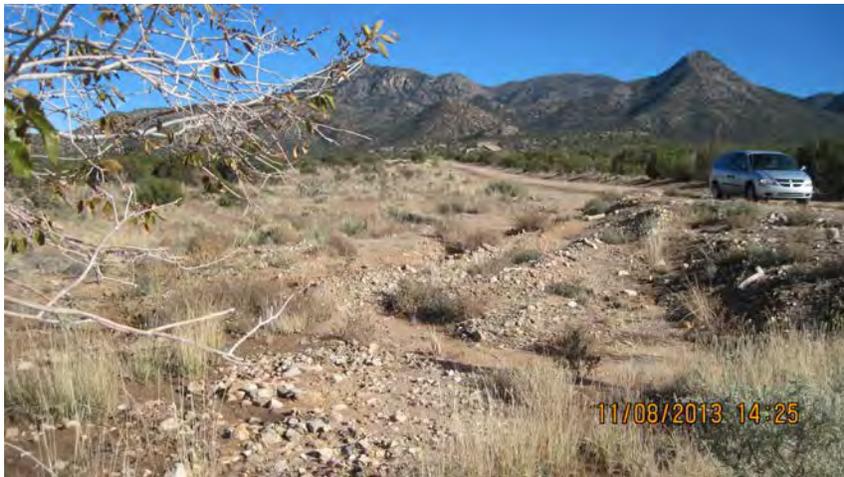
NMED/SWQB Official Photograph Log Photo # 16		
Photographer: Erin S. Trujillo	Date: 11/8/2013	Time: 1425 hours
City/County: North of Golden / Santa Fe		State: New Mexico
Location: Santa Fe County Road 57A Right of Way, Approximately 1,500 Feet Northwest of Intersection of NM 14 and CR 57A		
Subject: Looking east, wet soils north of County Road 57A (location of vehicle) existed in constructed swale continued to area where the channel is less defined. Wet soils continued north as shown in Photos 10 thru 14.
