**Re: Lots 4A, 5A, 6 and 7, Block 2, Sunrise Subdivision No. 12, Farmington; Construction Stormwater; SIC 1531; NPDES Compliance Evaluation Inspection; NMU001874; March 18, 2014**

### NPDES Compliance Inspection Report

**Tommy Ray King**  
**Lots 4A, 5A, 6 and 7, Block 2, Sunrise Subdivision No. 12**  
**NPDES Tracking No. NM001874**  
**Compliance Evaluation Inspection**  
**March 18, 2014**

**Further Explanations**

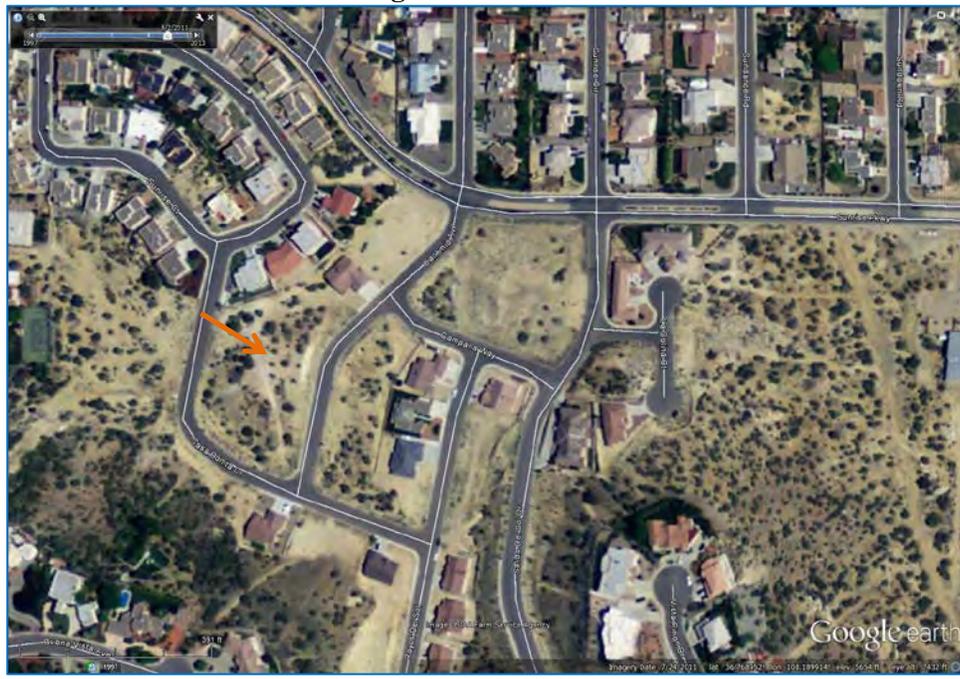
**Image dated 08/02/2011**

Images Reviewed by: Erin S. Trujillo	Image Dates: 08/02/2011 and 11/17/2013	Source: Google™ earth
City/County: Farmington / San Juan County	State: New Mexico	
Location: Lots 4A – 8, Block 2, Sunrise Subdivision No. 12		
Subject: Image dated 08/02/2011 shows constructed subdivision streets, including Calle Mio, with some disturbance on Lots 4A thru 8 that appear to be dirt trails/roads. Image dated 11/17/2013 shows more disturbance with a few trees and vegetation along site borders along streets remaining on Lots 4A thru 8.

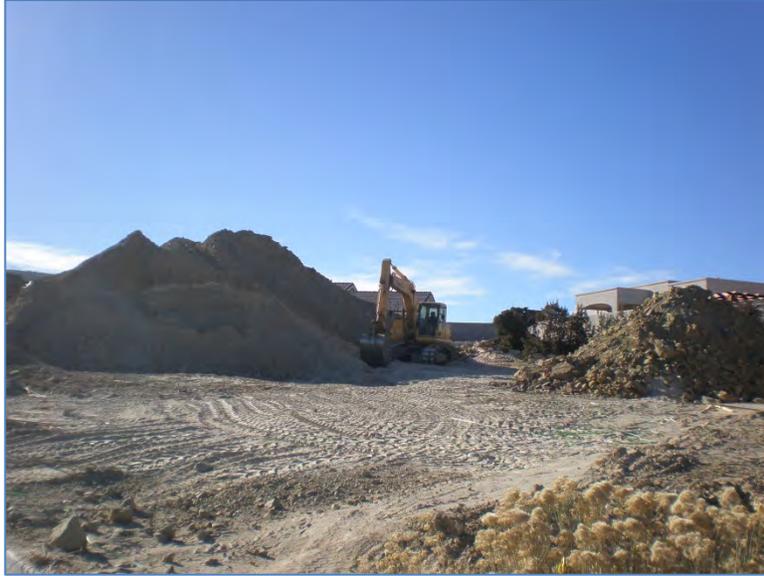
**1a (Stockpile on Lots 4A & 5A): File Information P1270026.jpg, File Date 1/27/2014, 4:21 pm**

Photographer: Not Documented	Date: Not Documented (file info below)	Time: Not Documented (file info below)
City/County: Farmington / San Juan County		State: New Mexico
Location: Lots 4A & 5A, Block 2, Sunrise Subdivision No. 12		
Subject: Photographs of stockpiles on portion of Lot 4A and Lot 5A provided by City of Farmington MS4 staff e-mail to NMED on 02/19/2014

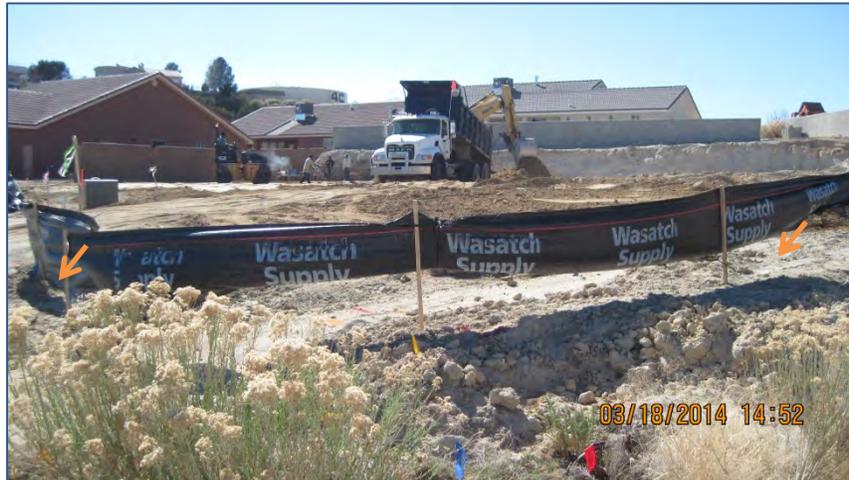
**NMED/SWQB  
Official Photograph Log  
Photo # 1**

Photographer: Erin S. Trujillo	Date: 03/18/2014	Time: 1552 hours (incorrect time displayed on photo)
City/County: Farmington / San Juan County		State: New Mexico
Location: Lots 4A, 5A & 6, Block 2, Sunrise Subdivision No. 12		
Subject: Looking southwest at portion of Lot 4A and Lot 5A, heavy equipment was in use on day of this inspection. Staked fabric along site boundaries and disturbed areas is not trenched into the soil. Arrows points to a gap between fabric and soil. House on left side of photo is on Lot 6.

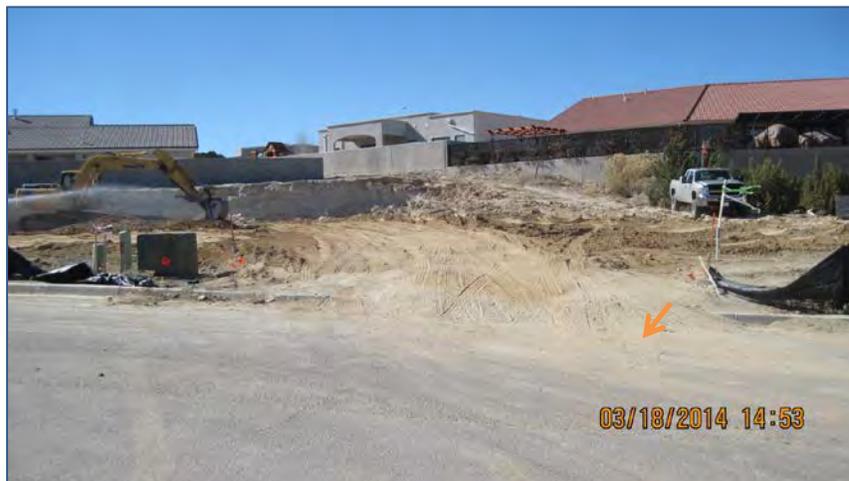
**NMED/SWQB  
Official Photograph Log  
Photo # 2**

Photographer: Erin S. Trujillo	Date: 03/18/2014	Time: 1553 hours (incorrect time displayed on photo)
City/County: Farmington / San Juan County		State: New Mexico
Location: Lots 4A& 5A, Block 2, Sunrise Subdivision No. 12		
Subject: Looking at portion of Lot 4A and Lot 5A, water was applied by on-site worker to disturbance from track hoe activities. Arrow points to dirt observed on Calle Mio.

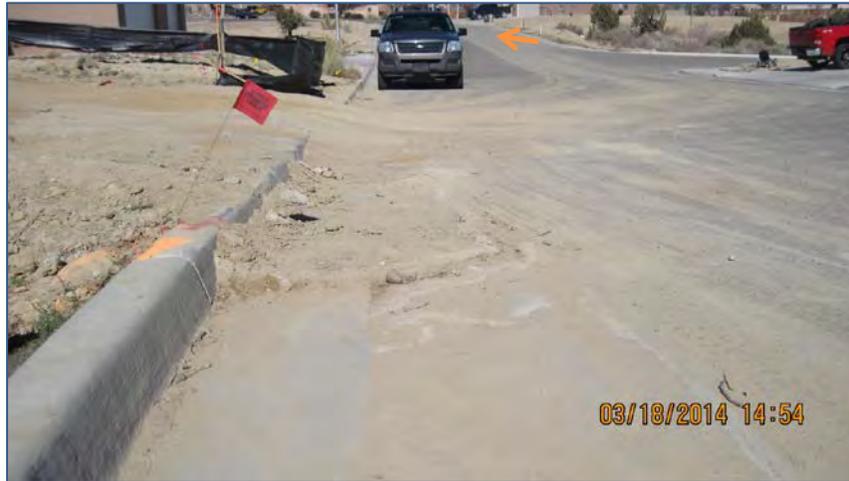
**NMED/SWQB  
Official Photograph Log  
Photo # 3**

Photographer: Erin S. Trujillo	Date: 03/18/2014	Time: 1454 hours (incorrect time displayed on photo)
City/County: Farmington / San Juan County		State: New Mexico
Location: Lot 4A & 5A, Block 2, Sunrise Subdivision No. 12		
Subject: Looking north on Calle Mio, dirt was in gutter at area where heavy equipment was observed entering site on day of this inspection. Arrow points to tracking that continues north on Calle Mio.

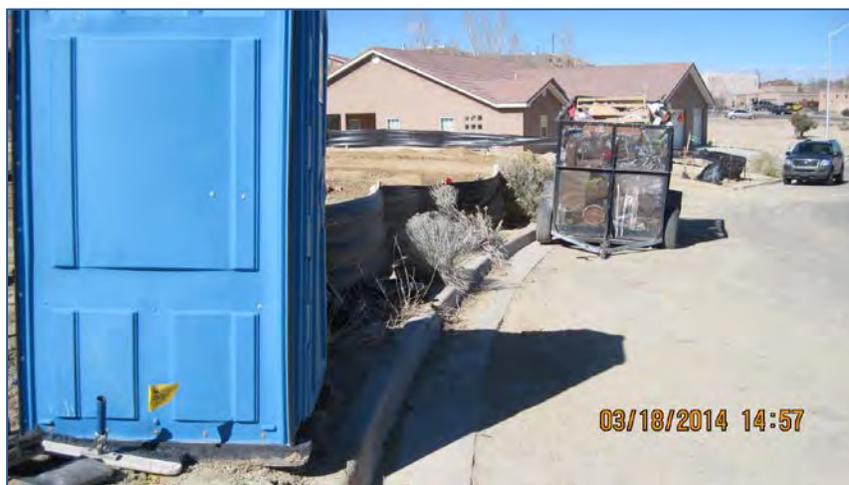
**NMED/SWQB  
Official Photograph Log  
Photo # 4**

Photographer: Erin S. Trujillo	Date: 03/18/2014	Time: 1557 hours (incorrect time displayed on photo)
City/County: Farmington / San Juan County		State: New Mexico
Location: Lots 4A & 5A, Block 2, Sunrise Subdivision No. 12		
Subject: Trash bin and sanitary toilet was located near construction activities on Lots 4A & 5A.

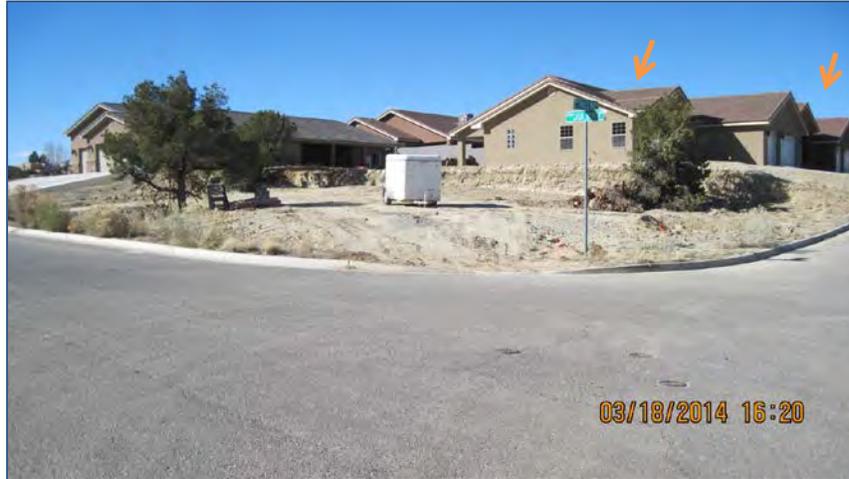
**NMED/SWQB  
Official Photograph Log  
Photo # 9**

Photographer: Erin S. Trujillo	Date: 03/18/2014	Time: 1620 hours
City/County: Farmington / San Juan County		State: New Mexico
Location: Lots 7 & 6, Block 2, Sunrise Subdivision No. 12		
Subject: Looking northwest from corner of Lot 8, arrows point to houses on Lots 7 & 6.
