Re: Lots 4A & 8, Block 2, Sunrise Subdivision No. 12, Farmington; Construction Stormwater; SIC 6552; NPDES Compliance Evaluation Inspection; NMU001876; March 18, 2014

**Teton Development, Limited Liability Company
Lots 4A & 8, Block 2, Sunrise Subdivision No. 12
NPDES Tracking No. NM001876
Compliance Evaluation Inspection
March 18, 2014**

Further Explanations

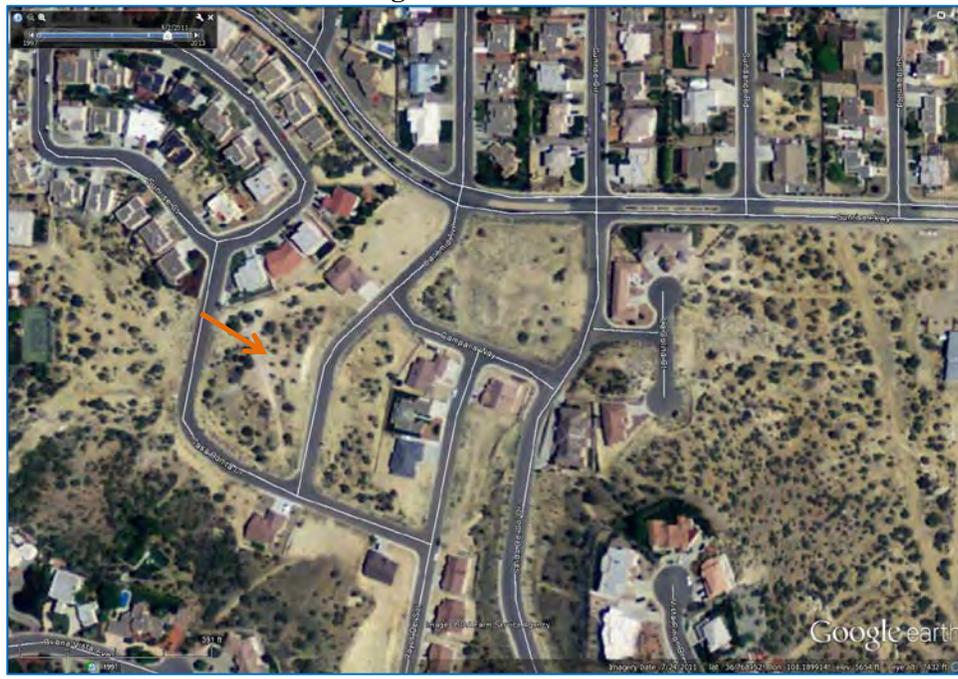
Images Reviewed by: Erin S. Trujillo	Image Dates: 08/02/2011 and 11/17/2013	Source: Google™ earth
City/County: Farmington / San Juan County	State: New Mexico	
Location: Lots 4A thru 8, Block 2, Sunrise Subdivision No. 12		
Subject: Image dated 08/02/2011 shows constructed subdivision streets, including Calle Mio, with some disturbance on Lots 4A thru 8 that appear to be dirt trails/roads. Image dated 11/17/2013 shows more disturbance with a few trees and some vegetation remaining on Lots 4A thru 8.

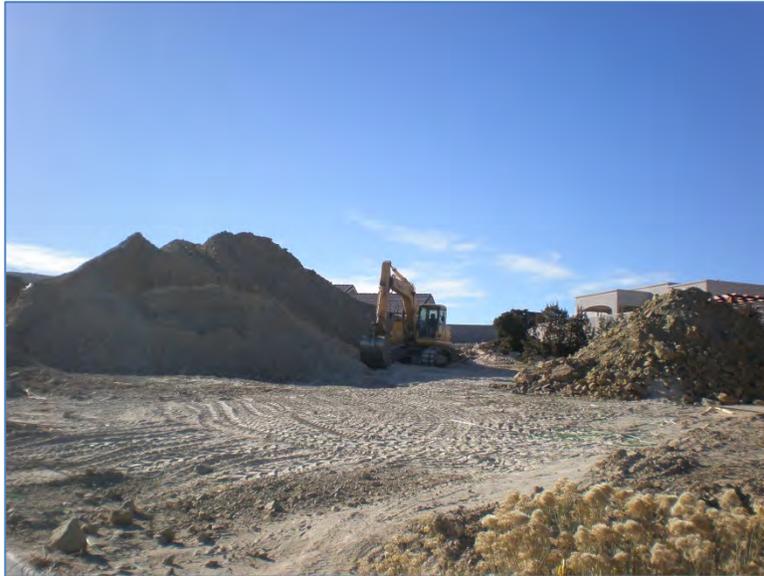
**City of Farmington
E-mailed Photograph
Photo # 1**

Photographer: Not Documented	Date: Not Documented (file info below)	Time: Not Documented (file info below)
City/County: Farmington / San Juan County		State: New Mexico
Location: Portion of Lot 4A, Block 2, Sunrise Subdivision No. 12		
Subject: Photograph of stockpile appears to be on portion of Lot 4A. Photographic image was provided by City of Farmington MS4 staff e-mail to NMED on 02/19/2014

File Information: P1270026.jpg, Date 1/27/2014, 4:21 pm

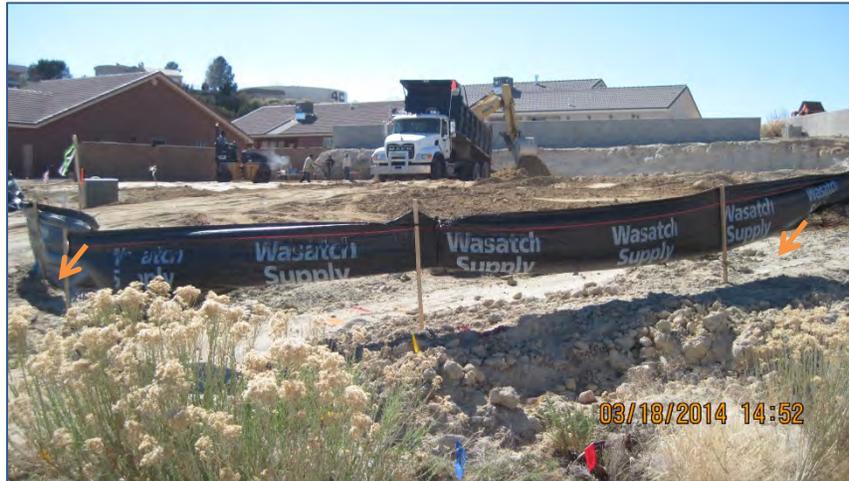
**NMED/SWQB
Official Photograph Log
Photo # 1**

Photographer: Erin S. Trujillo	Date: 03/18/2014	Time: 1552 hours (incorrect time displayed on photo)
City/County: Farmington / San Juan County		State: New Mexico
Location: Lot 4A, Block 2, Sunrise Subdivision No. 12		
Subject: Looking southwest at portion of Lot 4A and Lot 5A, heavy equipment was in use on day of this inspection. Staked fabric along site boundaries and disturbed areas is not trenched into the soil. Arrows points to a gap between fabric and soil.

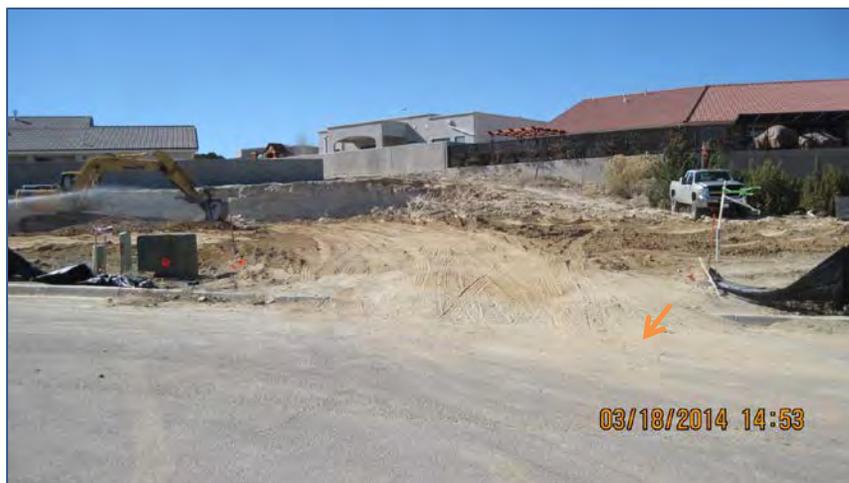
**NMED/SWQB
Official Photograph Log
Photo # 2**

Photographer: Erin S. Trujillo	Date: 03/18/2014	Time: 1553 hours (incorrect time displayed on photo)
City/County: Farmington / San Juan County		State: New Mexico
Location: Lots 4A and 5A, Block 2, Sunrise Subdivision No. 12		
Subject: Looking at Lots 4A and 5A, water was applied by on-site worker to disturbance from track hoe activities. Arrow points to dirt observed on Calle Mio.

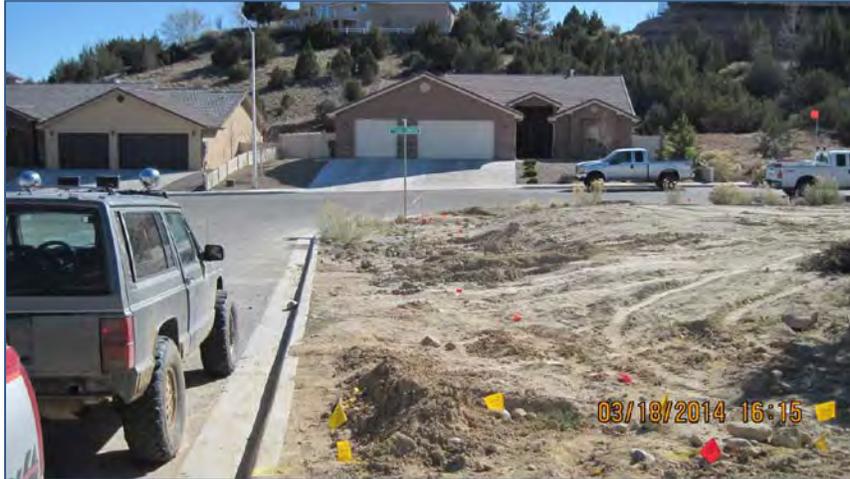
NMED/SWQB
Official Photograph Log
Photo # 5

Photographer: Erin S. Trujillo	Date: 03/18/2014	Time: 1615 hours
City/County: Farmington / San Juan County	State: New Mexico	
Location: Lot 8, Block 2, Sunrise Subdivision No. 12		
Subject: Earth disturbance on Lot 8.

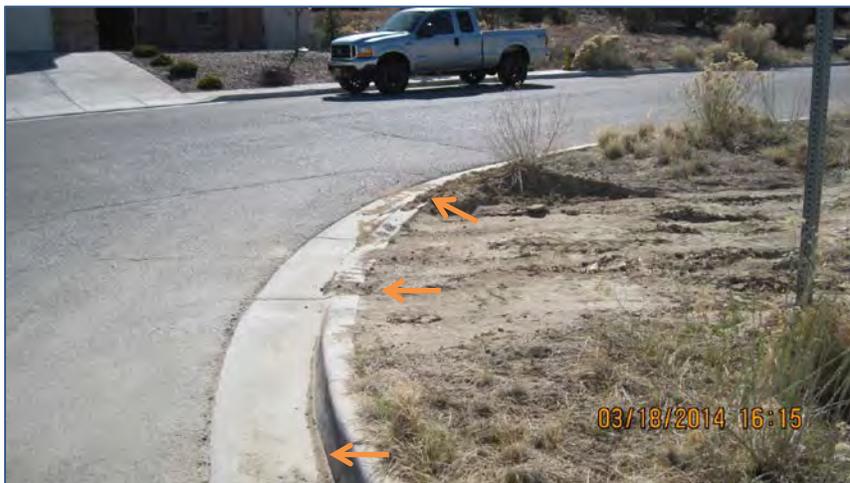
NMED/SWQB
Official Photograph Log
Photo # 6

Photographer: Erin S. Trujillo	Date: 03/18/2014	Time: 1615 hours
City/County: Farmington / San Juan County	State: New Mexico	
Location: Lot 8, Block 2, Sunrise Subdivision No. 12		
Subject: Vegetation remained along some site borders, except at curb cut entrance at Lot 8. Arrows point to dirt in gutter at this entrance.

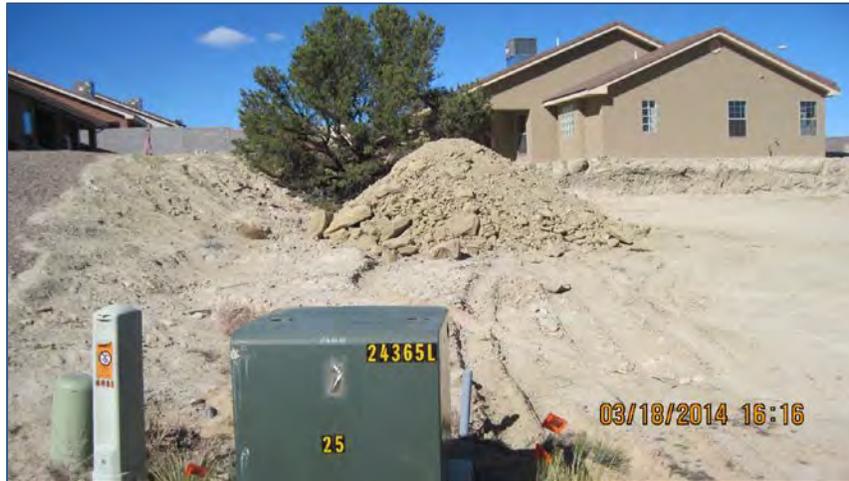
**NMED/SWQB
Official Photograph Log
Photo # 7**

Photographer: Erin S. Trujillo	Date: 03/18/2014	Time: 1616 hours
City/County: Farmington / San Juan County		State: New Mexico
Location: Lot 8, Block 2, Sunrise Subdivision No. 12		
Subject: Looking north from southwest corner of Lot 8, stockpile with rock and finer unconsolidated material was on Lot 8.

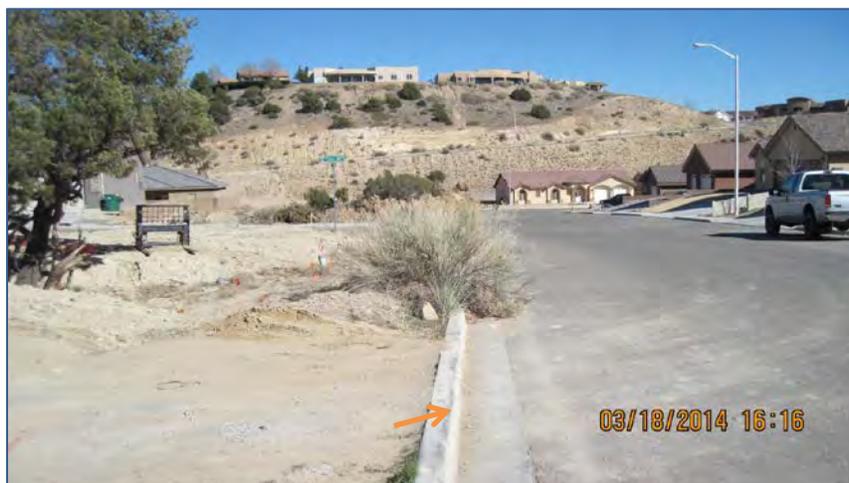
**NMED/SWQB
Official Photograph Log
Photo # 8**

Photographer: Erin S. Trujillo	Date: 03/18/2014	Time: 1616 hours
City/County: Farmington / San Juan County		State: New Mexico
Location: Lot 8, Block 2, Sunrise Subdivision No. 12		
Subject: Looking east from southwest corner of Lot 8, arrow points to dirt in gutter. Tracking was on street near this area of Lot 8 that did not have vegetation along curb.

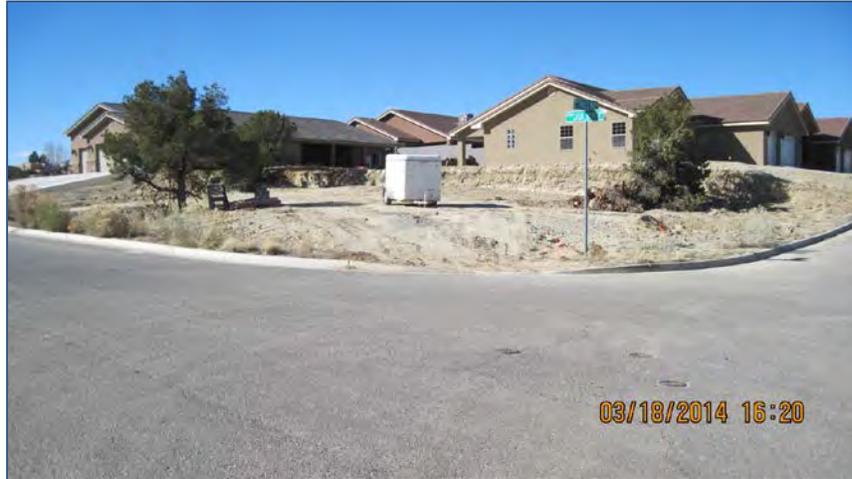
**NMED/SWQB
Official Photograph Log
Photo # 9**

Photographer: Erin S. Trujillo	Date: 03/18/2014	Time: 1620 hours
City/County: Farmington / San Juan County		State: New Mexico
Location: Lot 8, Block 2, Sunrise Subdivision No. 12		
Subject: Looking northwest at remaining vegetation and trailer on Lot 8.
