Re: Sam Blue / Portion of Northeast Corner of 73.73 Acre Parcel, Road 3002, Aztec, New Mexico; Construction Stormwater; NPDES Compliance Evaluation Inspection; NMU001881; December 2, 2014

NPDES Compliance Inspection Report

Sam Blue
Portion of Northeast Corner of 73.73 Acre Parcel
Road 3002, Aztec, New Mexico
NPDES Tracking No. NM001881
Compliance Evaluation Inspection
December 2, 2014

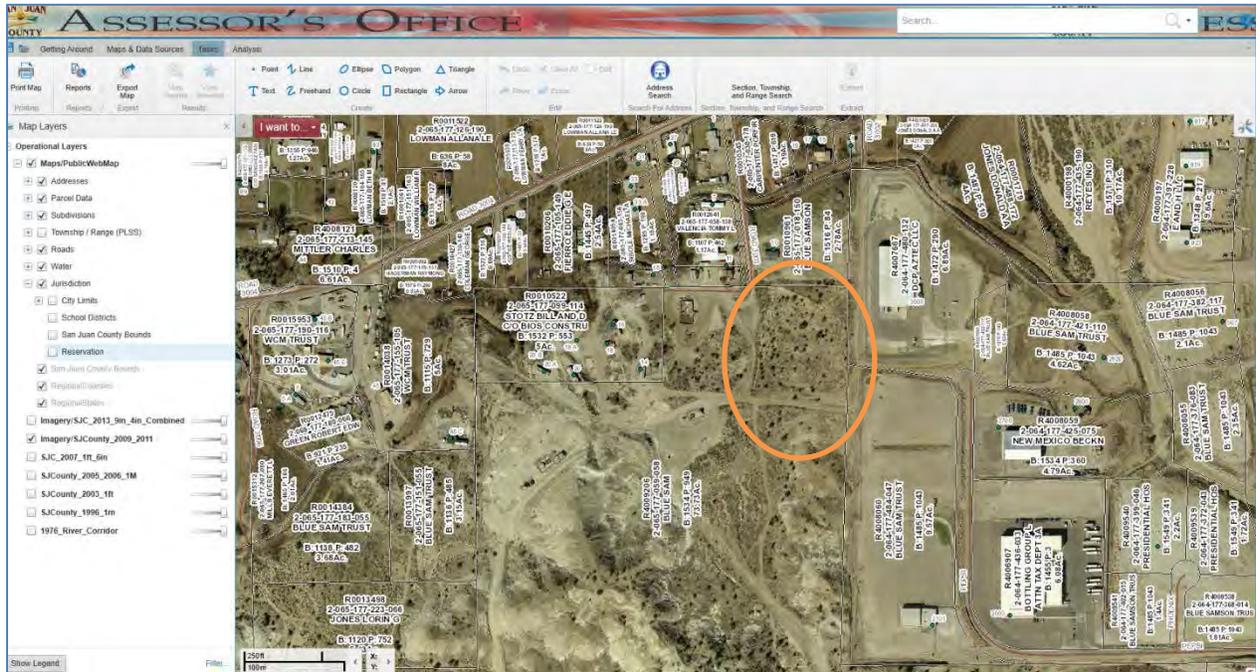
Aerial Image #1: San Juan County Assessor's Office Parcel Map Imagery Labeled 2009 to 2011

Notes: San Juan County Assessor's Office imagery labeled 2009_2011 shows scattered vegetation in northeast corner of the 73.73 acre parcel owned by Sam Blue at Road 3002, Aztec, New Mexico 87410.

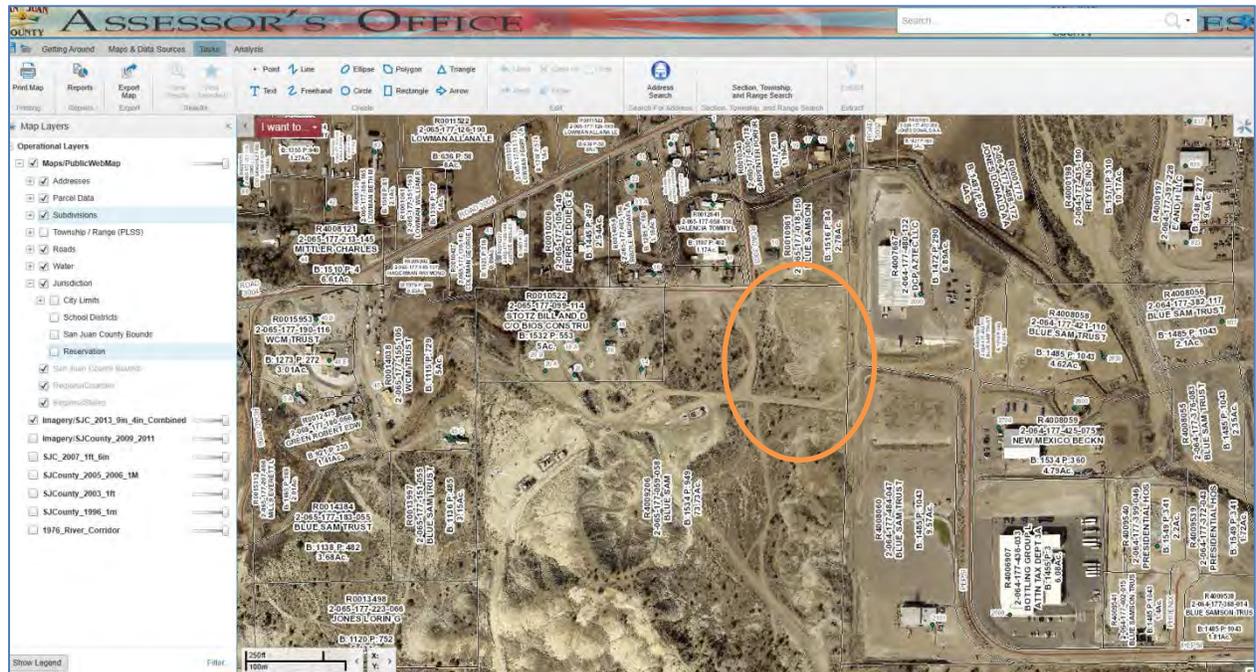
Aerial Image 2: San Juan County Assessor's Office Parcel Map Imagery Labeled 2013

Notes: San Juan County Assessor's Office imagery labeled 2013 shows disturbance in the northeast corner of the 73.73 acre parcel owned by Sam Blue at Road 3002, Aztec, New Mexico 87410.

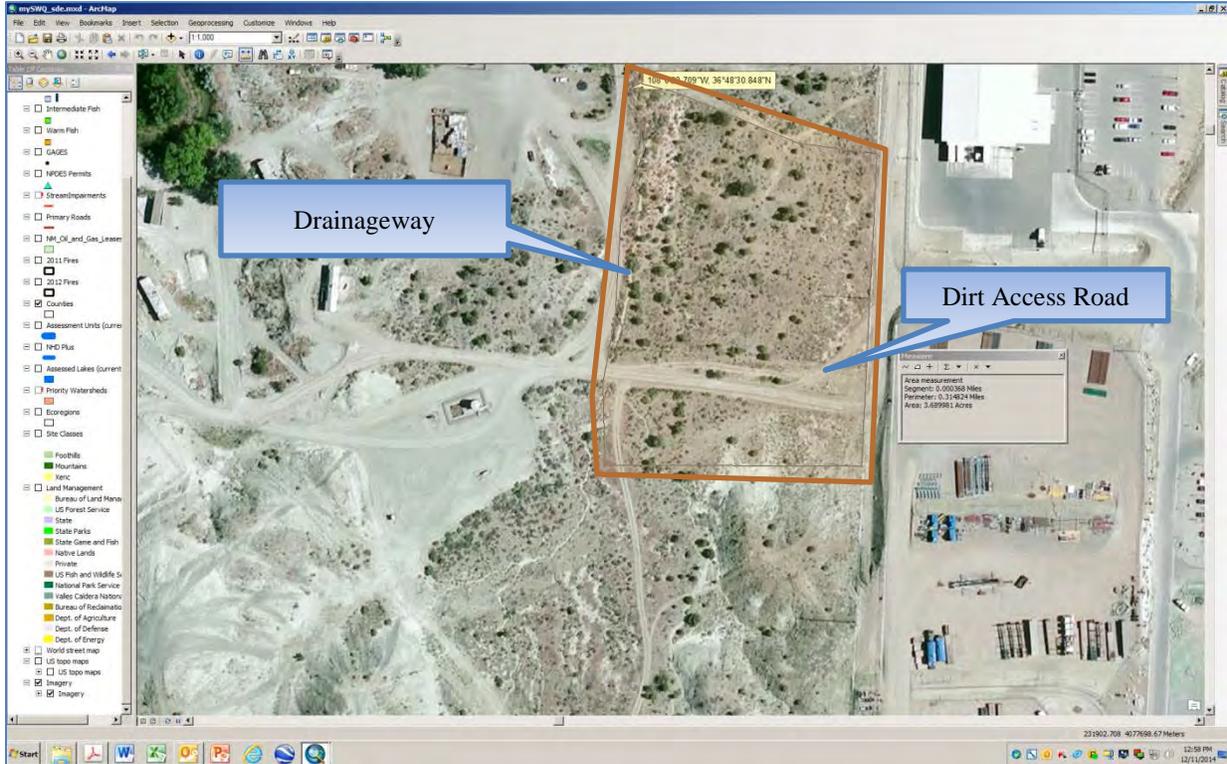
Aerial Image #3: General Area

Note: ArcMap measurement tool (thin line inside highlighted area) was used to estimate the general area of the northeast corner of the 73.73 acre parcel (approximately 3.7 acres).

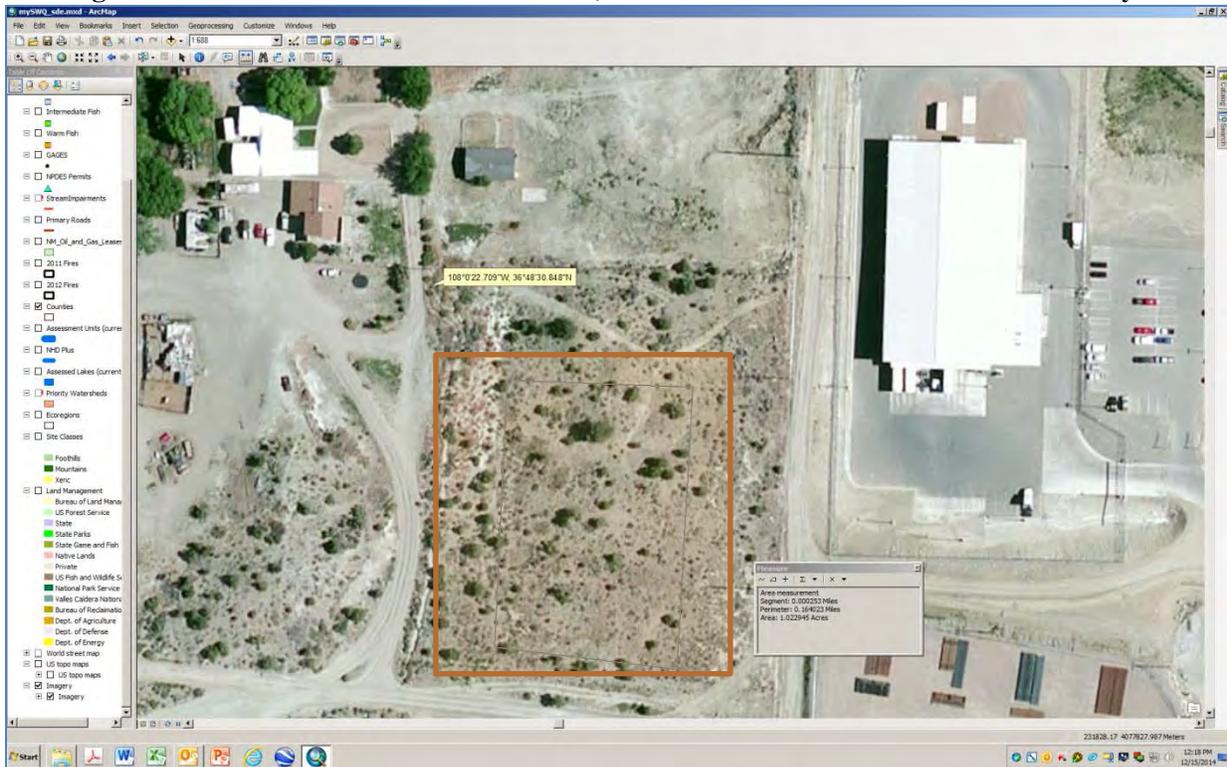
Aerial Image #4: General Area of Site Disturbance, North of Dirt Access Road > 1 acre on day of this CEI

Note: ArcMap measurement tool (thin line inside highlighted area) was used to show an approximate 1 acre area. More than 1 acre was observed to be disturbed on the day of this CEI.

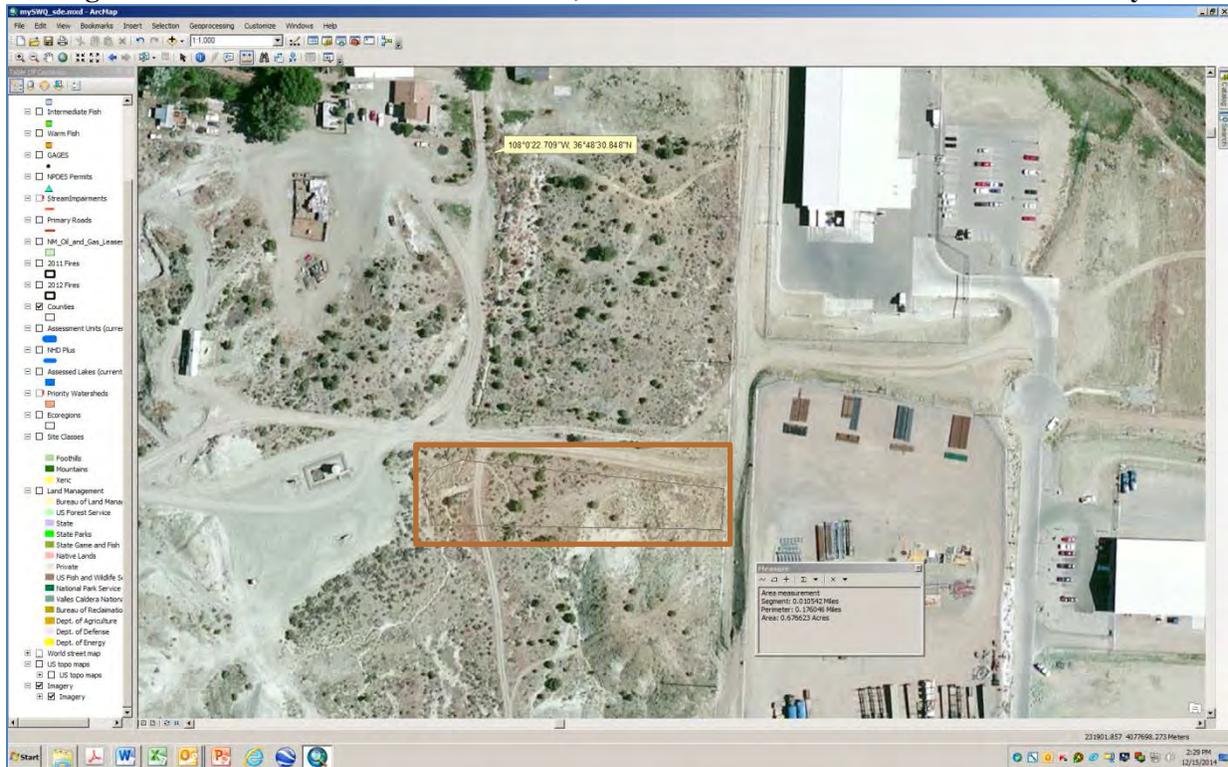
Aerial Image 5: General Area of Site Disturbance, South of Dirt Access Road ~ 0.6 acres on day of this CEI

Note: ArcMap measurement tool (thin line inside highlighted area) was used to estimate that approximately 0.6 acres south of the access road was observed to be disturbed on the day of this CEI.

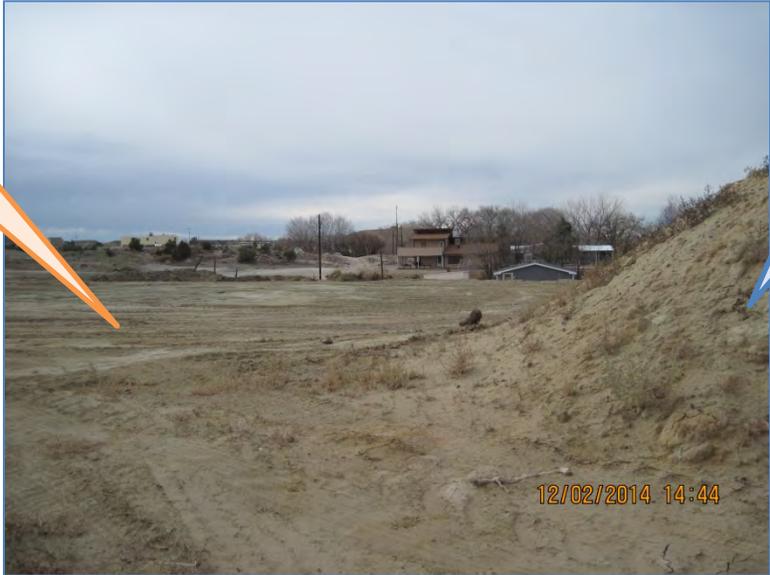
NMED/SWQB Official Photograph Log Photo # 1		
Photographer: Erin S. Trujillo	Date: 12/02/2014	Time: 1344 hours (adj. to standard time)
City/County: South of Aztec / San Juan County		State: New Mexico
Location: Property Owned by Sam Blue / Portion of Northeast Corner of 73.73 Acre Parcel, Road 3002, Aztec, New Mexico 87410		
Subject: Looking west from dirt road 3002, northern boundary of site was generally level with vehicle tracks and no vegetation. Slope on right side of photo, had some vegetation and did not appear to be recently disturbed.

Generally level ground surface with vehicle tracks

Slope with scattered vegetation

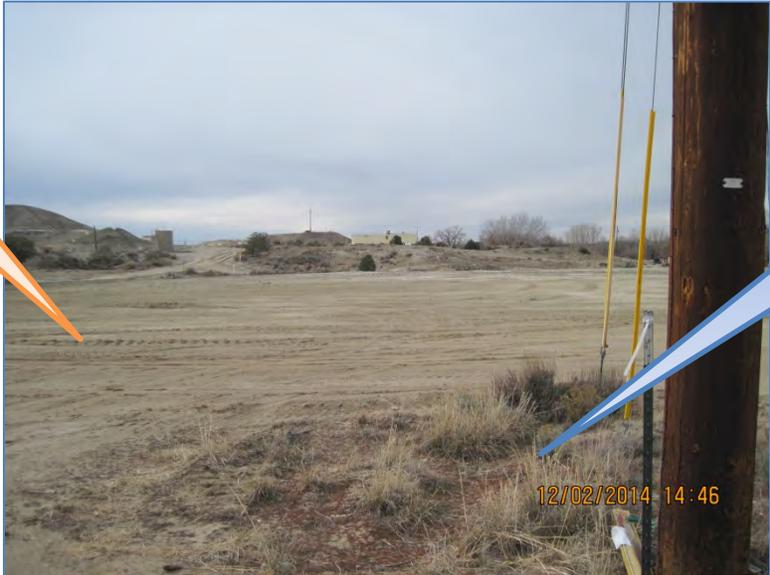
NMED/SWQB Official Photograph Log Photo # 2		
Photographer: Erin S. Trujillo	Date: 12/02/2014	Time: 1346 hours (adj. to standard time)
City/County: South of Aztec / San Juan County		State: New Mexico
Location: Property Owned by Sam Blue / Portion of Northeast Corner of 73.73 Acre Parcel, Road 3002, Aztec, New Mexico 87410		
Subject: Looking west from dirt road 3002 (south of previous photo), site is generally level with vehicle tracks and no vegetation. Vegetation remained along Road 3002 and utility pole.

Generally level ground surface with vehicle tracks

Remaining vegetation along Road 3002 and above-ground utility pole

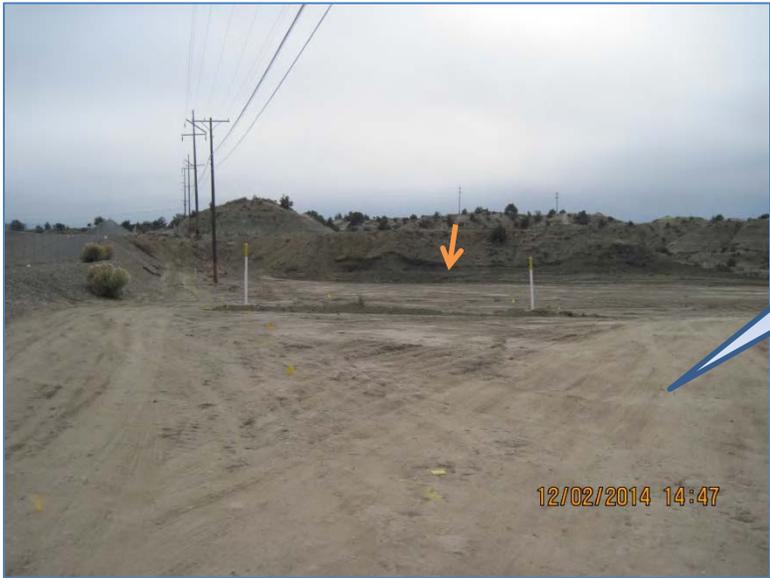
NMED/SWQB Official Photograph Log Photo # 3		
Photographer: Erin S. Trujillo	Date: 12/02/2014	Time: 1347 hours (adj. to standard time)
City/County: South of Aztec / San Juan County		State: New Mexico
Location: Property Owned by Sam Blue / Portion of Northeast Corner of 73.73 Acre Parcel, Road 3002, Aztec, New Mexico 87410		
Subject: Looking south from Road 3002 at south portion of site. Arrow points to extent of area that appeared recently disturbed.

Dirt access road shown on aerial image 3 above

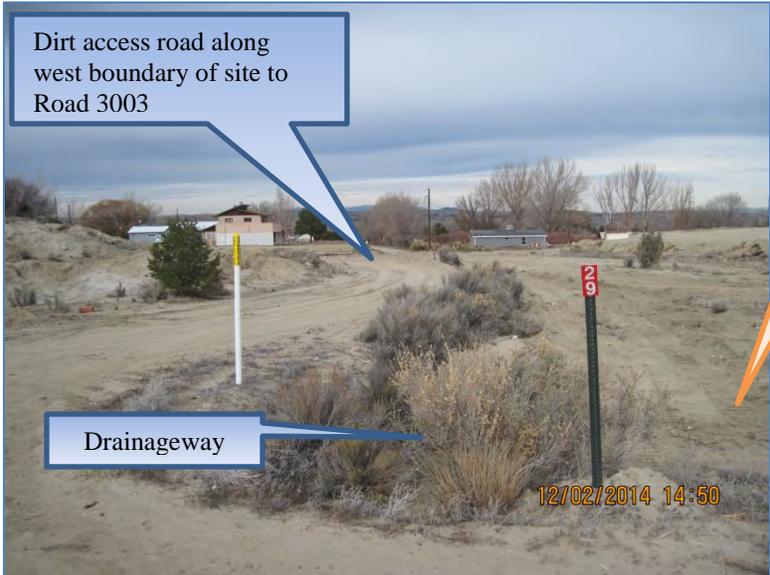
NMED/SWQB Official Photograph Log Photo # 4		
Photographer: Erin S. Trujillo	Date: 12/02/2014	Time: 1350 hours (adj. to standard time)
City/County: South of Aztec / San Juan County		State: New Mexico
Location: Property Owned by Sam Blue / Portion of Northeast Corner of 73.73 Acre Parcel, Road 3002, Aztec, New Mexico 87410		
Subject: Looking north at drainageway. East of drainageway, vegetation and soil appeared recently disturbed (cleared).

Dirt access road along west boundary of site to Road 3003

Drainageway

Vehicle tracks in area east of drainageway

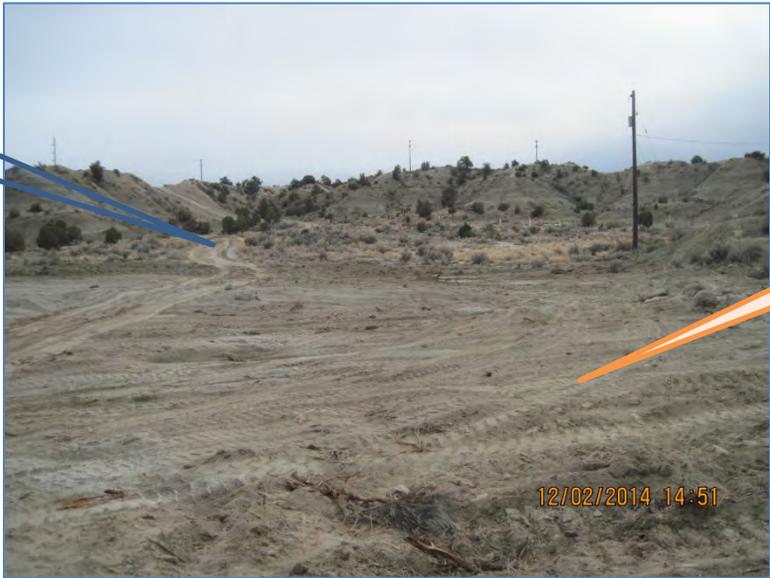
NMED/SWQB Official Photograph Log Photo # 5		
Photographer: Erin S. Trujillo	Date: 12/02/2014	Time: 1351 hours (adj. to standard time)
City/County: South of Aztec / San Juan County		State: New Mexico
Location: Property Owned by Sam Blue / Portion of Northeast Corner of 73.73 Acre Parcel, Road 3002, Aztec, New Mexico 87410		
Subject: Looking south from dirt access road at recent disturbance. Dirt access road outside recently disturbed area is in background of photo.

Dirt access road outside recently disturbed site

Generally level ground surface with vehicle tracks

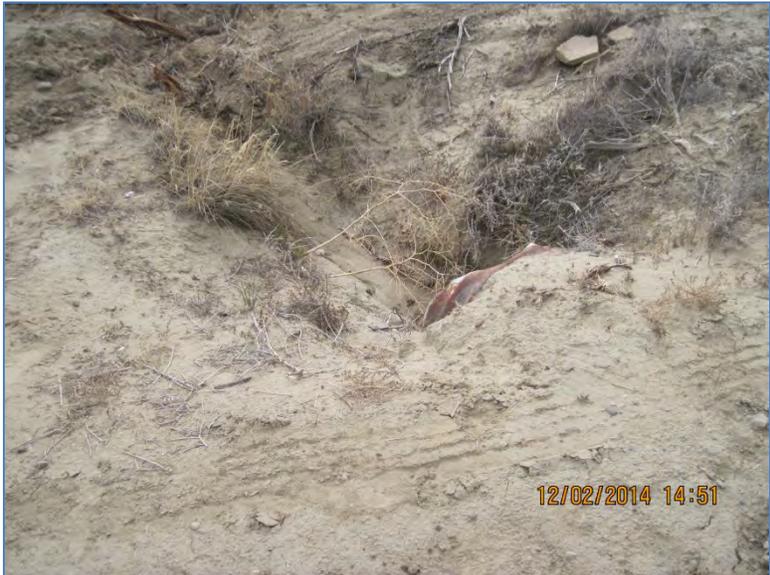
NMED/SWQB Official Photograph Log Photo # 6		
Photographer: Erin S. Trujillo	Date: 12/02/2014	Time: 1351 hours (adj. to standard time)
City/County: South of Aztec / San Juan County		State: New Mexico
Location: Property Owned by Sam Blue / Portion of Northeast Corner of 73.73 Acre Parcel, Road 3002, Aztec, New Mexico 87410		
Subject: From dirt access road, inlet for culvert crossing for drainageway. Culvert outlet area is shown in Photo #4.

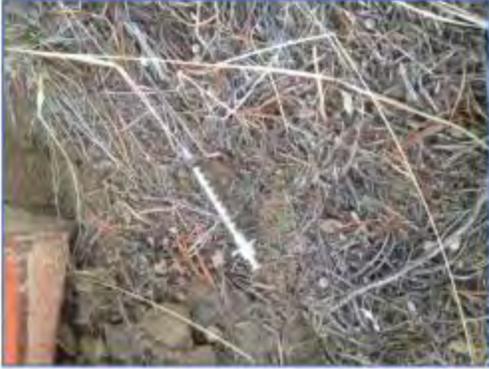
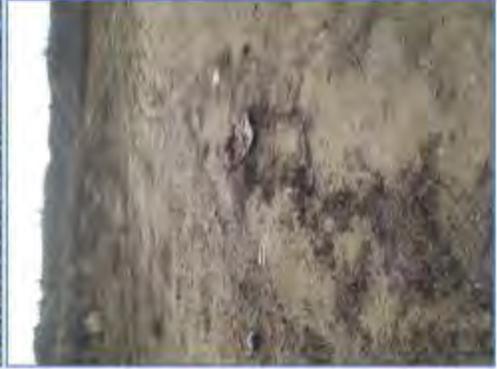
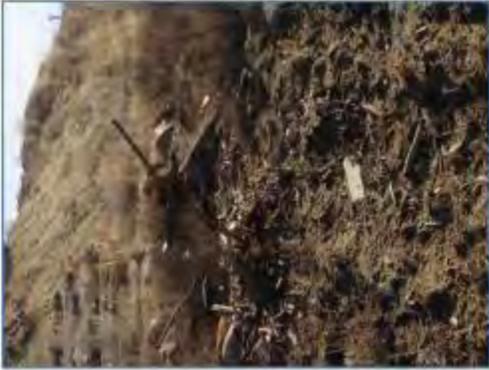
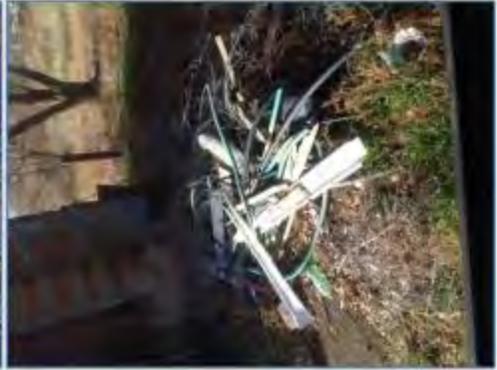
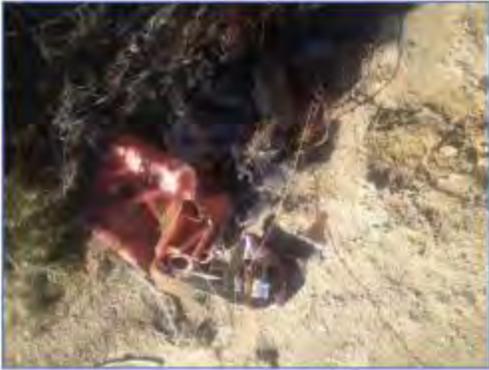
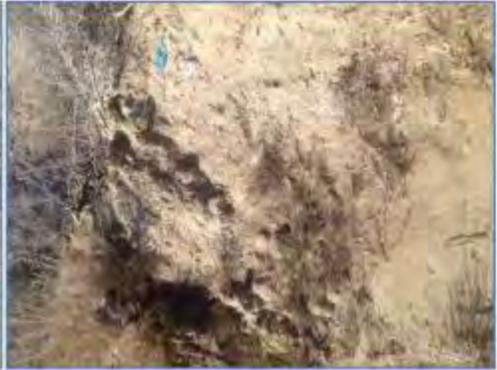
dispose of. This was determined by a physical onsite inspection by senior officials and then recommend to eliminate from their inventory due to it being a "public nuisance property" as I best recall the terminology. As you may know it's extremely rare if not unprecedented for the sale of public lands unless there was substantial issues. Also the map provided that has an area labeled number 5 proposed trail ARTS (Aztec Recreational Trail Systems) is a City of Aztec project where we are going to grant easement and or deed property to the city for public usage contingent the area is restored to something safe/ presentable. This last point once again being three agencies (BLM, County & City of Aztec) independently would be parallel with my reporting of the preexisting sites condition. Once again I understand your interpretation based on Google aerials can present a reasonable argument at first impression but please give considerable weight to the sources, and info provided that suggest otherwise. Also to factor in is the immediate public safety issue (see 3rd attachment) i.e. hypodermic needles, piercing rebar sticking up, gas containers and endless glass/ metal shards. (see pictures 1 to 6)

THE SURFACE STRIPPED OF TOP SOIL & A DEEP DIG PIT
SEVERAL OTHER PIT LOCATION APPEAR TO BE TRANSIATE
SHELTERS ALONG W/ HYPERDERMIC NEEDLES & CAMPFIRE REMNATS
