**Re: 2077 Pinon Bluffs Drive, Santa Fe, NM 87501 (Lot 14 Pinon Bluffs Subdivision); Construction Stormwater; NPDES Compliance Evaluation Inspection; NMU001899; August 11, 2015**

### NPDES Compliance Inspection Report

**Single Family House Construction Activity**  
**2077 Pinon Bluffs Drive Santa Fe, NM 87501 (Lot 14 Pinon Bluffs Subdivision)**  
**Mathew Montoya, NPDES Tracking No. NMU001899**  
**El Bosque Builders LLC, NPDES Tracking No. NMU001898**  
**Compliance Evaluation Inspection**  
**August 11, 2015**

**Further Explanations**

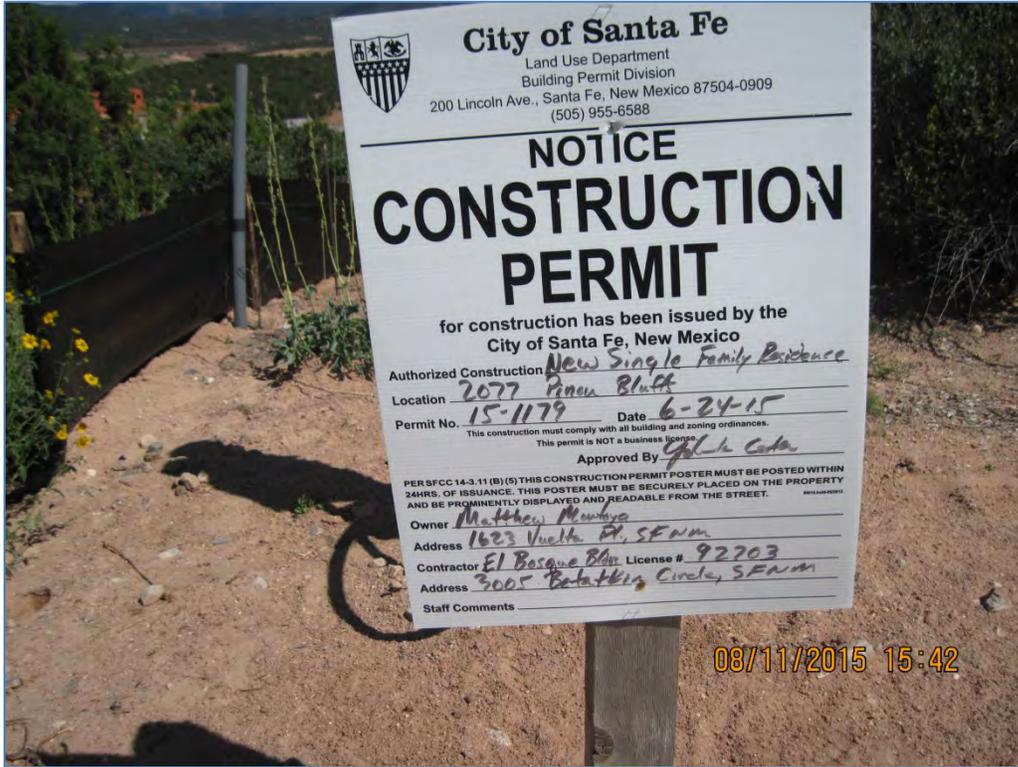
**NMED/SWQB  
Official Photograph Log  
Photo # 1**

Photographer: Erin S. Trujillo	Date: 08/11/2015	Time: 1542 hours
City/County: Santa Fe / Santa Fe County		State: New Mexico
Location: 2077 Pinon Bluffs Drive Santa Fe, NM 87501 (Lot 14 Pinon Bluffs Subdivision)		
Subject: Sign for City of Santa Fe Notice of Construction Permit dated 6-24-2015

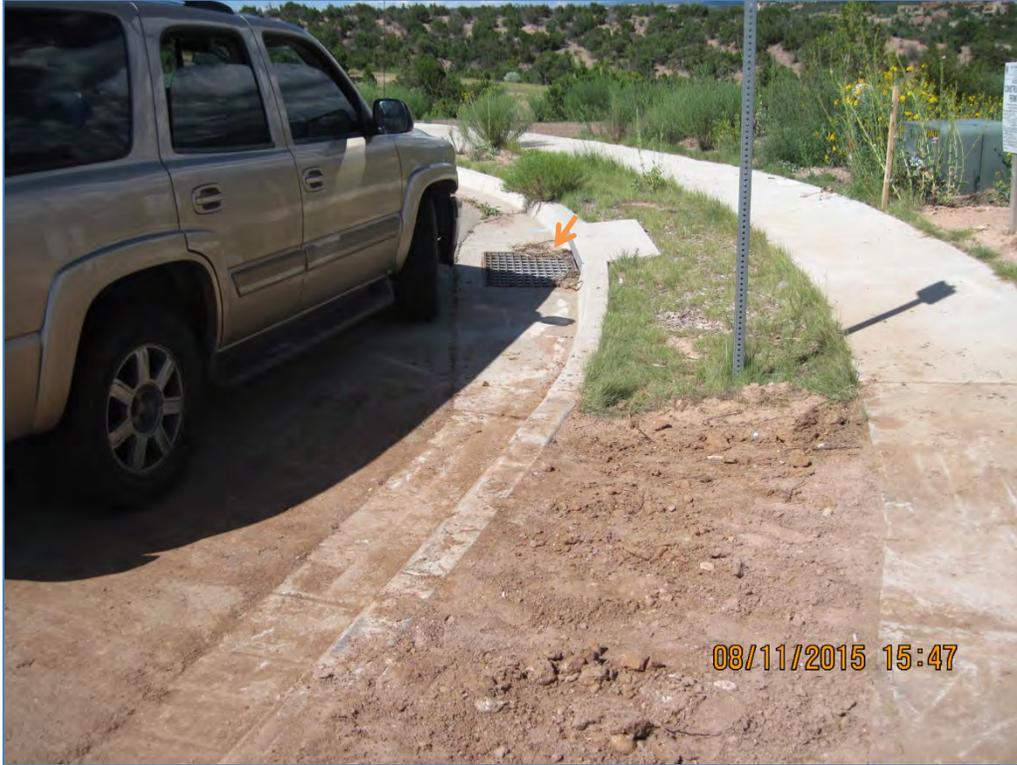
NMED/SWQB  
Official Photograph Log  
Photo # 2

- Some accumulated soil remained on the Pinon Bluffs sidewalk and cul-de-sac near City of Santa Fe MS4 storm sewer drop inlet. According to the on-site El Bosque Builders, LLC representative, soil was used as a curb ramp for heavy equipment to enter the site. The area appeared swept, but soil was still visible. Gravel at site entrance did not continue or span all exposed soil at the entrance. Additional measures to minimize sediment track out (e.g., use of less erodible materials like wood or other material instead of soil for ramps, additional gravel or larger sized cobble at the entrance, additional sweeping) may be needed as construction vehicles continue to enter the site (see Part 2.1.2.3 Minimize Sediment Track-Out of the 2012 CGP).

Subject: Accumulated soil existed on Pinon Bluffs sidewalk and cul-de-sac. Arrow points to City of Santa Fe MS4 storm sewer drop inlet.

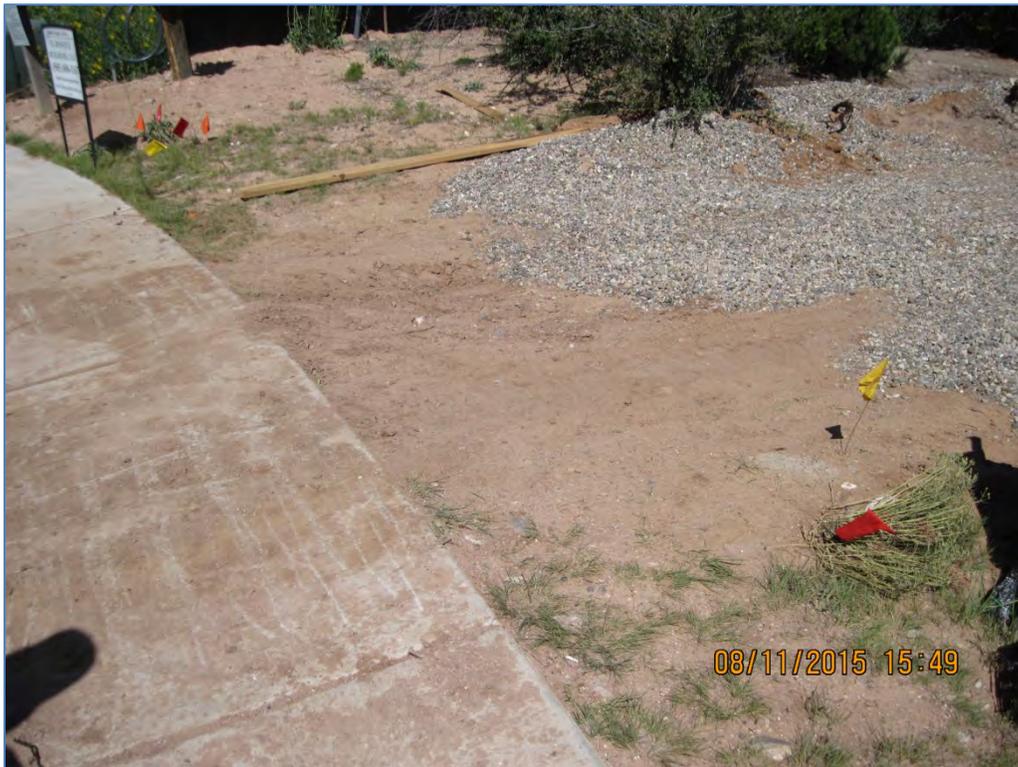
NMED/SWQB  
Official Photograph Log  
Photo # 3

Subject: Gravel at site entrance did not continue or span all exposed soil.

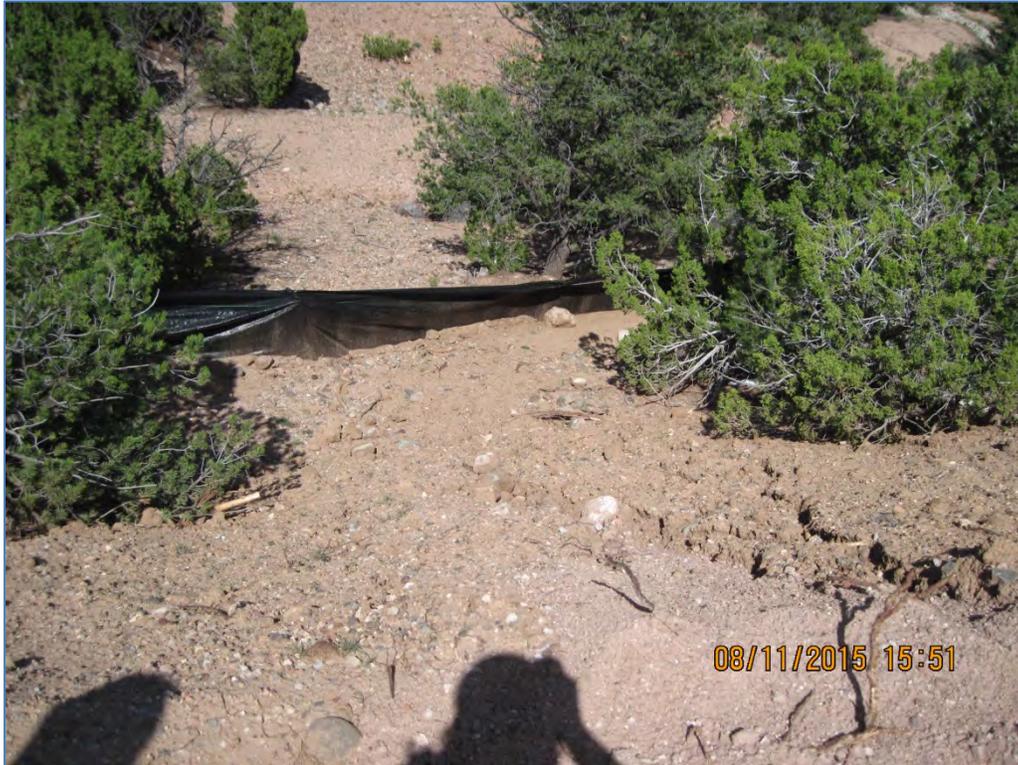
NMED/SWQB  
Official Photograph Log  
Photo # 4

Subject: Looking generally north at entrenched silt fence at northern perimeter. Accumulated soil was near the top of the fence.

- In one area of the entrenched silt fence at the northern perimeter, soil had accumulated and maintenance appeared needed to minimize stormwater from overtopping or damaging the control measure. Maintenance requirements in Part 2.1.2.2 (Install Perimeter Controls) of the 2012 CGP states “*You must remove sediment before it has accumulated to one-half of the above-ground height of any perimeter control.*”

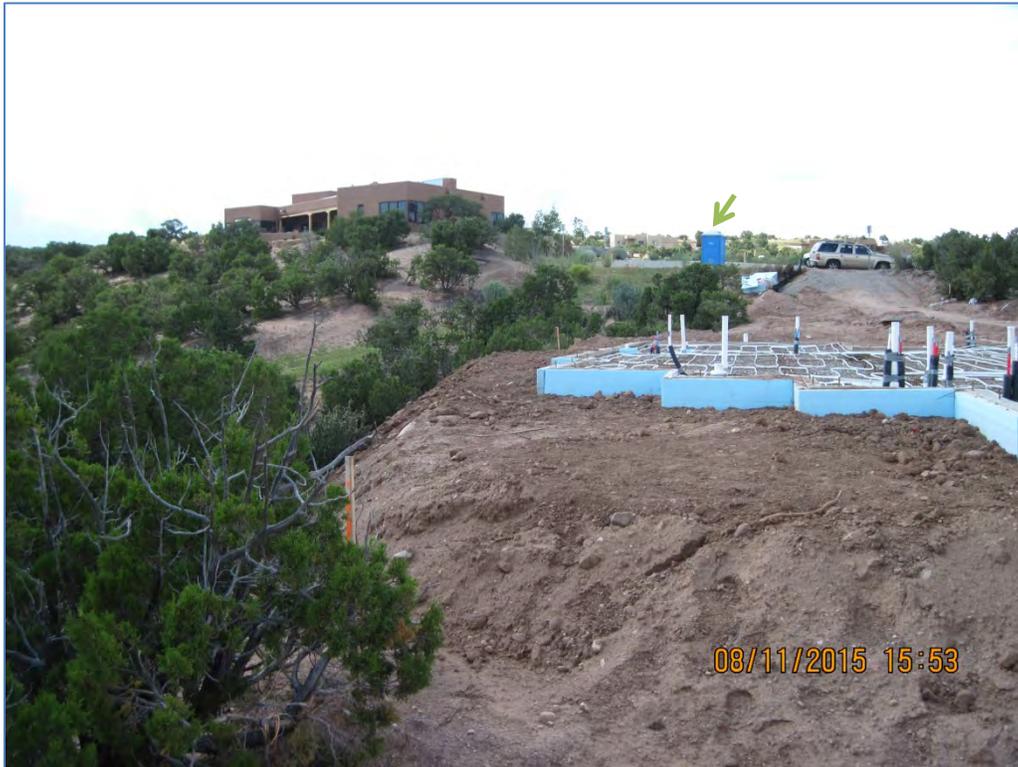
NMED/SWQB  
Official Photograph Log  
Photo # 5

Slopes at the site were disturbed and stabilization had not been designed according to the on-site El Bosque Builders, LLC representative (see Part 2.2 of the 2012 CGP for vegetative and/or non-vegetative stabilization deadlines and criteria). Part 2.1.2.6 of the 2012 CGP states *“The permit does not prevent or prohibit disturbance on steep slopes. For some projects, disturbance on steep slopes may be necessary for construction...minimizing the disturbances to steep slopes consistent with this requirement can be accomplished through the implementation of a number of standard erosion and sediment control practices, such as by phasing disturbances to these areas and using stabilization practices designed to be used on steep grades.”*

Subject: Looking generally west at disturbance (exposed soils) of site, including steep slopes. Arrow points to portable toilet (pollution prevention control).

- Measures to ensure that the portable toilet remain secure and would not be tipped or knocked over as construction continues may be needed (see Part 2.3.3.3 Storage, Handling, and Disposal of Construction Products, Materials, and Wastes of the 2012 CGP).

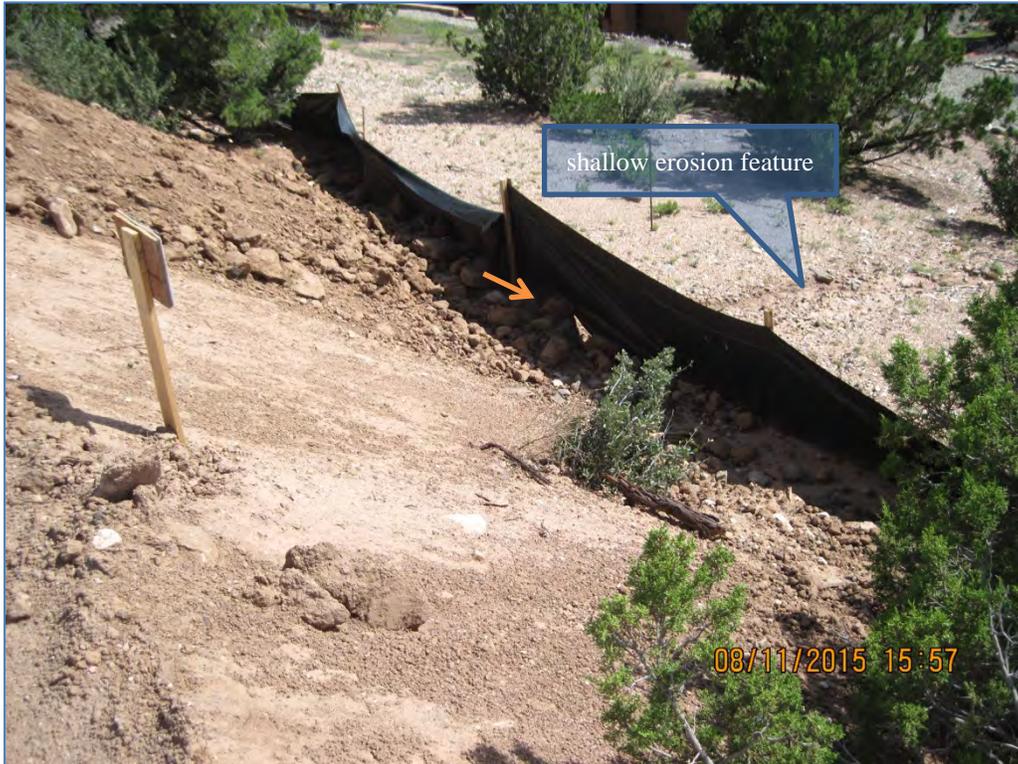
NMED/SWQB  
Official Photograph Log  
Photo # 6

Subject: Looking generally south, arrow points to gap in silt fence control measure downslope at site southern perimeter. Silt fence was not entrenched at this location. An erosion feature existed downgradient of fence gap.

- In one area of the silt fence at the southern perimeter, the silt fence was not entrenched. An erosion feature existed downgradient of the fence gap. Maintenance and/or corrective action (e.g., re-installation or re-trenching, repair, modify, or replace) of the stormwater erosion and sediment control in this one area appeared needed (see Part 7.2.12. Procedures for Inspection, Maintenance, and Corrective Action of the 2012 CGP).
