Re: 2068 South Ridgetop Road, Santa Fe, NM 87501 (Lot 1 Pinon Bluffs Subdivision); Construction Stormwater; NPDES Compliance Evaluation Inspection; NMU001900; August 11, 2015

NPDES Compliance Inspection Report

Single Family House Construction Activity
2068 South Ridgetop Road, Santa Fe, NM 87501 (Lot 1 Pinon Bluffs Subdivision)
Joseph C de Baca, NPDES Tracking No. NMU001902
Compliance Evaluation Inspection
August 11, 2015

Further Explanations

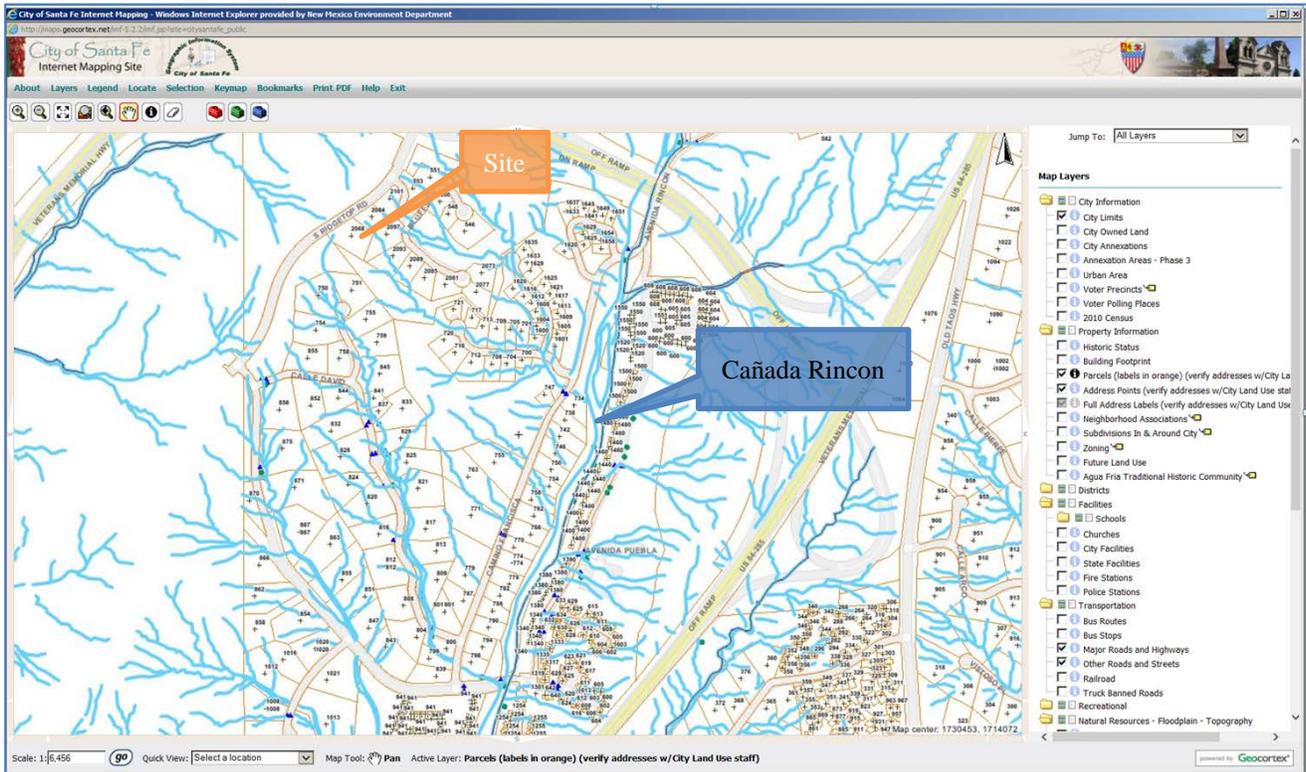
Figure 1: Site Map showing Surface Hydrology (Drainageways)
Source: City of Santa Fe Internet Mapping Site

Stormwater discharges to the City of Santa Fe small Municipal Separate Storm Sewer System (sMS4) and drainageways, thence approximately 0.5 miles to Cañada Rincon subject to unclassified Segment 20.6.4.98 NMAC (New Mexico Administrative Code), thence to an unnamed tributary (arroyo), thence to Santa Fe River approximately 1.5 miles south of the site in the Rio Grande Basin.

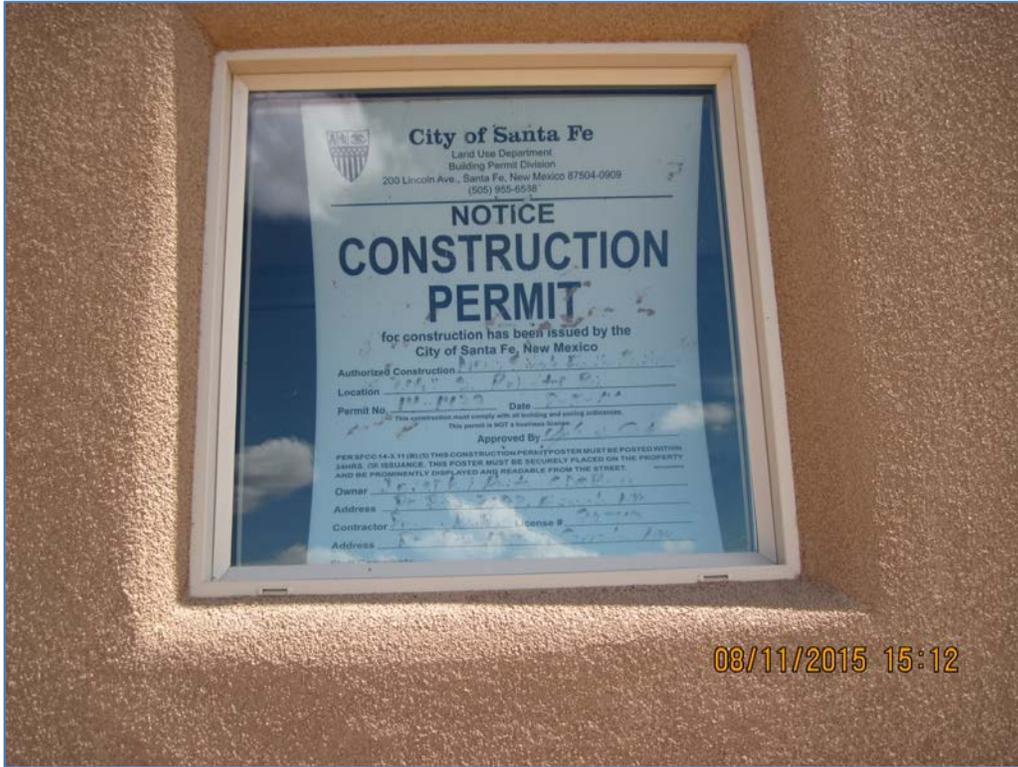
NMED/SWQB
Official Photograph Log
Photo # 1

The on-site sign for the City of Santa Fe notice of construction permit indicated a date of August 5, 2014. Picasso Builders, LLC 2012 CGP NOI states that the estimated project start date was August 15, 2014. Between August 15, 2014 and the day of this CEI, the following precipitation 0.25 inches or greater was recorded at weather station

Photographer: Erin S. Trujillo	Date: 08/11/2015	Time: 1512 hours
City/County: Santa Fe / Santa Fe County		State: New Mexico
Location: 2068 South Ridgetop Road, Santa Fe, NM 87501 (Lot 1 Pinon Bluffs Subdivision)		
Subject: Sign for City of Santa Fe Notice of Construction Permit dated 8-5-2014

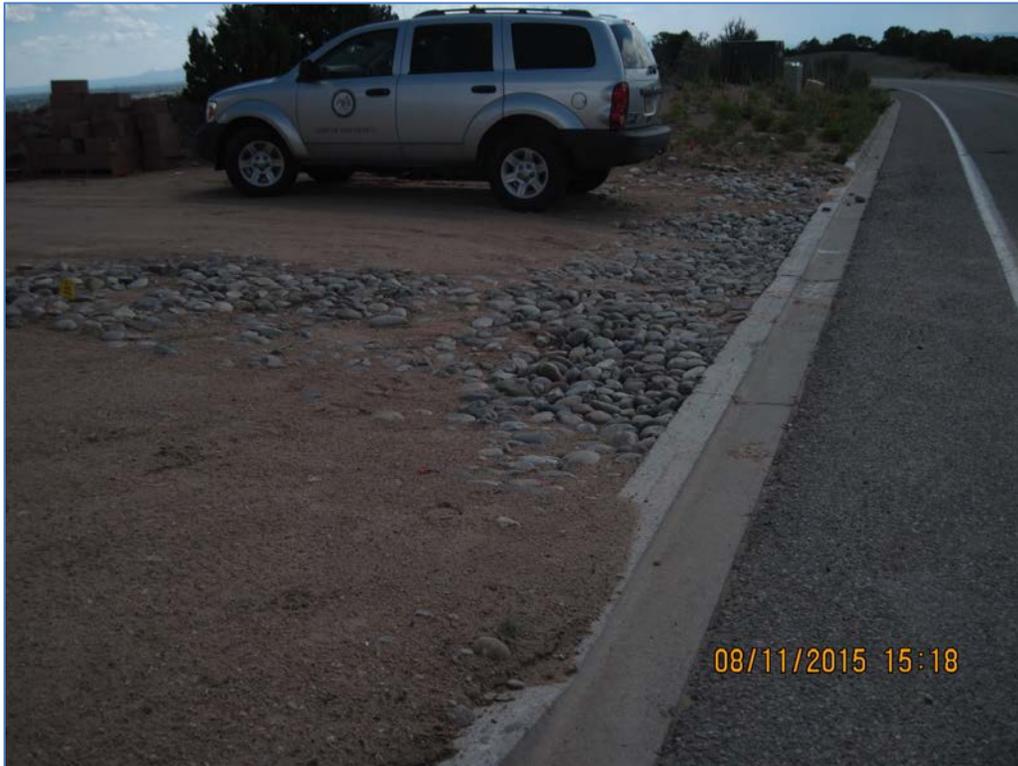
**NMED/SWQB
Official Photograph Log
Photo # 2**

Subject: Cobble-sized rock at entrance spanned most, but not all, of the curb cut at the site entrance. Accumulated soil existed in the control measure. Little to no tracking was observed on South Ridgetop Road.

On the day of this CEI, construction activities appeared to be on-going. Materials storage was on site. Portions of the site that were not covered by permanent structures had exposed soil (were not vegetated). No structural sediment or erosion control measures for disturbance outside the site southern perimeter wall were observed. Cobble-size rock at the driveway entrance appeared to provide erosion control; but, accumulated sediment in the rock cobble indicated that periodic inspection and maintenance (e.g., sweeping, re-installation, adding more rock, etc.) may be needed.

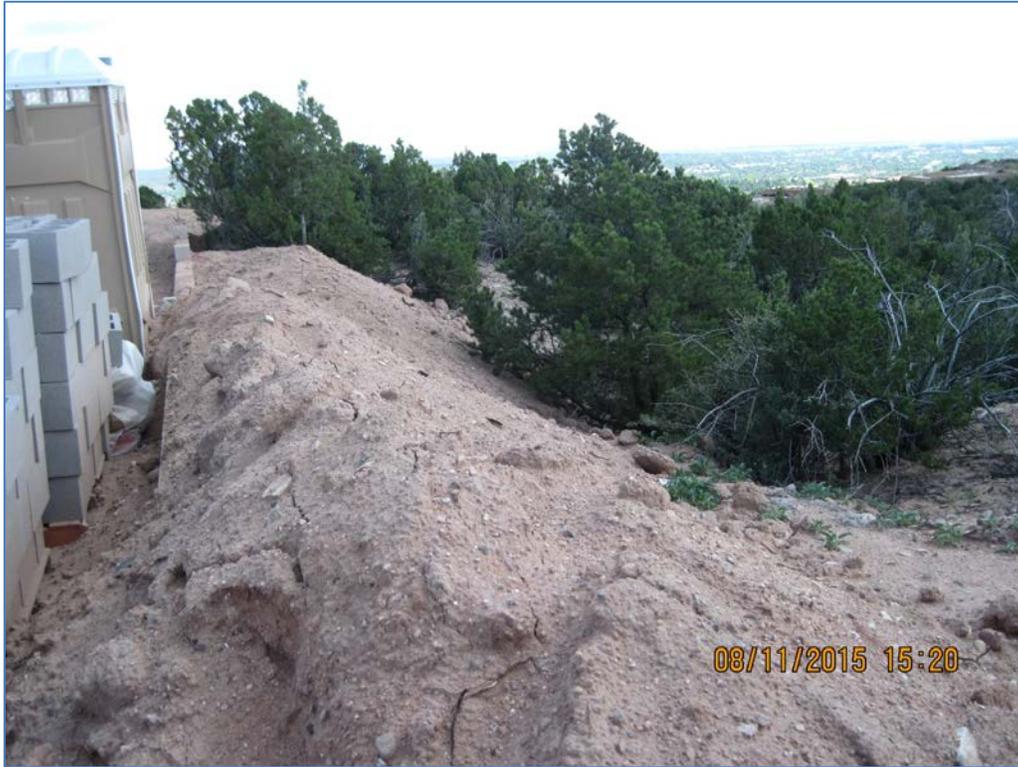
NMED/SWQB
Official Photograph Log
Photo # 3

Subject: Looking generally southeast, disturbed soil and steep slope was observed south of block wall near construction material storage.

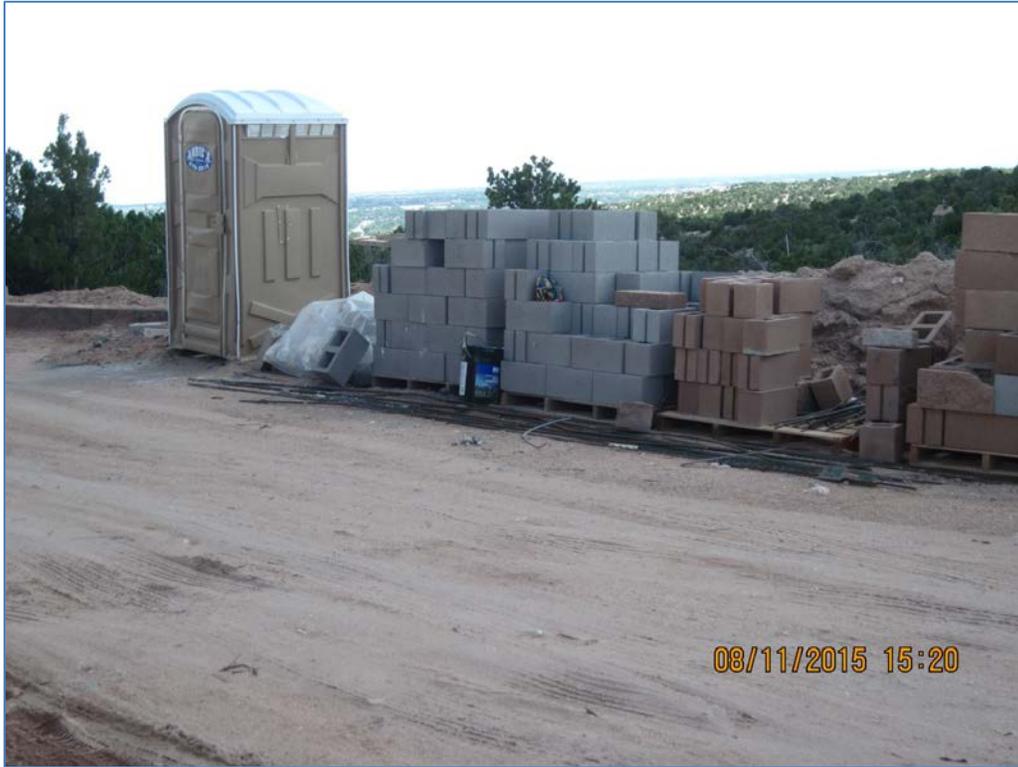
**NMED/SWQB
Official Photograph Log
Photo # 4**

Subject: Looking generally southeast, construction materials and portable toilet were on-site.

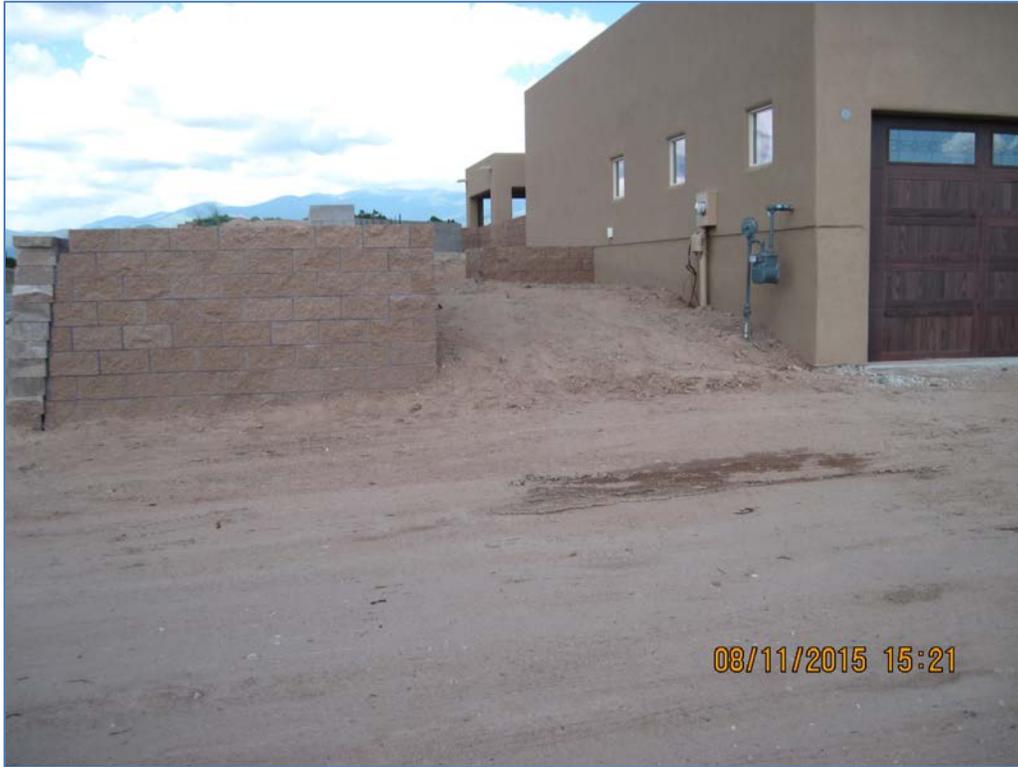
**NMED/SWQB
Official Photograph Log
Photo # 5**

Subject: Looking generally northeast, disturbed soils exist at the west corner of the constructed house.

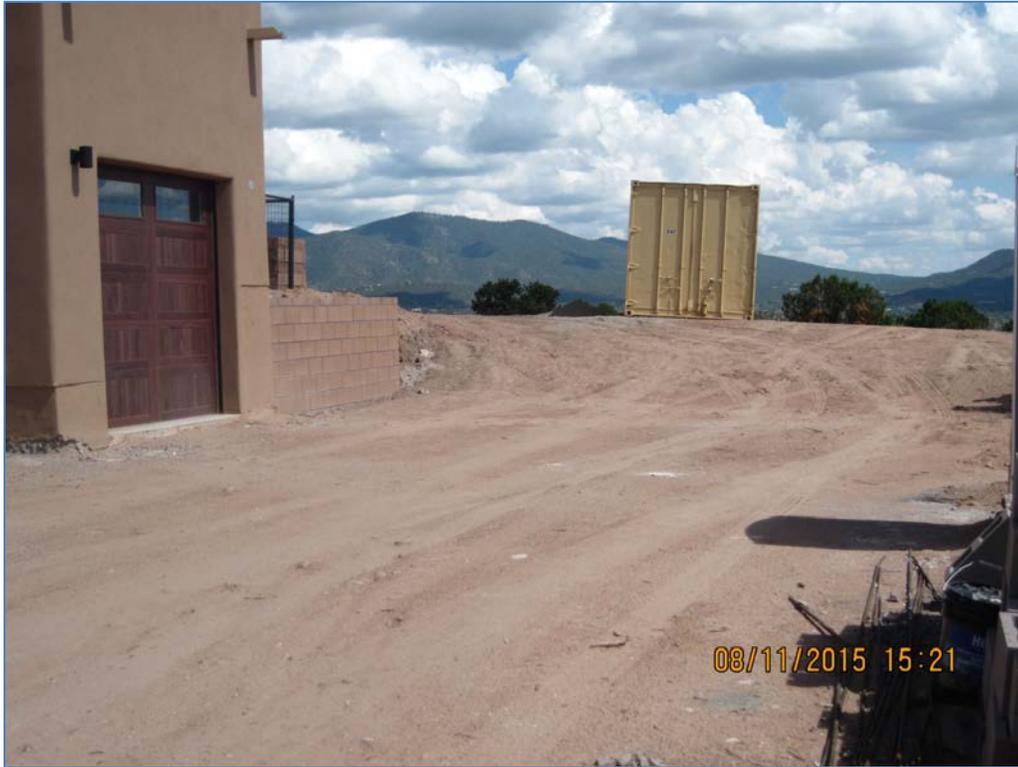
NMED/SWQB
Official Photograph Log
Photo # 6

Subject: Looking generally east, disturbed soil exists at the east corner of the constructed house.
