Re: M.A.G. Construction, LLC; Lot 42 Las Lomas Subdivision, Santa Fe; Unpermitted Construction Stormwater; SIC 1521; NPDES Compliance Evaluation Inspection; NPDES Tracking No. NMU001909; February 25 & 26, 2016

Lot 42 Las Lomas Subdivision, Santa Fe, New Mexico
Mr. & Ms. Spencer and Carol Snow, Trustee Owner/Operator, NPDES Tracking No. NMU001908
M.A.G. Construction, LLC, Operator/General Contractor, NPDES Tracking No. NMU001909
Compliance Evaluation Inspection
February 25 & 26, 2016

NPDES Compliance Inspection Report

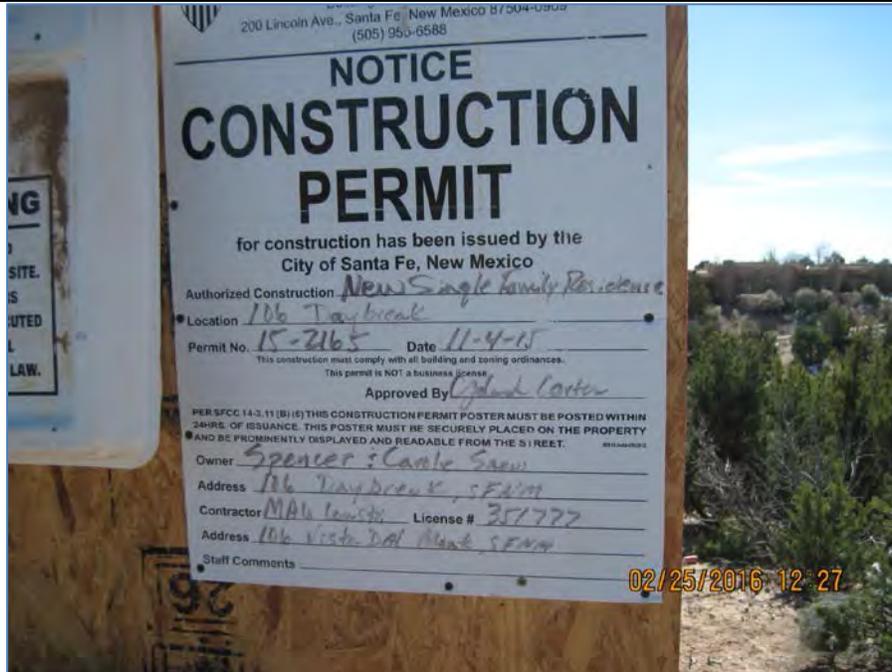
**NMED/SWQB
Official Photograph Log
Photo # 1**

| Subject: City Notice Construction Permit sign with date of 11-4-15. | | |

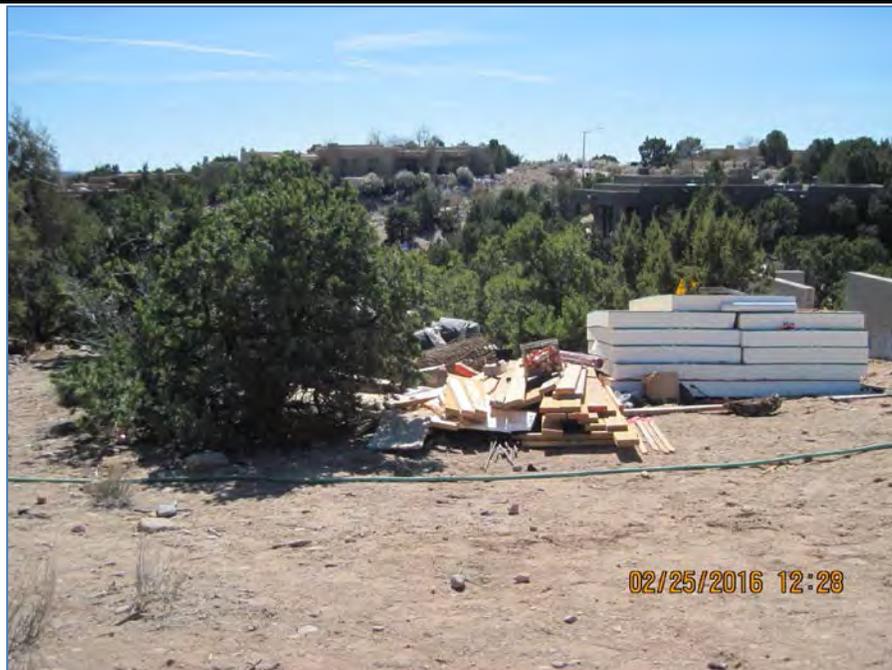
**NMED/SWQB
Official Photograph Log
Photo # 2**

| Subject: Looking south at construction materials stored on site. | | |

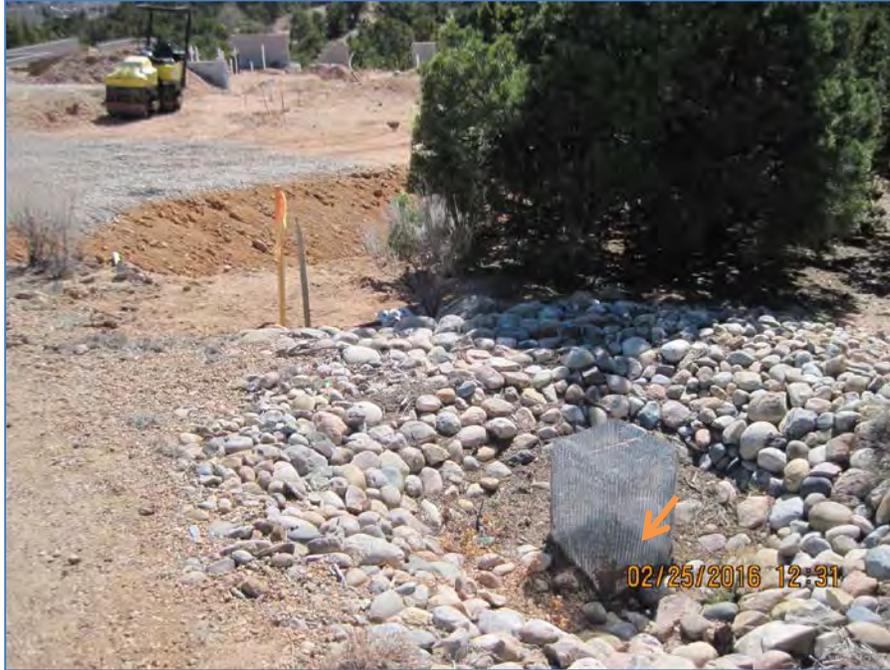
NMED/SWQB
Official Photograph Log
Photo # 3

Subject: Arrow points to offsite stormwater drop inlet. On-site outlet of pipe according to on-site representative is shown in Photo #9.

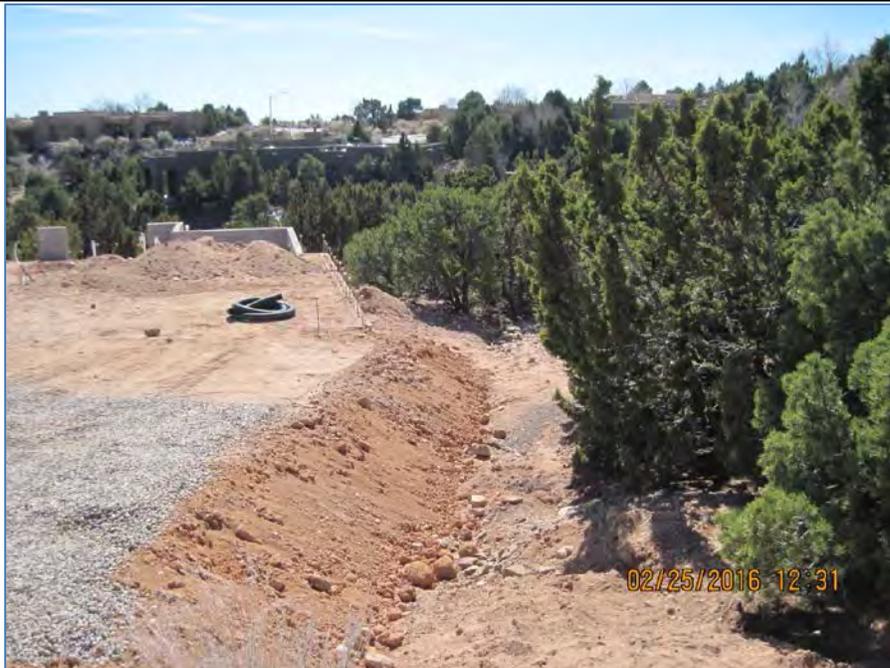
NMED/SWQB
Official Photograph Log
Photo # 4

No other temporary sediment or erosion control measures from disturbed areas, including steep slopes were observed on site.

Subject: Looking south at disturbed area at property boundary. Slope of topography is to the south (background shown in this photo).

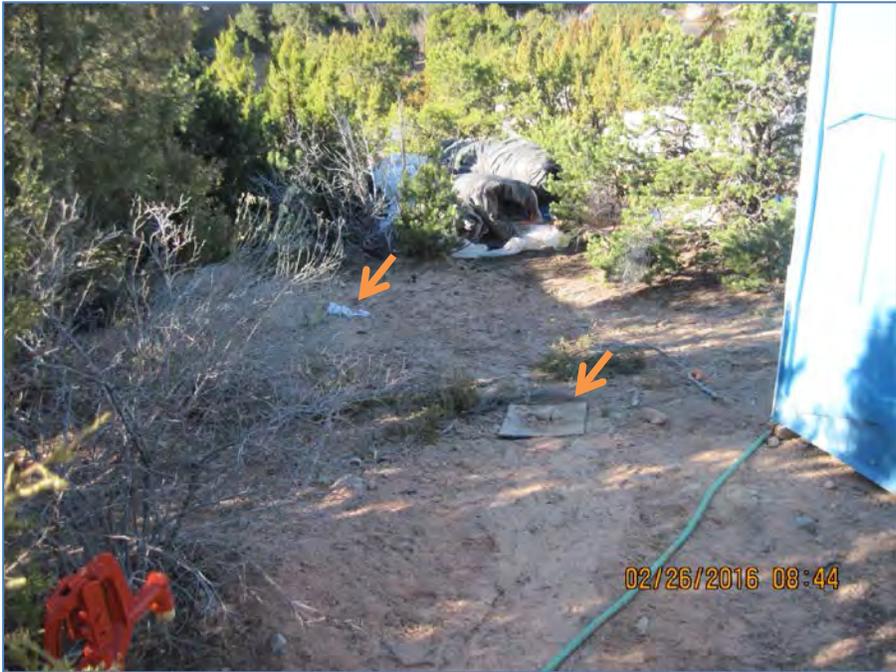
| NMED/SWQB Official Photograph Log Photo # 5 | | |

The site had tarps and plastic, but these were not being used to cover construction materials during this CEI. A portable sanitary toilet existed on site. The toilet was not staked down. The toilet was in a corner of the site and appeared away from current construction traffic on the small lot. Construction materials and sand screening may also be sources of pollutants. No concrete washout control measures were observed. Debris, paper and drink container trash was observed on the ground on site. No other trash control measures were observed.

| NMED/SWQB Official Photograph Log Photo # 5 | | |
|--|---|---|
| Subject: Looking south at construction materials (plastic and tarps). Arrows point to examples of paper and debris south and behind the portable toilet on site. | | |

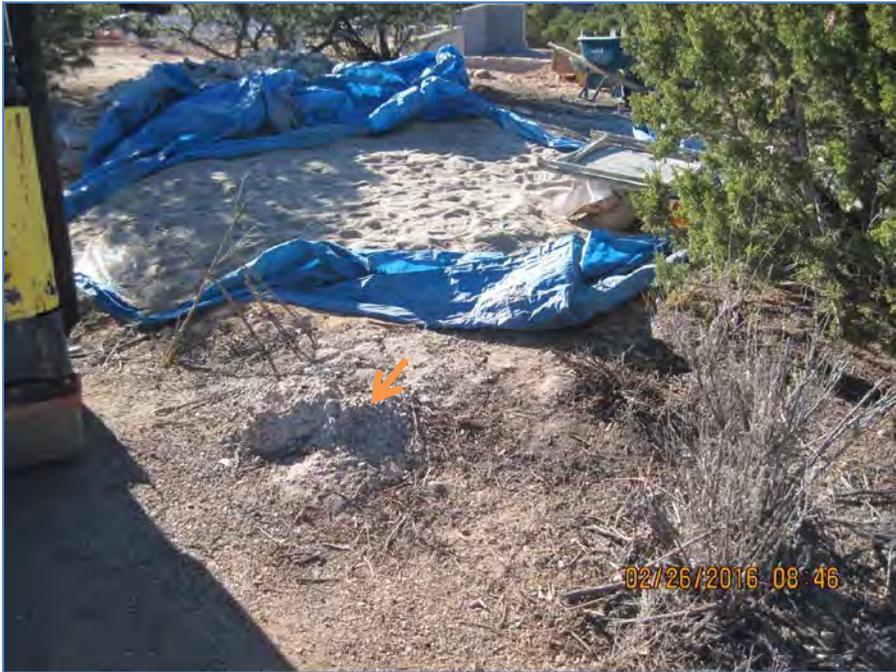
| NMED/SWQB Official Photograph Log Photo # 6 | | |

| NMED/SWQB Official Photograph Log Photo # 6 | | |
|--|---|---|
| Subject: Arrow points to concrete in the sand screening work area on site. | | |

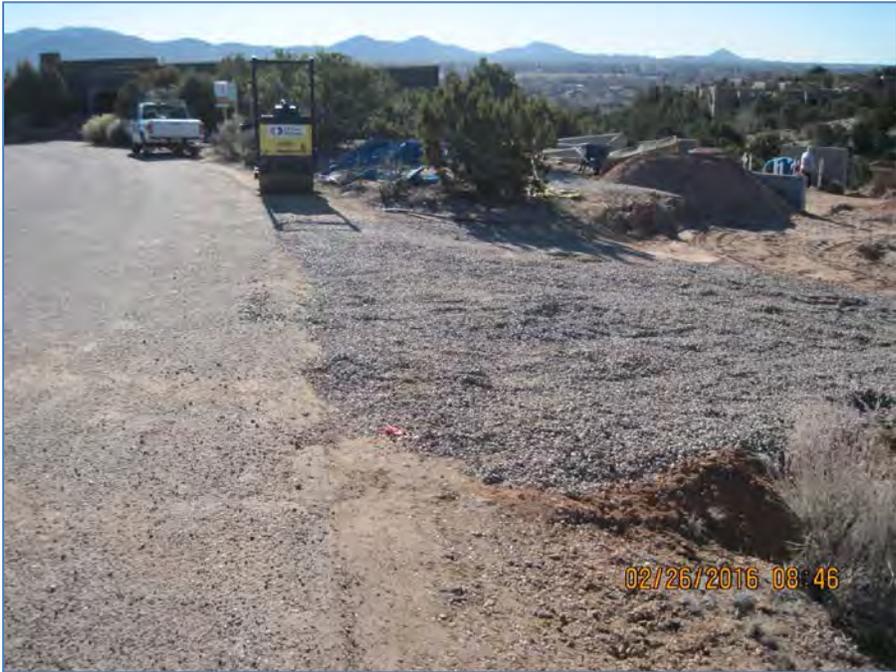
| NMED/SWQB Official Photograph Log Photo # 7 | | |

Gravel-size rock was at the driveway entrance and appeared to provide sediment and erosion control at the entrance. Some gravel, but no substantial accumulated sediment was tracked out onto the adjacent street which was at a higher elevation than the disturbed area of the construction site.

| NMED/SWQB Official Photograph Log Photo # 7 | | |
|--|---|---|
| Subject: Gravel covers entire entrance. | | |

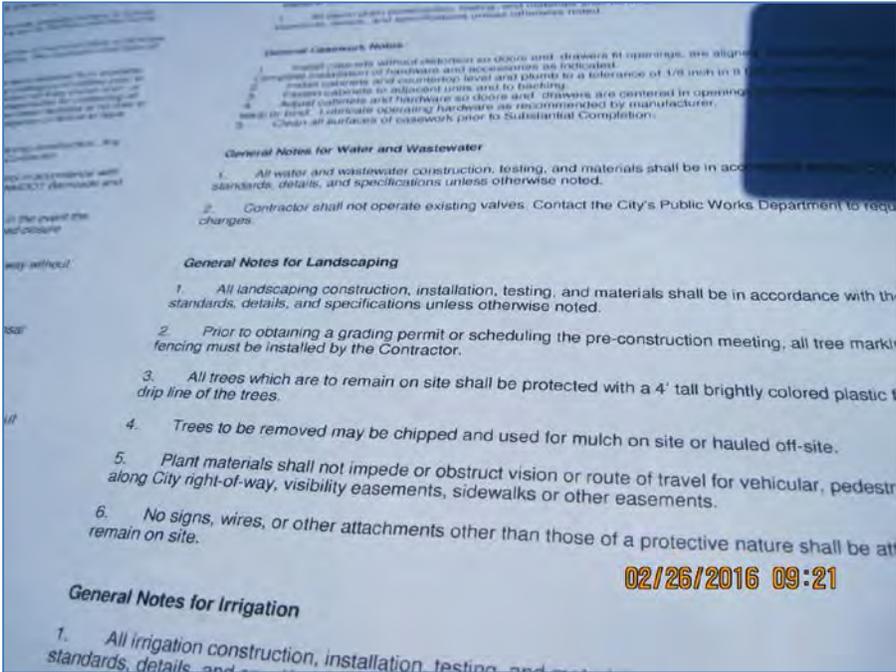
| NMED/SWQB Official Photograph Log Photo # 8 | | |

Mr. Garcia described that some remaining vegetation was to not be disturbed if possible. Remaining trees were not otherwise identified or protected from damage from construction activities. For example, fencing described in the site's construction plan general notes stated "*All trees which are to remain on site shall be protected with a 4' tall brightly colored plastic fence.*"

| NMED/SWQB Official Photograph Log Photo # 8 | | |
|---|---|---|
| Subject: Site's construction plans included a landscape plan and general notes for Landscaping (#3) with measures to protect trees. | | |

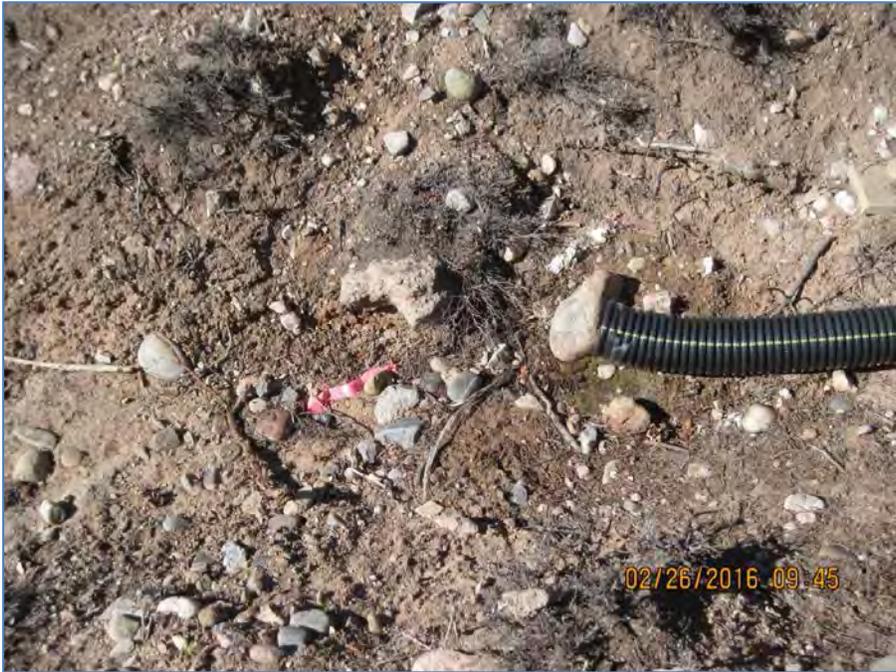
| NMED/SWQB Official Photograph Log Photo #9 | | |

A stormwater inlet existed northwest of the site near the entrance. According to Mr. Gracia, the buried stormwater pipe had an outlet on site. The outlet was above the shallow drainageway in the southwest portion of the site. There was no on-site temporary erosion control for the stormwater pipe outlet.

| NMED/SWQB Official Photograph Log Photo #9 | | |
|--|---|---|
| Subject: As described by on-site representative, this pipe outlet is from the stormwater inlet shown in Photo #3 . | | |

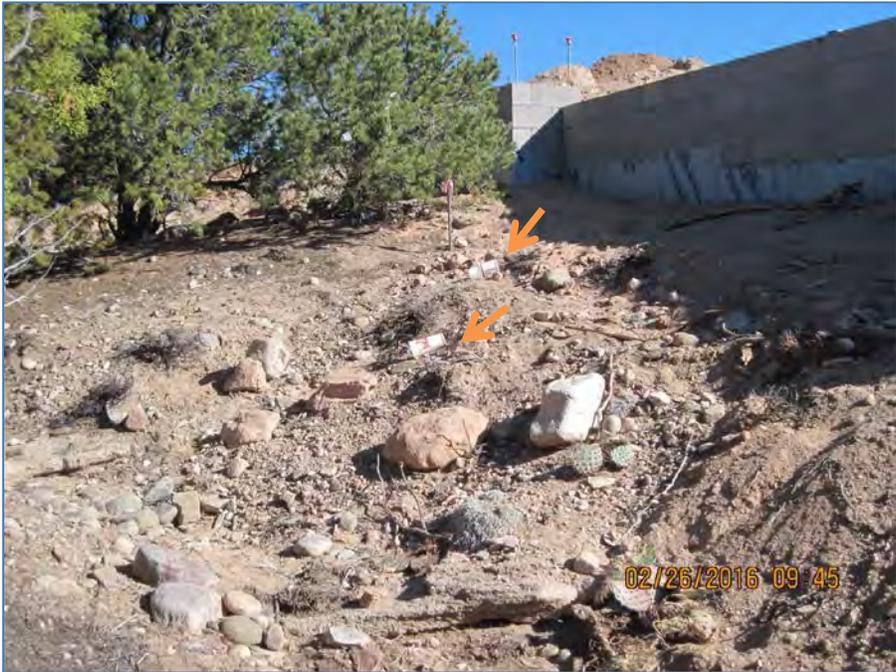
| NMED/SWQB Official Photograph Log Photo # 10 | | |

| NMED/SWQB Official Photograph Log Photo # 10 | | |
|---|---|---|
| Subject: Looking north near western property boundary, arrows point to examples of trash on site. | | |

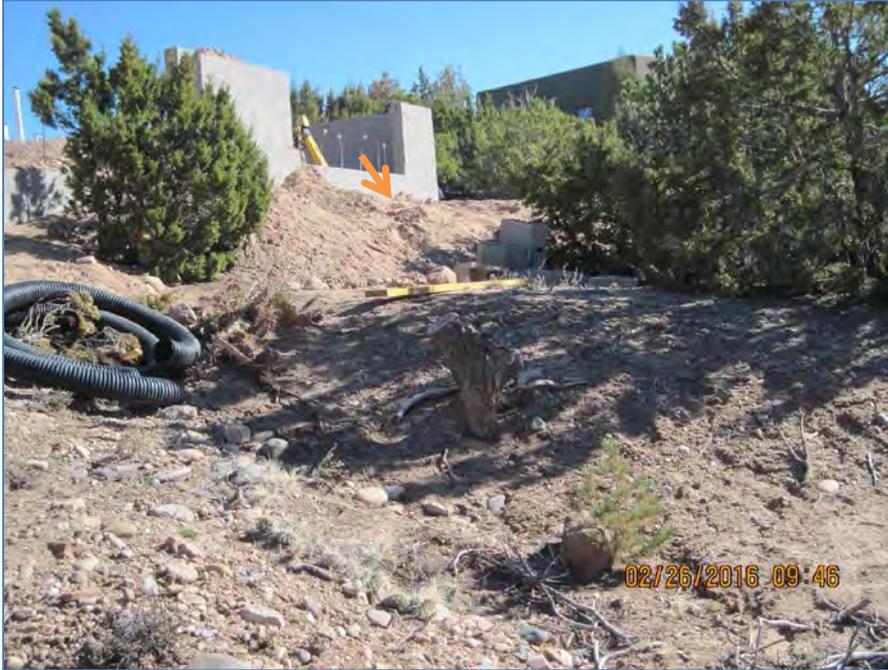
NMED/SWQB
Official Photograph Log
Photo # 11

Subject: Looking northeast near western property boundary, arrow points to disturbed area and steep slope near foundation.

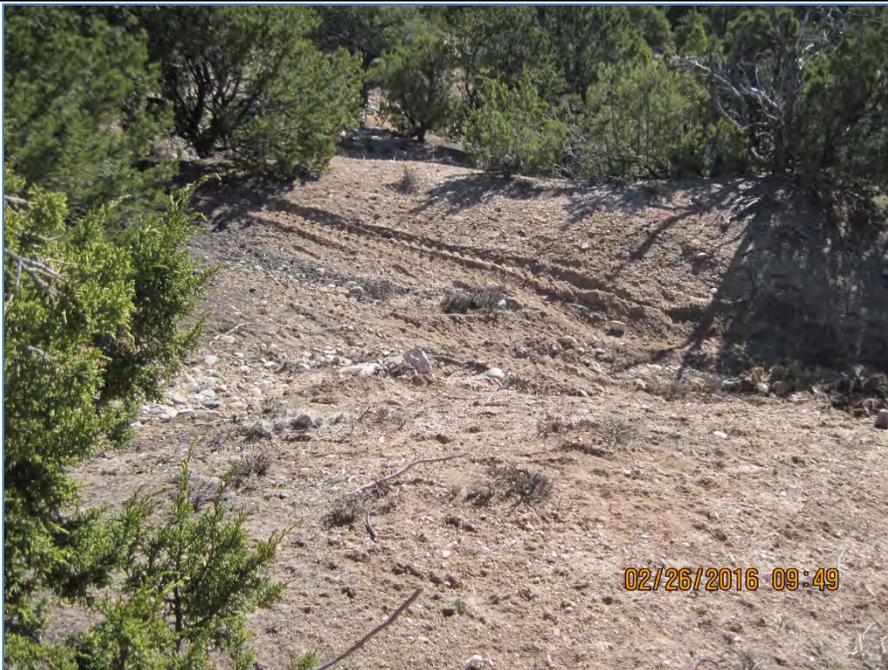
NMED/SWQB
Official Photograph Log
Photo # 12

Subject: Looking east from central portion of site, vehicle tracks existed near remaining vegetation on site.
