Re: Ochoa Residence, Lot 14 Las Lagunitas Subdivision, La Cienega; Unpermitted Construction Stormwater; SIC 1521; NPDES Compliance Evaluation Inspection; NPDES Tracking No. NMU001910; February 25 & 29, 2016

NPDES Compliance Inspection Report

Lot 14 Las Lagunitas Subdivision, Santa Fe, New Mexico
Mr. Valente Ochoa, Owner/Operator/General Contractor, NPDES Tracking No. NMU001910
February 25 & 29, 2016

Compliance Evaluation Inspection

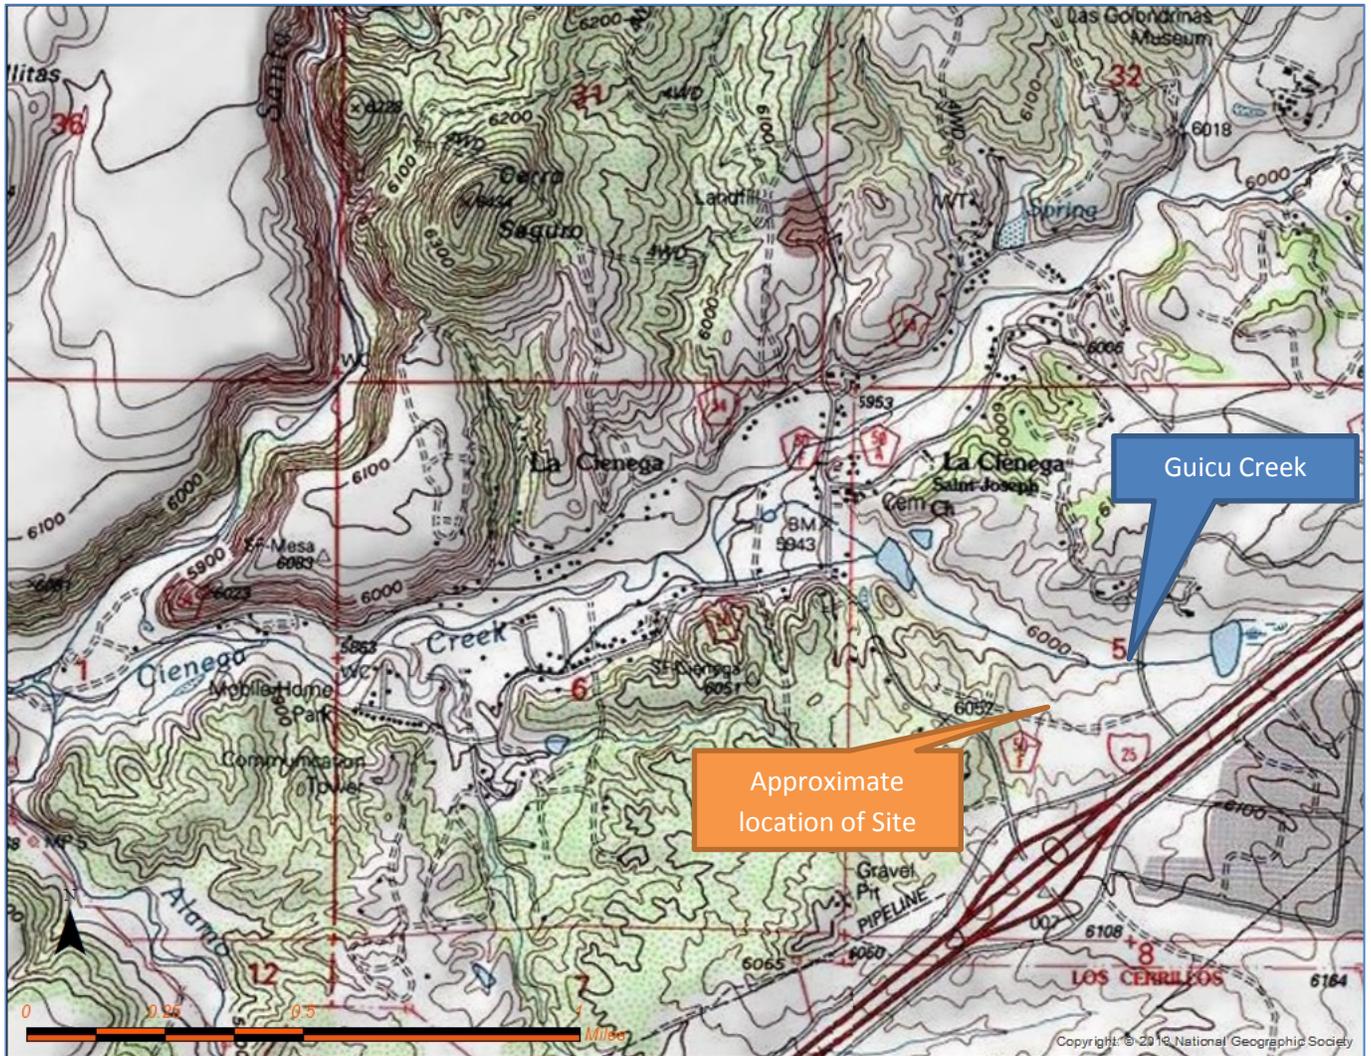
Figure 2: General Site Map/Topography

Stormwater would flow north to areas identified on National Wetland Inventory maps as wetlands and locally named Guicu Creek tributary approximately 450 feet from the disturbed areas of the site, thence to Cienega Creek, thence Santa Fe River, both in classified segment 20.6.4.113 New Mexico Administrative Code (NMAC) in the Rio Grande Basin. See Figure 1 and 2 for site location.

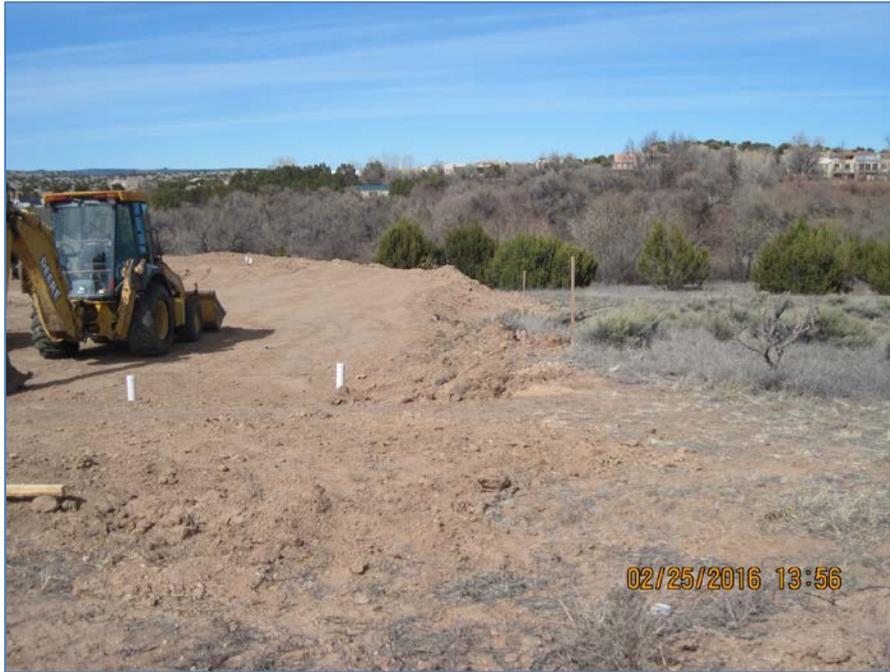
NMED/SWQB
Official Photograph Log
Photo # 1

Subject: Looking north, soil disturbance and fill along eastern property boundary. Northeast corner of the disturbed area is shown in Photo #9

I have reviewed the inspection report submitted by Ms. Erin Trujillo. In order to address the immediate concern regarding stormwater discharges, a row of sediment filter logs will be set along all disturbed areas of the site before the end of the month. Furthermore, please be advised that I will be submitting my NPDES permit application shortly.

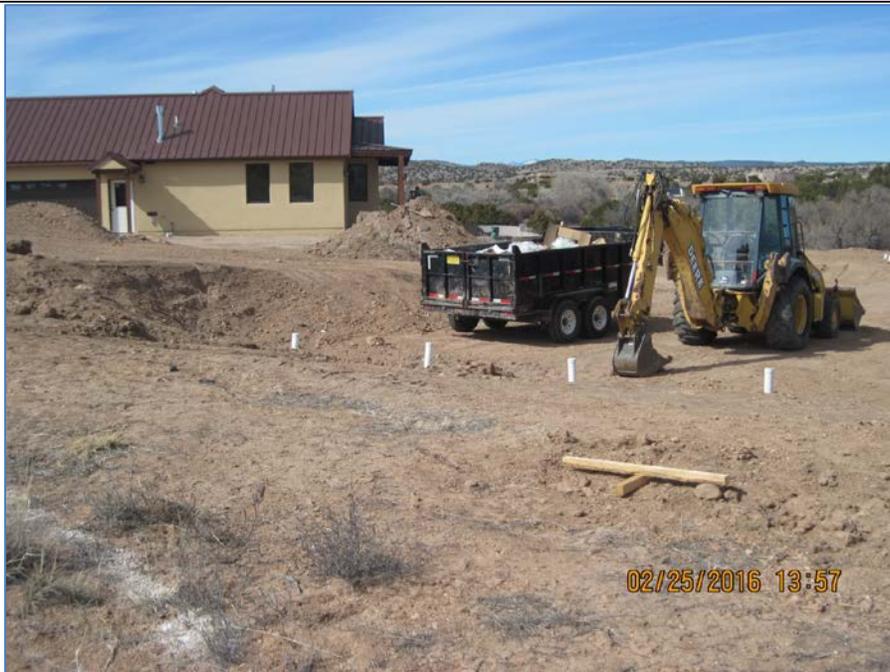
NMED/SWQB
Official Photograph Log
Photo # 2

Subject: Looking northwest at trailer with collected trash, construction equipment, disturbed soil and soil stockpile.

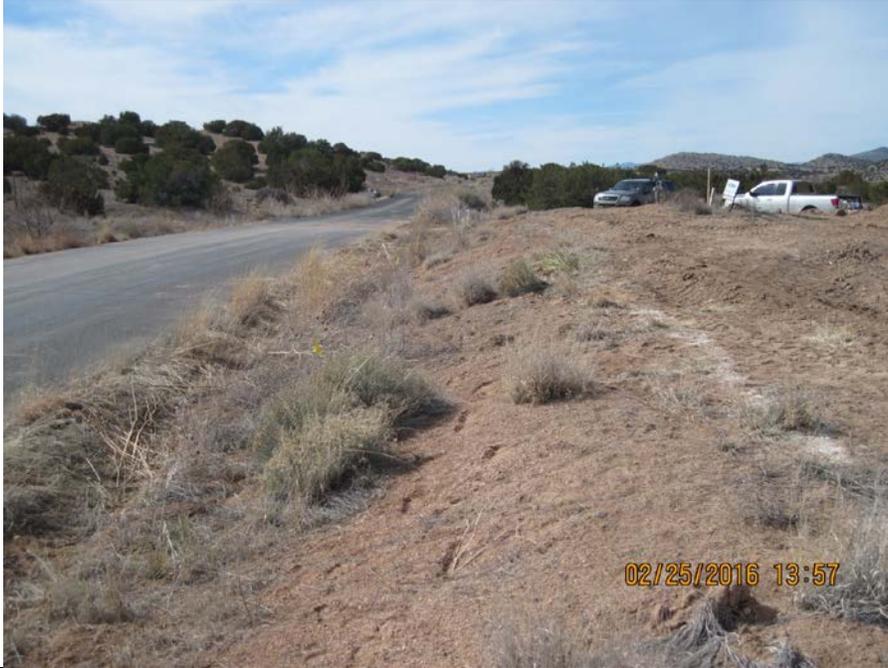
NMED/SWQB
Official Photograph Log
Photo # 3

Subject: Looking west, disturbance along southern boundary at Calle Milpa.

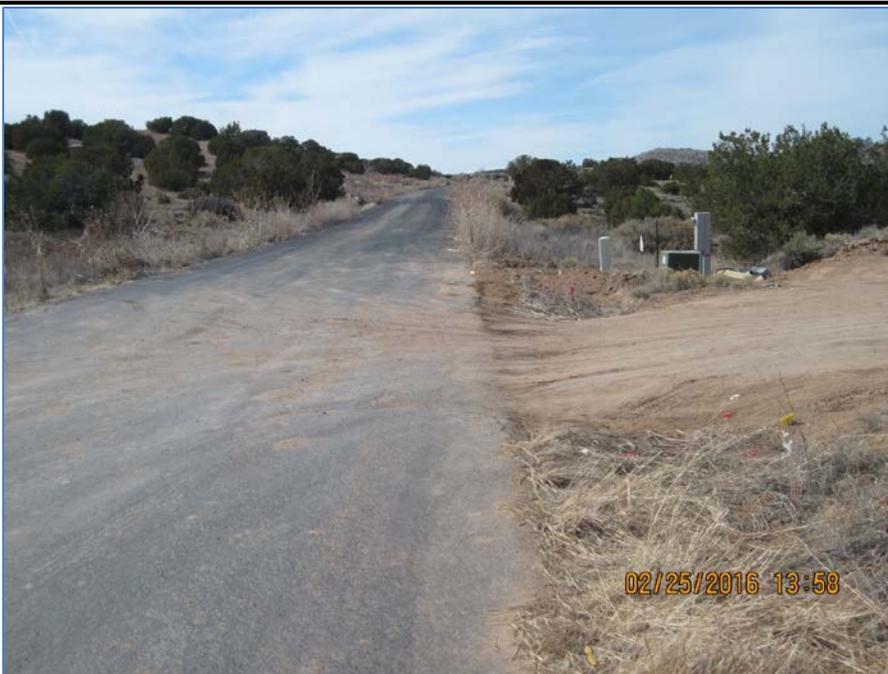
NMED/SWQB
Official Photograph Log
Photo # 4

Subject: Accumulated sediment was on Calle Milpa. The paved road did not have a constructed drainage ditch. A culvert underneath the road existed west of the site, but there was no bed or bank of a watercourse.

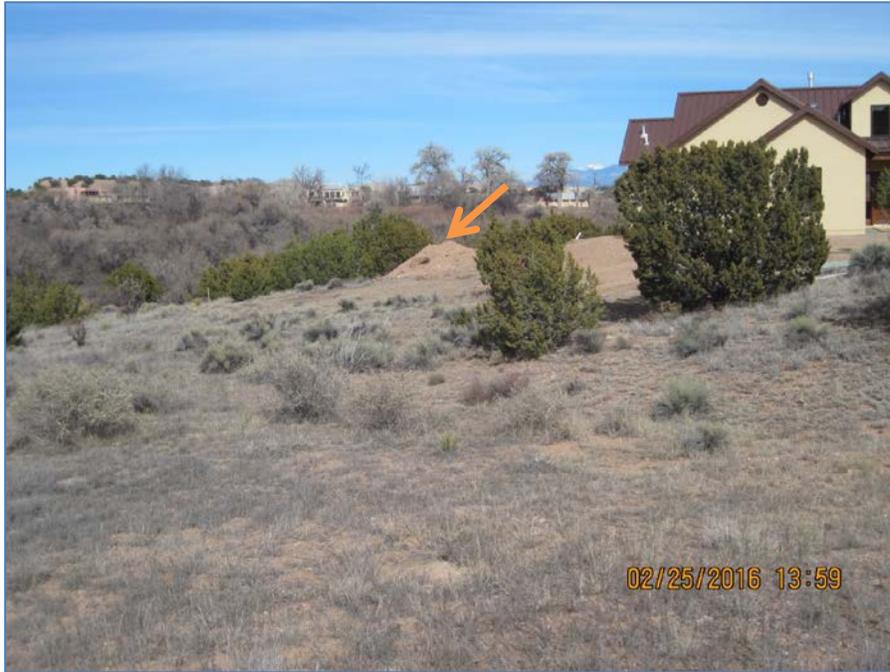
NMED/SWQB
Official Photograph Log
Photo # 5

Subject: Looking northeast from Calle Milpa, arrow points to soil stockpile north of the constructed residence.

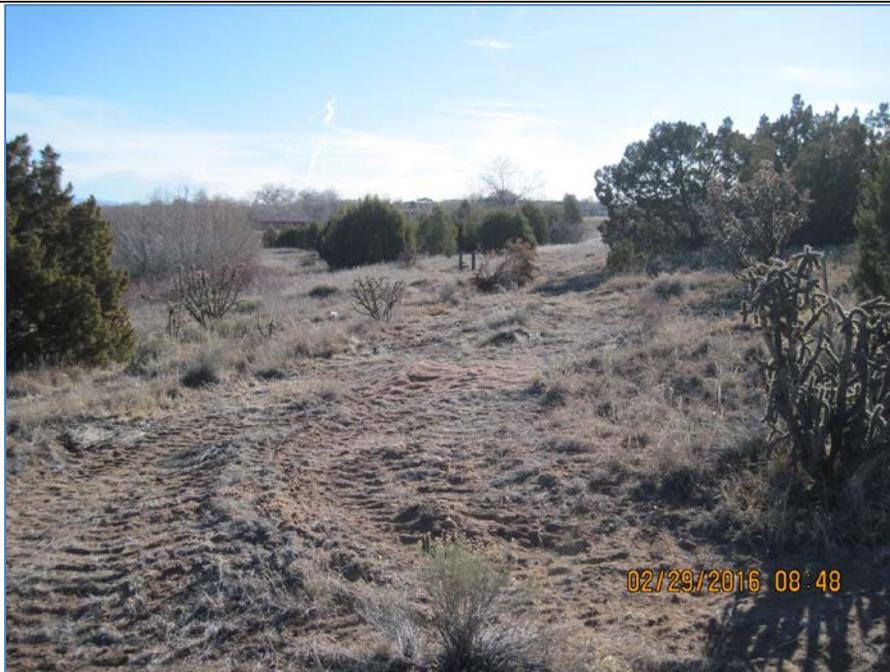
NMED/SWQB
Official Photograph Log
Photo # 6

Subject: Vehicle tracks existed north of the constructed residence within the remaining vegetation.

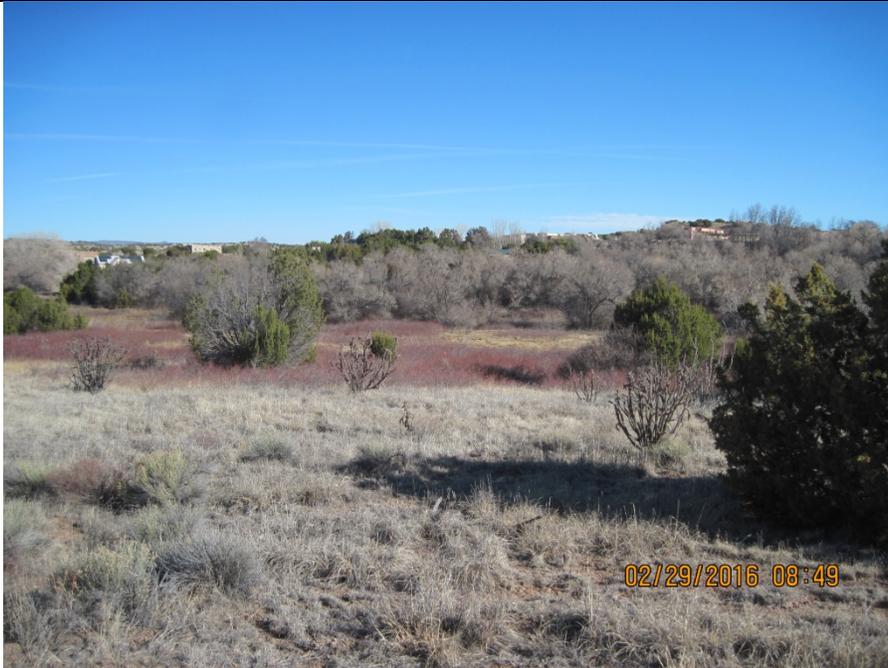
NMED/SWQB
Official Photograph Log
Photo # 7

Photographer: Erin S. Trujillo	Date: 02/29/2016	Time: 0849 hours
City/County: Santa Fe / Santa Fe County	State: New Mexico	
Location: Lot 14 Las Lagunitas Subdivision, Santa Fe, New Mexico		
Subject: Example of undisturbed area north of the constructed residence.

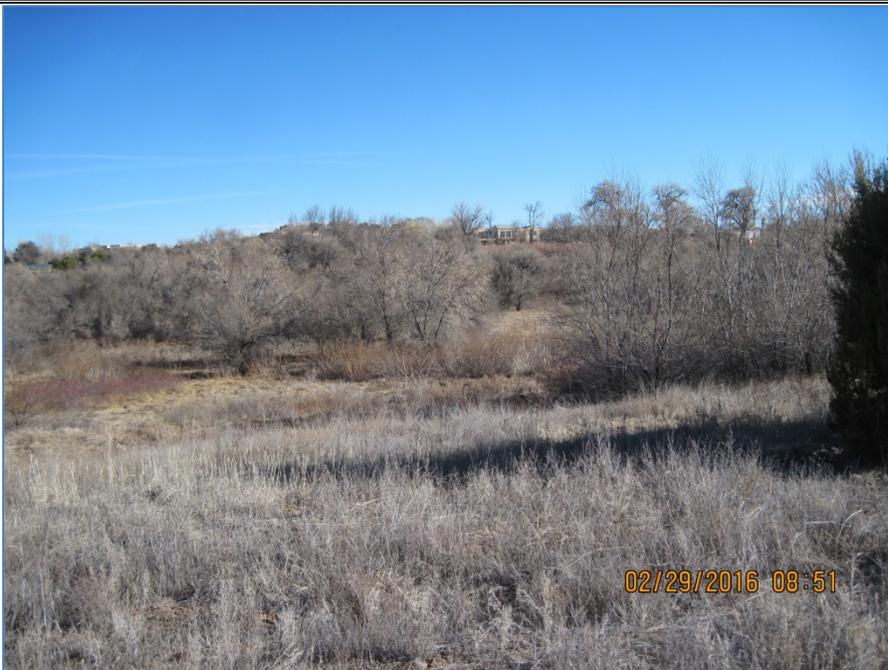
NMED/SWQB
Official Photograph Log
Photo # 8

Photographer: Erin S. Trujillo	Date: 02/29/2016	Time: 0851 hours
City/County: Santa Fe / Santa Fe County	State: New Mexico	
Location: Lot 14 Las Lagunitas Subdivision, Santa Fe, New Mexico		
Subject: Example of undisturbed area north of the constructed residence.

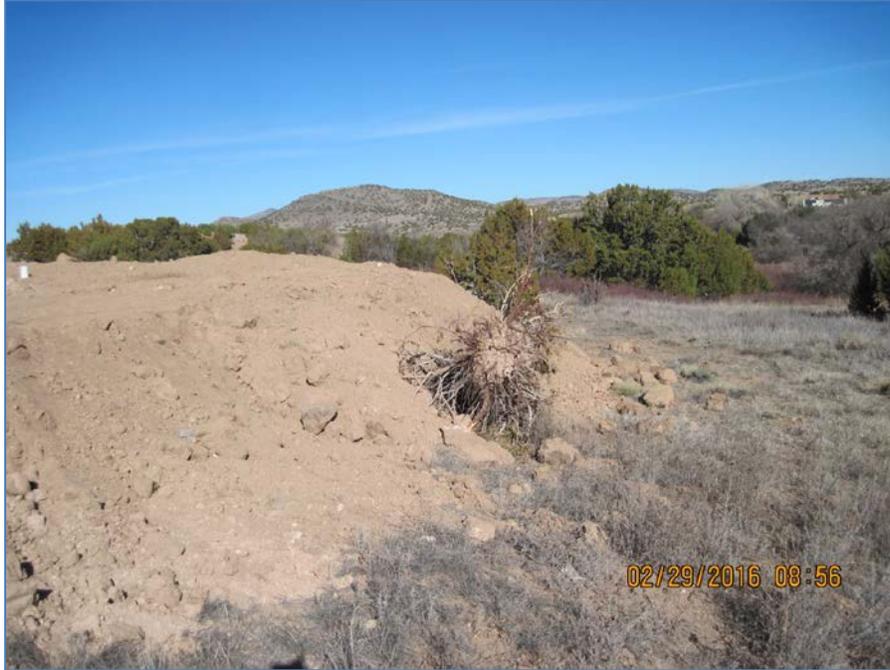
NMED/SWQB
Official Photograph Log
Photo # 9

Vegetation and underlying soil had been disturbed (cleared). Vertical construction of the residence and utilities were complete. Disturbed areas were not stabilized. The site topography sloped to the north. No erosion rills or gully features were observed to have formed on site. No temporary sediment or erosion control measures from disturbed areas, including slopes of fill materials, were observed on site. Collected trash was in an open trailer on site. Windblown trash was observed on the ground east of the site which was picked up by Mr. Ochoa during this CEI. Construction plans showed rain barrels and detention ponds; however, Mr. Ochoa did not provide information

Subject: Unstablized fill material slope northeast of the constructed residence.

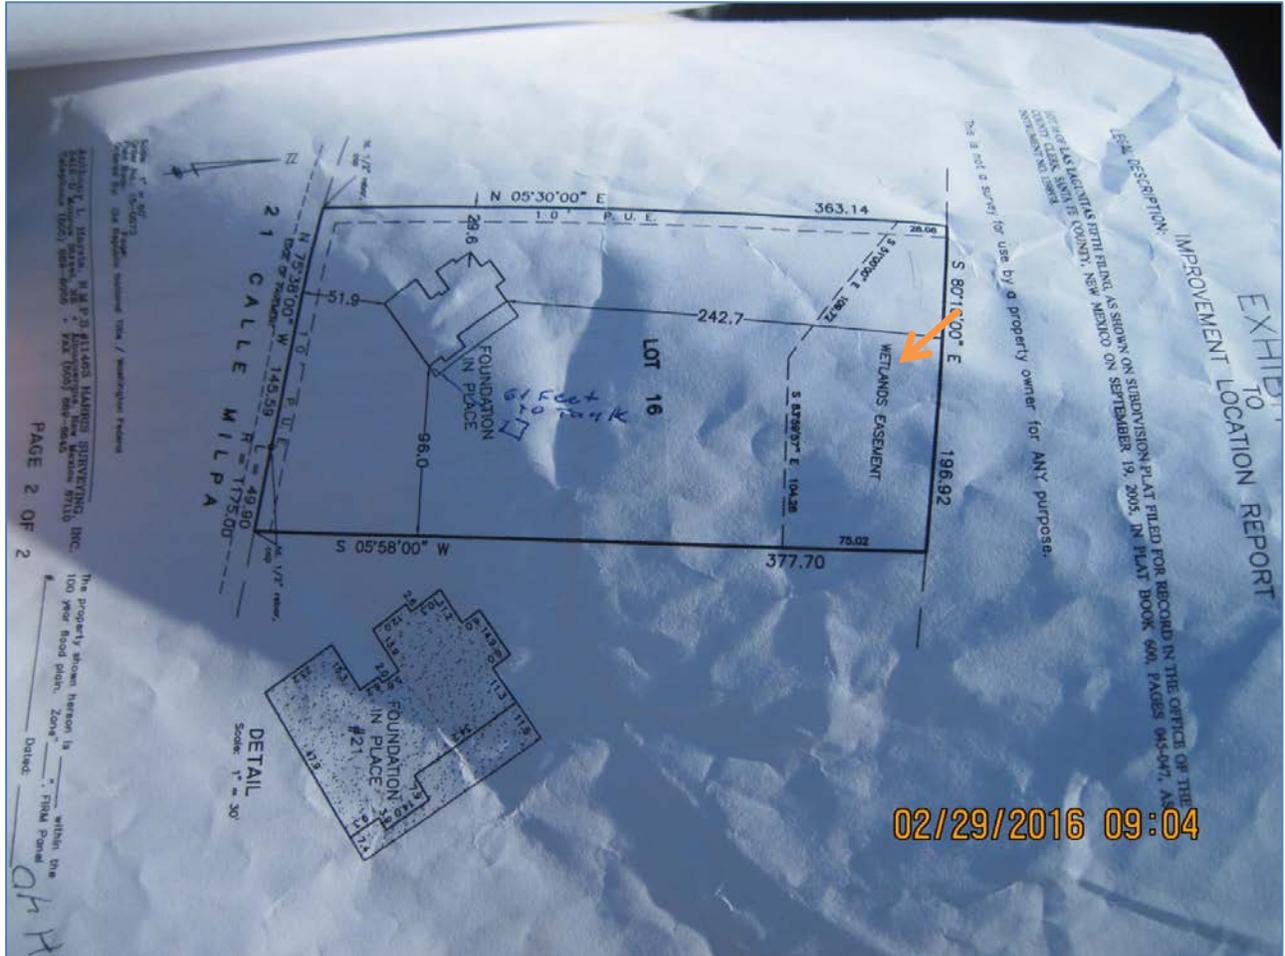
NMED/SWQB
 Official Photograph Log
 Photo # 10

Subject: Arrow points to delineated "wetland easement."

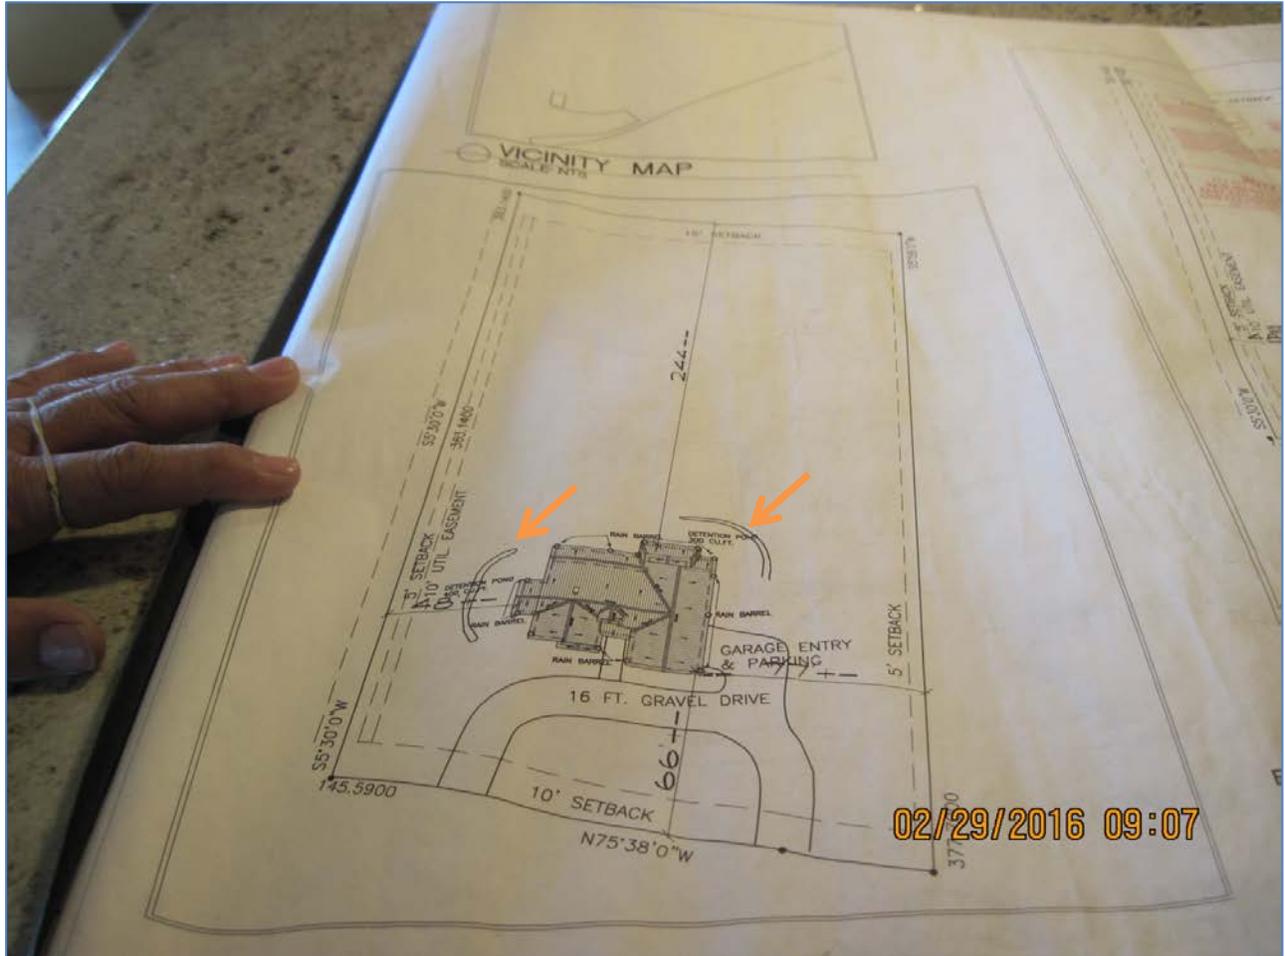
NMED/SWQB
Official Photograph Log
Photo # 11

as to when or if those permanent measures would be installed. Mr. Ochoa estimated that the end of construction activity and completion of landscaping would be in August of 2016.

Subject: Arrows point to detention ponds shown on construction plans.
