**Re: Family Dollar, Angel Fire; Unpermitted Construction Stormwater; SIC 1542; NPDES Compliance Evaluation Inspection; NPDES Tracking No. NMU001924; September 22, 2016**

### NPDES Compliance Inspection Report

**Family Dollar, Highway 434 & Sage Lane, Angel Fire, New Mexico**

**Compliance Evaluation Inspection  
September 22, 2016**

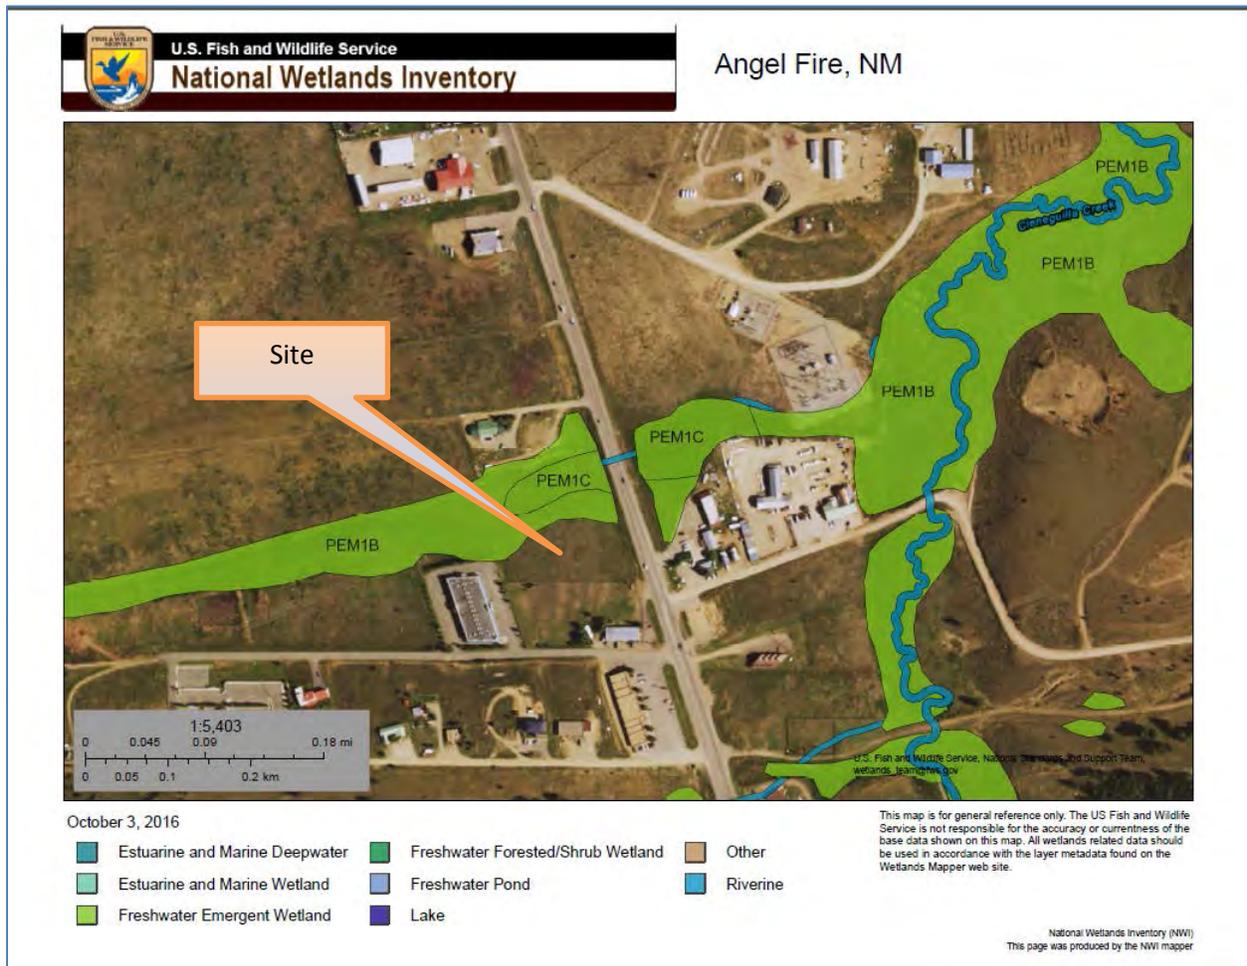
Figure 2: National Wetlands Inventory Map (Source: USFW at <https://www.fws.gov/wetlands/data/mapper.HTML>)

Stormwater discharges would be north to an area shown as a freshwater emergent wetland on National Wetland Inventory Map (see Figure 2), thence to Cieneguilla Creek, thence to Eagle Nest Lake, thence to Cimarron River in classified Segment 20.6.3.309 NMAC in the Canadian watershed. Designated uses of the segment are water supply, irrigation, high quality coldwater aquatic life, livestock, watering, wildlife habitat, and primary contact. Cieneguilla Creek from Eagle Nest Lake to headwaters, Assessment Unit NM-2306.A\_065, is impaired with listed causes nutrient/eutrophication, sedimentation/siltation, temperature, turbidity and e. coli (see Figure 3).

Inspector Comment: Given the proximity of wetlands shown on readily available on-line NWI map (northwest corner of the site), the operators may contact Regulatory Program, U.S. Army Corps of Engineers, Albuquerque District, 4101 Jefferson Plaza NE, Albuquerque, NM 87109 (see <http://www.spa.usace.army.mil/Missions/RegulatoryProgramandPermits.aspx>) for more information on regulatory requirements for current or any future disturbance and fill activities under Section 404 of the federal Clean Water Act.

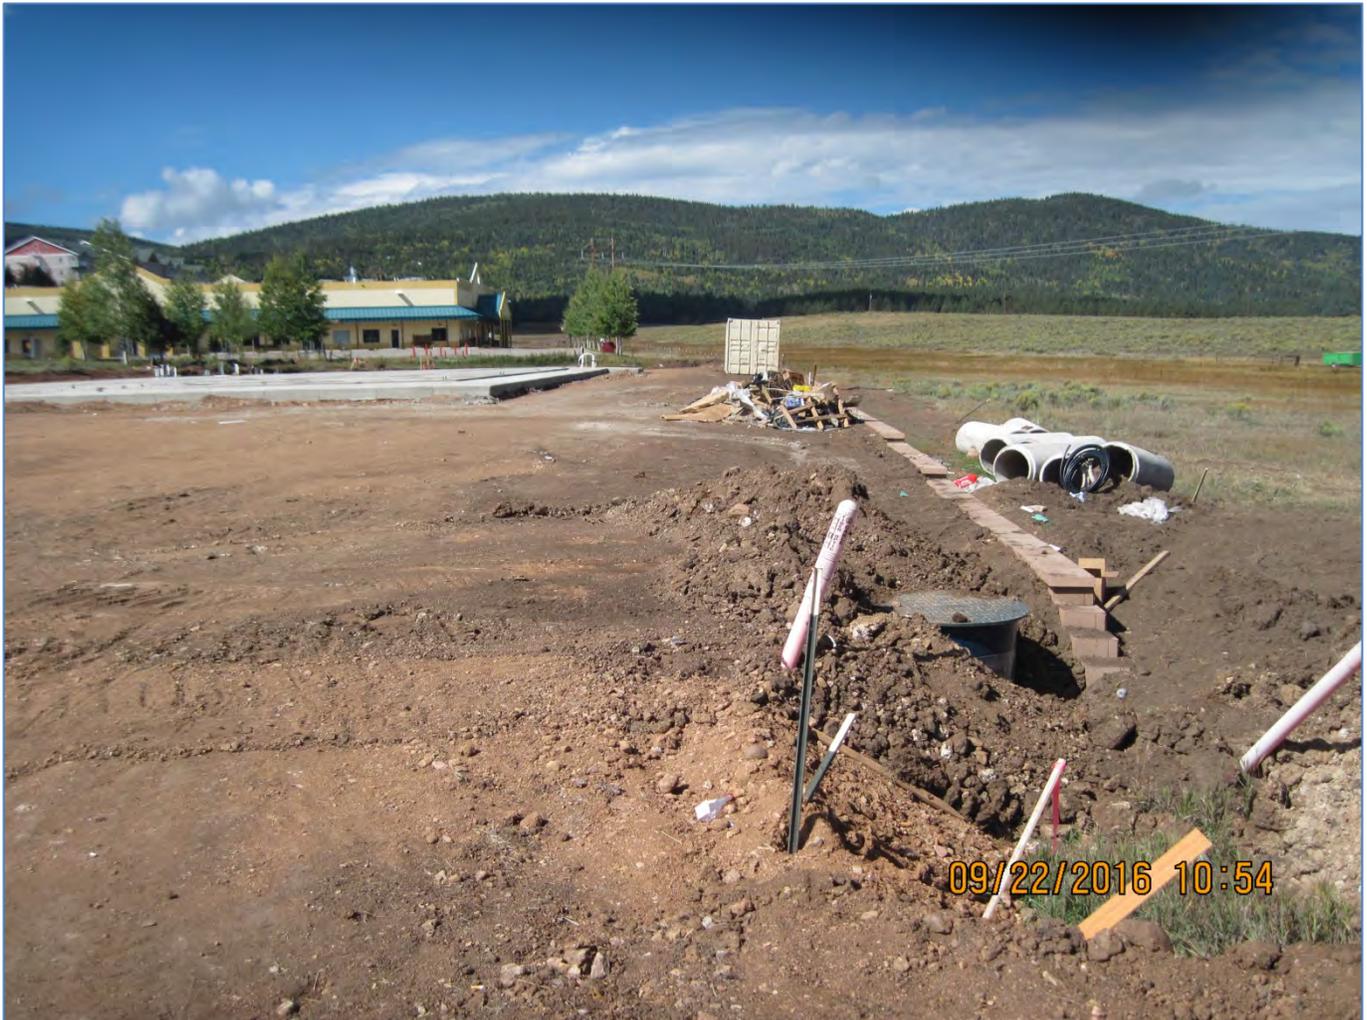
NMED/SWQB  
Official Photograph Log  
Photo # 1

Subject: From NM 434, looking west, construction materials and what appeared to be trash were observed piled on-site, and materials and trash (e.g., pastic, cardboard) existed north of constructed wall. Building concrete slab foundation had been constructed/poured. Site appears to have concrete solids near foundation work.

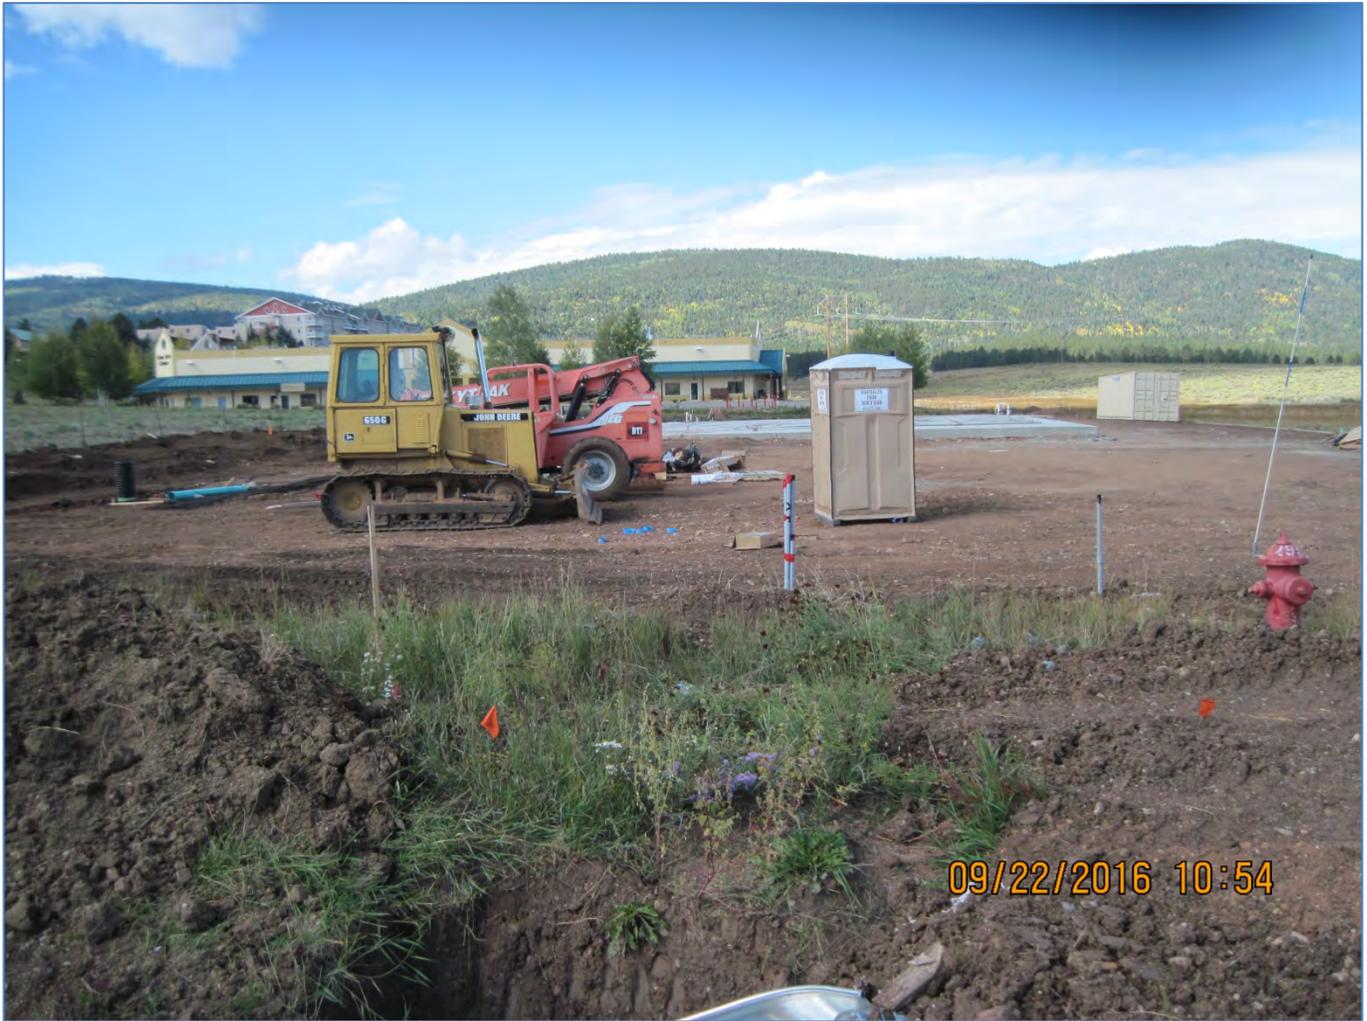
NMED/SWQB  
Official Photograph Log  
Photo # 2

Subject: From NM 434 looking west, heavy equipment was on site. More construction material and what appeared to be trash (e.g., cardboard, plastic) was observed on-site. From right of way, it was not determined if portable toilet was staked or otherwise had measures to minimize potential for or prevent tipping. Toilet was in area with parked vehicles and did not appear to be protected from vehicle traffic.

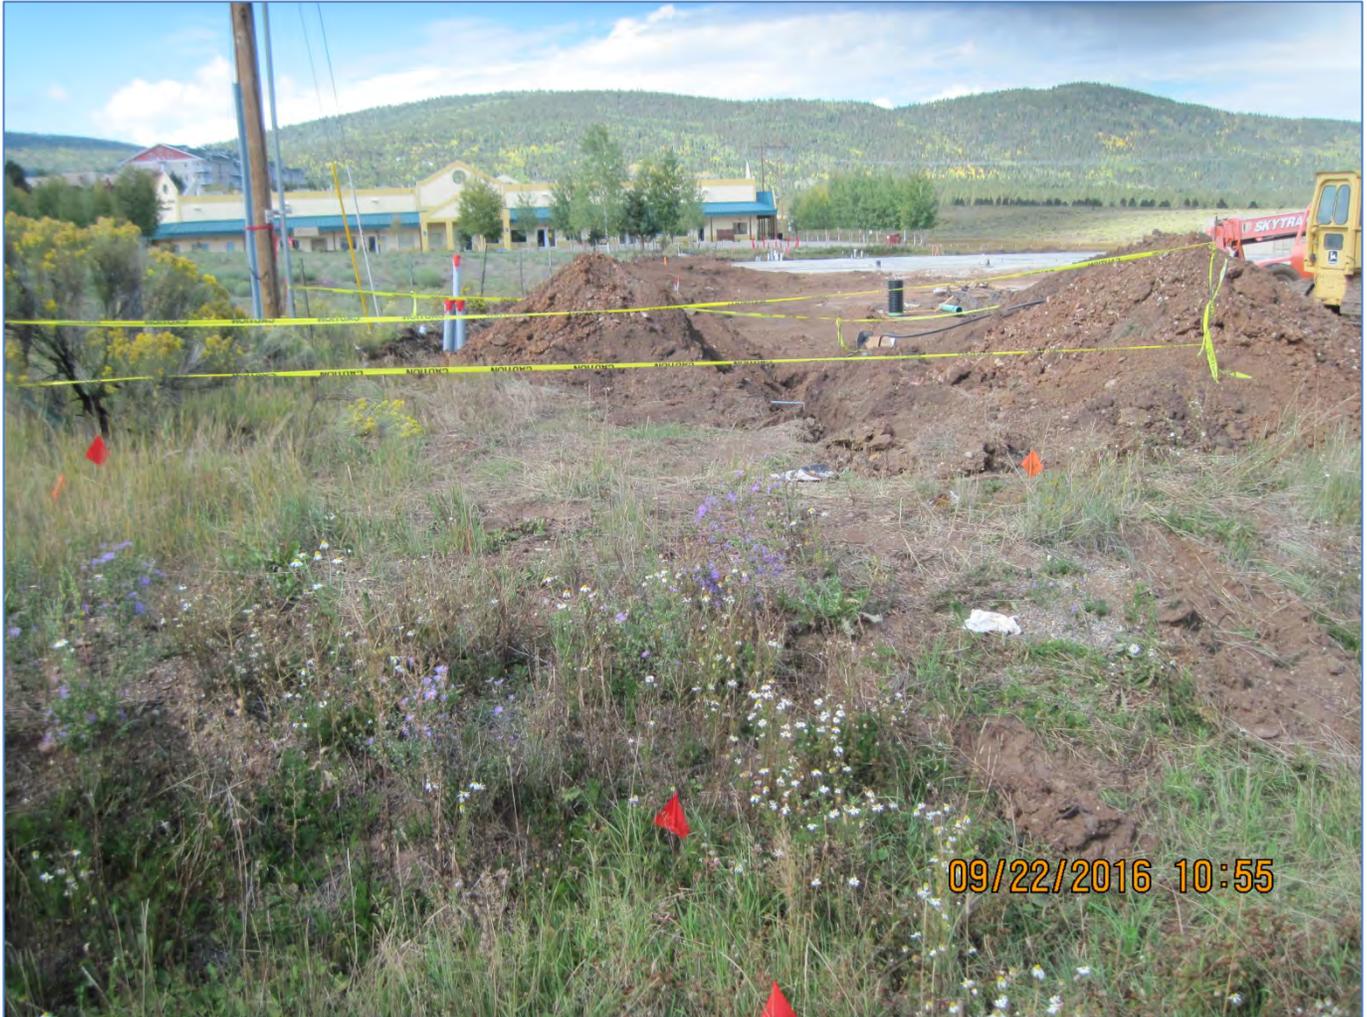
NMED/SWQB  
Official Photograph Log  
Photo # 3

Subject: From NM 434 looking west, disturbed areas and un-stabilized areas existed along southern boundary of site.

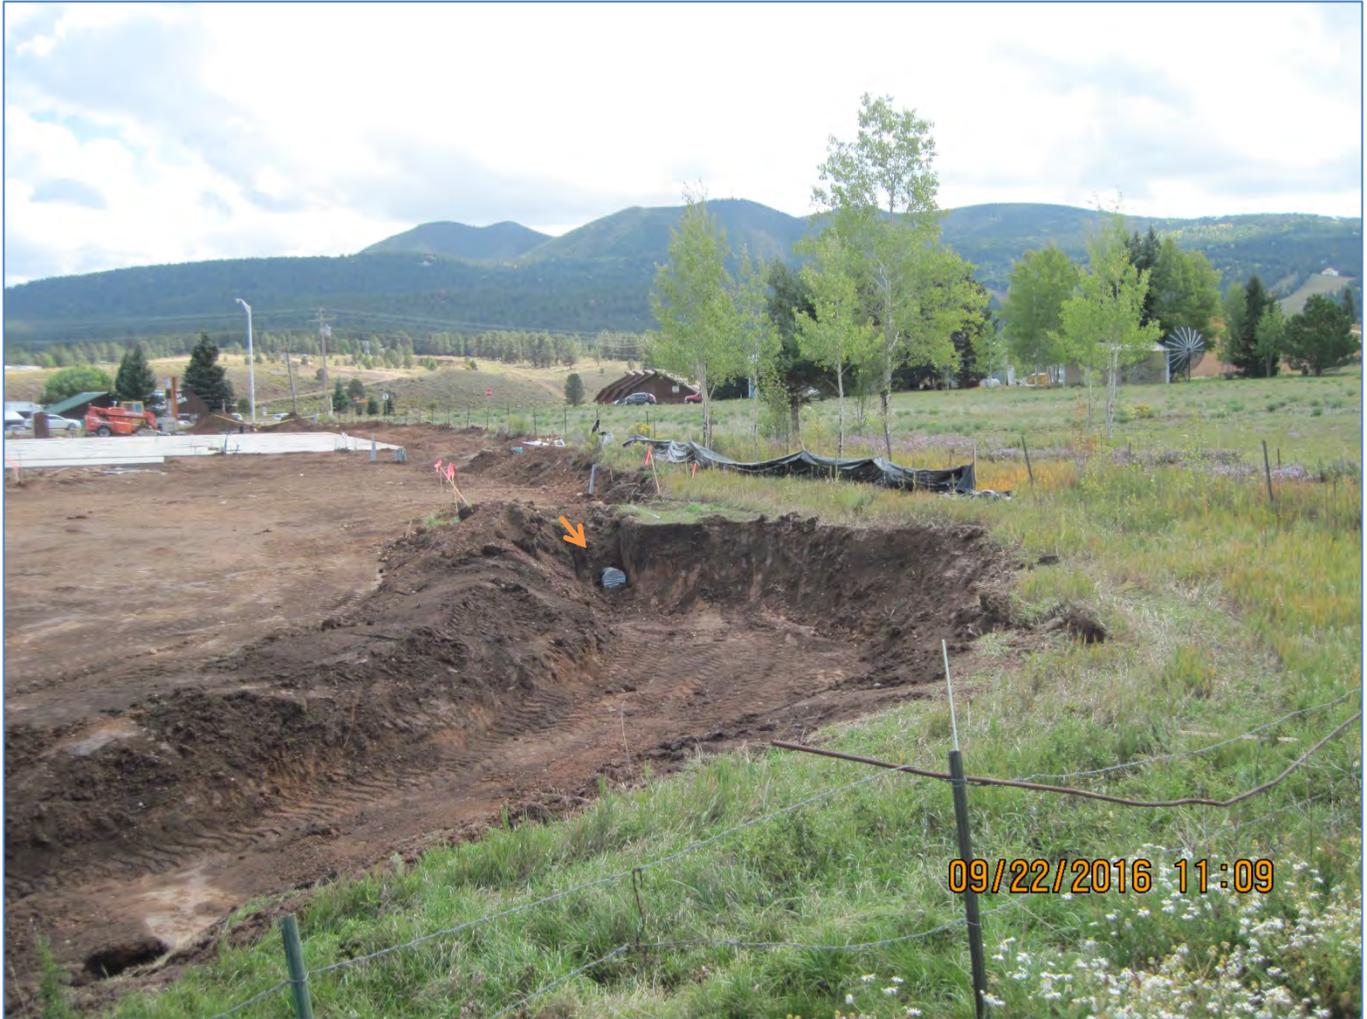
NMED/SWQB  
Official Photograph Log  
Photo # 4

Subject: Looking east, excavated area existed in southwest corner of site. Arrow points to pipe at bottom of excavation. Observed silt fence appeared to be in upgradient area of site and may provide some protection from stormwater runoff to the site. See next photo.

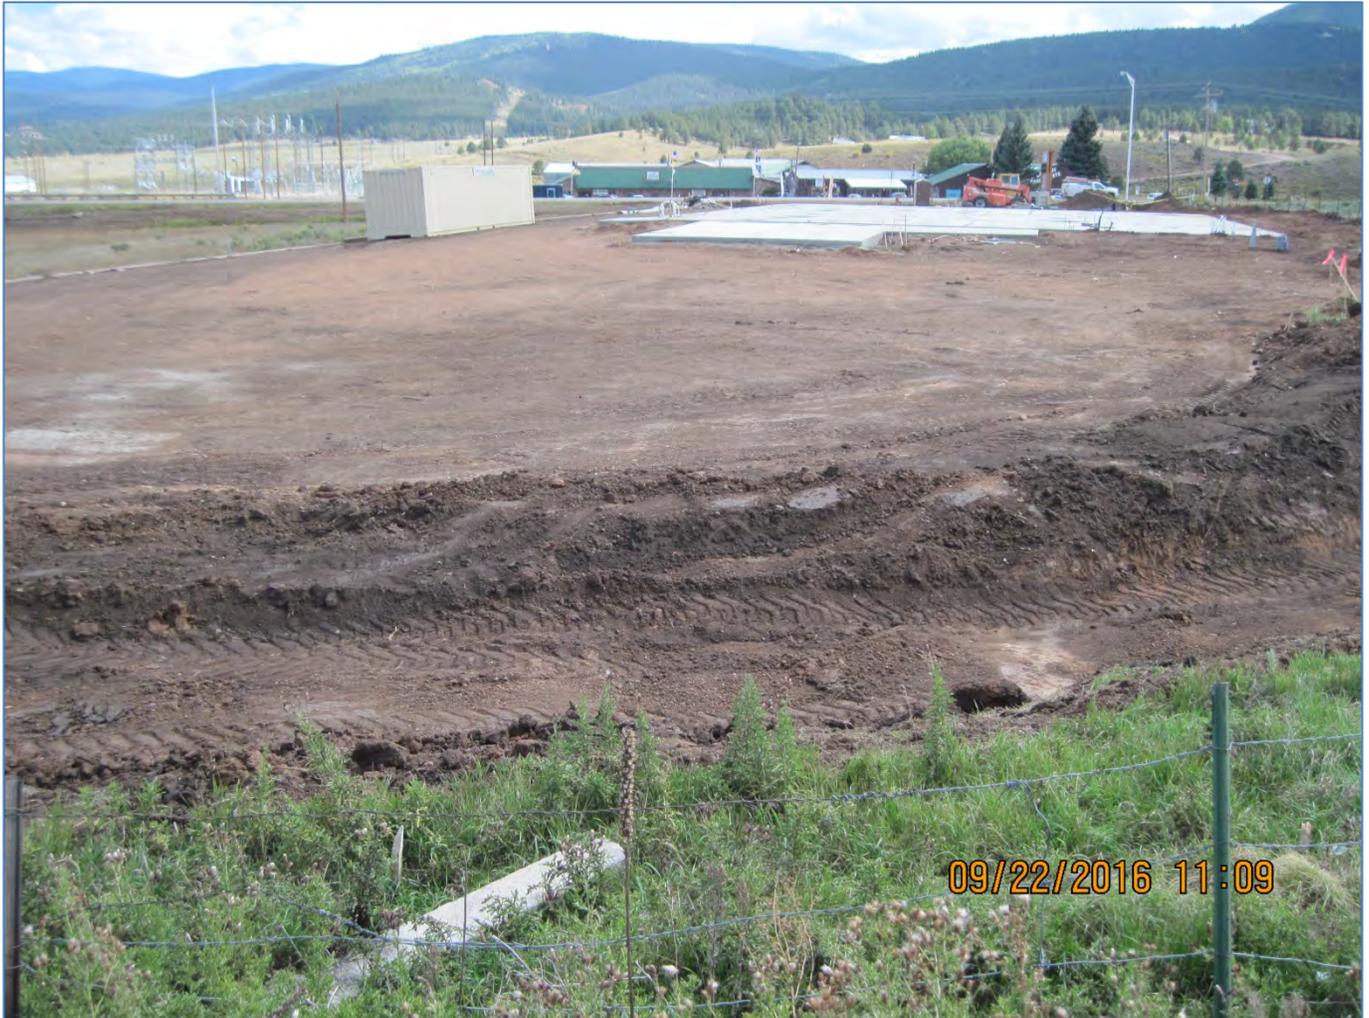
NMED/SWQB  
Official Photograph Log  
Photo # 5

Subject: Looking east, excavated area continues along property boundary.

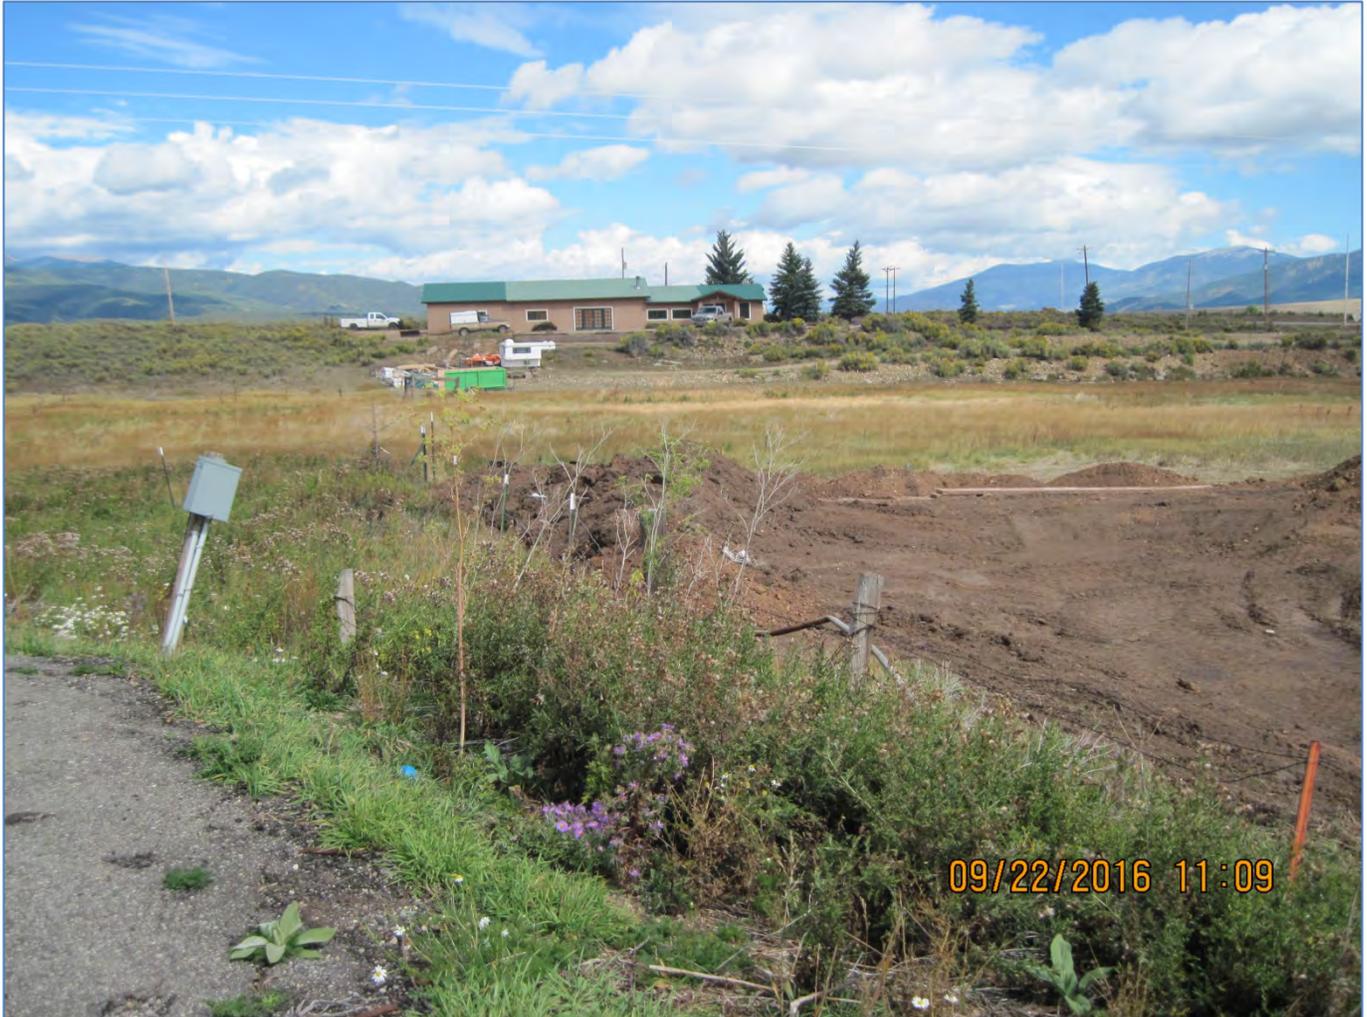
NMED/SWQB  
Official Photograph Log  
Photo # 6

Subject: Looking north, disturbed area and stockpile existed north of the constructed wall. Any stormwater flow from the excavated area would appear to be toward the northwest corner of the site.

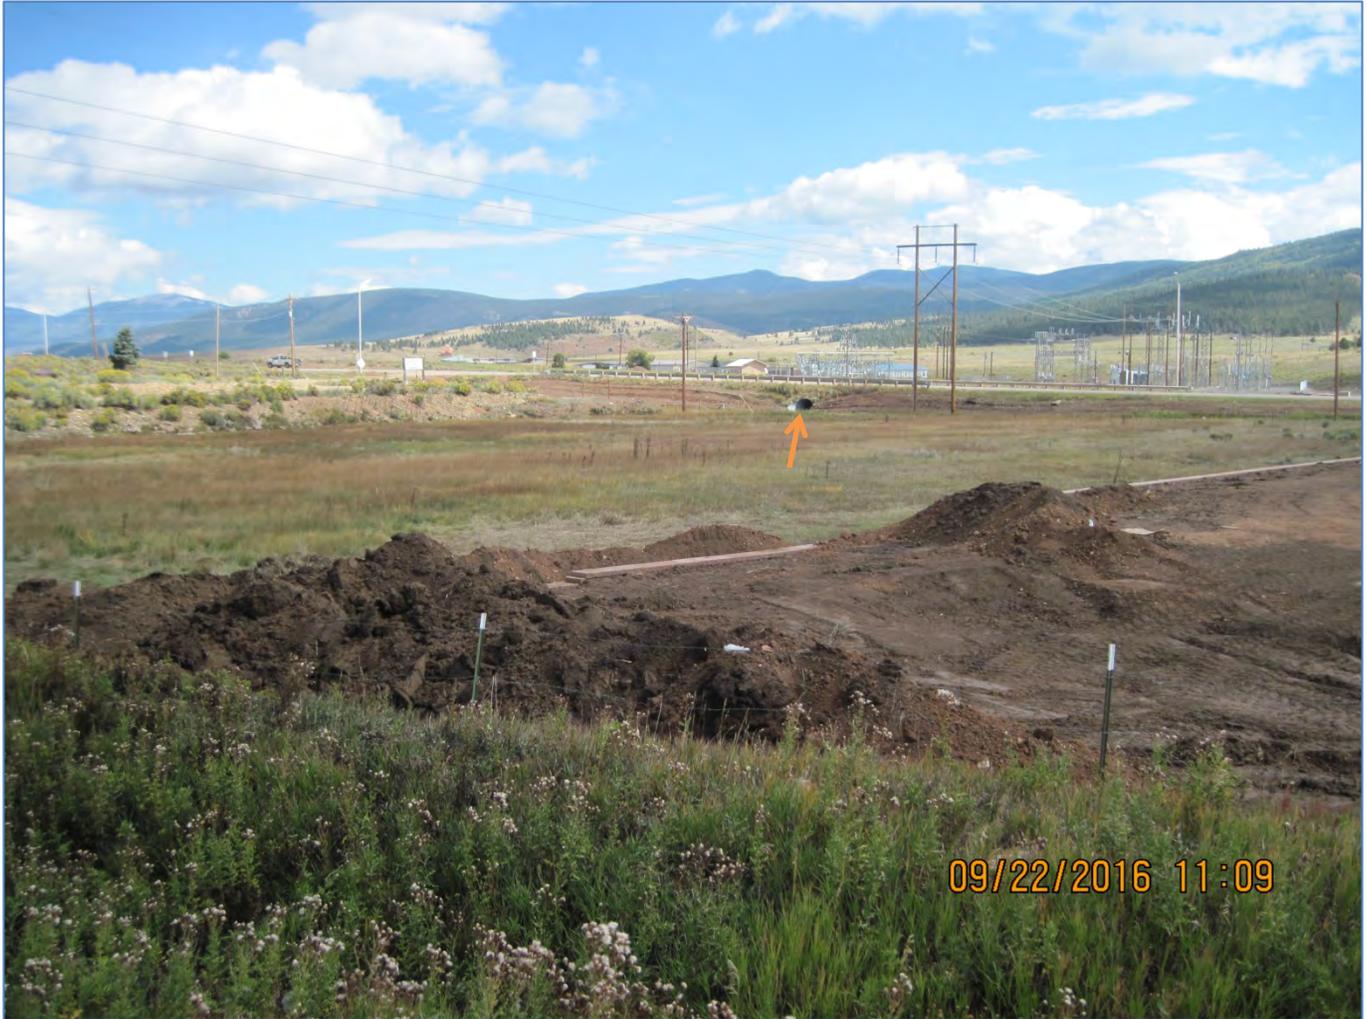
NMED/SWQB  
Official Photograph Log  
Photo # 7

Subject: From adjacent parking lot near northwest corner of site, arrow points to culvert crossing at NM 434. Disturbance along NM 434 in background of photo is from recent utility work along highway.
