WATER QUALITY SURVEY SUMMARY
FOR THE
DRY CIMARRON RIVER WATERSHED
(AND SELECTED TRIBUTARIES)
2000

Surface Water Quality Bureau
New Mexico Environment Department

August 2004

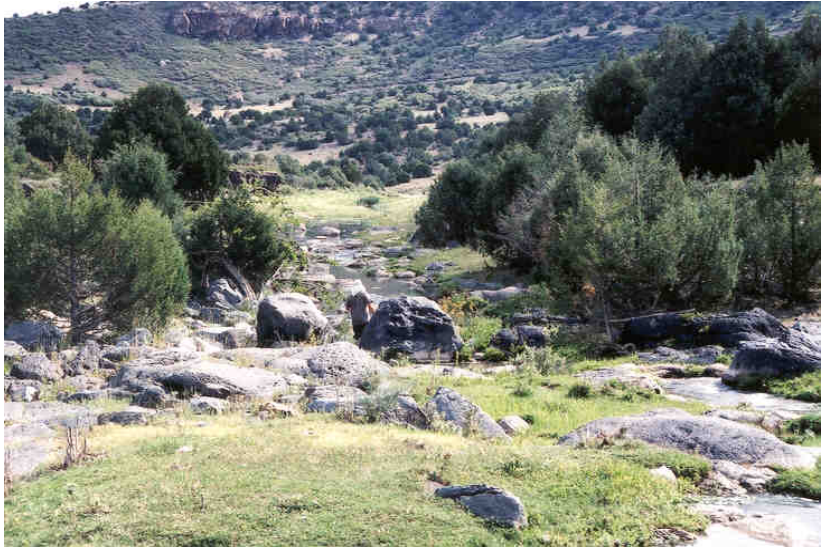
Figure 1. Dry Cimarron River Watershed Sampling Stations

A map of the study area is presented in Figure 1. The STORET identification codes (where available) and location descriptions of sampling stations selected for this survey are provided in Table 1.
