Use Attainability Analysis for Unclassified Non-Perennial Watercourses with NPDES Permitted Facilities

New Mexico Environment Department
October 2012

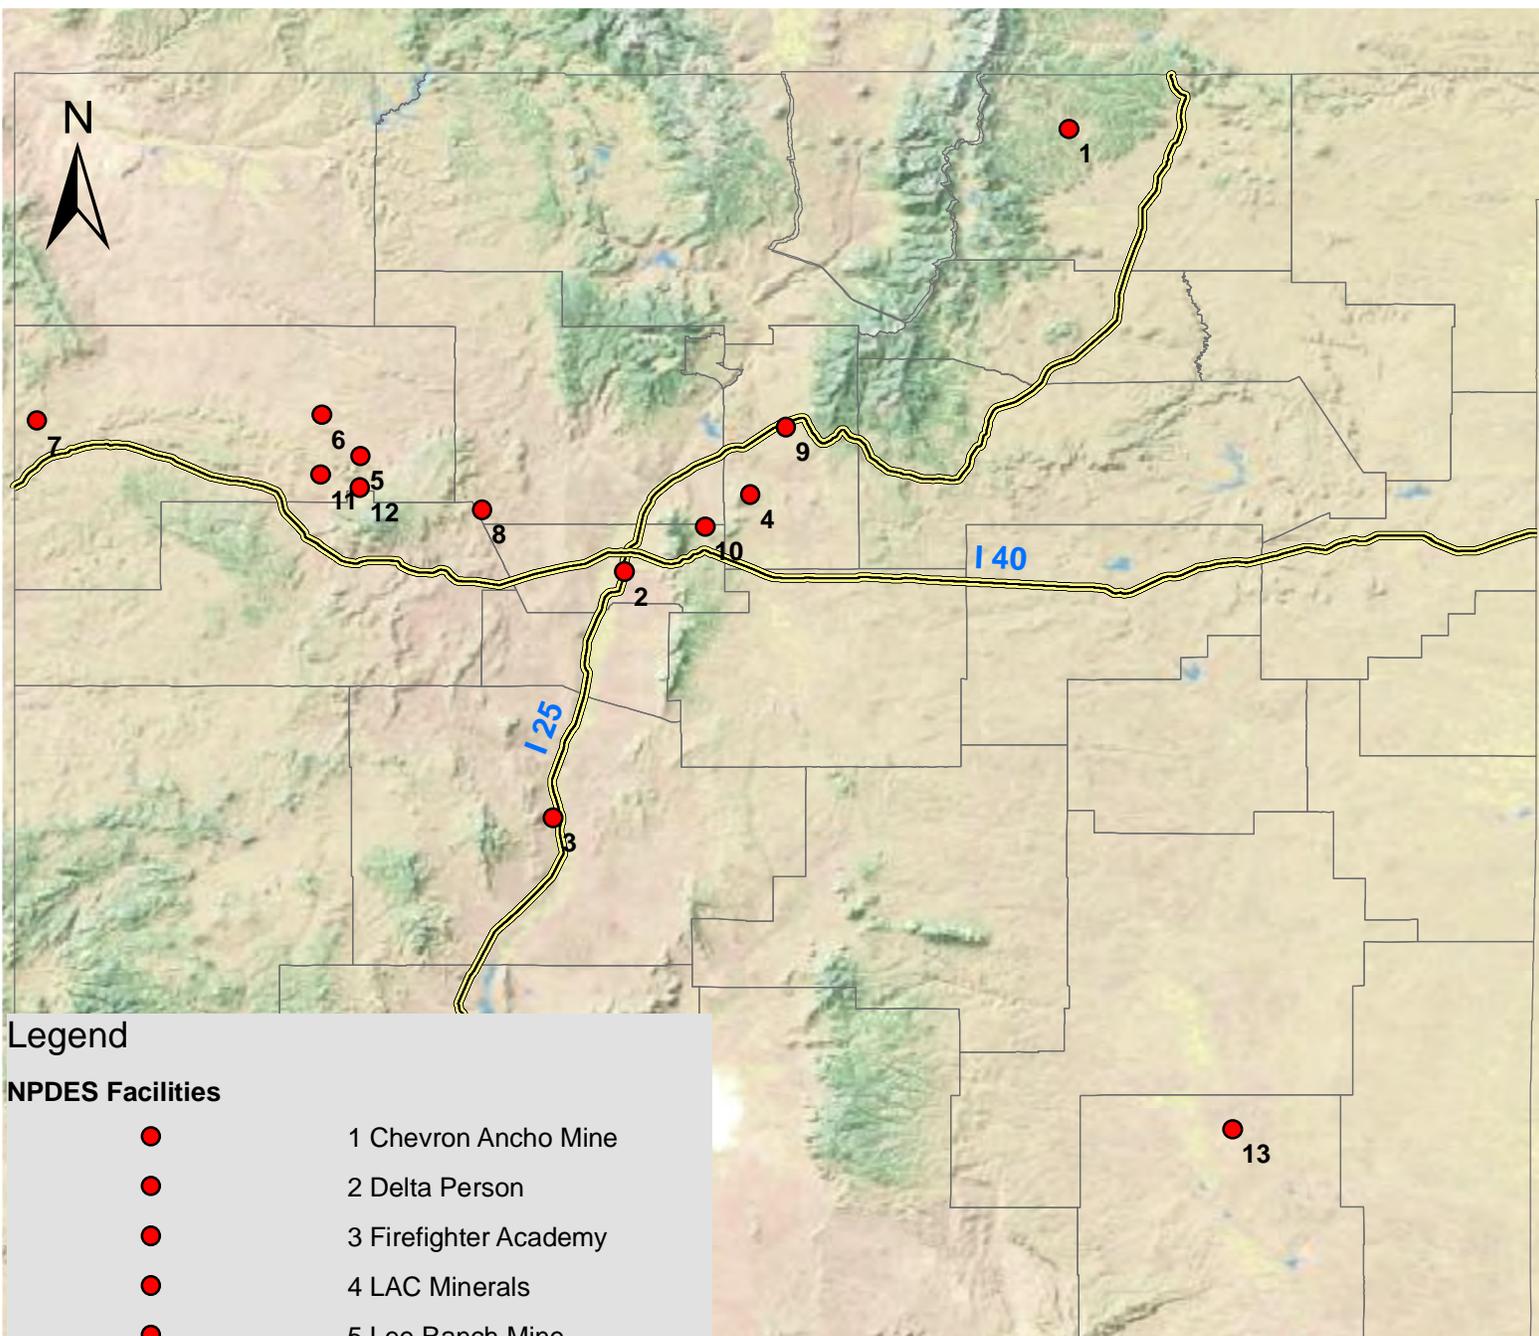
New Mexico Environment Department Surface Water Quality Bureau Use Attainability Analysis NPDES Facility Locations

- 1 Chevron Ancho Mine
- 2 Delta Person
- 3 Firefighter Academy
- 4 LAC Minerals
- 5 Lee Ranch Mine
- 6 Lee Ranch El Segundo Mine
- 7 Chevron McKinley Mine
- 8 Resurrection Mining
- 9 Oshara Village
- 10 Paa-Ko
- 11 Rio Algom
- 12 Strathmore Roca Honda
- 13 S.W. Public Services

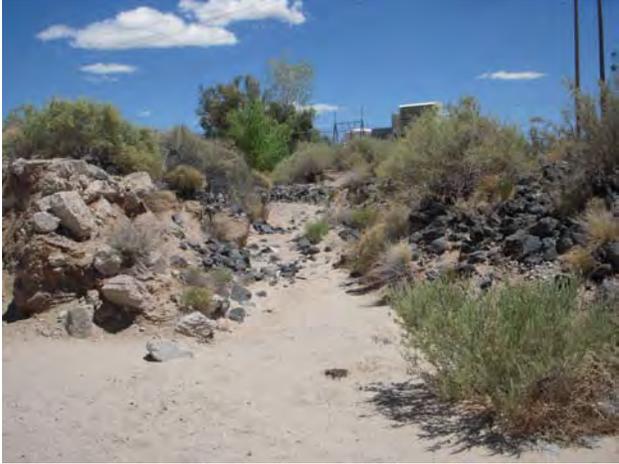
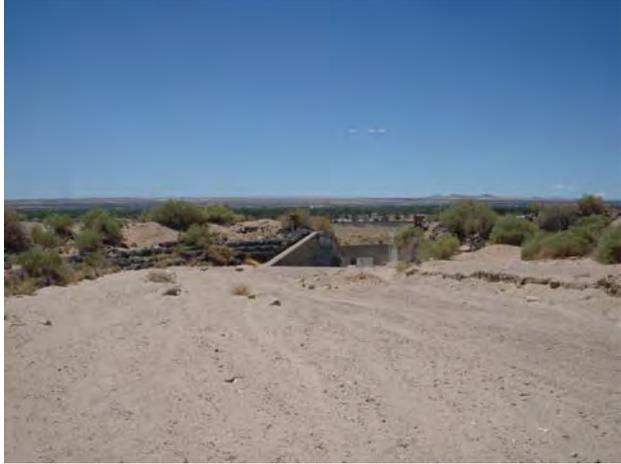
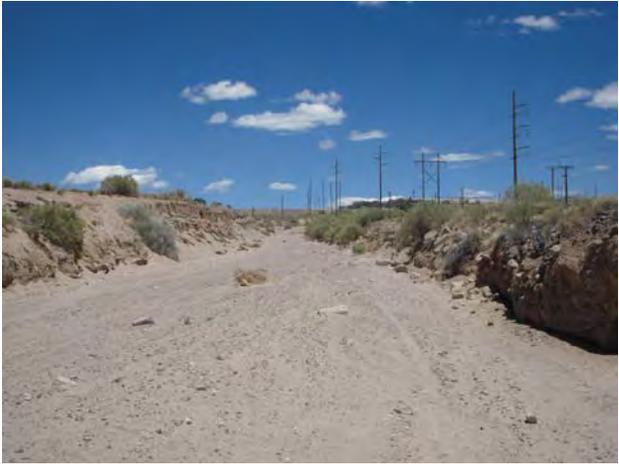
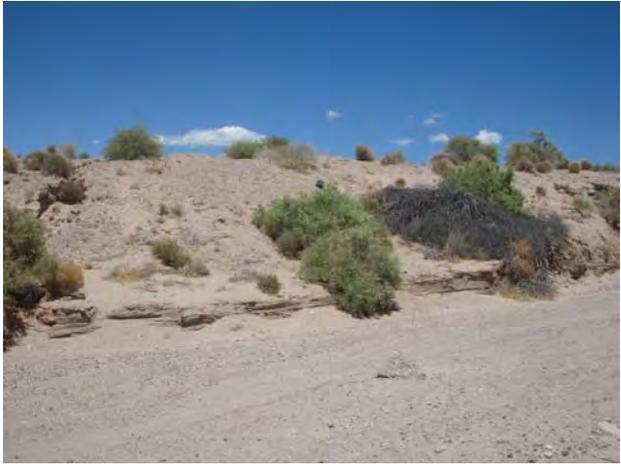
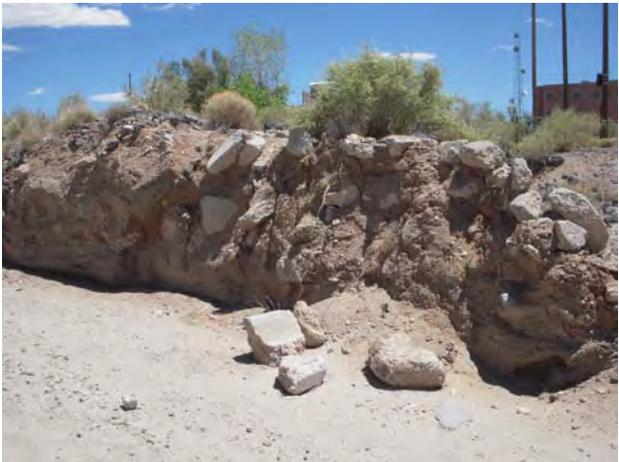
Delta Person UAA Photos

Modifications: culvert near end of channel, where channel enters
 south diversion channel.

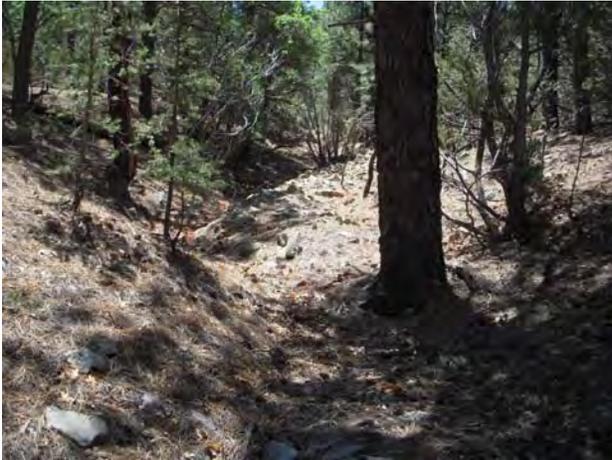
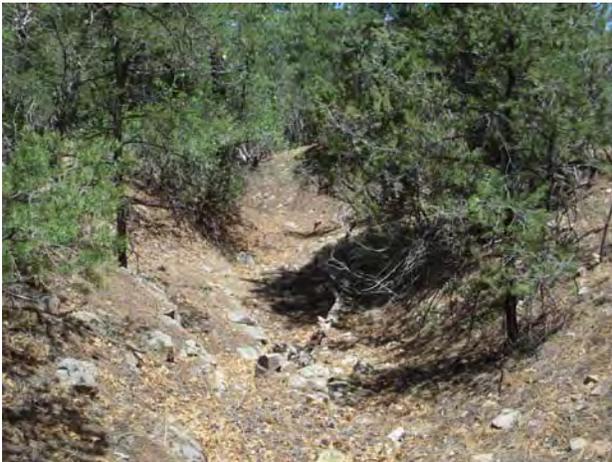
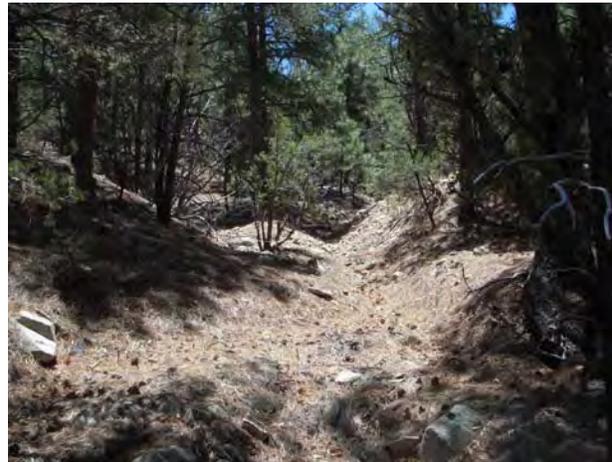
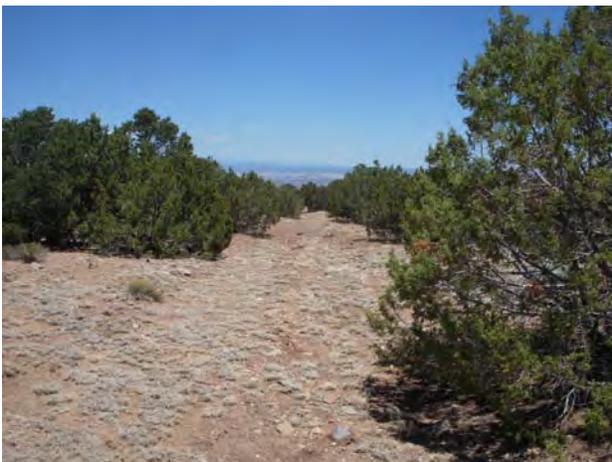
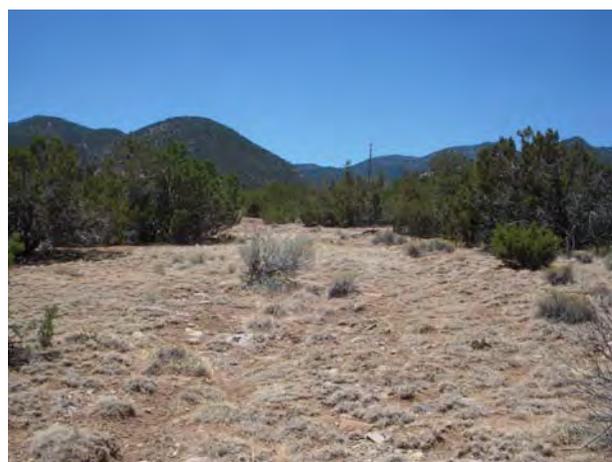
LAC Minerals UAA Photos

Modifications: roads and mining activities. channel no longer would flow in this historic channel.

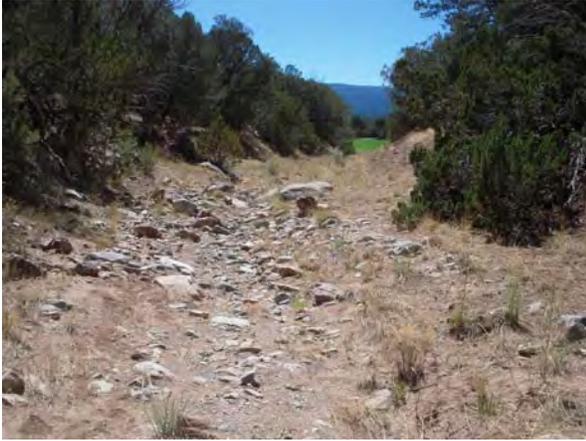
Paa-Ko-42

Note: In the channel there is mostly grass, while trees are mainly on the banks. There are 1 cottonwood and 2 russian olives in the channel. They are very established and do not indicate currently wet conditions.

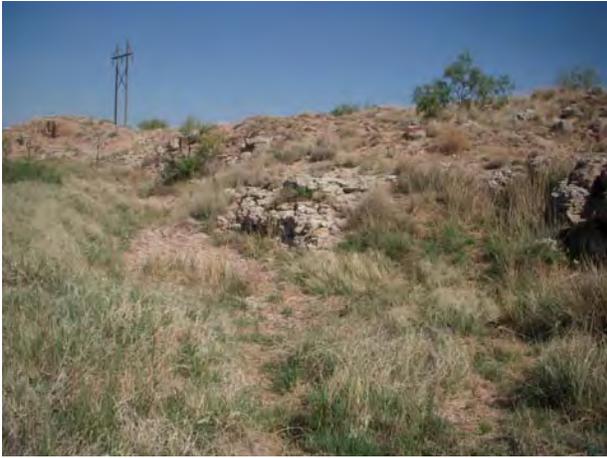
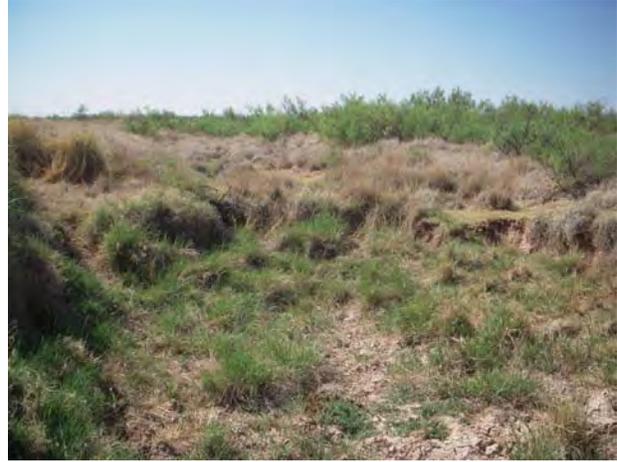
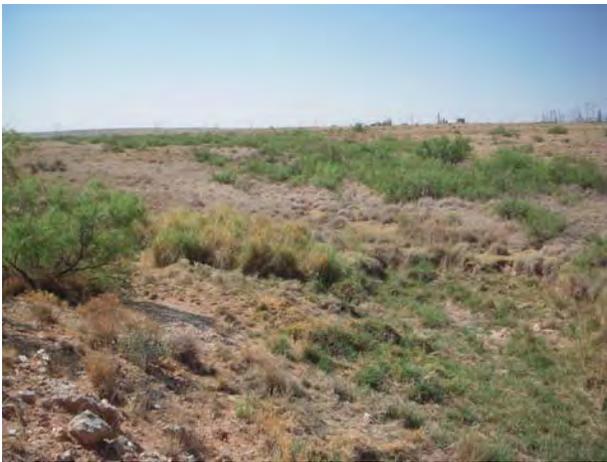
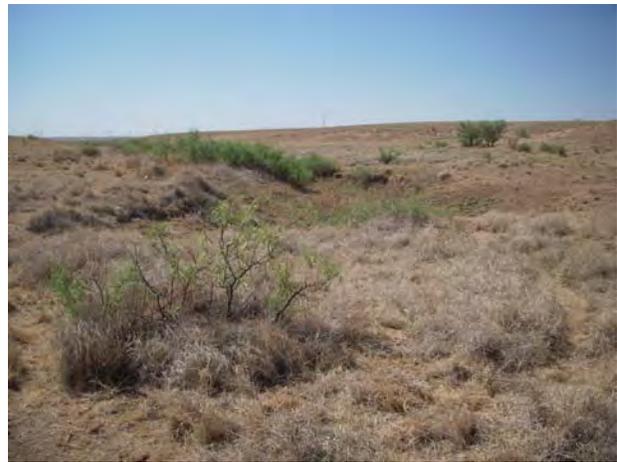
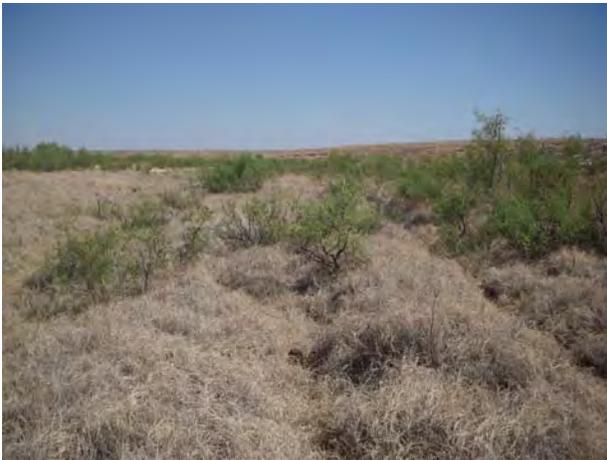
Southwest Public Service UAA Photos

channel is extremely wide and much evidence
of cattle.
