The New Mexico Environment Department (Department) conducted a Use Attainability Analysis (UAA) to determine the most protective attainable aquatic life and contact uses for six (6) stream reaches located throughout New Mexico (**Vcdrg'30.'Hl wt g'3**). This UAA is based on the *Hydrology Protocol for the Determination of Uses Supported by Ephemeral, Intermittent, and Perennial Waters* (NMED 2011) and follows the procedures described in Subsection C of 20.6.4.15 NMAC. This UAA concludes that four (4) of the evaluated stream reaches in the Pecos River basin, Tularosa closed basin and the Mimbres closed basin are naturally ephemeral, and that the designated uses applicable to 20.6.4.97 NMAC are appropriate and attainable. Attainment of the CWA §101(a)(2) uses for these ephemeral waters is not feasible due to the factor identified in 40 CFR 131.10(g)(2): *natural, ephemeral, intermittent, or low flow conditions or water levels prevent the attainment of the use*. The Department proposes these four stream reaches for inclusion in 20.6.4.97 C. NMAC as ephemeral waters.

Figure 30 Locations of evaluated stream reaches

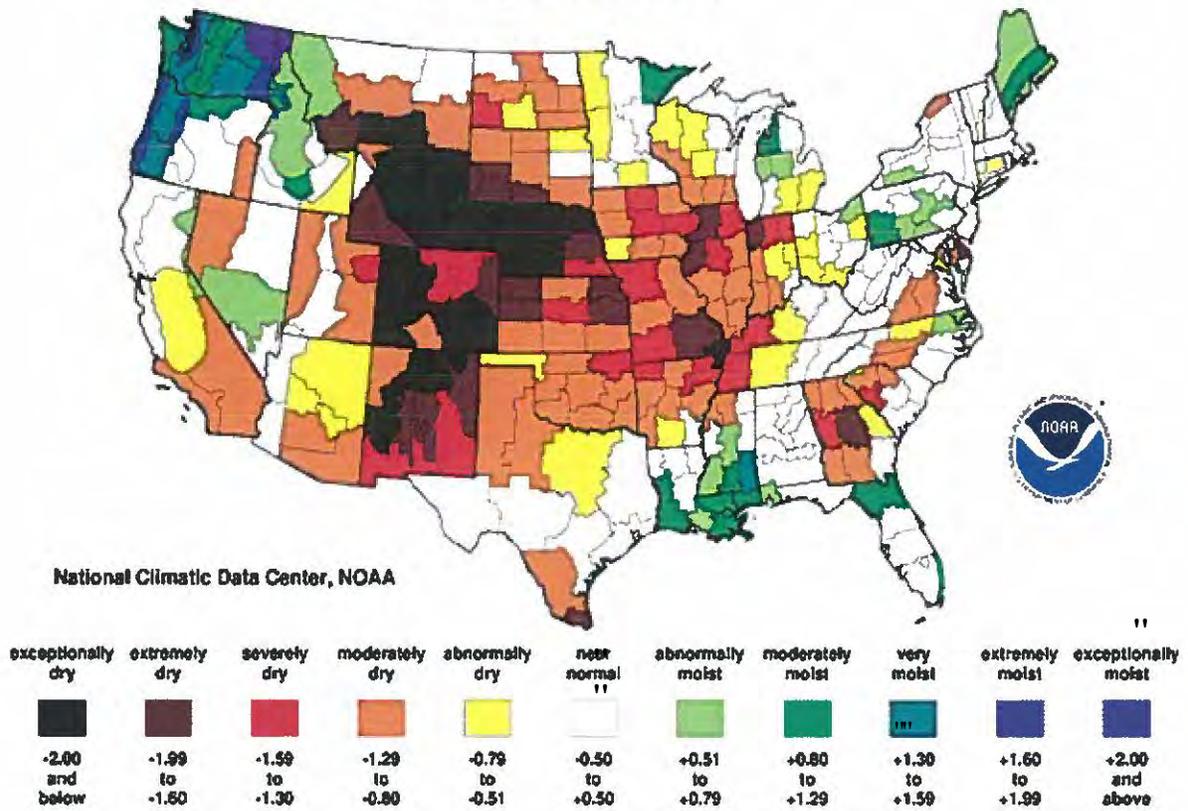
Figure E-6. 12-month SPI: NCDC/NOAA (2012)

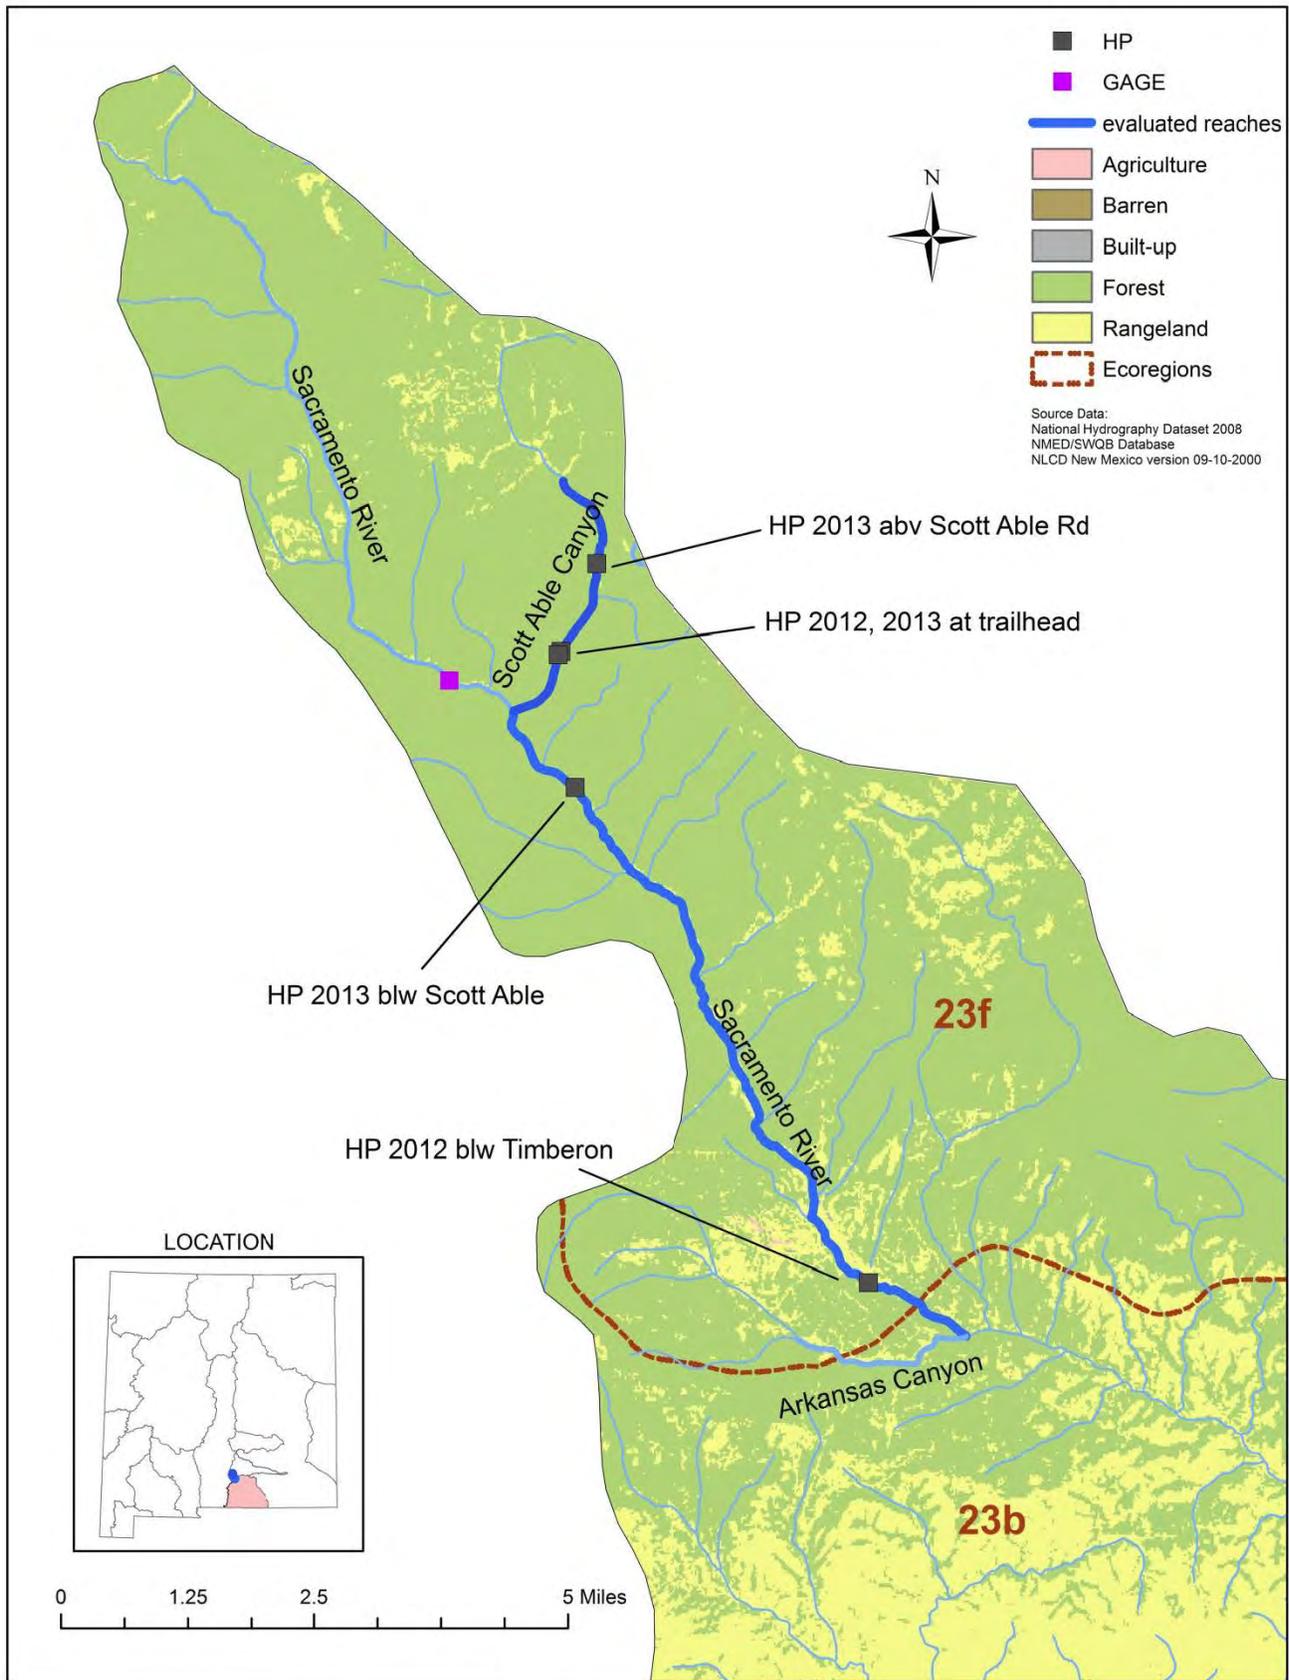
Figure F-1. Sacramento River and Scott Able Canyon Ecoregions and Land Use/Land Cover

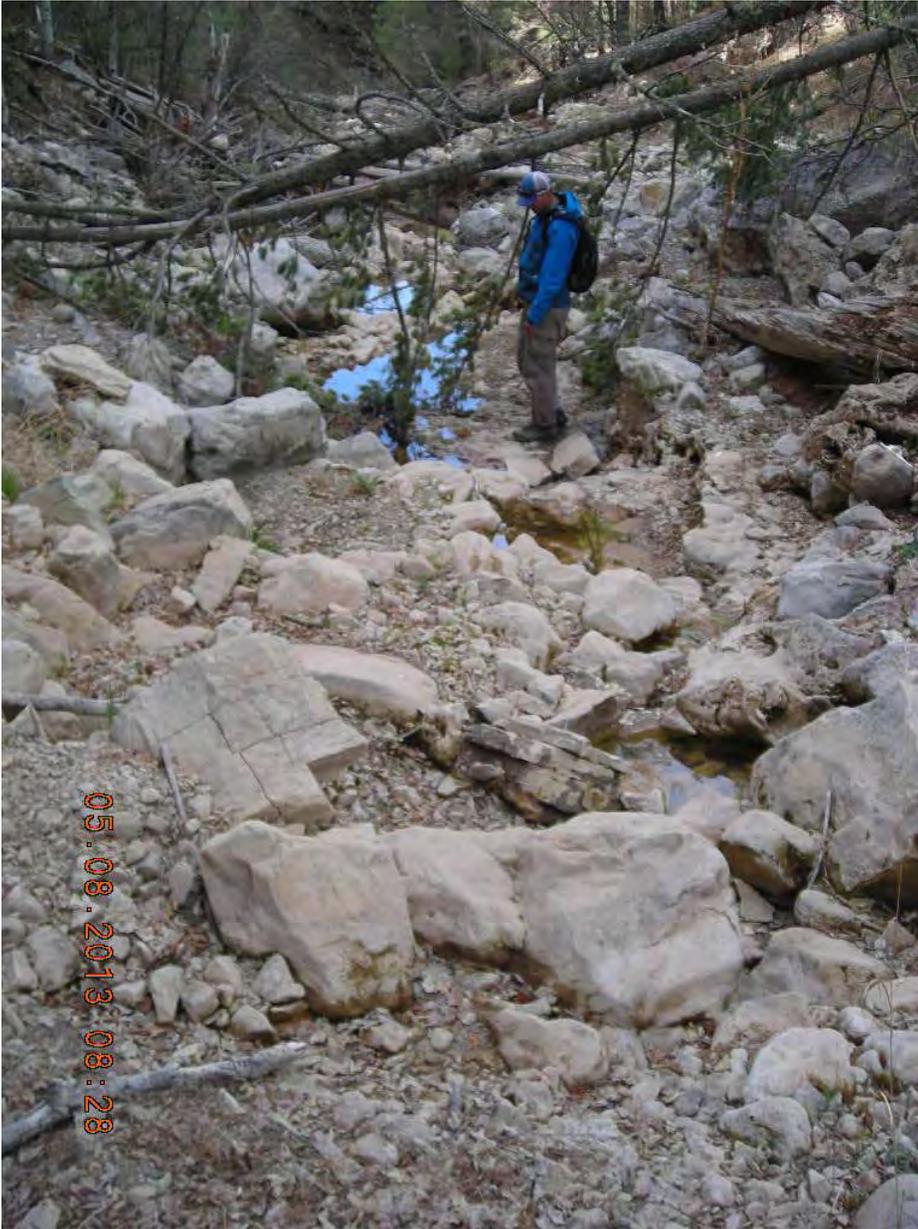
Figure F-2. Pools above road crossing on Scott Able Canyon

Flood scour in the past still very evident.
FR crosses creek below 4A camp.
Many dry caddisfly casings. Live cadd's
fly in seep.

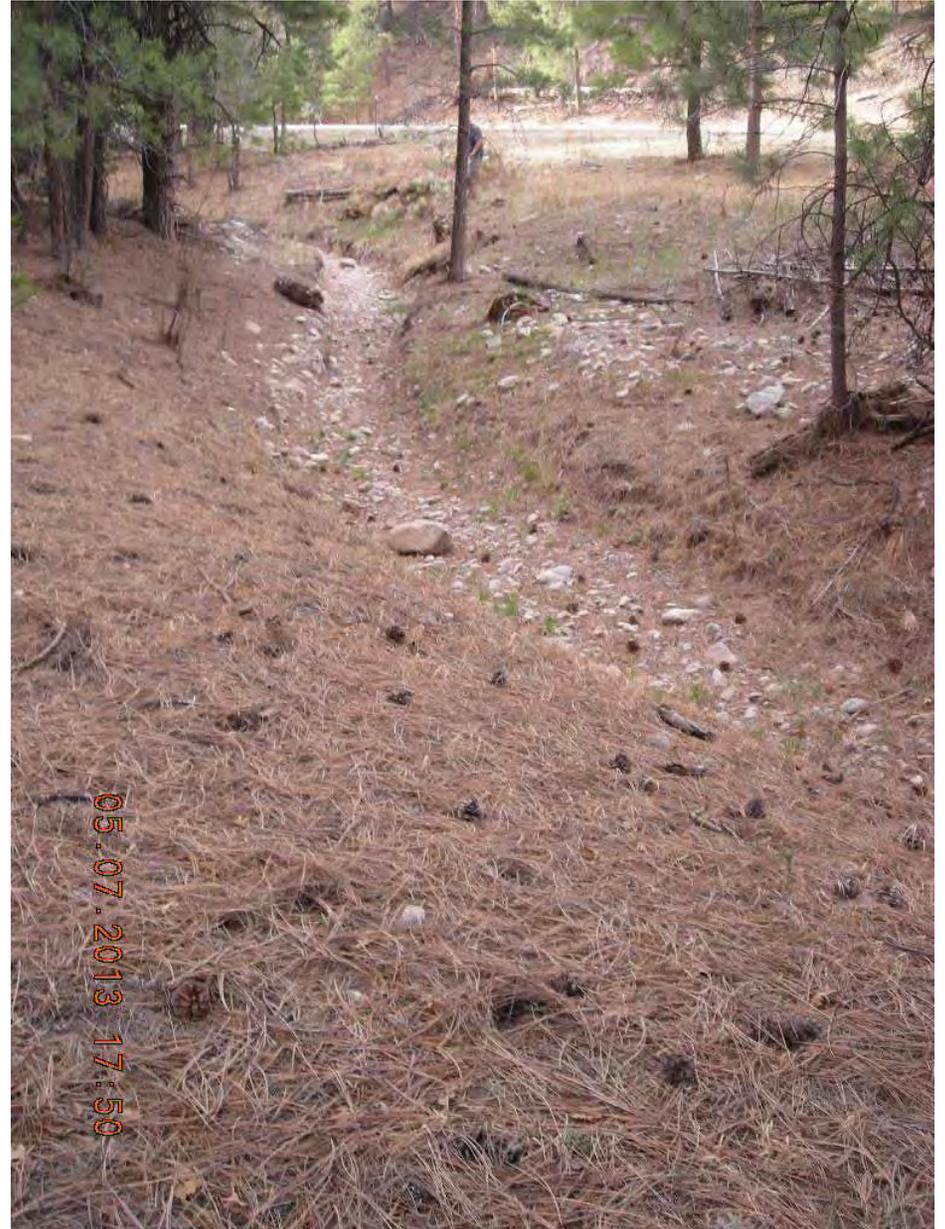
Figure F-3. Sacramento River below Scott Able Canyon
