3.0 INDIVIDUAL WATERSHED DESCRIPTIONS

3.1 East Fork Jemez Subwatershed

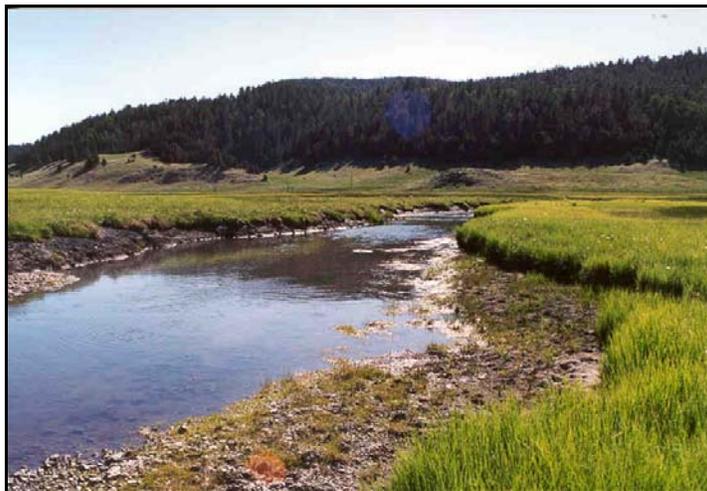
Photo 3.1 East Fork Jemez below unnamed drainage (2001)

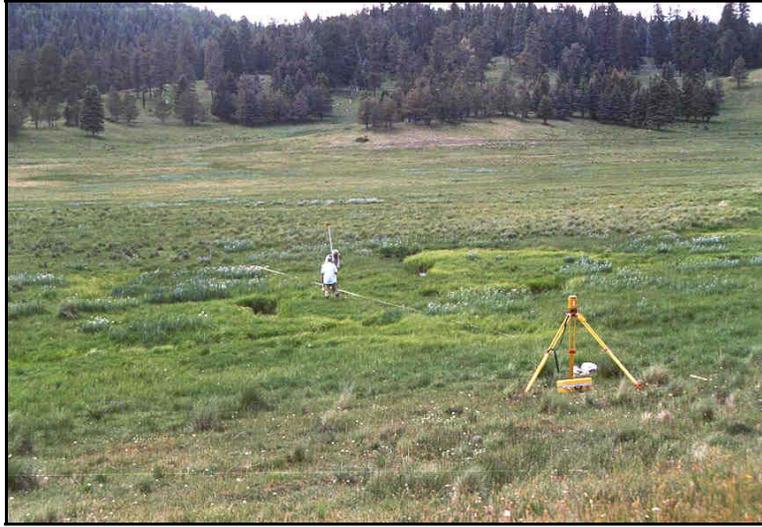
Photo 3.2 Jaramillo Creek geomorphological survey (June 2001)
