RE: Minor Non-Municipal, SIC 4911, NPDES Compliance Evaluation Inspection, City of Farmington, Electric Utility System, Animas Power Plant, NM0000043, October 14, 2010

NPDES Compliance Inspection Report

City of Farmington, Electric Utility System, Animas Power Plant
NPDES Permit No NM0000043
Compliance Evaluation Inspection
October 14, 2010

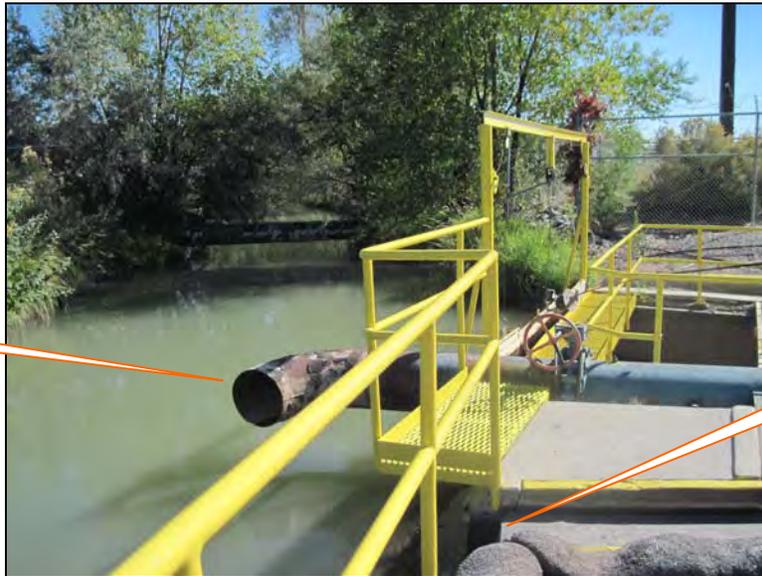
**NMED/SWQB
Official Photograph Log
Photo # 1**

Willet Ditch, plant intake, and Outfalls 001 and 003 (see Photo #1) are located at the northeast corner of the facility directly east of a clarifier pump house that is no longer used according to the permittee on-site representative. When operating, gravity fed intake water from Willet Ditch is passed through a coarse material traveling screen to remove leaves, tree branches, and trash. After the screen, intake water flows to a sump where it is pumped through the condenser cooling circuit then the noncontact once-through condenser cooling water is discharged from Outfall 001 directly downstream from the intake to Willet Ditch. Periodically, the traveling screen is back-washed to remove coarse build-up and these materials as well as back-wash water is discharged from Outfall 003 (adjacent to Outfall 001). Outfall 001 is sampled from a port prior to mixing with Willet Ditch (see Photo #2), except for temperature, which is at the end of Willet Ditch prior to discharging into the Animas River. Outfall 003 is sampled from the discharge of the screen backwash prior to mixing with Willet Ditch. The hydroelectric plant would also use water from Willet Ditch. Intake water from the ditch would pass through a coarse material screen similar to the one described above and sent through the turbine. Periodically, this screen is back-washed to remove coarse material build-up. Course materials are collected and back-wash water is discharged from Outfall 003A, located approximately 100 feet northwest from Outfall 001 and Outfall 003. Outfall 003A is sampled from the discharge of the screen backwash prior to mixing with Willet Ditch. Solids removed from the traveling screens are placed in open drums, transferred to an on-site trash dumpster, then disposed at a municipal solid waste landfill.

Photographer: Erin S. Trujillo	Date: 10/14/2010	Time: 1123 hours
City/County: Farmington / San Juan County		State: New Mexico
Location: Farmington Animas Power Plant		
Subject: Willet Ditch, Outfall 001 and Outfall 003 at intake structure.

Outfall 001

Outfall 003

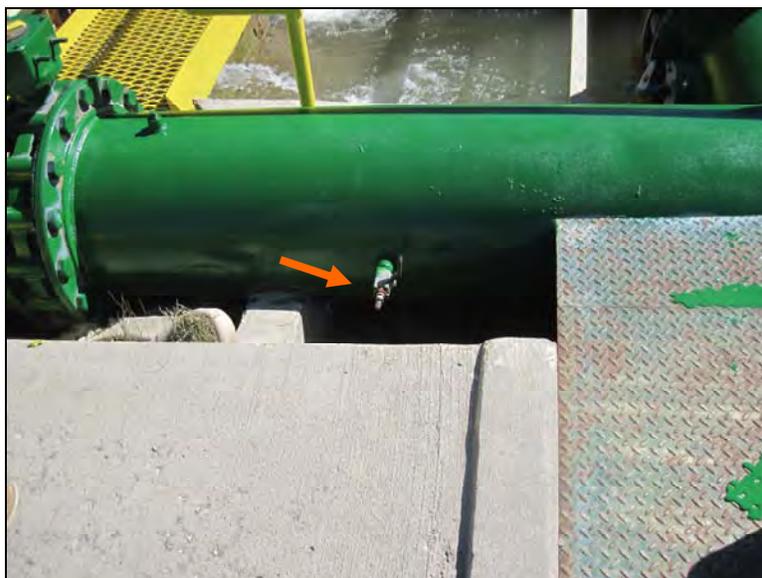
**NMED/SWQB
Official Photograph Log
Photo # 2**

Photographer: Erin S. Trujillo	Date: 10/14/2010	Time: 1224 hours
City/County: Farmington / San Juan County		State: New Mexico
Location: Farmington Animas Power Plant		
Subject: Arrow points to sampling port for Outfall 001. Discharge pipe was painted during inspection.
