**NEW MEXICO
ENVIRONMENT DEPARTMENT**

RE: Minor Non-Municipal, SIC 3241, NPDES Compliance Evaluation Inspection, GCC Rio Grande, NM0000116, June 7, 2012

**Compliance Evaluation Inspection
GCC Rio Grande, Inc. (Tijeras Plant)
NPDES Permit No. NM0000116
Date of Inspection: June 7, 2012**

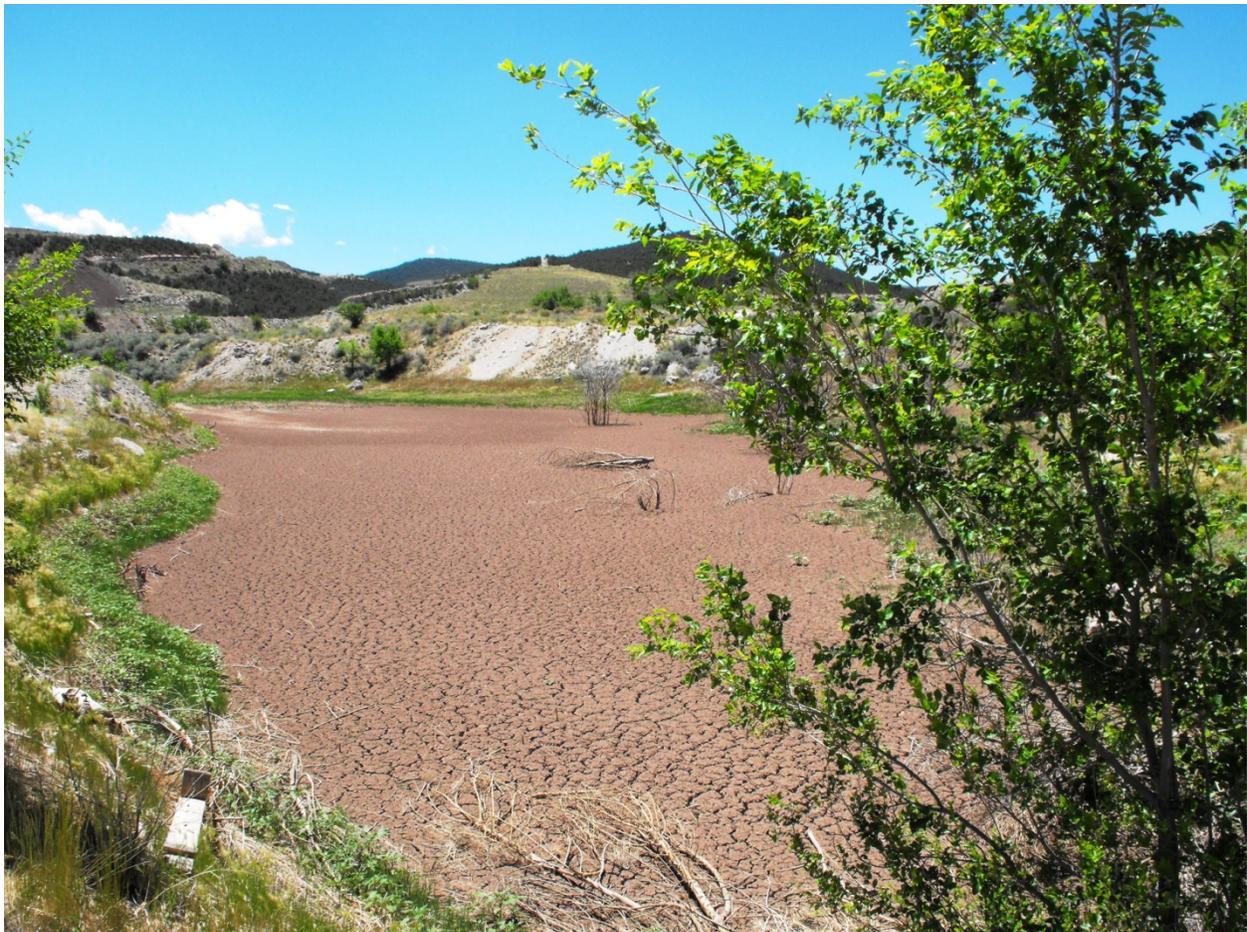
NMED/SWQB
Official Photograph Log
Photo # 1

Photographer: Daniel Valenta	Date: June 7, 2012	Time: 1211 Hours
City/County: Tijeras / Bernalillo County		State: New Mexico
Location: GCC Rio Grande, Inc. (Tijeras Plant)		
Subject: Quarry #1 Pond (Outfall 001) Northwest corner of property.

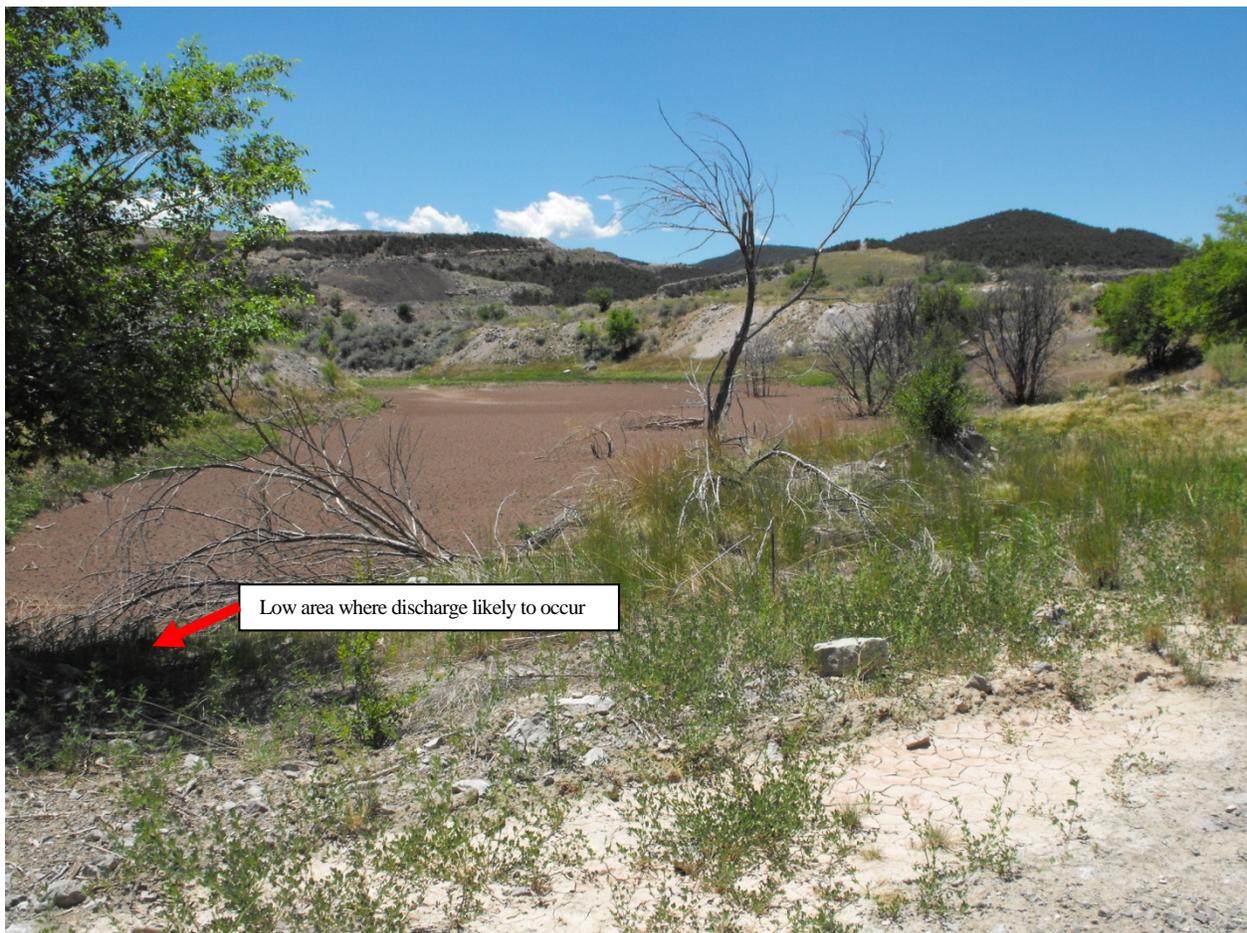
NMED/SWQB
Official Photograph Log
Photo # 2

Photographer: Daniel Valenta	Date: June 7, 2012	Time: 1212 Hours
City/County: Tijeras / Bernalillo County		State: New Mexico
Location: GCC Rio Grande, Inc. (Tijeras Plant)		
Subject: Quarry #1 Pond (Outfall 001) Northwest corner of property.

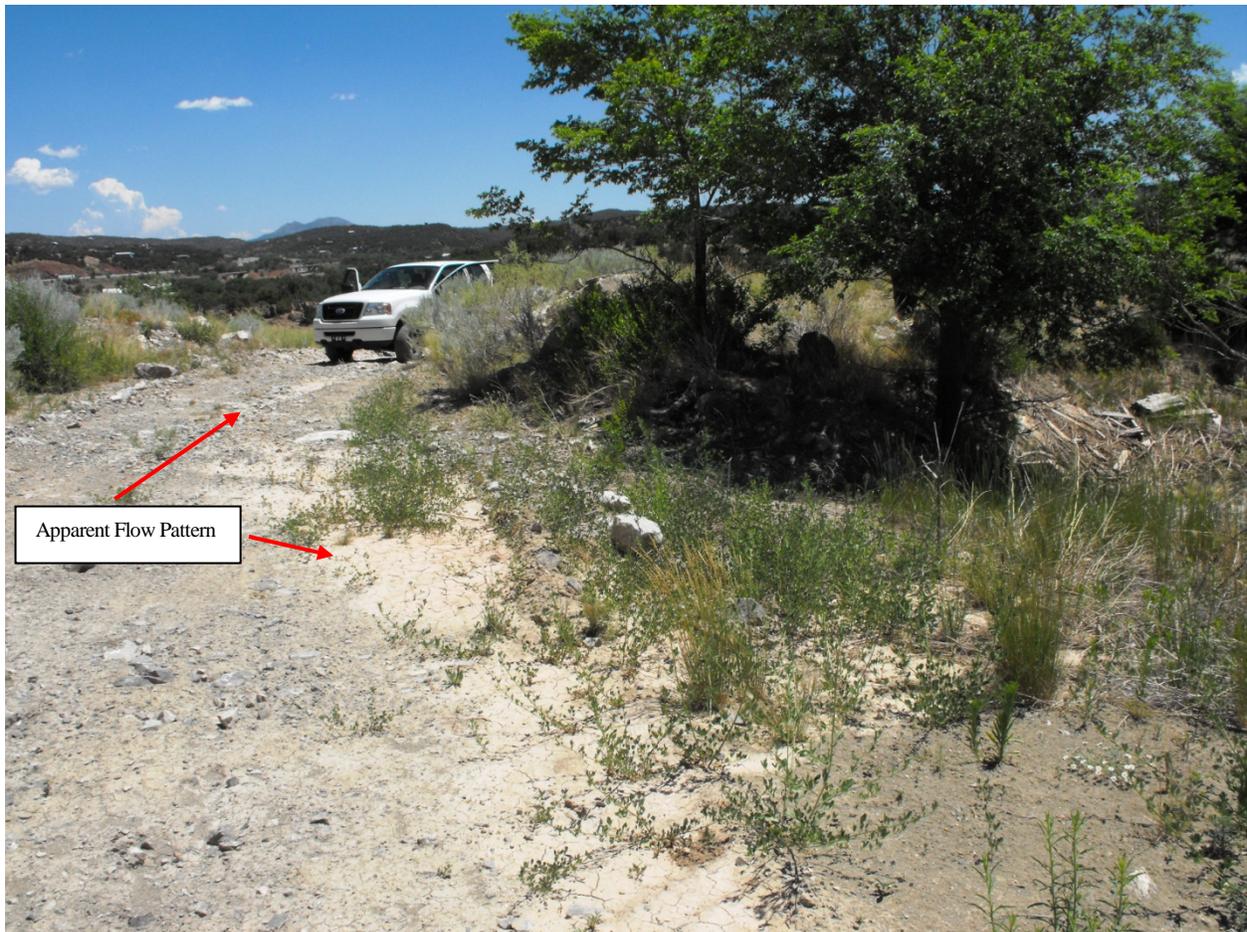
NMED/SWQB
Official Photograph Log
Photo # 3

The plant's drainage system (discharge flow paths) include surface runoff, curb and constructed swales in paved areas, series of manmade unlined ditches, culvert, and drop inlets that would convey process water and stormwater primarily to Quarry #1 pond (Outfall 001) in the north-northwest portion of the site. If Outfall #1 pond overflows, discharges would likely occur from a low point in the pond's constructed berm across an access road. There is no well-defined channel in the uneven surfaces of the limestone bedrock and soils of outfall 001.

Photographer: Daniel Valenta	Date: June 7, 2012	Time: 1212 Hours
City/County: Tijeras / Bernalillo County		State: New Mexico
Location: GCC Rio Grande, Inc. (Tijeras Plant)		
Subject: Flow pattern adjacent to Outfall #1. Below truck is limestone bedrock where apparent discharge off property would occur.
