NEW MEXICO
ENVIRONMENT DEPARTMENT

Surface Water Quality Bureau

Re: Major-Municipal, SIC 4952, NPDES Compliance Evaluation, Silver City, Wastewater Treatment Plant, NM0020109, July 15, 2010

**Compliance Evaluation Inspection
Silver City Wastewater Treatment Facility
NPDES Permit No. NM0020109
July 15, 2010**

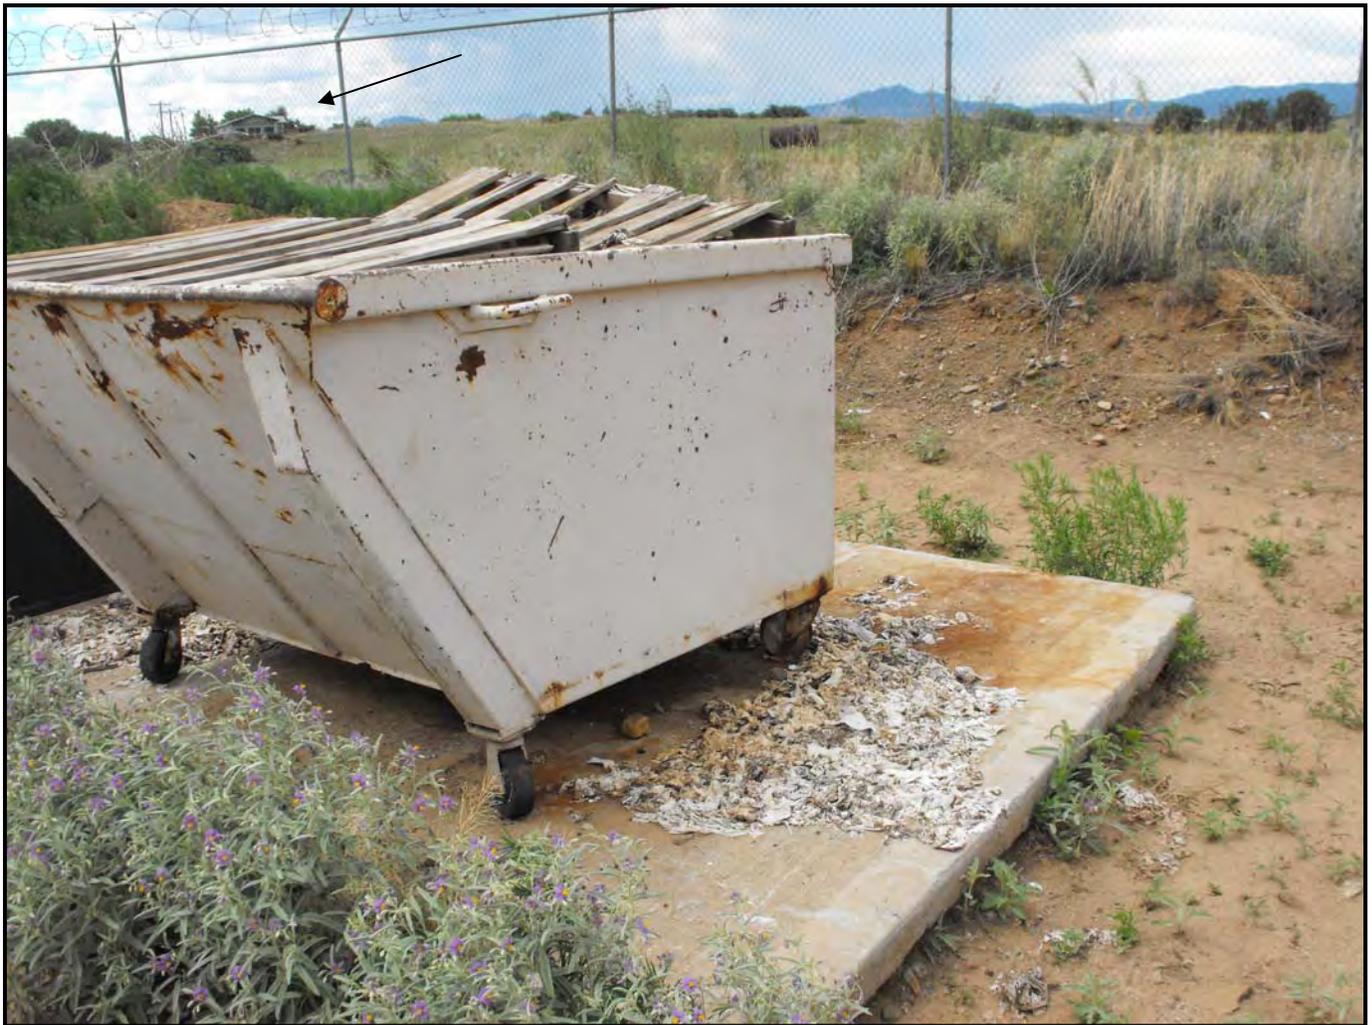
Photo #1

Three large dumpsters and several smaller containers were on site, no containers had lids. Birds and other animals are free to enter the containers and drag waste material out, (see photo 1 & 2). Facility personnel have to constantly clean these areas. Due to residential houses within a block of the facility vector control issues may present a human health issue. Rain events, as occurred on the day of the inspection, present the issue of stormwater entering these open containers and waste being mobilized to flow off site. Solid waste from the headwork’s screen should be kept on a contained surface such as a cement bermed pad and in a closed container.

| Location: Silver City WWTP, facing northwest, north side of facility at 1660 East Filaree Road, Silver City, New Mexico 88061. | | |
| Subject: Waste from headwork's at WWTP. Waste containers with no lids to keep out rainwater, debris blows out and animals drag waste out. Note house a top of hill. | | |

1. The Permit Requirements on Page 3 of Part III, B, 6: REMOVED SUBSTANCES *Unless otherwise authorized, solids, sewage sludges, filter backwash, or other pollutants removed in the course of treatment or wastewater control shall be disposed of in a manner such as to prevent any pollutant from such materials from entering navigable waters.*

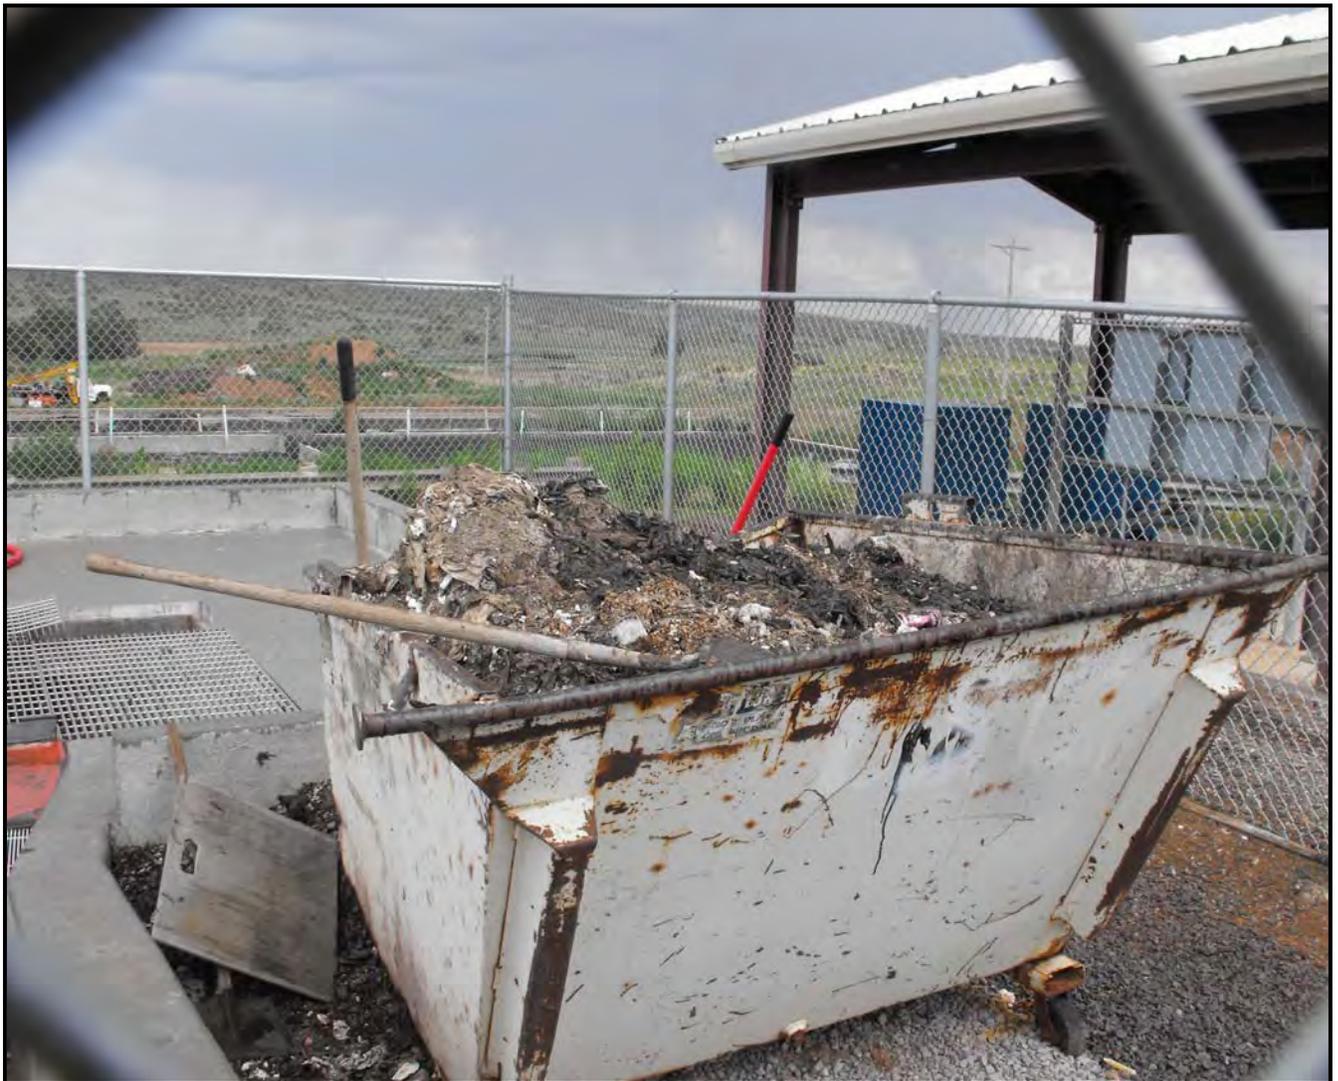
Photo # 2

| Location: Silver City WWTP, facing east, septic discharge station at 1660 East Filaree Road, Silver City, New Mexico 88061. | | |
| Subject: Septic discharge station headwork's area. Waste from the location is placed in uncovered container, rain approaching site. | | |

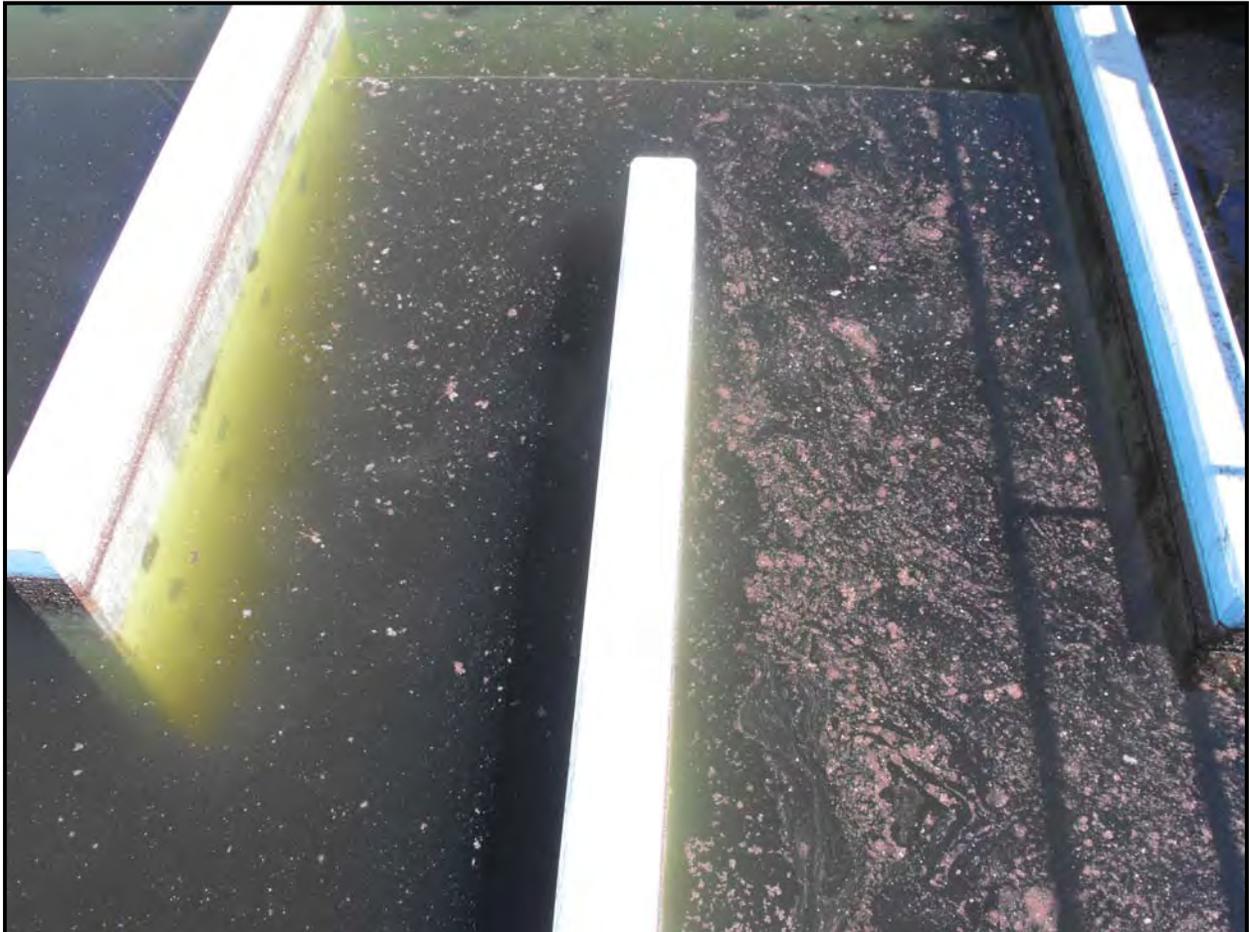
Log Photo # 3

After final treatment by the UV disinfection system the effluent flows through the unused chlorine contact chamber (see photo 3). It is unknown if the visible material on the surface in the discharge water passed through the treatment process or was introduced after final treatment and then discharge to a Golf Course or Outfall 001.

| Location: Silver City WWTP, facing north, north side of chlorine contact chamber at 1660 East Filaree Road, Silver City, New Mexico 88061 | | |
| Subject: Treated effluent before it is released to the Golf Course or outfall 001, water flows through unused chlorine contact chamber before discharging. | | |

1. Per Part I, A,1, FLOATING SOLIDS, VISIBLE FOAM AND/OR OILS, *“There shall be no discharge of floating solids or visible foam in other than trace amounts. There shall be no discharge of visible films of oil, globules of oil, grease or solids in or on the water, or coatings on stream banks.”*
