NEW MEXICO
ENVIRONMENT DEPARTMENT
Surface Water Quality Bureau

RE: Major Municipal, SIC 4952, NPDES Compliance Evaluation Inspection, Town of Silver City / Waste Water Treatment Plant, NM0020109, April 24, 2012

NPDES Compliance Inspection Report

**Town of Silver City WWTP
NPDES Permit No NM0020109
Compliance Evaluation Inspection
April 24 & April 25, 2012**

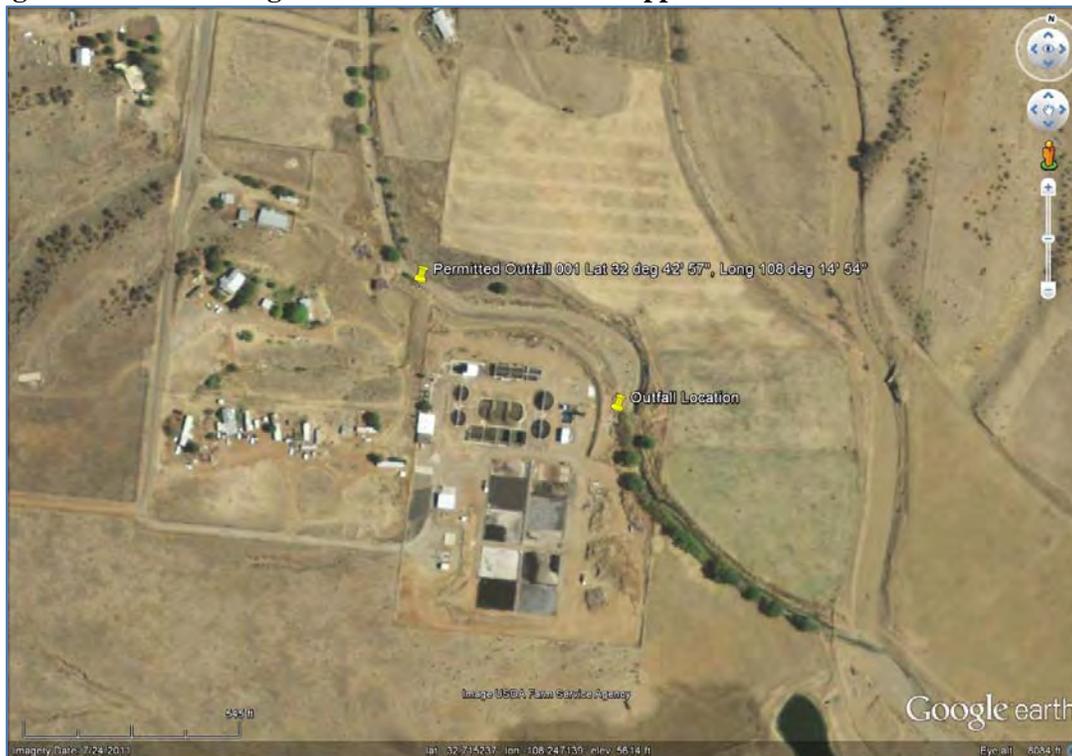
Figure 1: Latitude/Longitude as Described in Permit/Application and Actual Outfall Location

Based on on-line mapping tools, the description of Outfall 001 stated on the title page of the permit and in the Permittee application (Latitude 32° 42 ' 57" North and Longitude 108° 14' 54" West) is incorrect. The actual outfall location is at approximately Latitude 32° 42' 54.2" North, Longitude 108° 14' 47.5" West. In decimal degrees, the location is at approximately Latitude 32.715056° and Longitude -108.246528° (see Figure 1).

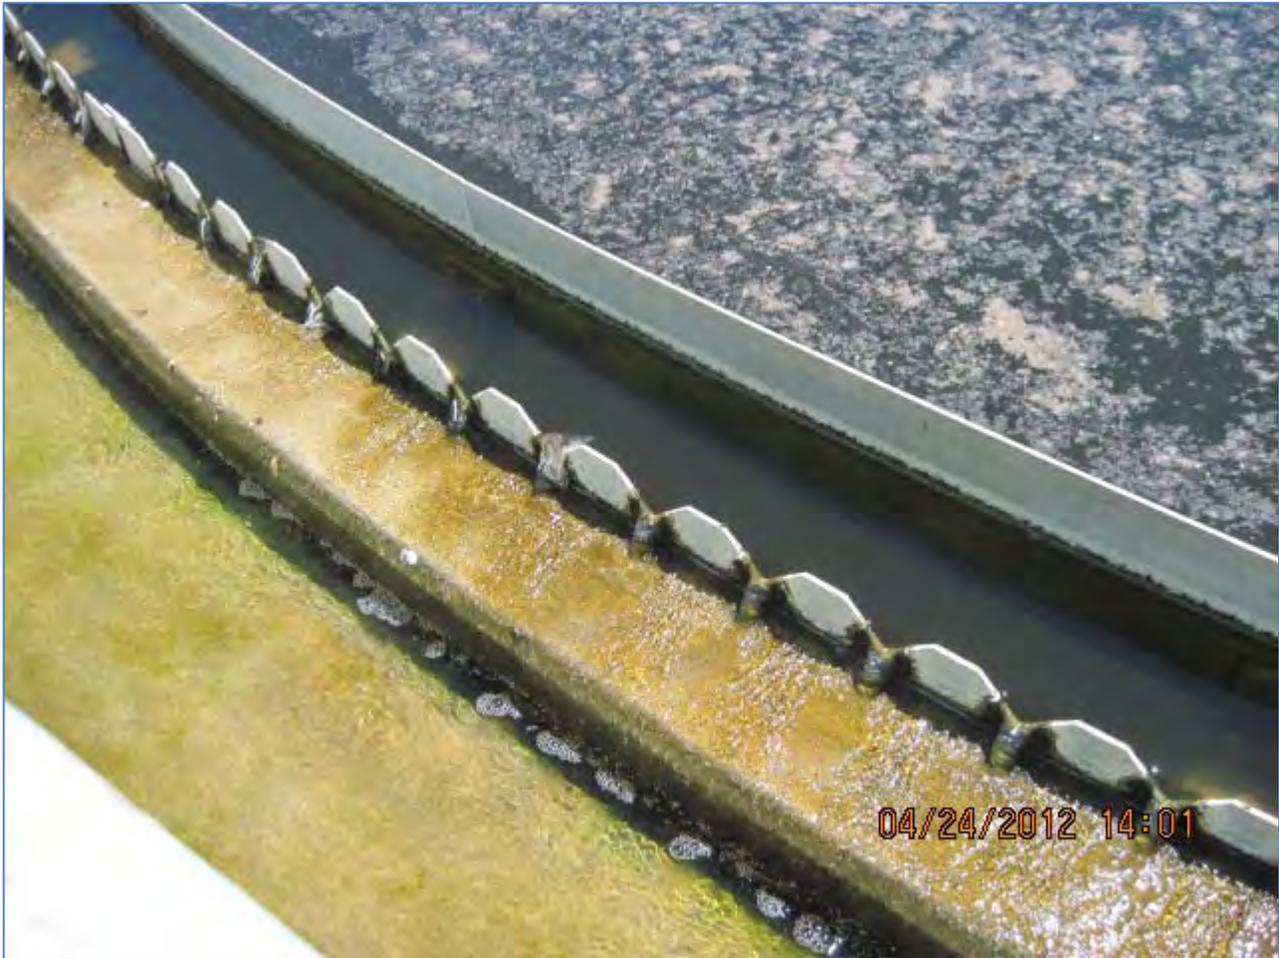
NMED/SWQB
Official Photograph Log
Photo # 1

Photographer: Erin S. Trujillo	Date: 04/24/2012	Time: 1401 hours
City/County: Silver City / Grant County	State: New Mexico	
Location: Town of Silver City WWTP		
Subject: Example of floating solids in secondary clarifier, including some algal growth on teeth of weir and some foam past effluent weir.

Treatment units did not appear properly maintained on the day of this inspection. Each basin and clarifier had floating solids including paper and plastic solids. A missing bar (tooth) in the primary automatic bar screen had not been replaced. The need for the replacement of the bar screen among other improvements has been identified (Town of Silver City Improvement Project List letter dated 01/15/2009). Substantial algal growth was observed in flume and channel after flume (often an indicator of nutrients in effluent). Some algal growth (slime) was observed in the clarifiers especially on the weir teeth.

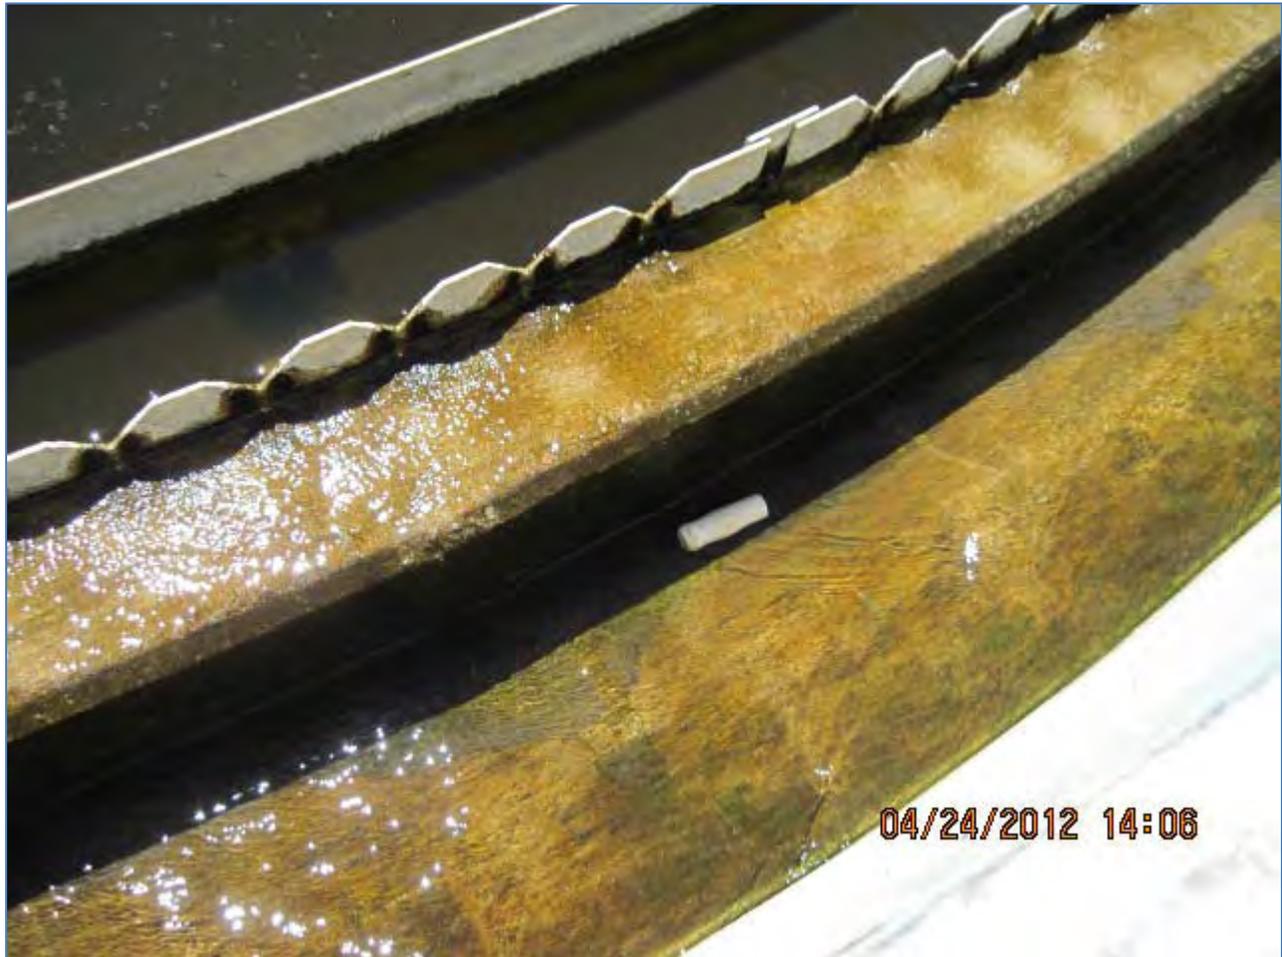
NMED/SWQB
Official Photograph Log
Photo # 2

Photographer: Erin S. Trujillo	Date: 04/24/2012	Time: 1406 hours
City/County: Silver City / Grant County	State: New Mexico	
Location: Town of Silver City WWTP		
Subject: Example of paper solids in secondary clarifier.

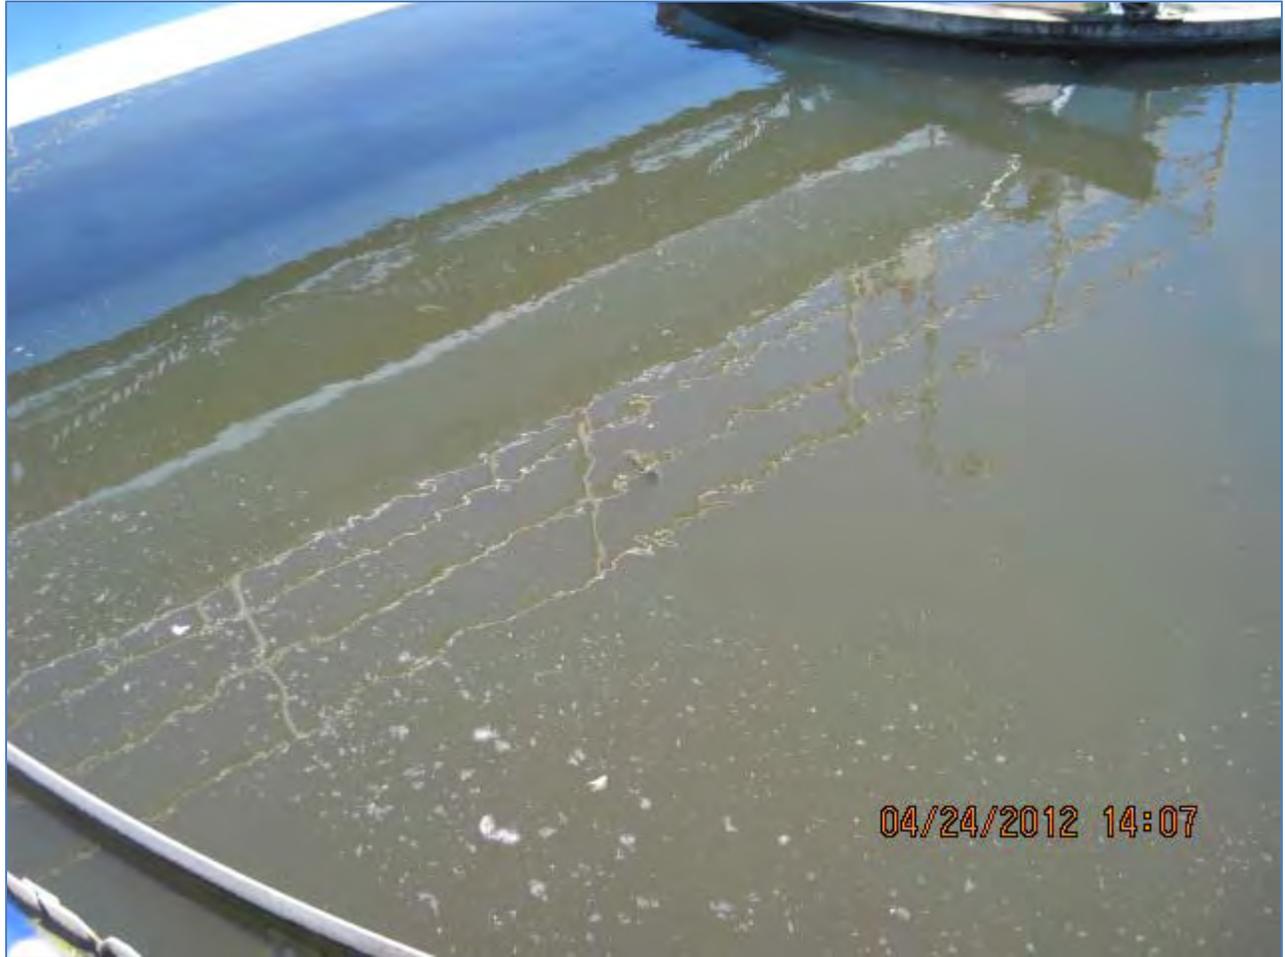
NMED/SWQB
Official Photograph Log
Photo # 3

Photographer: Erin S. Trujillo	Date: 04/24/2012	Time: 1407 hours
City/County: Silver City / Grant County	State: New Mexico	
Location: Town of Silver City WWTP		
Subject: Example of floating solids in secondary clarifier.

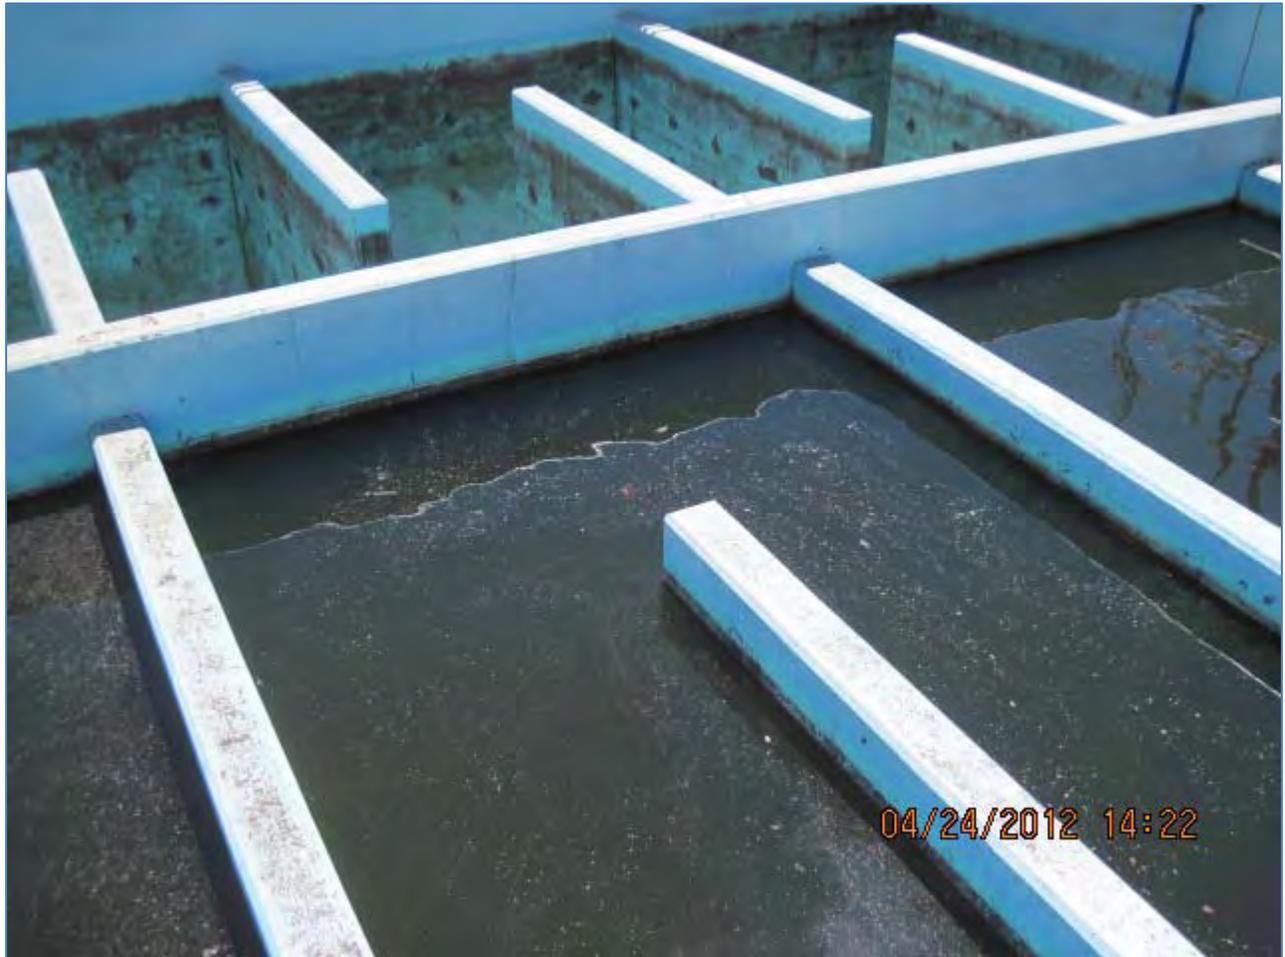
NMED/SWQB
Official Photograph Log
Photo # 4

Photographer: Erin S. Trujillo	Date: 04/24/2012	Time: 1422 hours
City/County: Silver City / Grant County	State: New Mexico	
Location: Town of Silver City WWTP		
Subject: Floating solids in equalization basin before outfall. Basin walls were not clean.

The effluent stored in an equalization basin is open to the sunlight, blowing leaves, and any other contaminate that may fall into this area. On the day of the inspection, the equalization basin walls were not clean and had a build up of slime or other coatings. The water was green with foam, floating grease and solids. Not all of the solids, which were similar to those observed through out the treatment works, appeared from windblown sources. The Permittee on-site representative indicated that some of the solids in the equalization basin may be from insufficient cleaning and removal of solids from the treatment works. Manual removal of floating solids from the equalization tank was occurred during this inspection and was collected in a trash bin adjacent to the tank.

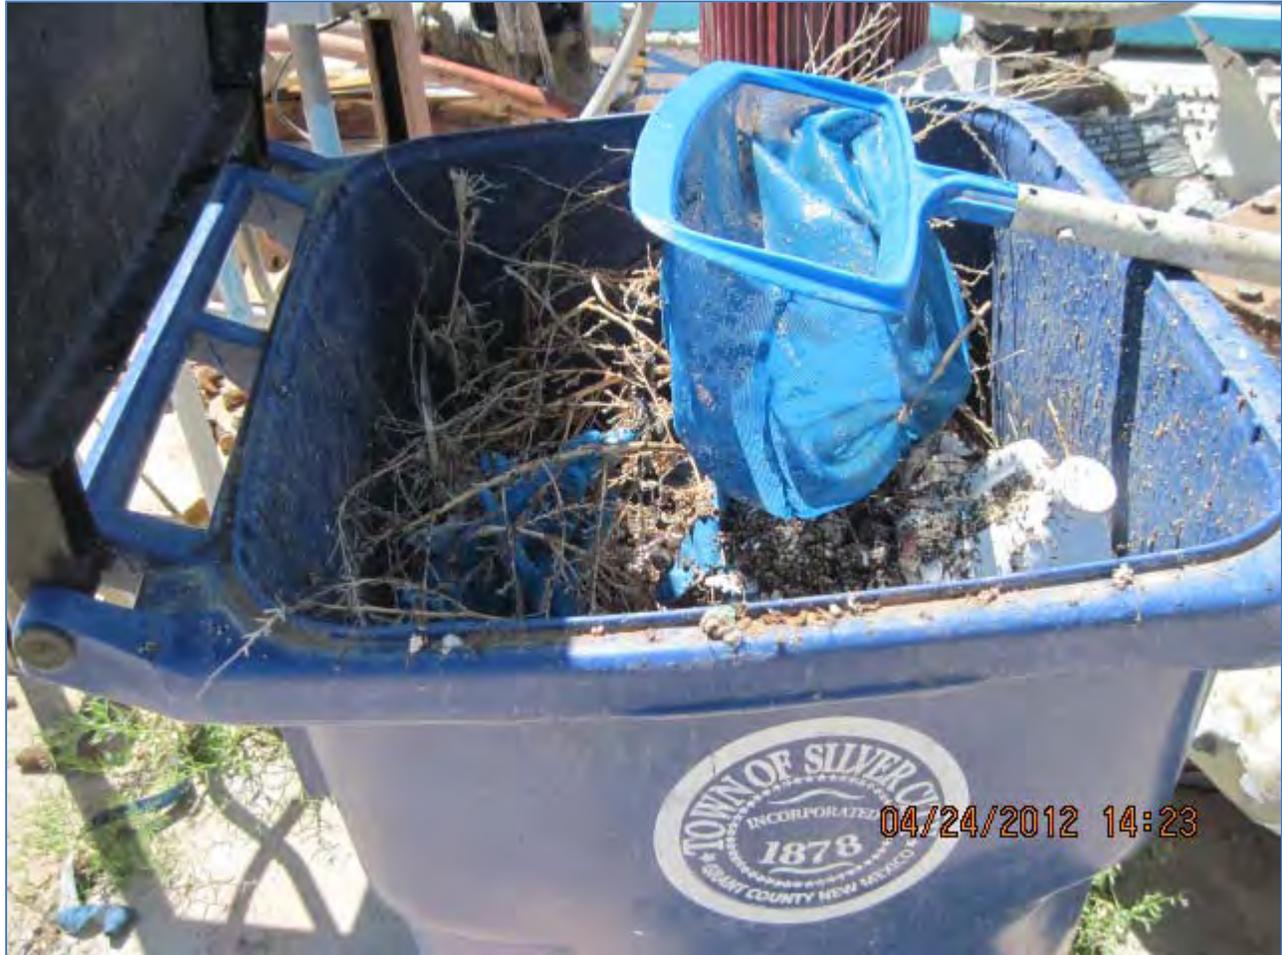
NMED/SWQB
Official Photograph Log
Photo # 5

Photographer: Erin S. Trujillo	Date: 04/24/2012	Time: 1423 hours
City/County: Silver City / Grant County	State: New Mexico	
Location: Town of Silver City WWTP		
Subject: Solids and grit in trash container next to equalization basin.

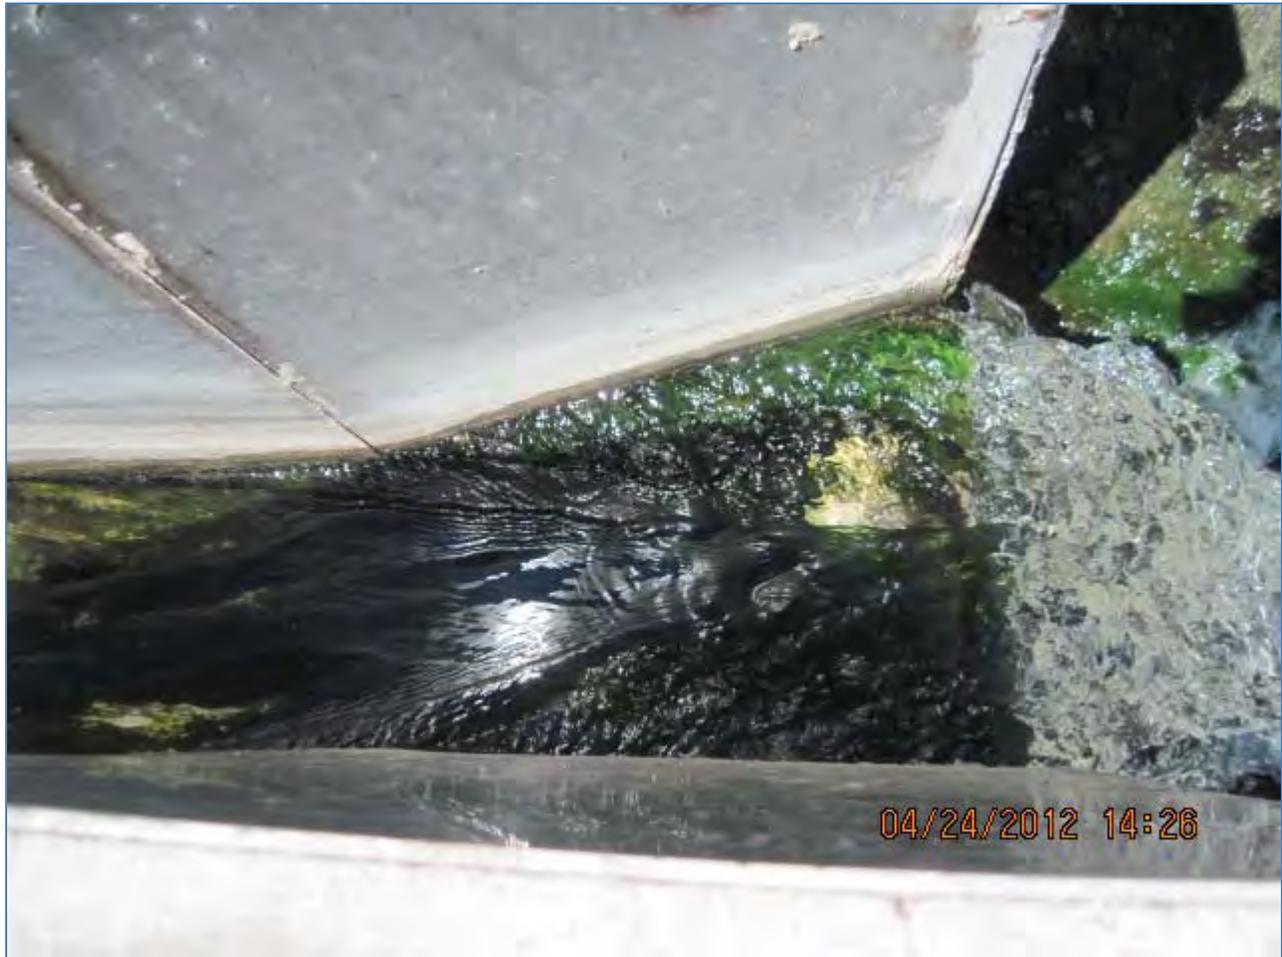
NMED/SWQB
Official Photograph Log
Photo # 6

Photographer: Erin S. Trujillo	Date: 04/24/2012	Time: 1426 hours
City/County: Silver City / Grant County	State: New Mexico	
Location: Town of Silver City WWTP		
Subject: Effluent flow, including some turbulence, through flume.

Flow entering the device was not free of turbulence. Substantial algal growth was observed in the flume. Operation and maintenance procedures in Recommended Practice for the Use of Parshall Flumes and Palmer-Bowlus Flumes in Wastewater Treatment Plants, EPA 600/2-84-186, November 1984, Section 11.1.5 states, "*Flume surfaces should be wiped down weekly to free them of slimes or other coatings.*"

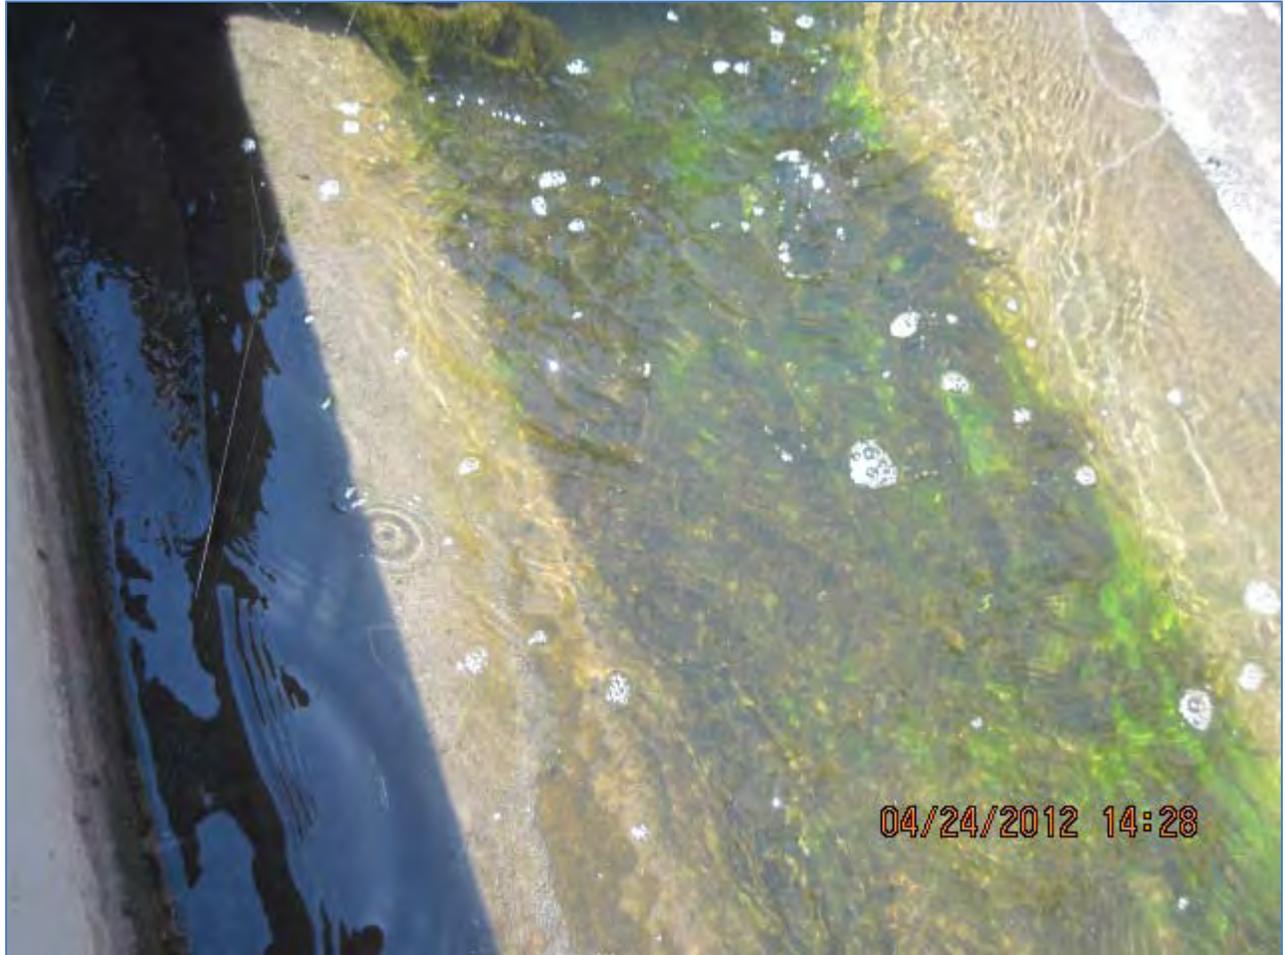
NMED/SWQB
Official Photograph Log
Photo # 7

Photographer: Erin S. Trujillo	Date: 04/24/2012	Time: 1428 hours
City/County: Silver City / Grant County	State: New Mexico	
Location: Town of Silver City WWTP		
Subject: Agal growth in flume channel. Solids (possibly foil or metal) was observed in agal growth. Some foam on effluent.

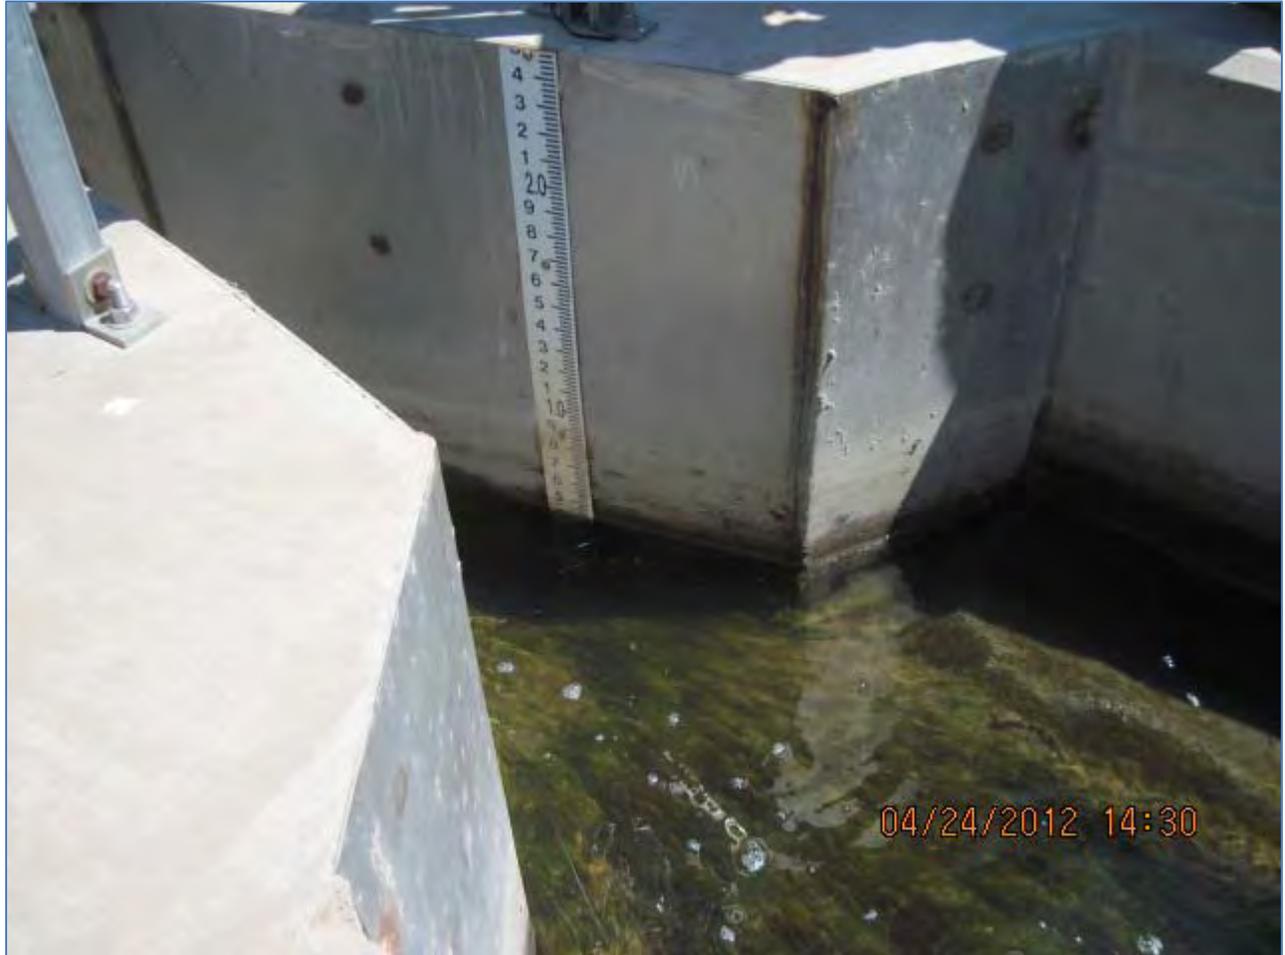
NMED/SWQB
Official Photograph Log
Photo # 8

Photographer: Erin S. Trujillo	Date: 04/24/2012	Time: 1430 hours
City/County: Silver City / Grant County	State: New Mexico	
Location: Town of Silver City WWTP		
Subject: Algal growth in flume channel. Some foam on effluent. Gage was not clean below water level.

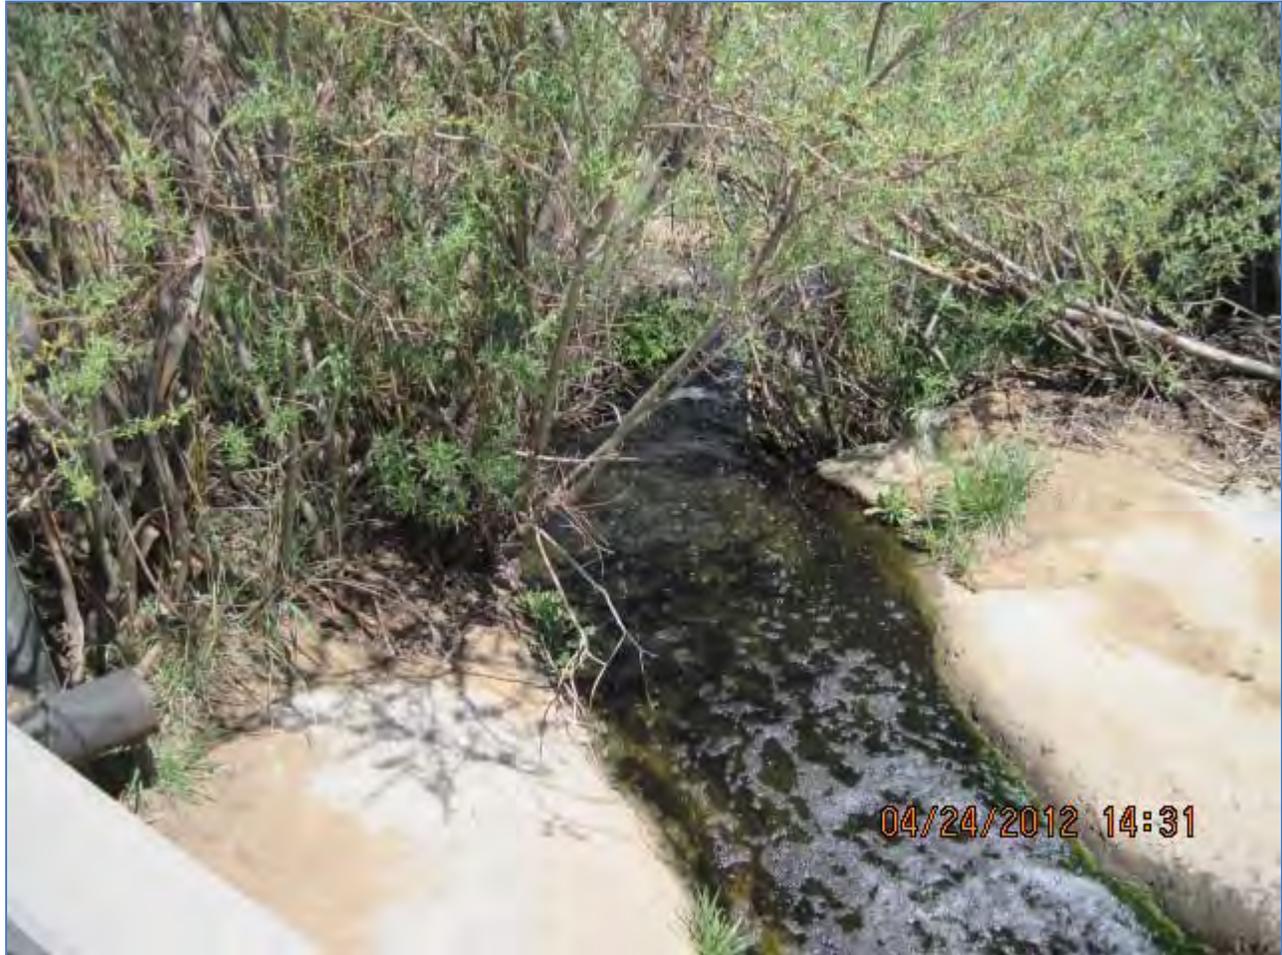
NMED/SWQB
Official Photograph Log
Photo # 9

Photographer: Erin S. Trujillo	Date: 04/24/2012	Time: 1431 hours
City/County: Silver City / Grant County	State: New Mexico	
Location: Town of Silver City WWTP		
Subject: Effluent in channel after flume. Agal growth and foam observed.

RECEIVING WATER OBSERVATIONS: **As previously described, substantial algal growth was observed in flume & channel after flume (often an indicator of nutrients in effluent). Effluent looked dark green at a distance from algal growth. Un-reported pH 6.41 su (lower than 6.6 su) measured in January of 2012. Prior to this inspection, a sewer system overflow ultimately discharged into an unnamed surface water tributary of Maudes Canyon then San Vicente Arroyo. Chlorine solution was used to disinfect sewage in the receiving stream channel. Some paper solids remained in channel. See further explanations for information on overflow at WWTP occurring after this inspection.**

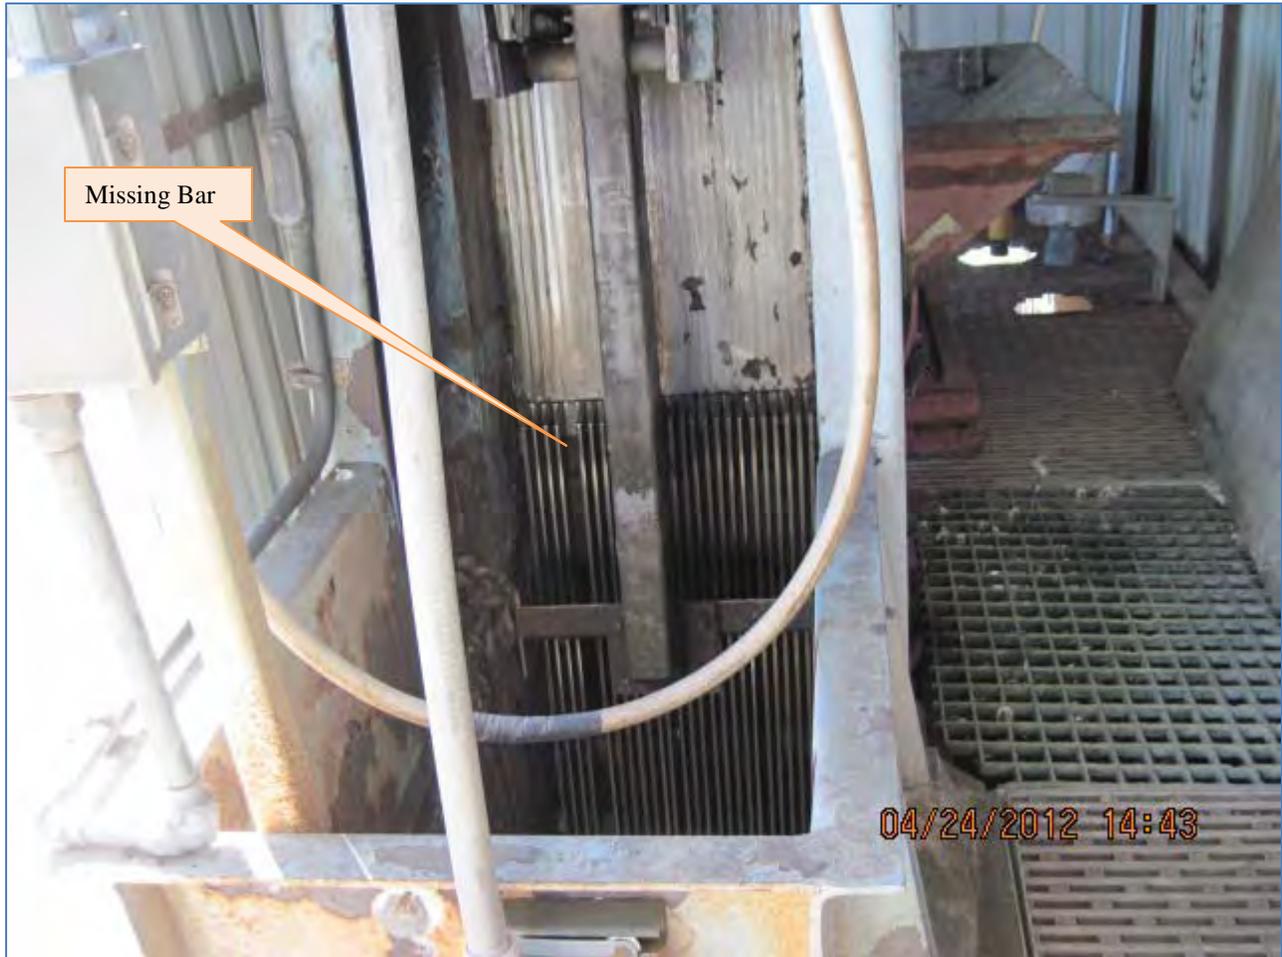
NMED/SWQB
Official Photograph Log
Photo # 10

Photographer: Erin S. Trujillo	Date: 04/24/2012	Time: 1443 hours
City/County: Silver City / Grant County	State: New Mexico	
Location: Town of Silver City WWTP		
Subject: Missing bar (tooth) in automatic bar screen.

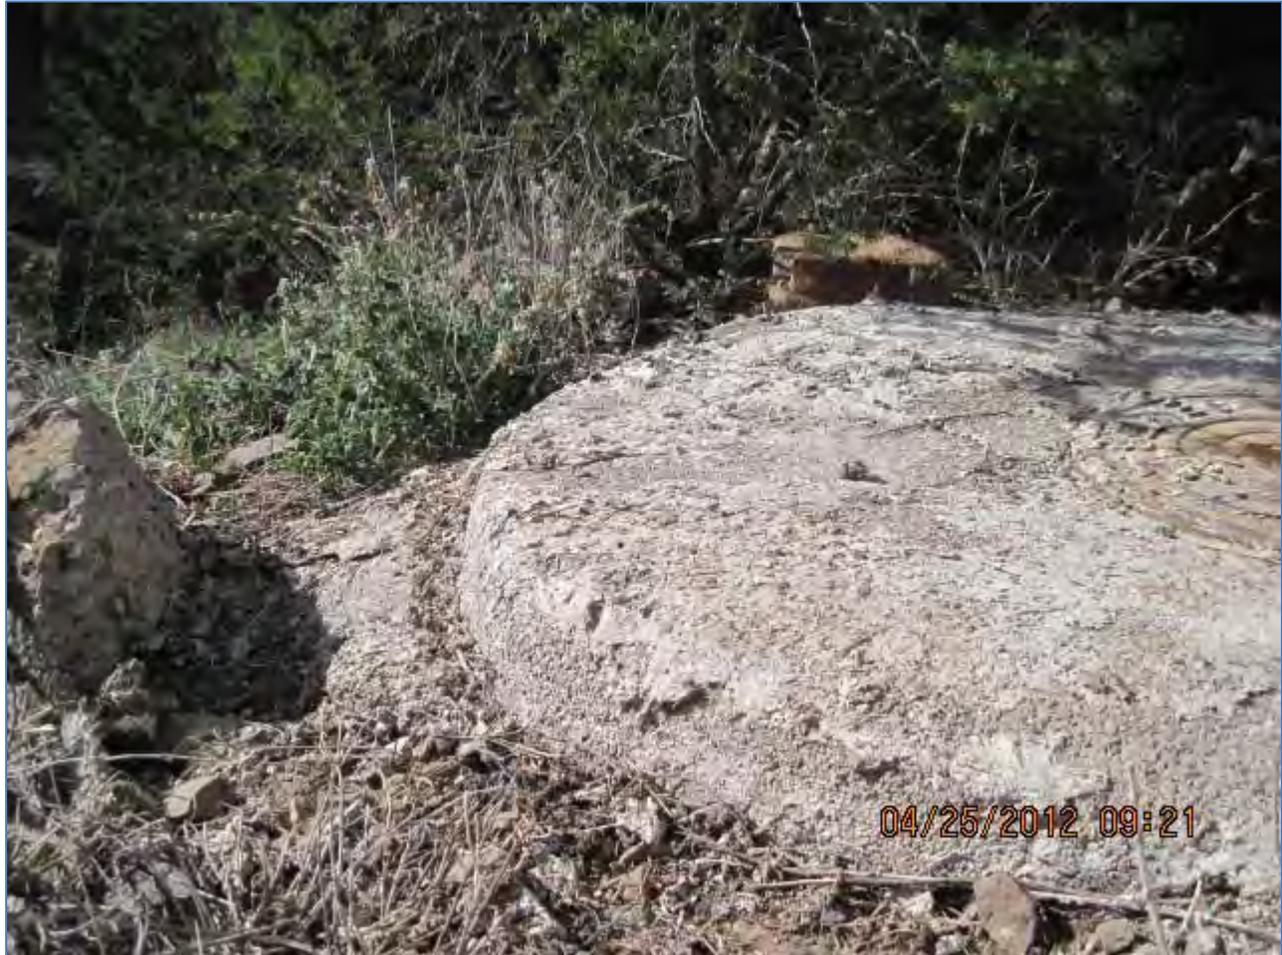
NMED/SWQB
Official Photograph Log
Photo # 11

Photographer: Erin S. Trujillo	Date: 04/25/2012	Time: 0921 hours
City/County: Silver City / Grant County	State: New Mexico	
Location: SSO north of Pinon Lane		
Subject: Some remaining dry solids (paper) on manhole that had overflow. There was no remaining sewage odor in this area.

The sewage overflow that occurred in the collection system north of Pinon Lane resulted in the discharge of solids to a surface water tributary to Maudes Canyon. Chlorine solution was used to disinfect sewage in the receiving stream channel and pools. Some paper solids that were not raked or shoveled because of bedrock remained in the channel on the day of this inspection. No settleable or floatable solids from the sewage overflow were observed in the remaining pool on the day of this inspection.

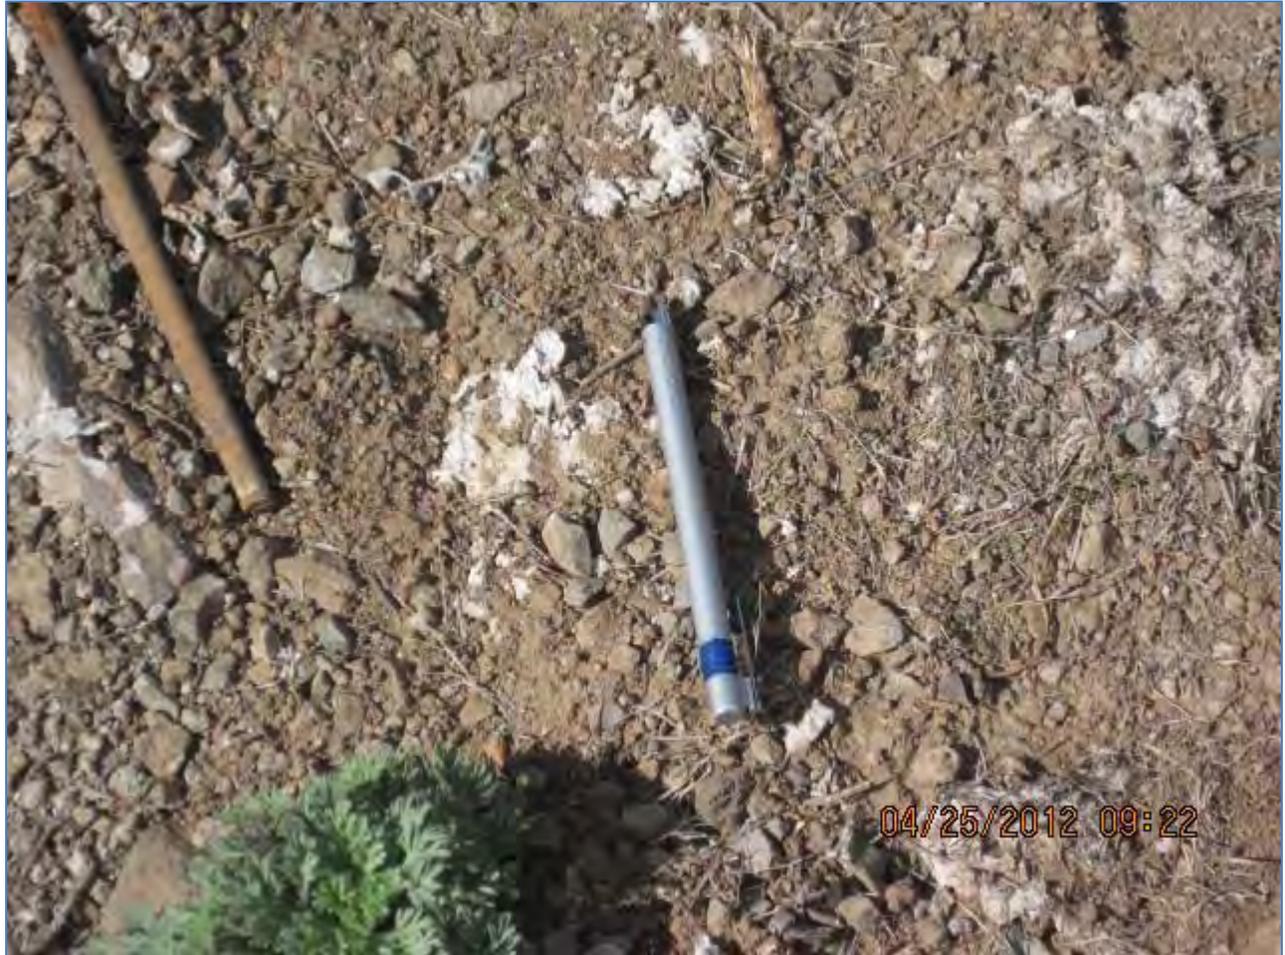
NMED/SWQB
Official Photograph Log
Photo # 12

Photographer: Erin S. Trujillo	Date: 04/25/2012	Time: 0922 hours
City/County: Silver City/Grant County	State: New Mexico	
Location: SSO north of Pinon Lane		
Subject: Some remaining dry solids (paper) above stream channel. There was no remaining sewage odor in this area.

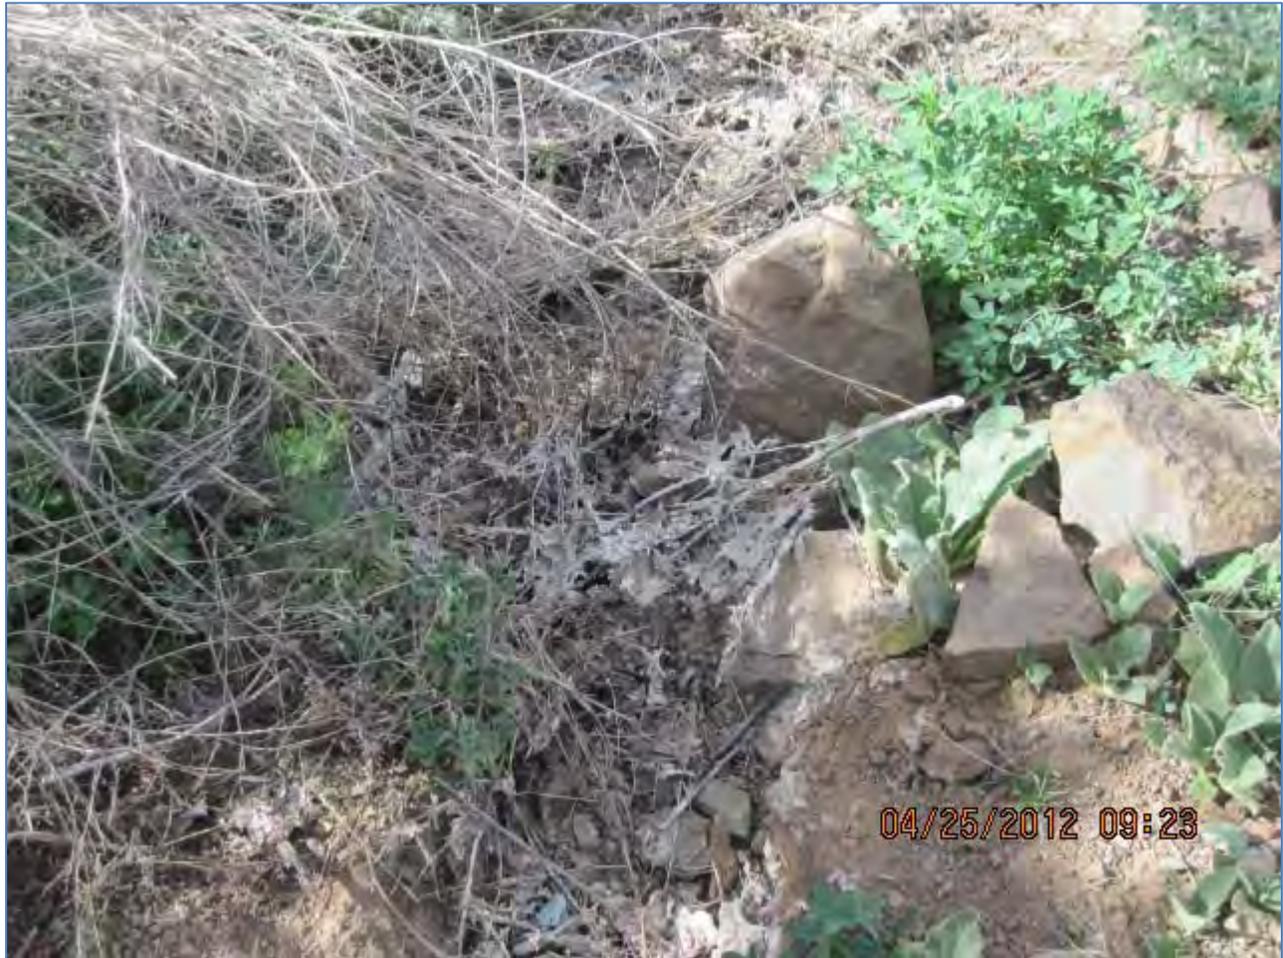
NMED/SWQB
Official Photograph Log
Photo # 13

Photographer: Erin S. Trujillo	Date: 04/24/2012	Time: 0923 hours
City/County: Silver City / Grant County	State: New Mexico	
Location: SSO north of Pinon Lane		
Subject: Remaining dry solids on vegetation and ground in stream channel. There was no remaining sewage odor in this area.

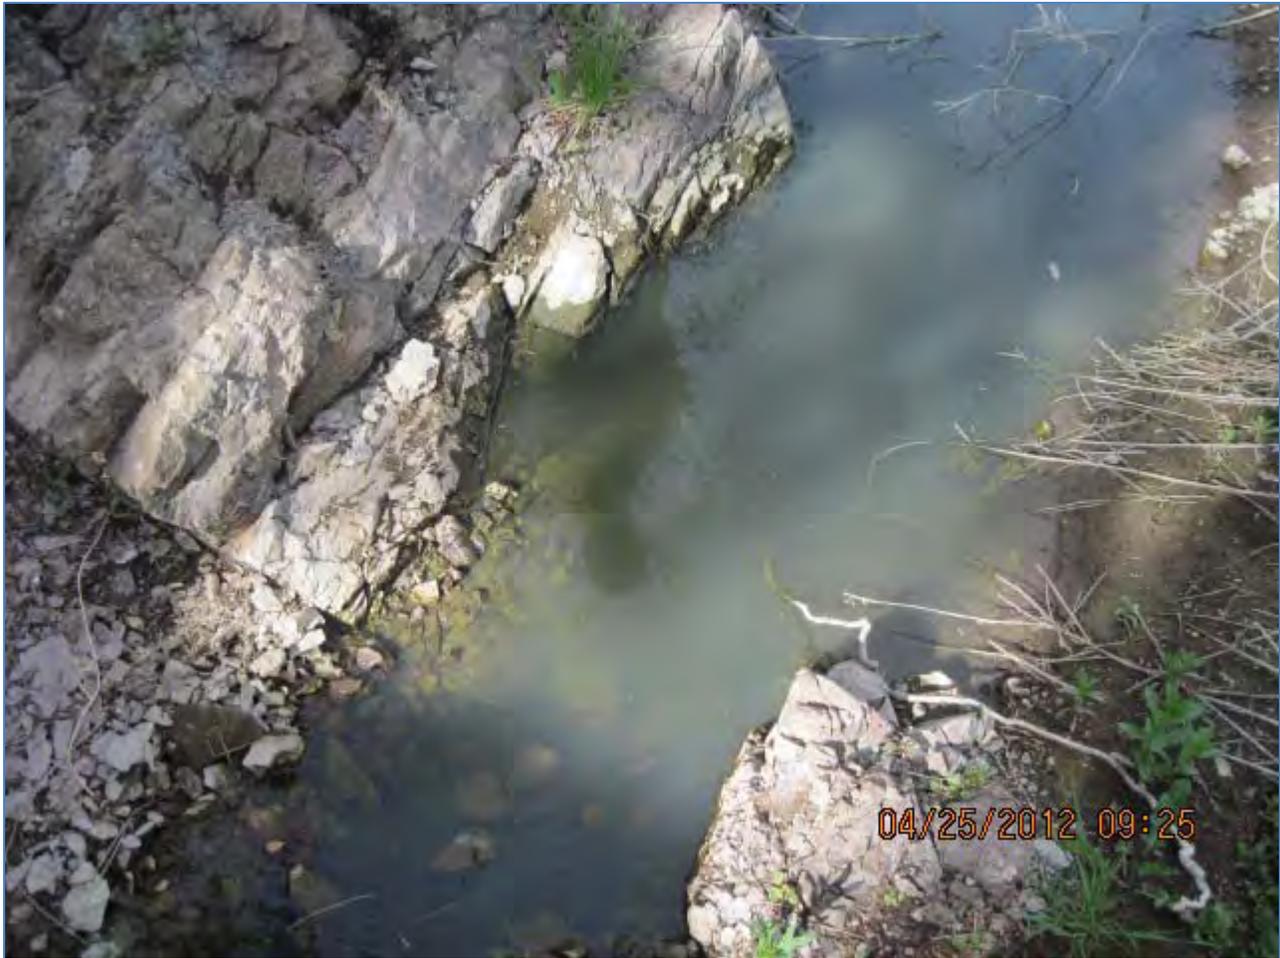
NMED/SWQB
Official Photograph Log
Photo # 14

Photographer: Erin S. Trujillo	Date: 02/25/2012	Time: 0925 hours
City/County: Silver City / Grant County	State: New Mexico	
Location: Pool in Unnamed Tributary above described SSO north of Pinon Lane		
Subject: Surface water in a remaining pool upgradient of where the overflow was described by the Permittees on-site representatives to have entered the stream channel appeared green from algal growth and had a faint odor common of stagnant water. No settled or floatable solids from the sewage overflow were observed in the remaining pool on the day of this inspection.

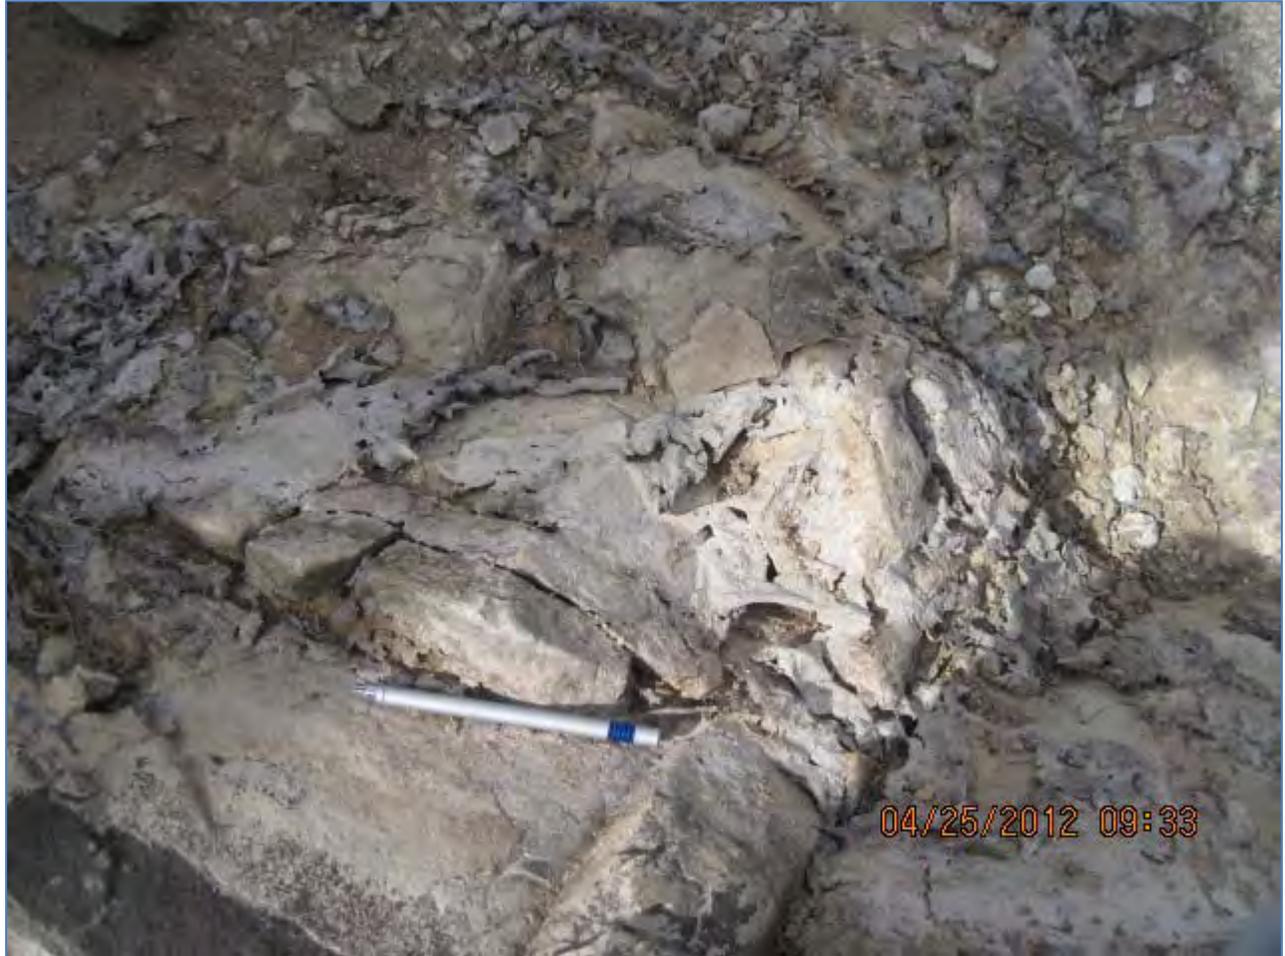
NMED/SWQB
Official Photograph Log
Photo # 15

Photographer: Erin S. Trujillo	Date: 04/25/2012	Time: 0933 hours
City/County: Silver City / Grant County	State: New Mexico	
Location: SSO north of Pinon Lane		
Subject: Remaining dry solids from sewage overflow on bedrock in stream channel. There was no remaining sewage odor in this area.

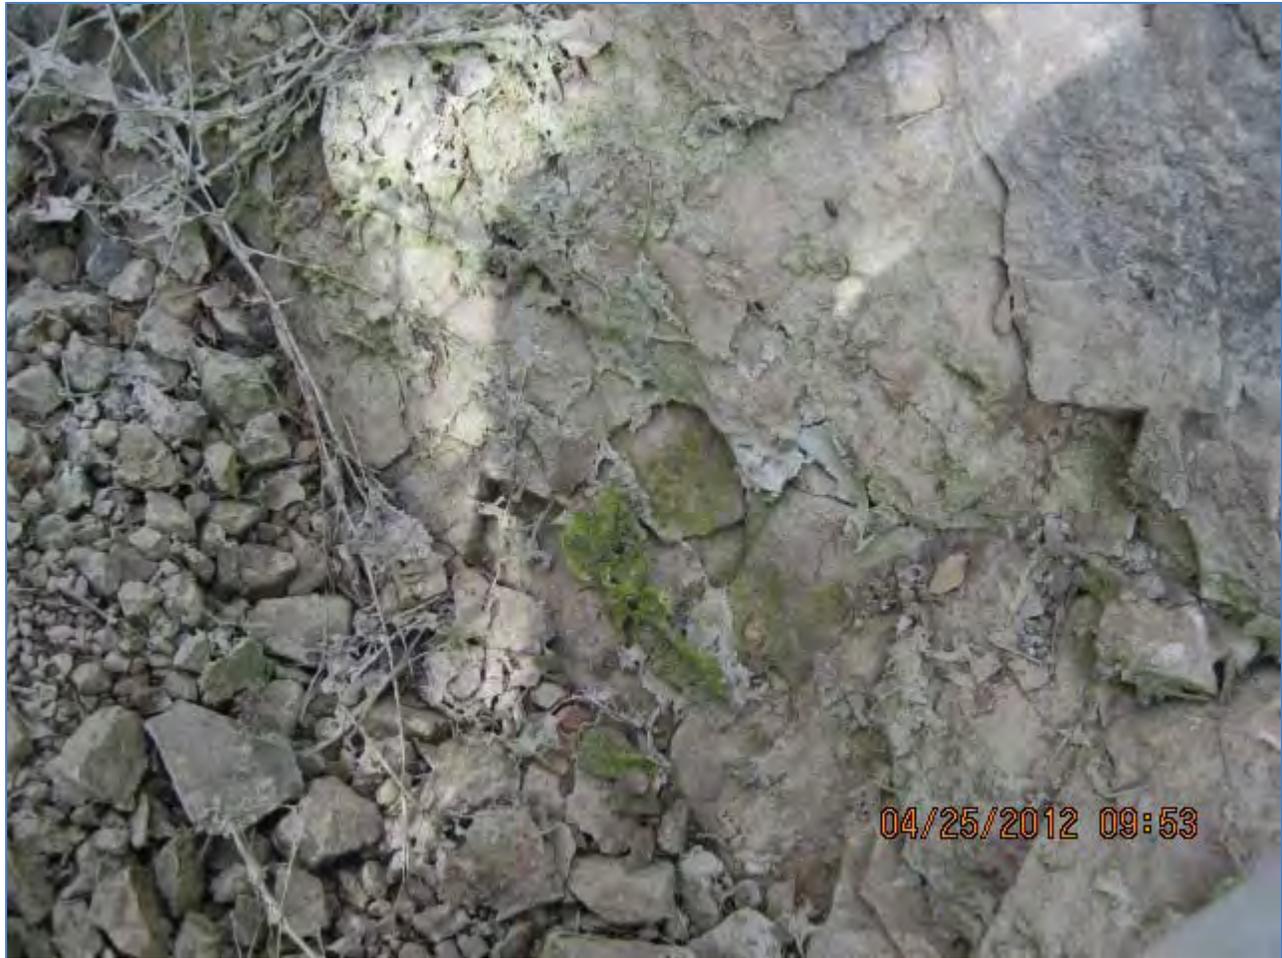
NMED/SWQB
Official Photograph Log
Photo # 16

Photographer: Erin S. Trujillo	Date: 04/25/2012	Time: 0953 hours
City/County: Silver City / Grant County	State: New Mexico	
Location: Unnamed tributary below SSO north of Pinon Lane		
Subject: Dried mud and algal growth was observed on bedrock and vegetation in the stream channel near the culverts at Pinon Lane (approximately 700 feet downstream from the manhole that overflowed). There was no sewage odor associated with these dried muds. It did not appear that the sewage overflow that continued approximately 300 feet downstream from the manhole continued downstream to this area near the culverts at Pinon Lane.
