Re: Minor Municipal; SIC 4952; NPDES Compliance Evaluation Inspection; Los Alamos County Wastewater Treatment Plant; NM0020133; March 6, 2012

### NPDES Compliance Inspection Report

On 6 March 2012 a Compliance Evaluation Inspection (CEI) was conducted at the Los Alamos County White Rock Wastewater Treatment Plant (WWTP) NM0020133 by Barbara Cooney of the State of New Mexico Environment Department (NMED), Surface Water Quality Bureau (SWQB).

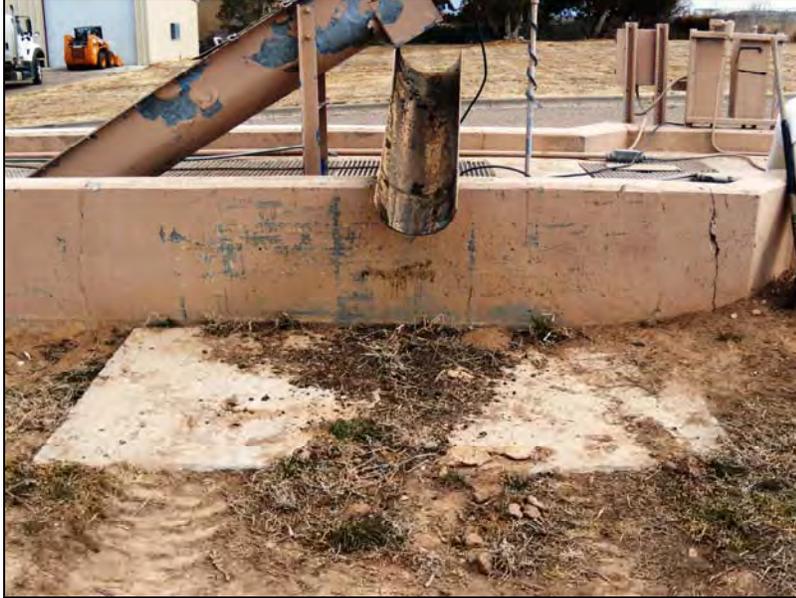
NMED/SWQB  
Official Photograph Log  
Photo # 1

Subject: Headworks - screw pump. Note the debris on bare ground past the cement receptacle pad.

4. The screw pump at the headwork has a shoot that allows the removed solids to flow into a receptacle to be taken to the landfill. The cement platform for the receptacle does not have berms around it and a small amount of solids could be seen on the bare ground past the cement. These solids should be contained.

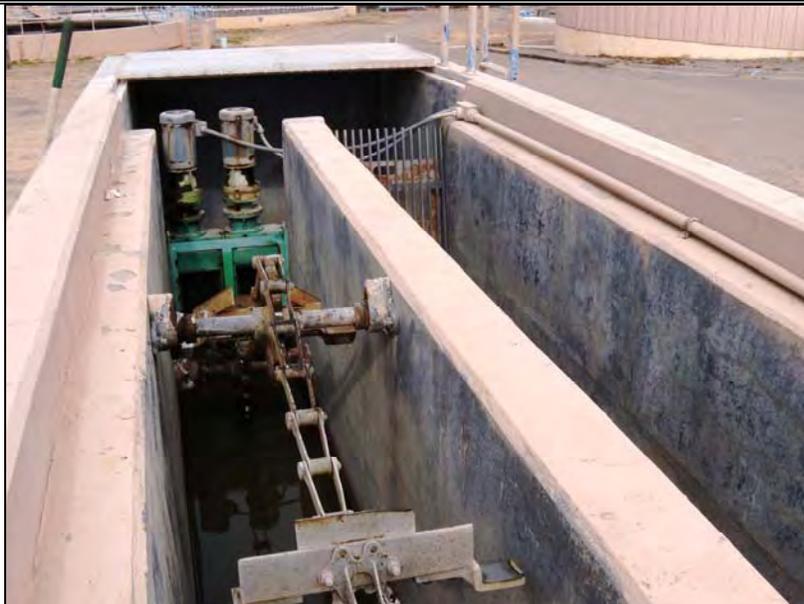
NMED/SWQB  
Official Photograph Log  
Photo # 2

Subject: Parallel Grit chamber to the grinder at the headworks.

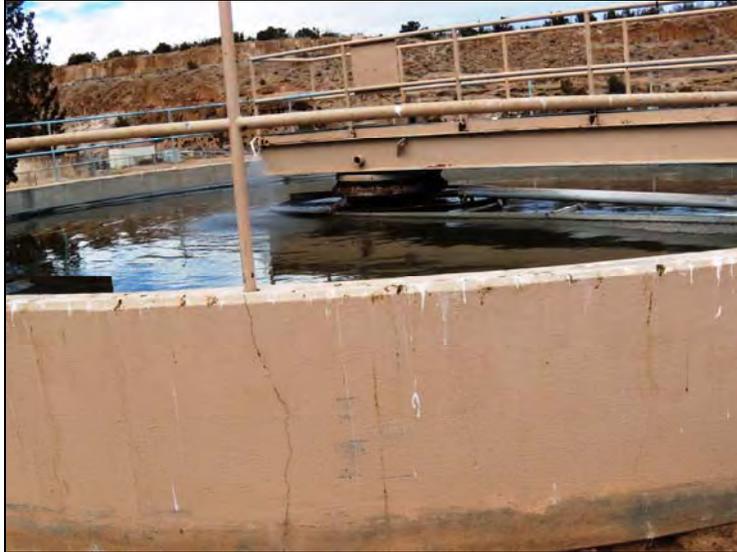
NMED/SWQB  
Official Photograph Log  
Photo #3

Subject: West Primary Clarifier - note some cracking in the walls. The plant is more than 20 years old.

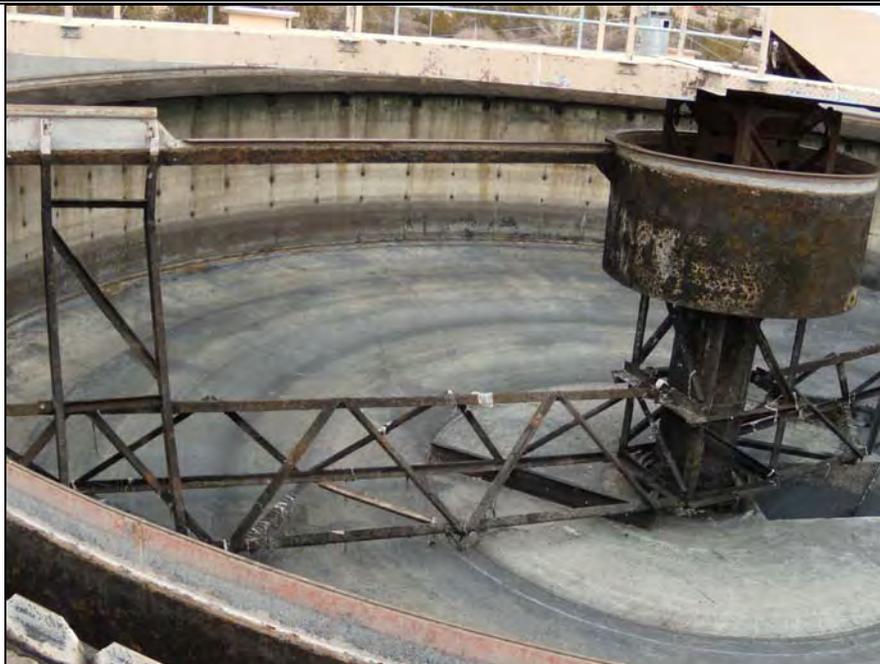
NMED/SWQB  
Official Photograph Log  
Photo #4

Subject: The East Primary Clarifier is off line for service. The Actual flow through the WWTP is less than 1/2 the design capacity so all the flow at this stage of the treatment can be processed at the West Primary Clarifier.

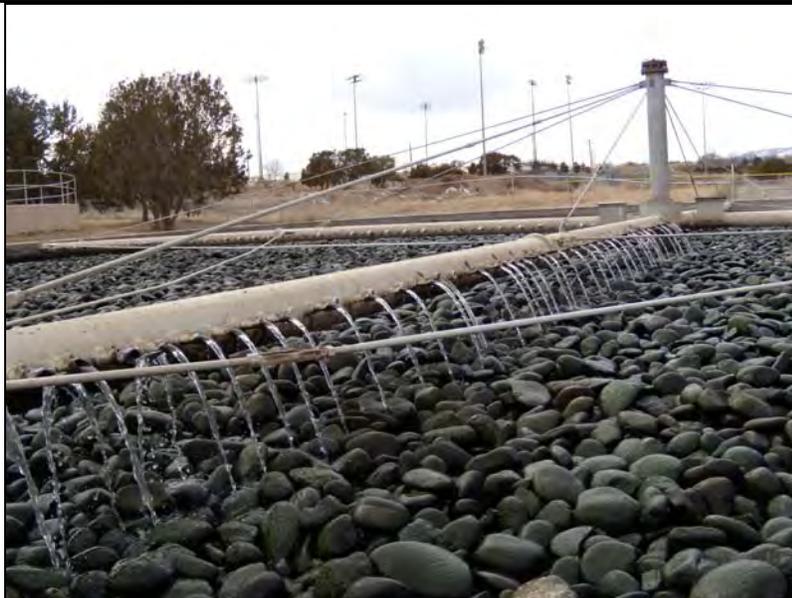
NMED/SWQB  
Official Photograph Log  
Photo # 5

The distribution arms all appeared to be operating properly and evenly spreading the waste water over the rocks.

Subject: West Trickling Filter has health Zooglea slime growth. The distribution arms were clear of debris and an even spread of water was flowing.

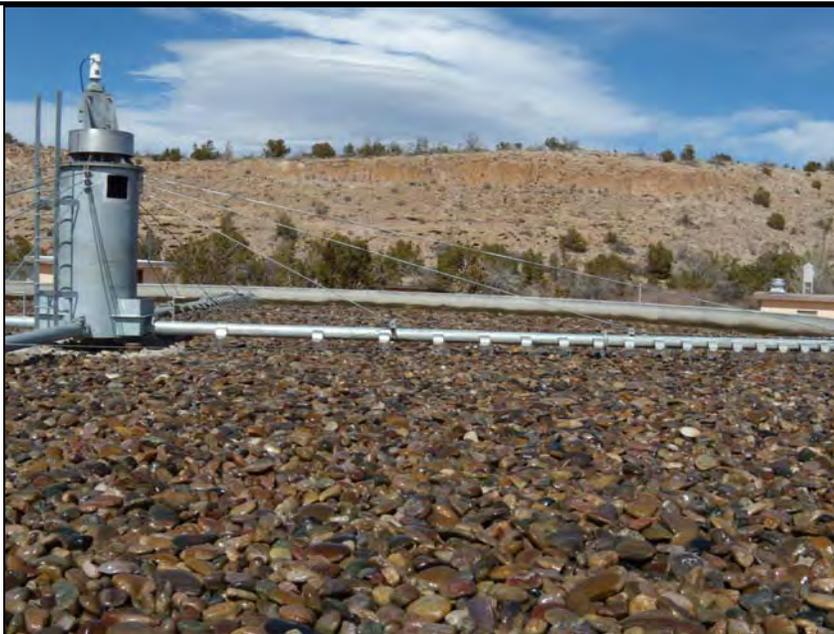
NMED/SWQB  
Official Photograph Log  
Photo # 6

1. The two trickling filters are run in series. The County recently rehabilitated one of the trickling filters that was put back on line January 2012. The zoogical growth on that trickling filter was very sparse. It appears that three factors are contributing to the lack of growth on the rough rock media: 1. Lack of enough "food" in the wastewater to promote and sustain growth. 2. Cold winter weather reduces the growth. 3. The filter has been on line for just two months. Even though it has been on line for only two months, if there was sufficient food, even in cold weather the growth should have returned on this media.

Subject: East Trickling Filter: Came on line in January 2012 just a few months before this photo was taken. Note the limited Zooglea growth on the rock media compared with the photo of the West Trickling Filter.

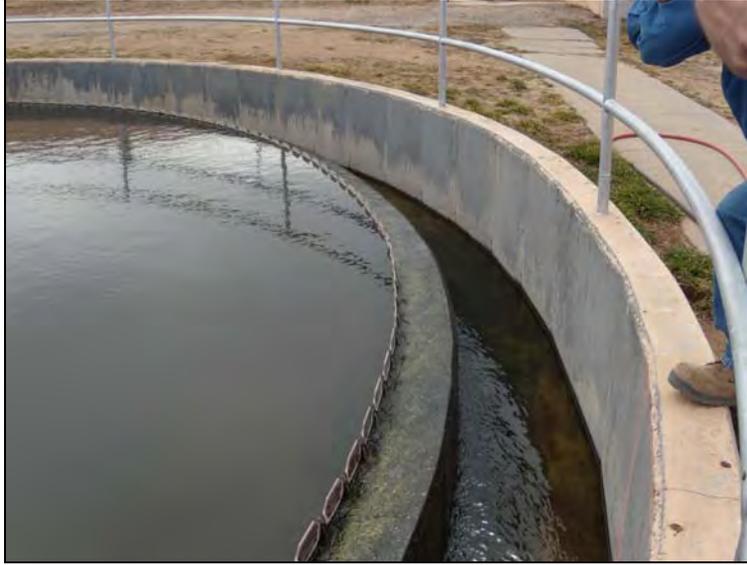
NMED/SWQB  
Official Photograph Log  
Photo # 7

Subject: East Secondary Clarifier: The weirs were clean and there was not apparent short circuiting from the basin.

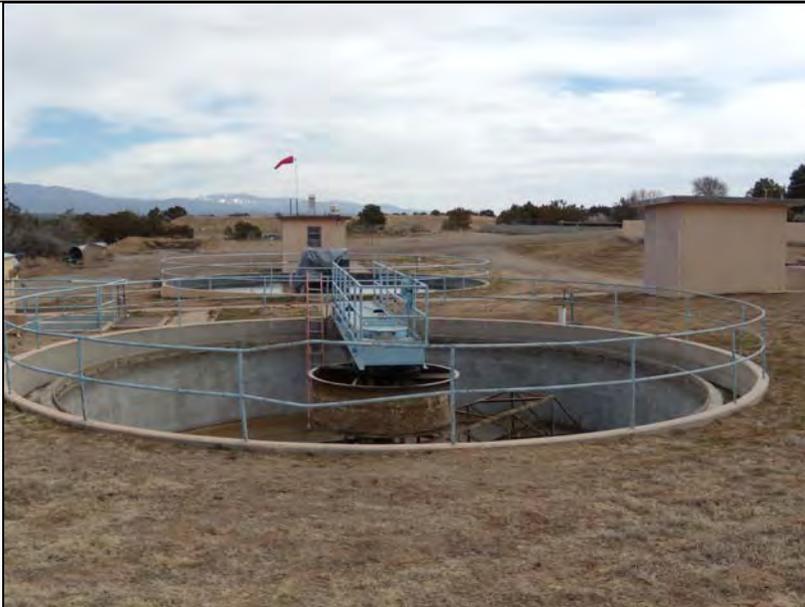
NMED/SWQB  
Official Photograph Log  
Photo # 8

Subject: West Secondary Clarifier is off line.

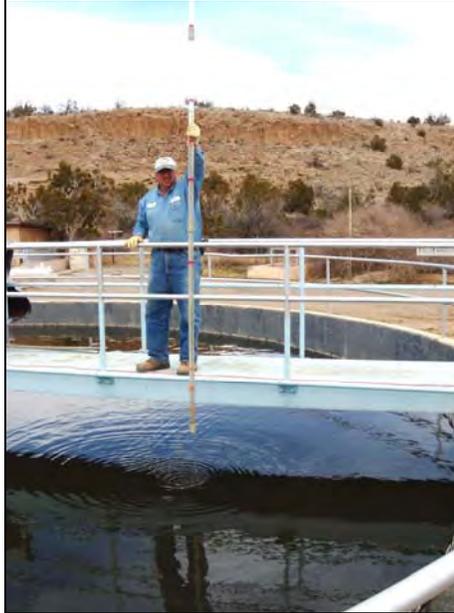
NMED/SWQB  
Official Photograph Log  
Photo # 9

Subject: East Secondary Clarifier has only a few inches of solids after wasting.

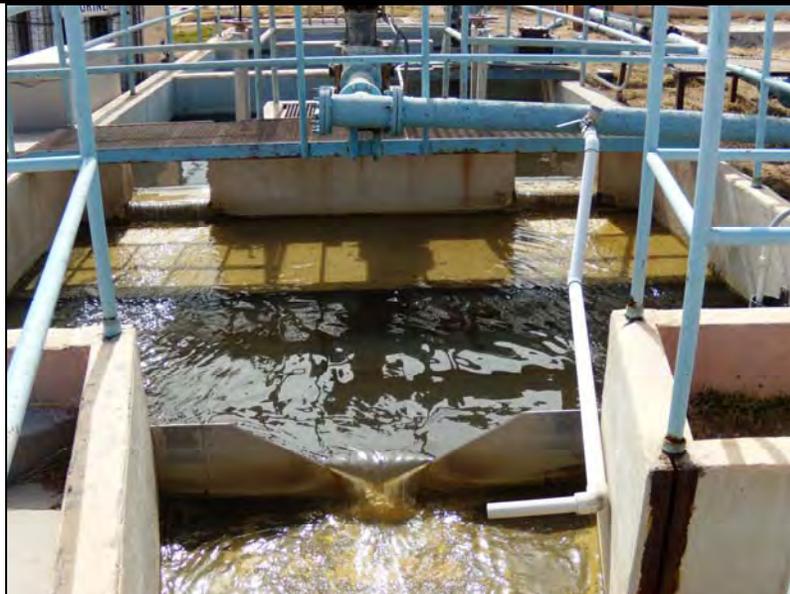
NMED/SWQB  
Official Photograph Log  
Photo # 10

Subject: Following the Chlorine Contact Chamber is the De-Chlorination basin. Water treated by trickling filters typically have a slight color of yellow-green -brown as seen in this photo.

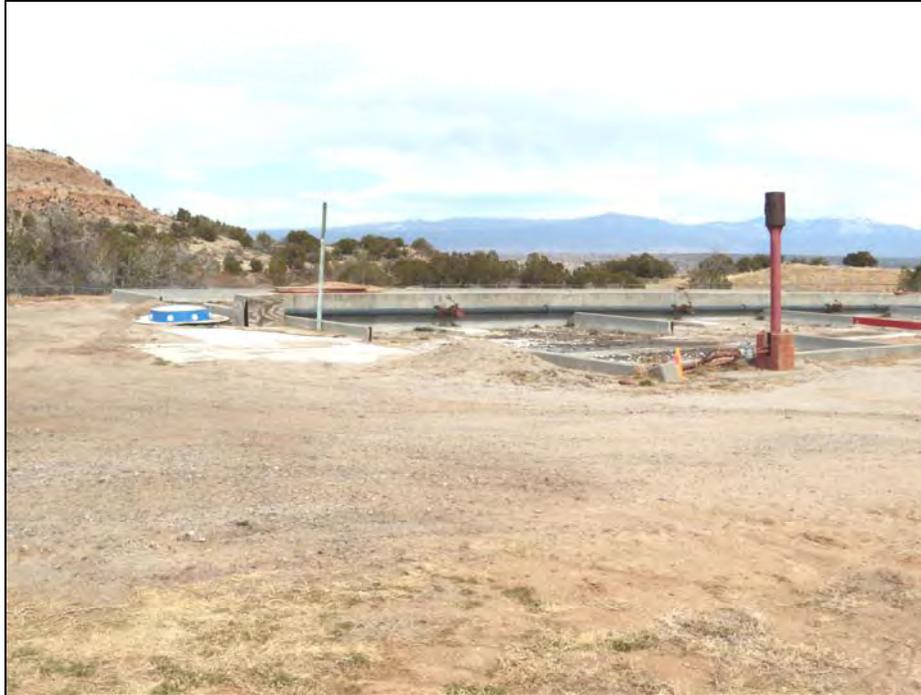
NMED/SWQB  
Official Photograph Log  
Photo # 11

3. The aerobic digester has been taken out of service and is currently acting as a holding tank for the wasted solids. The heating boilers for the digester are no longer operable.

Subject: Sludge Drying Beds are not being used now that the Digester is out of operation.

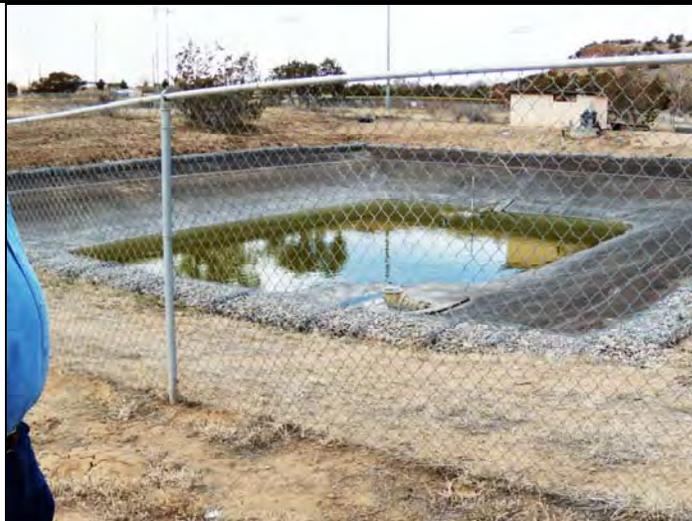
NMED/SWQB  
Official Photograph Log  
Photo # 12

Subject: Lined Reuse holding pond.
