NEW MEXICO  
ENVIRONMENT DEPARTMENT

*Surface Water Quality Bureau*

Re: **Major Municipal; SIC 4952; NPDES Compliance Evaluation Inspection; Farmington Wastewater Treatment Plant; NM0020583; May 24, 2012**

### NPDES Compliance Inspection Report

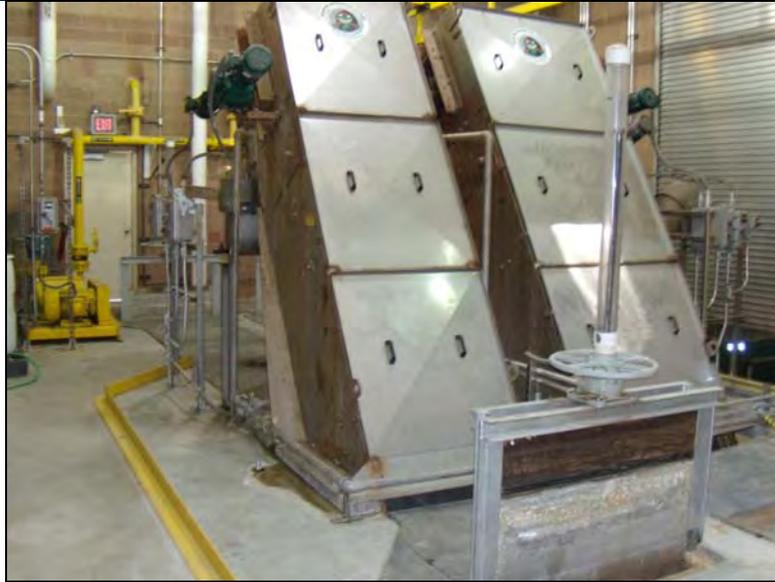
NMED/SWQB  
Official Photograph Log  
Photo # 1

Subject: Parallel Influent Channels - screw pumps for grit removal.

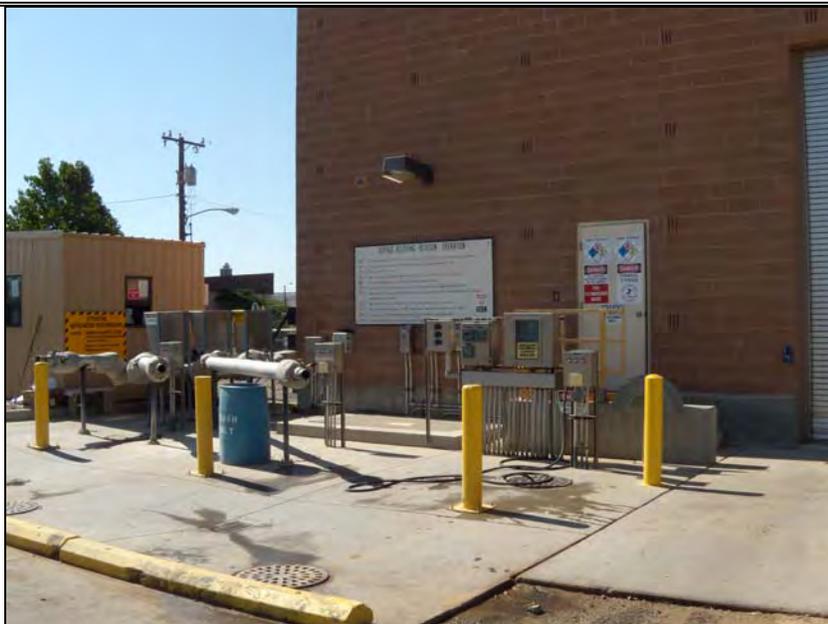
NMED/SWQB  
Official Photograph Log  
Photo # 2

Subject: Septage Dump Station - contained and monitored full time by an operator.

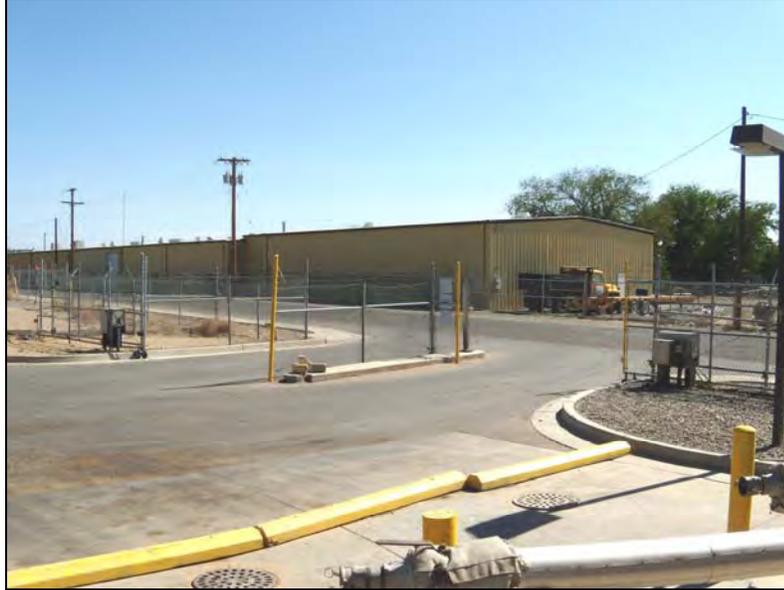
NMED/SWQB  
Official Photograph Log  
Photo #3

Subject: Berms at the Septage Dump Station - contain waste from leaving the site.

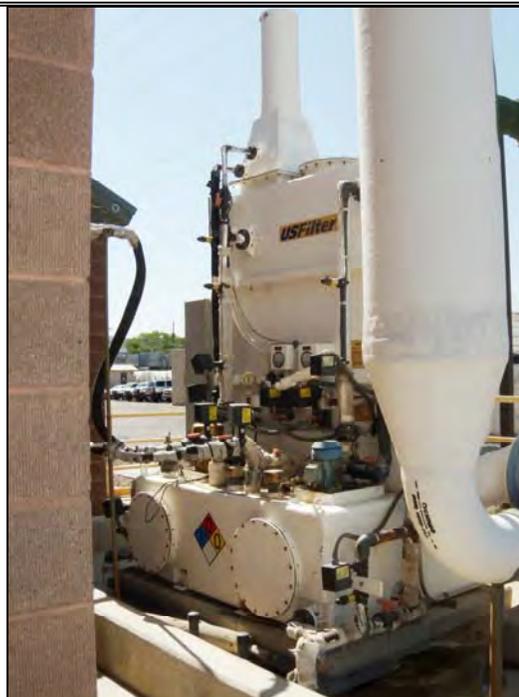
NMED/SWQB  
Official Photograph Log  
Photo #4

4. The air scrubber system at the head works has been modified to incorporate a water and biological media system that is effective at reducing the potential release of influent odors and noxious gasses.

Subject: Influent Air Scrubber System - An innovative use of water and biological filtration.

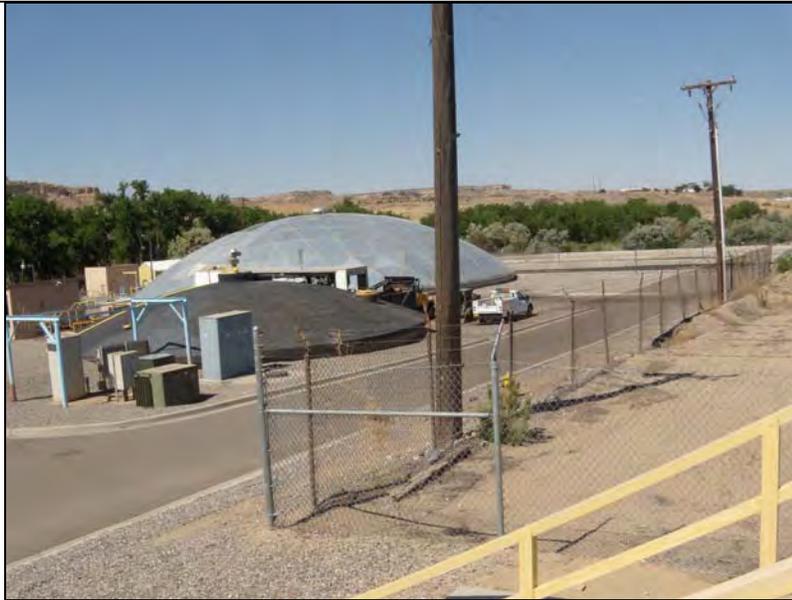
NMED/SWQB  
Official Photograph Log  
Photo # 5

Subject: Covered Tricking Filters.

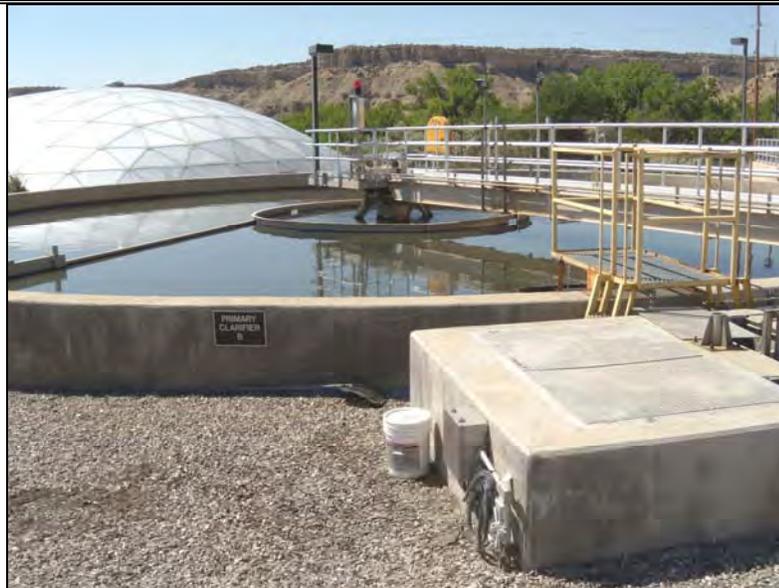
NMED/SWQB  
Official Photograph Log  
Photo # 6

Subject: One of two primary clarifiers

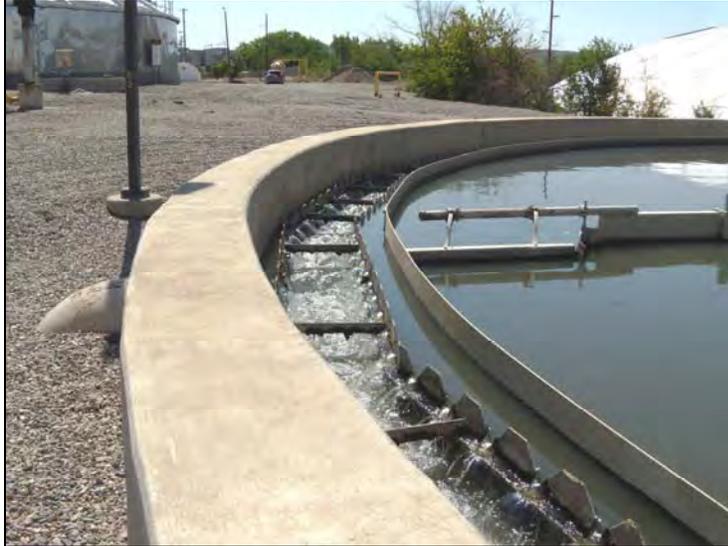
NMED/SWQB  
Official Photograph Log  
Photo # 7

Subject: Primary clarifier - weirs are level and no evidence of short circuiting occurring.

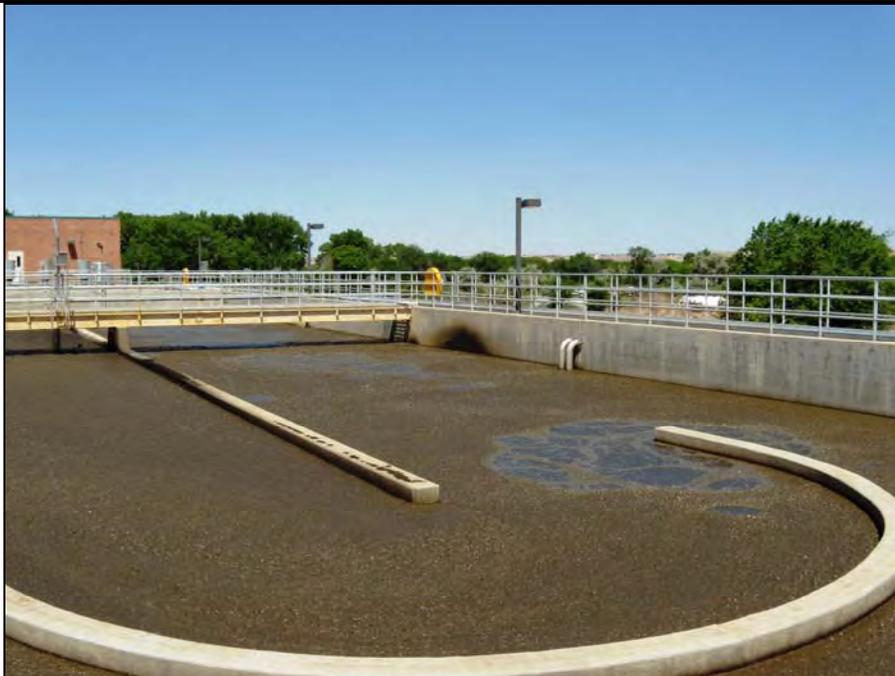
NMED/SWQB  
Official Photograph Log  
Photo # 8

5. The MRAS treatment unit had a slightly grey color, indicating some unhealthy effects of recent influent on the aerobic microbes in the treatment unit. Prior to the inspection there had been some unknown substances entering the collection system in combination with the rapidly changing Spring season weather and increasing temperatures. This requires close monitoring by the plant operators to insure effective treatment is maintained.

Subject: Medium Rate Activated Sludge System (MRAS). - the basin has both aerated and non-aerated sections for biological treatment.

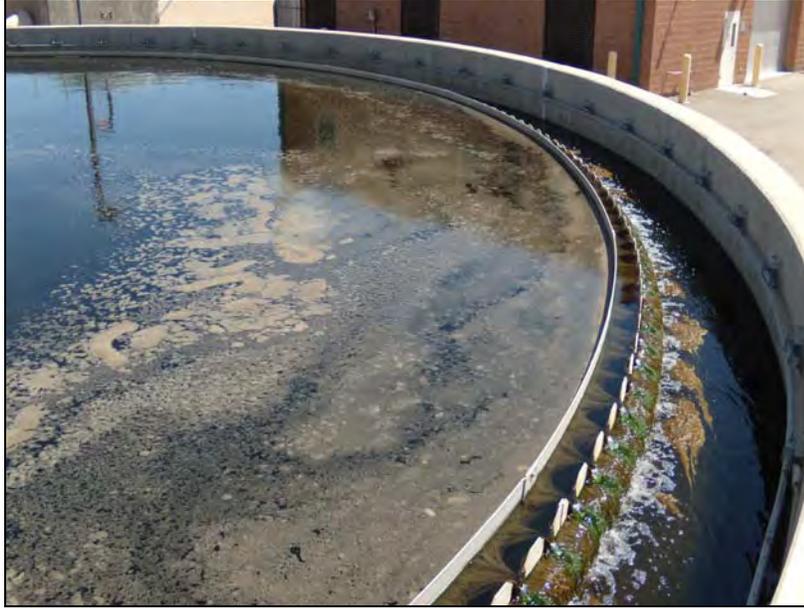
NMED/SWQB  
Official Photograph Log  
Photo # 9

Subject: Secondary Clarifier past the MRAS system shows signs of floating solids within the basin and algae on the weirs. It was scheduled for weekly cleaning the following day.

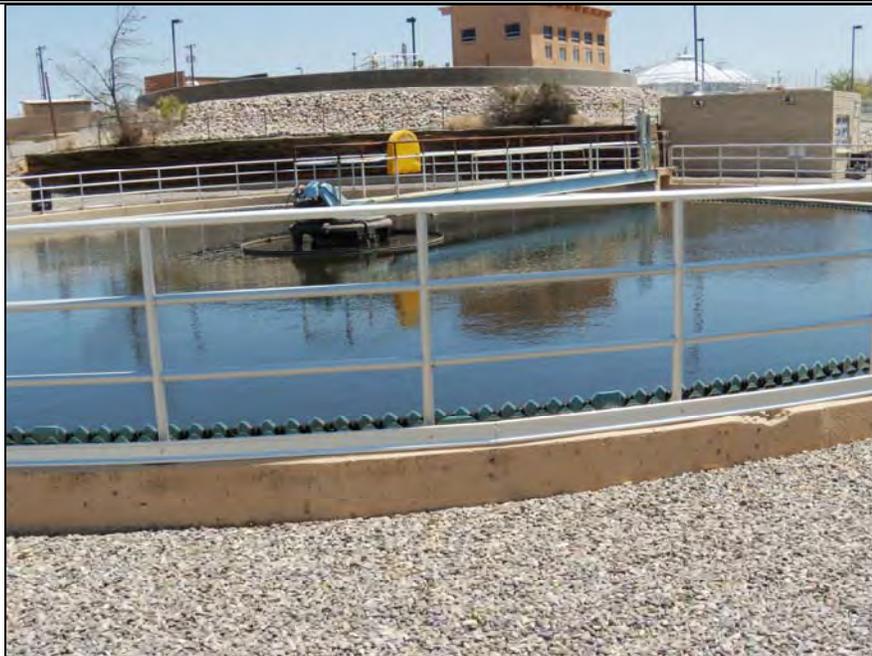
NMED/SWQB  
Official Photograph Log  
Photo # 10

Subject: Secondary Clarifier that receives water from the trickling filters - note the clear decant free of floating solids.

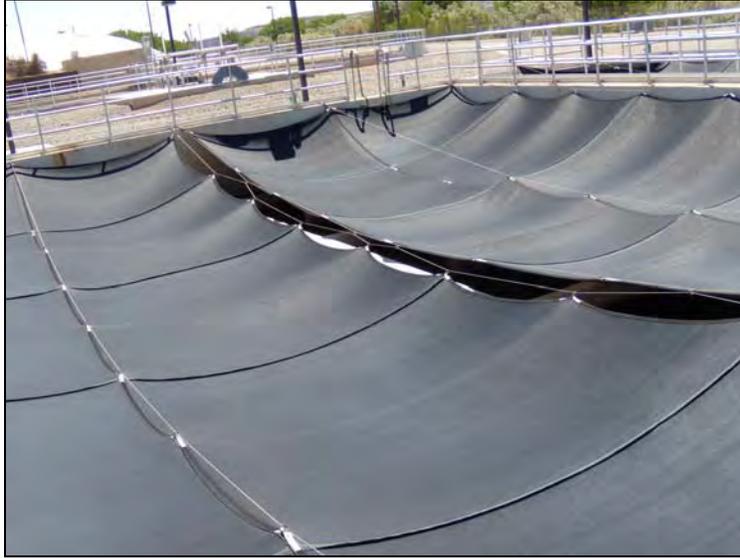
NMED/SWQB  
Official Photograph Log  
Photo # 11

Subject: The Chlorine Contact Chamber is covered to prevent excess growth of algae. It is important however that the basins are cleaned on a regular basis to remove any other solids that make it past the secondary clarifiers.

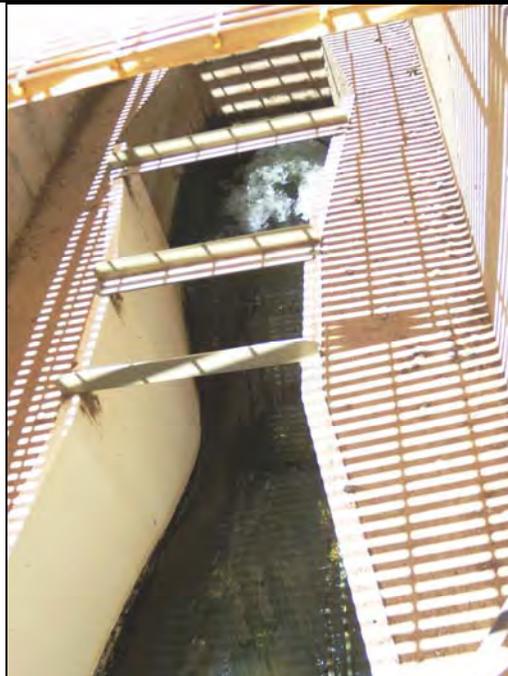
NMED/SWQB  
Official Photograph Log  
Photo # 12

Subject: Effluent Channel with Parshall Flume - Staff gauge and ultrasonic flow meter. This is where effluent samples are taken for NPDES monitoring.

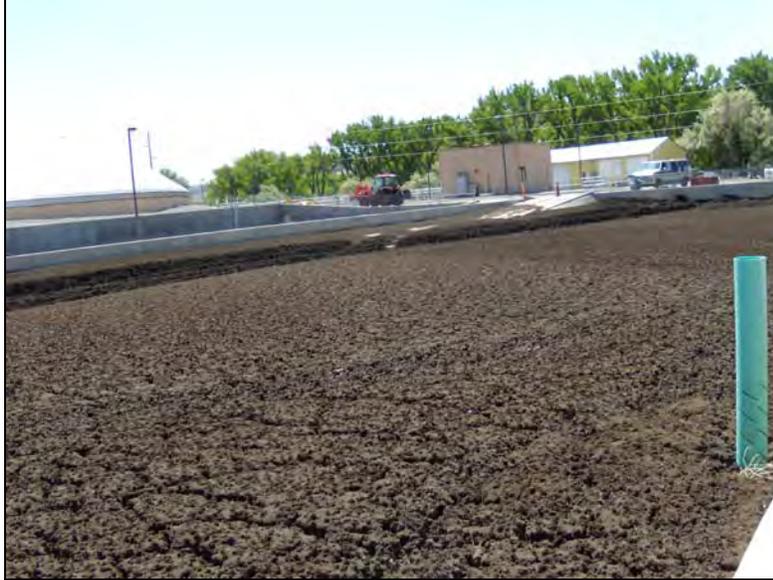
NMED/SWQB  
Official Photograph Log  
Photo # 13

Subject: Sludge Drying Beds are cement basins with under drains that send the water back to the head of the WWTP.
