Re: Wastewater Treatment Plant; Major; Municipal; SIC 4952; Tucumcari WWTP; NPDES Compliance Evaluation Inspection; NPDES NM0020711; August 15, 2013

NPDES Compliance Inspection Report

City of Tucumcari Wastewater Treatment Plant
NPDES Permit Number NM0020711
August 15, 2013

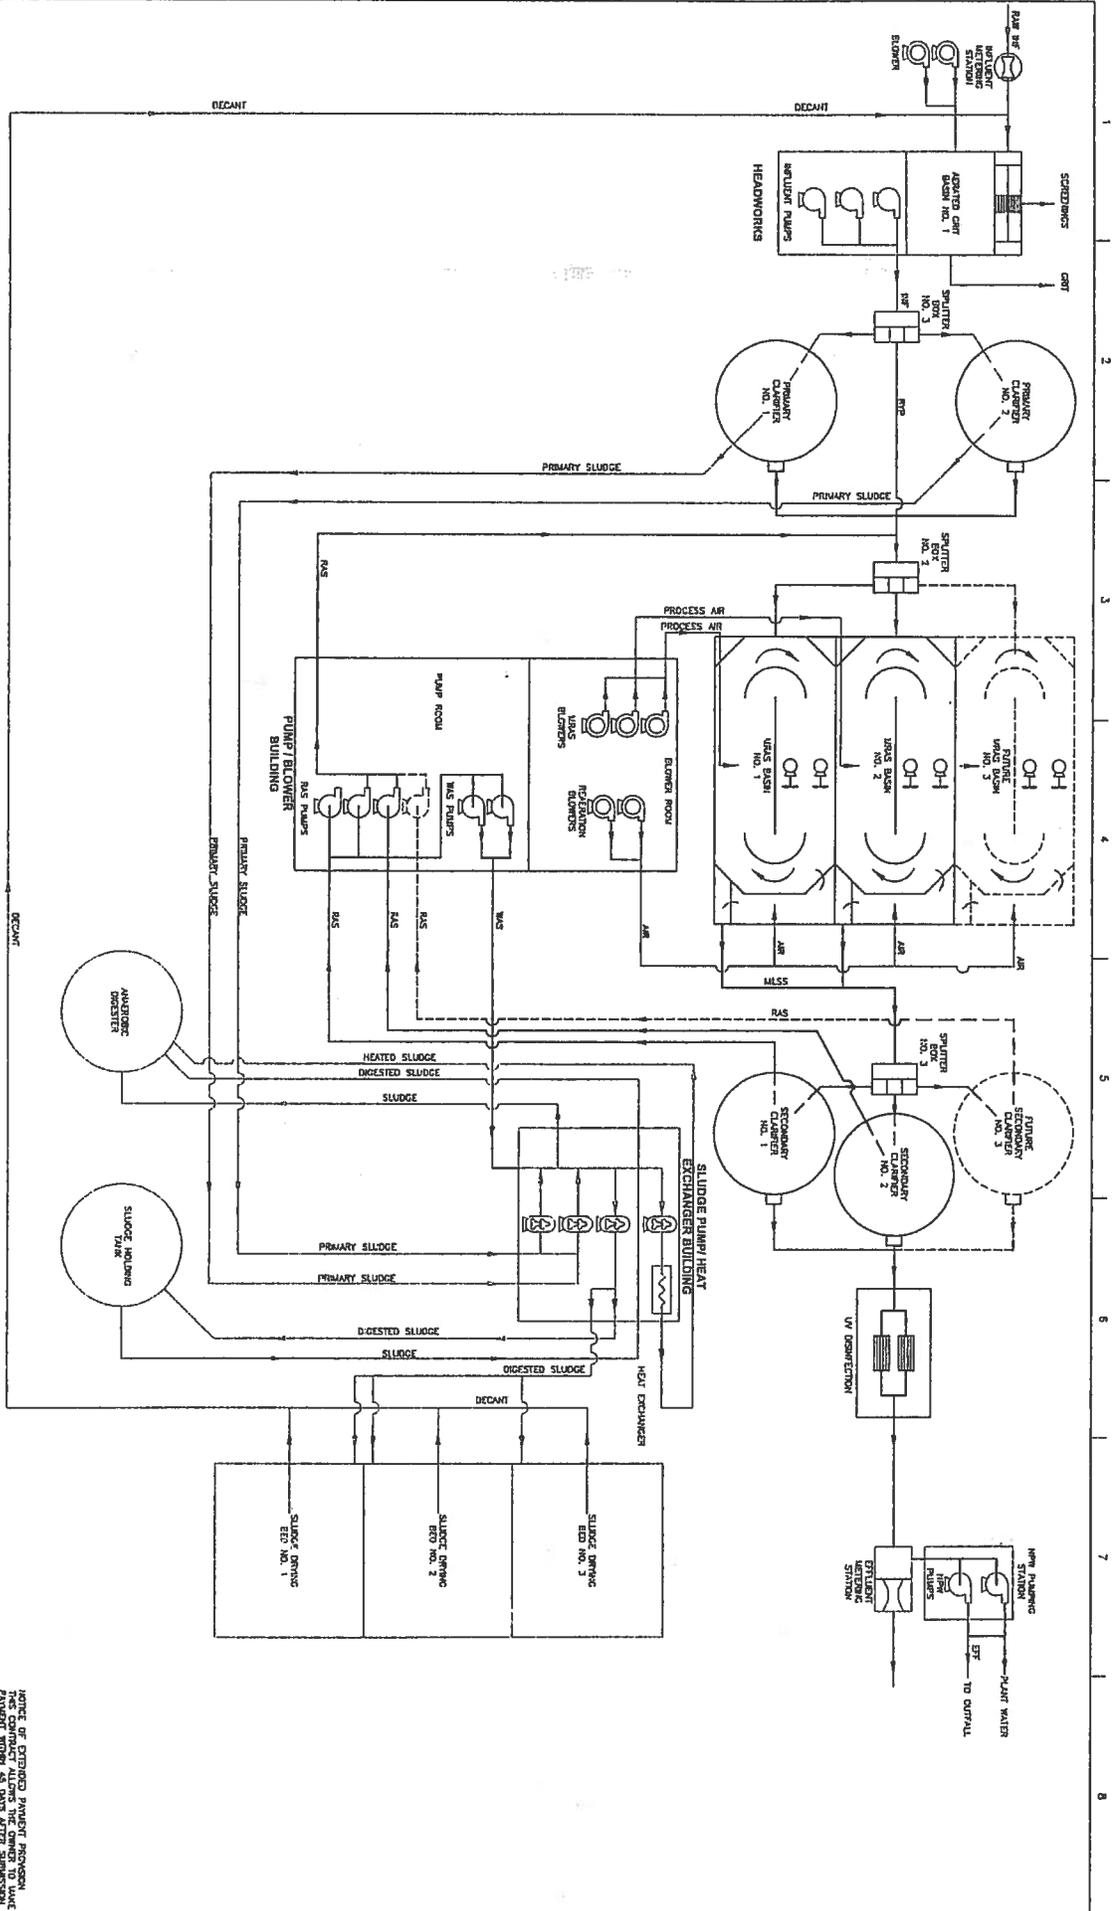
GENERAL PROCESS SCHEMATIC

CITY OF TUCUMCARI
WASTE WATER TREATMENT FACILITY
PHASE III IMPROVEMENTS

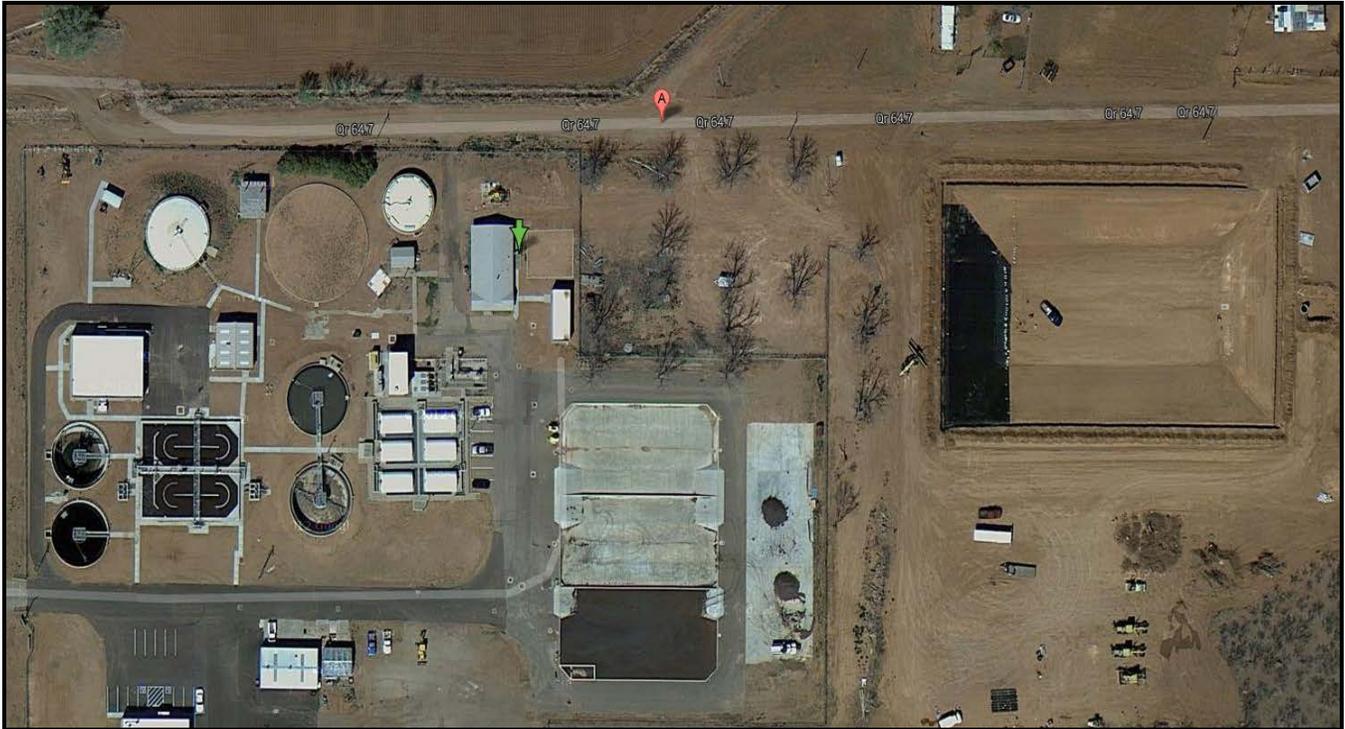
**NMED/SWQB
Site Overview**

| Subject: Tucumcari WWTP, picture taken 3/21/2012, recycle pond is being built. | |

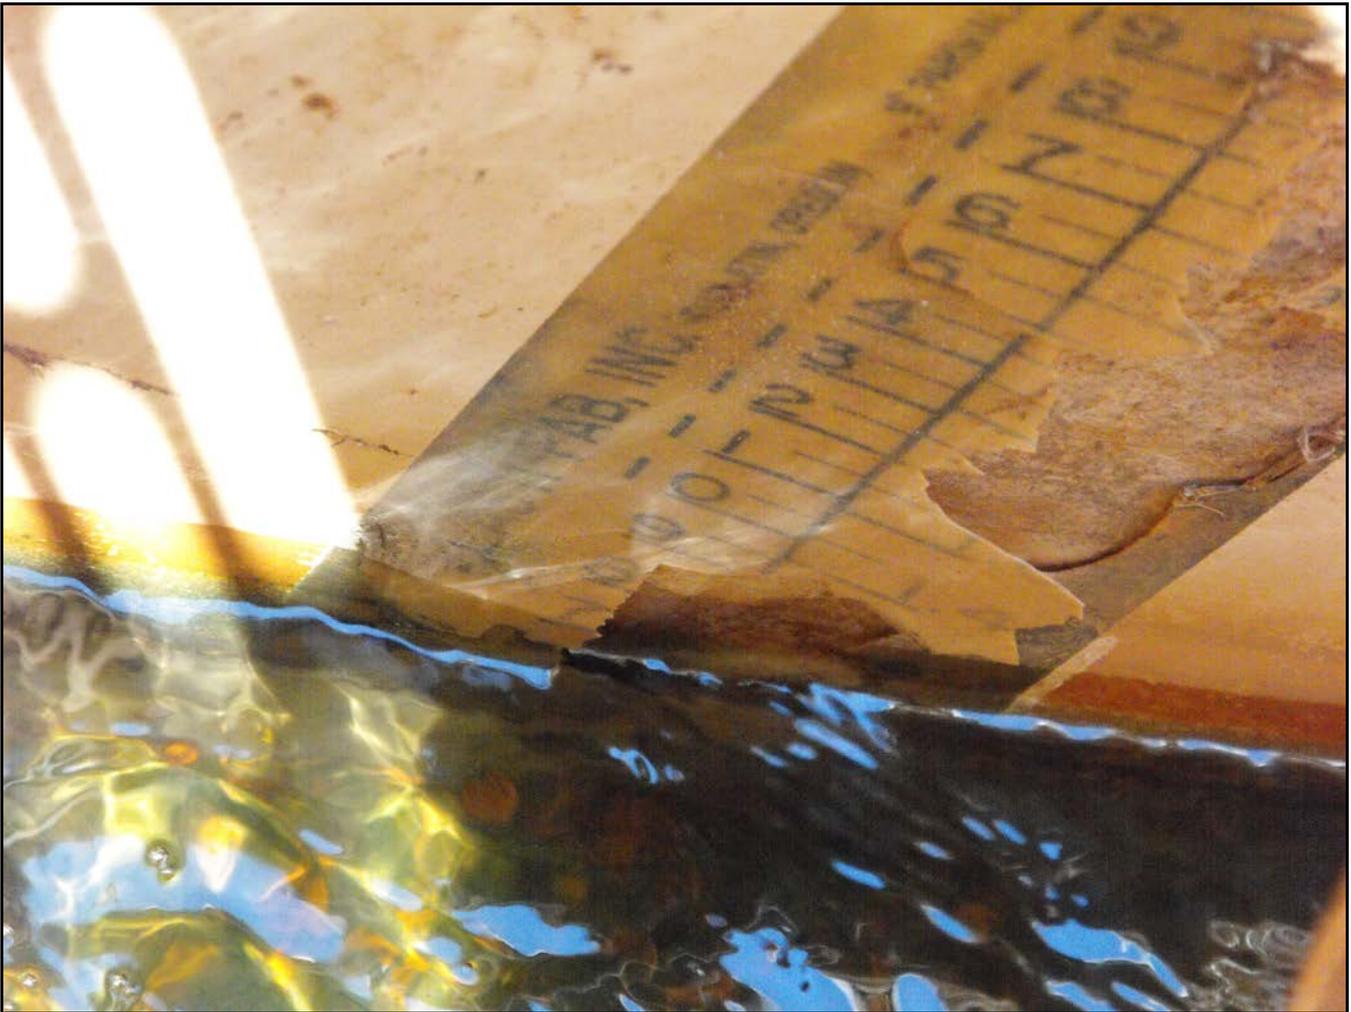
Photo # 1

Facility has a nine inch Parshall and Fisher & Porter ultrasonic flow meter at their effluent discharge point which was installed in November 2011. Per facility personnel no calibration checks have been performed at the flume. The staff gage was so worn and cracked at the bottom an accurate reading of the height of flow would be very difficult. **This is a repeat finding of the May 9, 2012 inspection.**

| Subject: Staff gauge on outfall flume. The gauge is cracked and cannot be read below 7". | | |

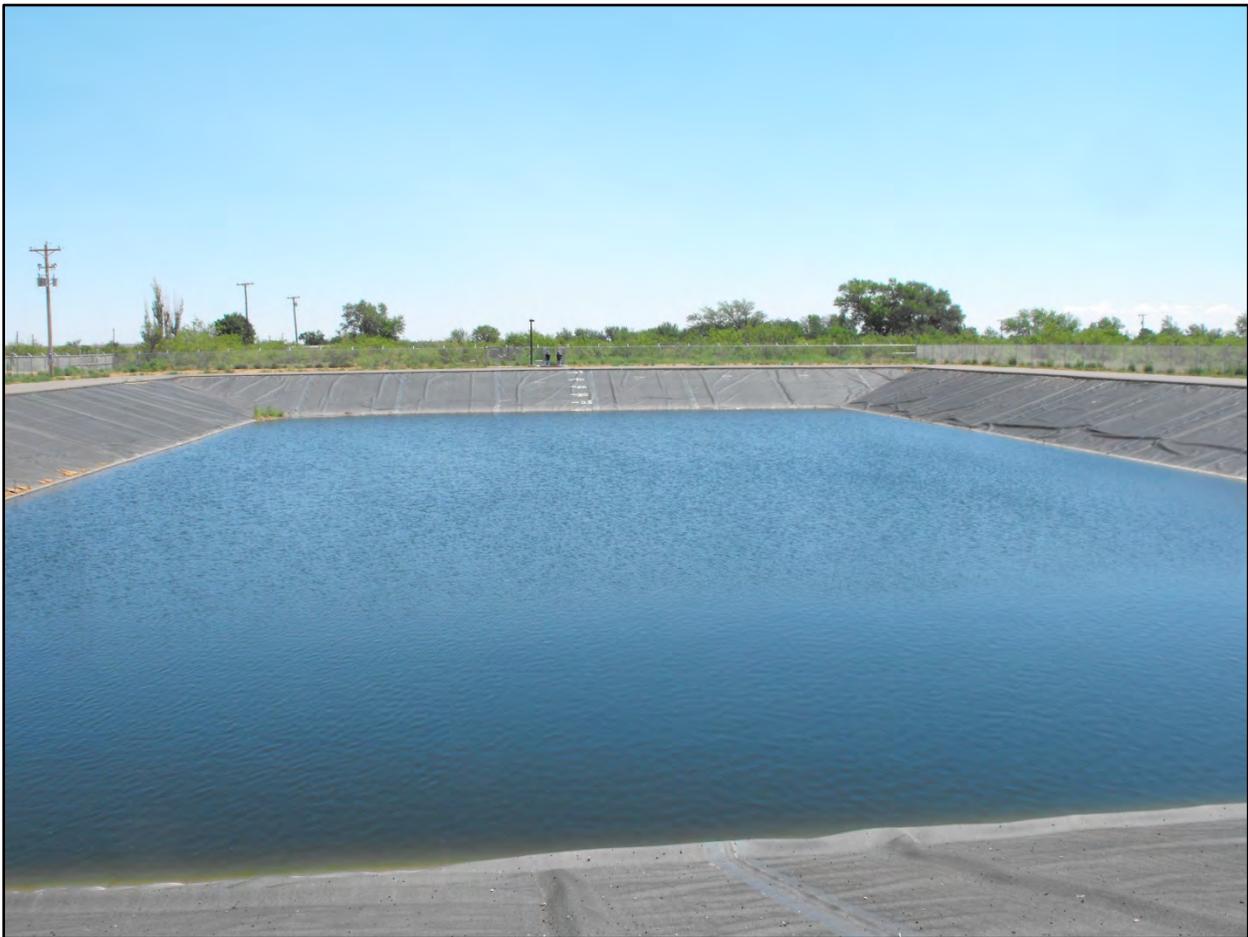
Photo # 2

The City has built a lined retention pond next to the WWTP; effluent from the plant is being diverted to this pond for reuse, (see photo 1.). At the present time this diversion is not being metered and subtracted from the discharge submitted on DMR's. The flows reported in the DMR's are not the correct values that should be used when calculating loading requirements. Thus the reported values are higher than what was discharged.

| Subject: Storage pond for effluent, to be piped to other areas for reuse. | | |
