**NEW MEXICO
ENVIRONMENT DEPARTMENT**

RE: Sanitary Sewer Overflow into the Rio San Jose, City of Grants (NM0020737/Terminated NPDES Permit) December 25, 2012

NPDES Compliance Inspection Report

Terminated NPDES Permit NM0020737
Lift Station #66 / 16" Force Main Break Sanitary Sewer Overflow
Spill Dates: December 25 – 26, 2012
NMED Site Inspection: January 7, 2012
NMED/SWQB Inspectors: Sandra Gabaldon, Daniel Valenta

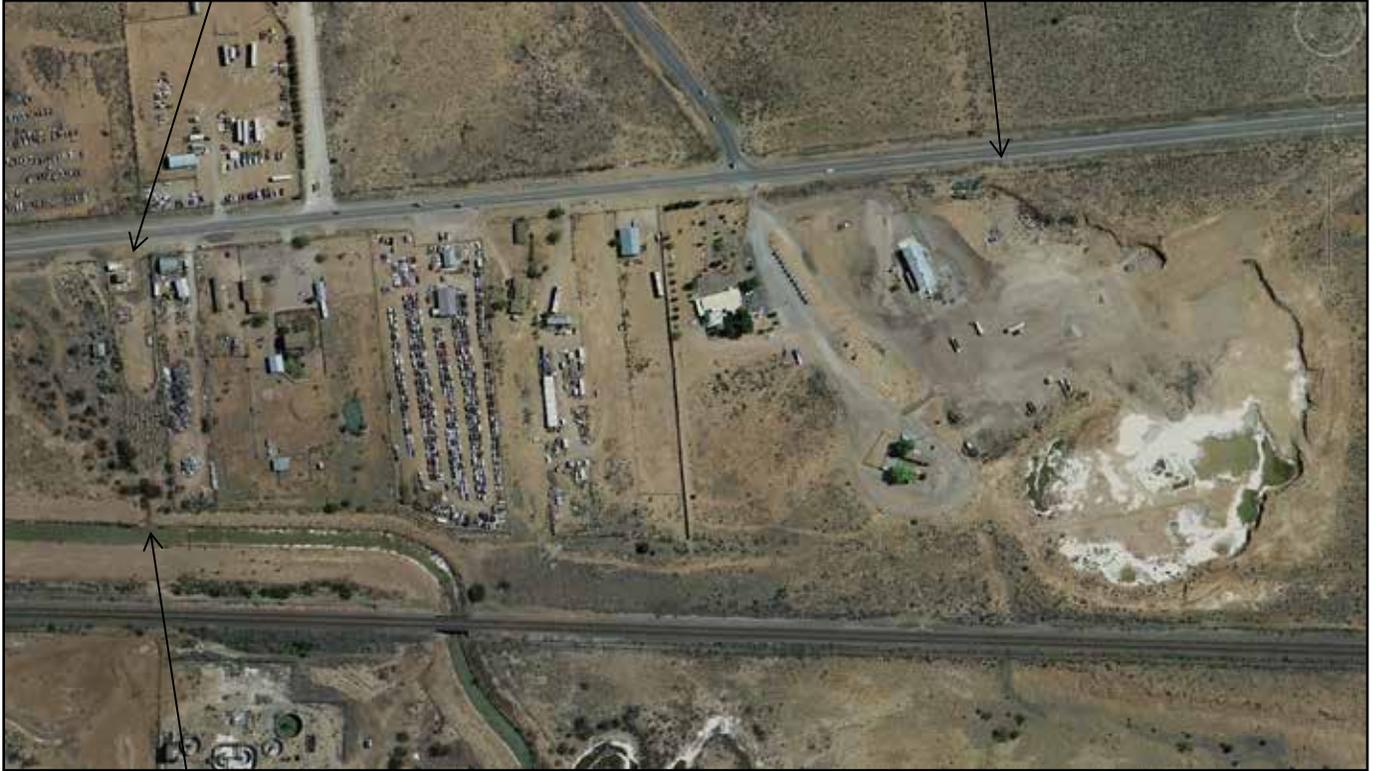
2.

Lift station is shut down to repair pipe and starts to overflow.

1.

Pipe to WWTP breaks and discharges to old sand and gravel pit

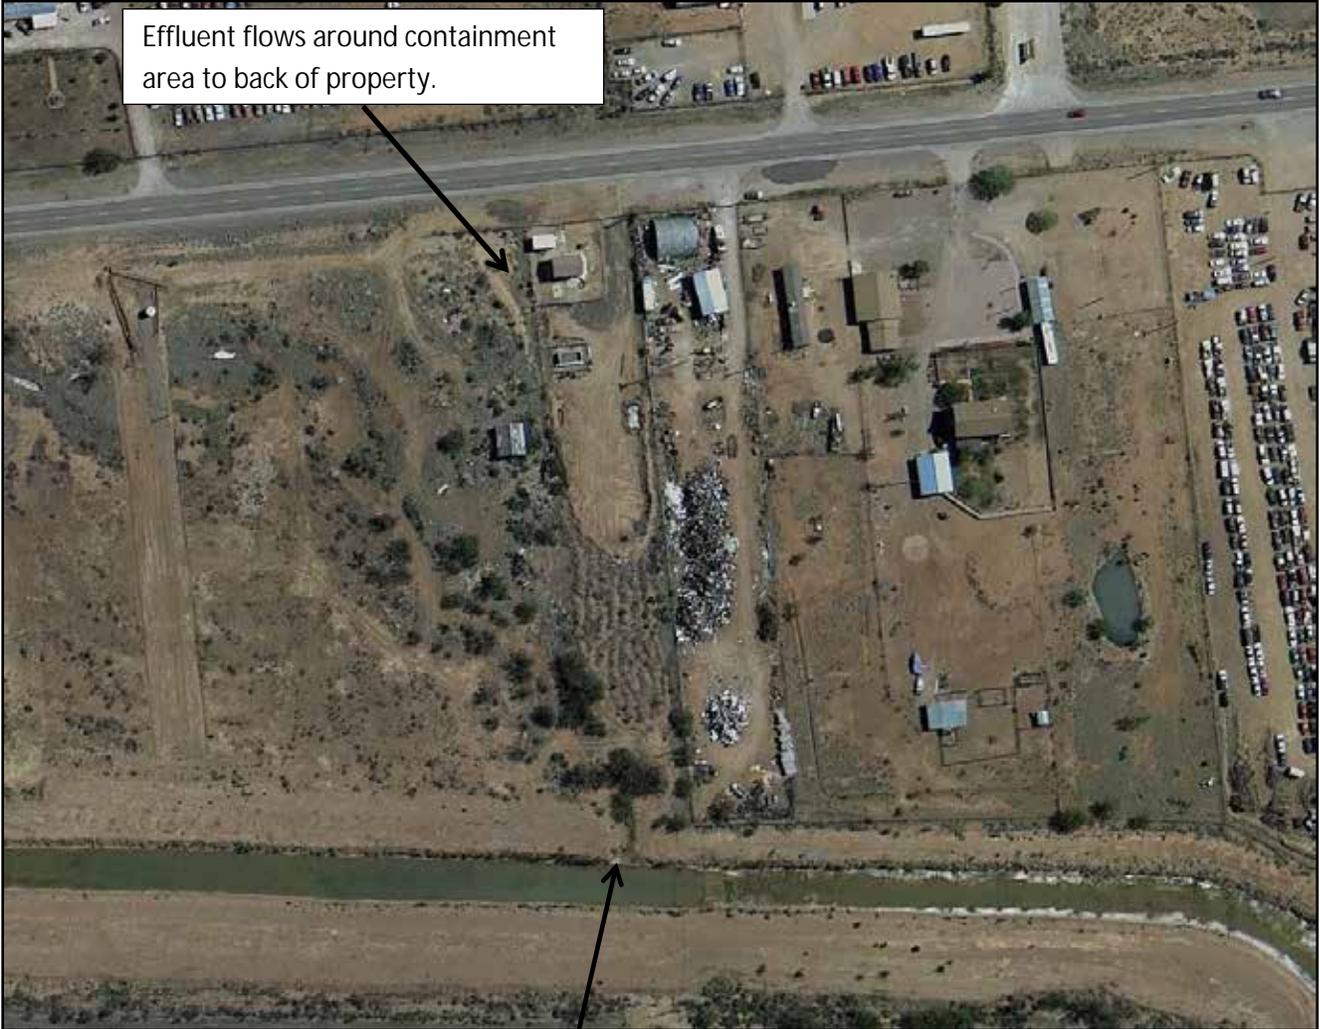
Google Imagery 5/3/2012

3.

Overflow from lift station flows to the river through the cut berm.

Effluent flows around containment area to back of property.

Effluent travels to back of property and discharges through the cut in the berm to the river.

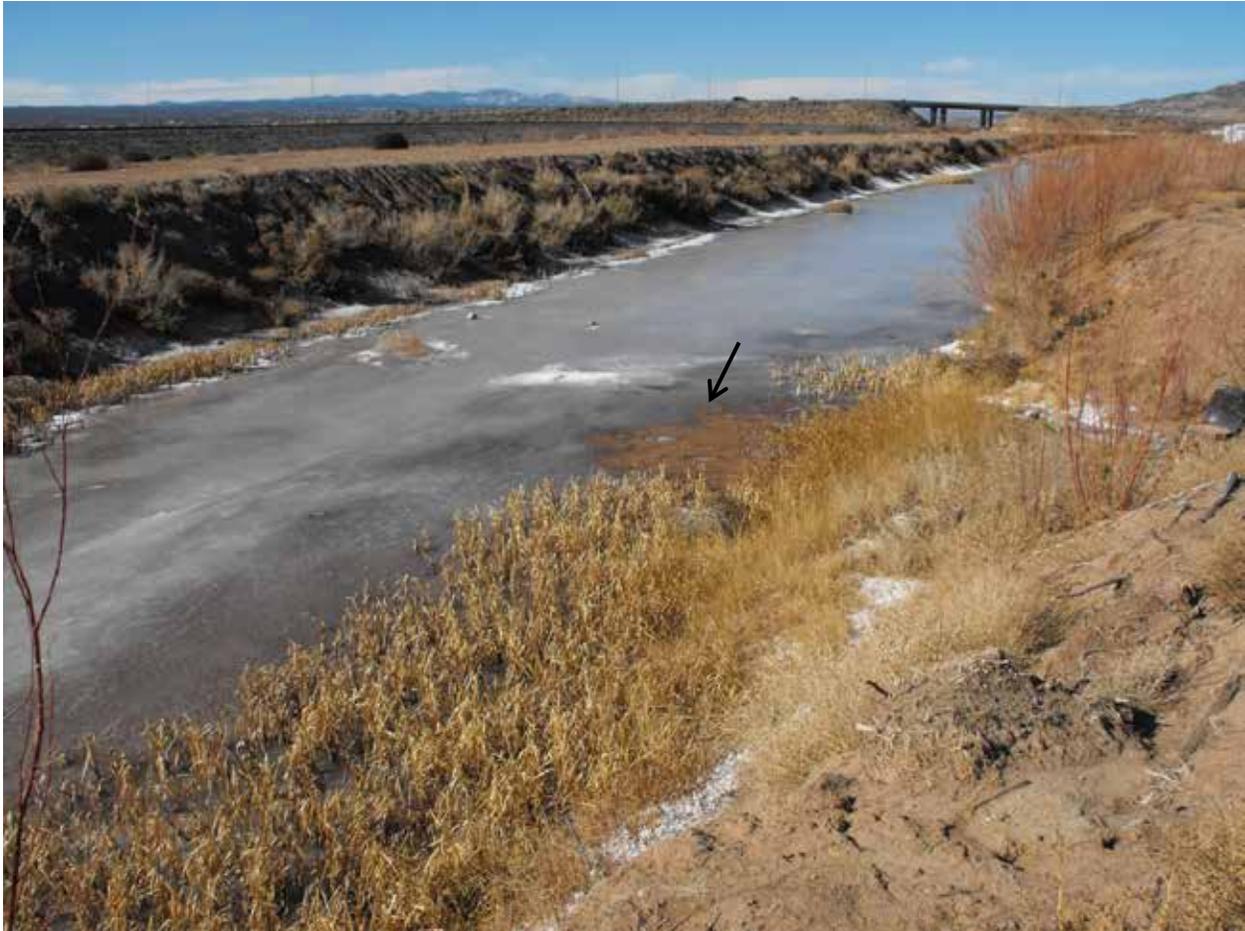
New Mexico Environment Department/Surface Water Quality Bureau
Official Photo Log
Photo #1

Photographer: Daniel Valenta	Date: January 7, 2012	Time: 1158 hours
City/County: Grants/Cibola		
Location: Rio San Jose; Grants, NM		
Subject: Rio San Jose – Discharge material indicated on photo.

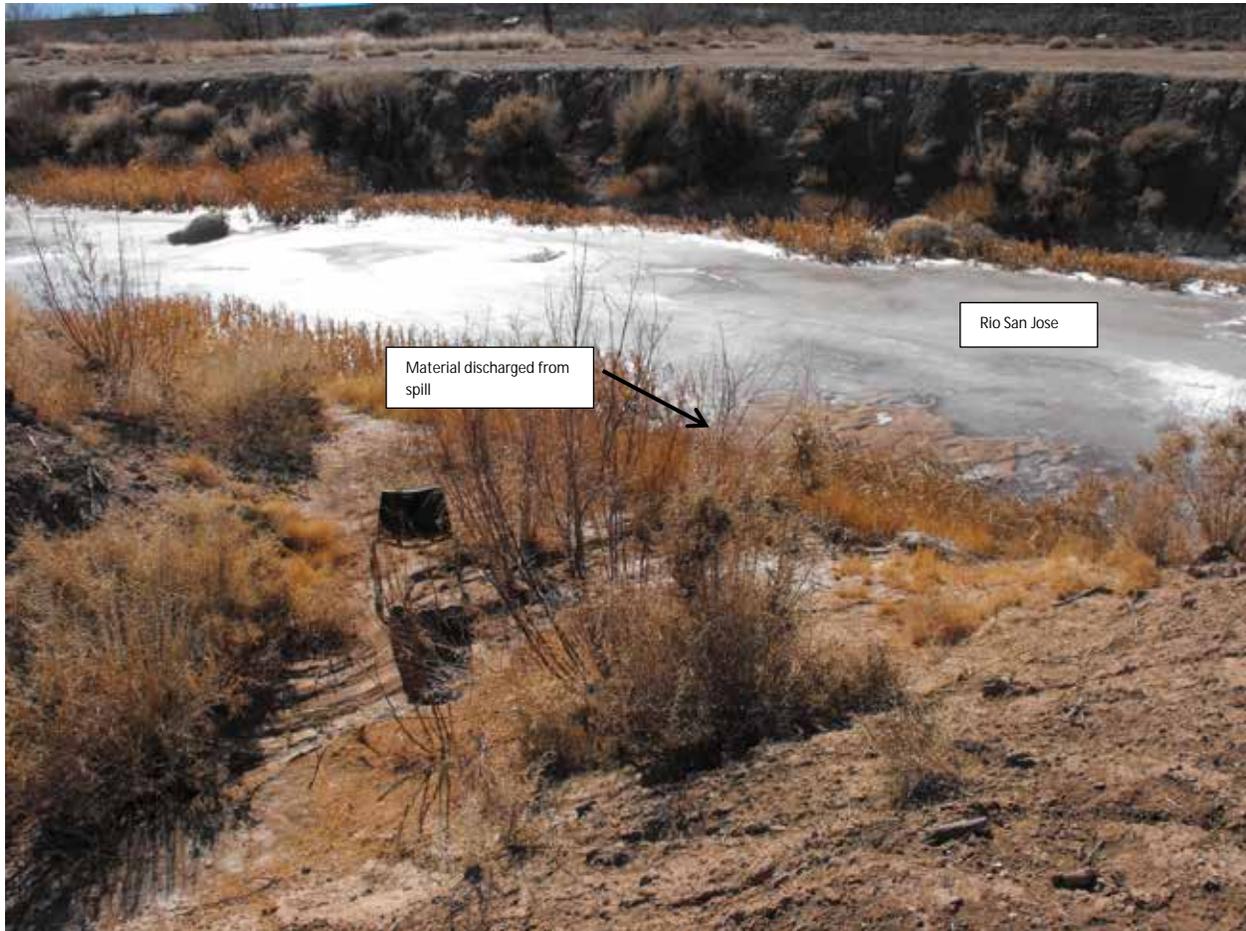
New Mexico Environment Department/Surface Water Quality Bureau
Official Photo Log
Photo #2

To complete the repairs, the force main was had to be shut off. Because of this, the lift station began to overflow. Some of the raw sewage was maintained by a four foot bermed area just south of the lift station on city owned property. However, approximately 10,000 to 20,000 gallons of raw sewage bypassed this bermed area, traveled across private property and was discharged to the Rio San Jose located approximately 400 yards south on the west side of the lift station. (see pictures).

When the inspector questioned the operators further regarding any best management practices that might have been in place to avoid the discharge, Mr. Quintana stated that he did not put any berming along the west side of the lift station. If Mr. Quintana had placed berming along the west side of the lift station and directed the raw sewage flow, they may have been able to maintain a larger amount of sewage in the containment area to the south of the lift station.

Photographer: Daniel Valenta	Date: January 7, 2012	Time: 1156 hours
City/County: Grants/Cibola		
Location: #66 Lift Station; E. Santa Fe Avenue; Grants, NM		
Subject: Discharge point into the Rio San Jose from the lift station overflow

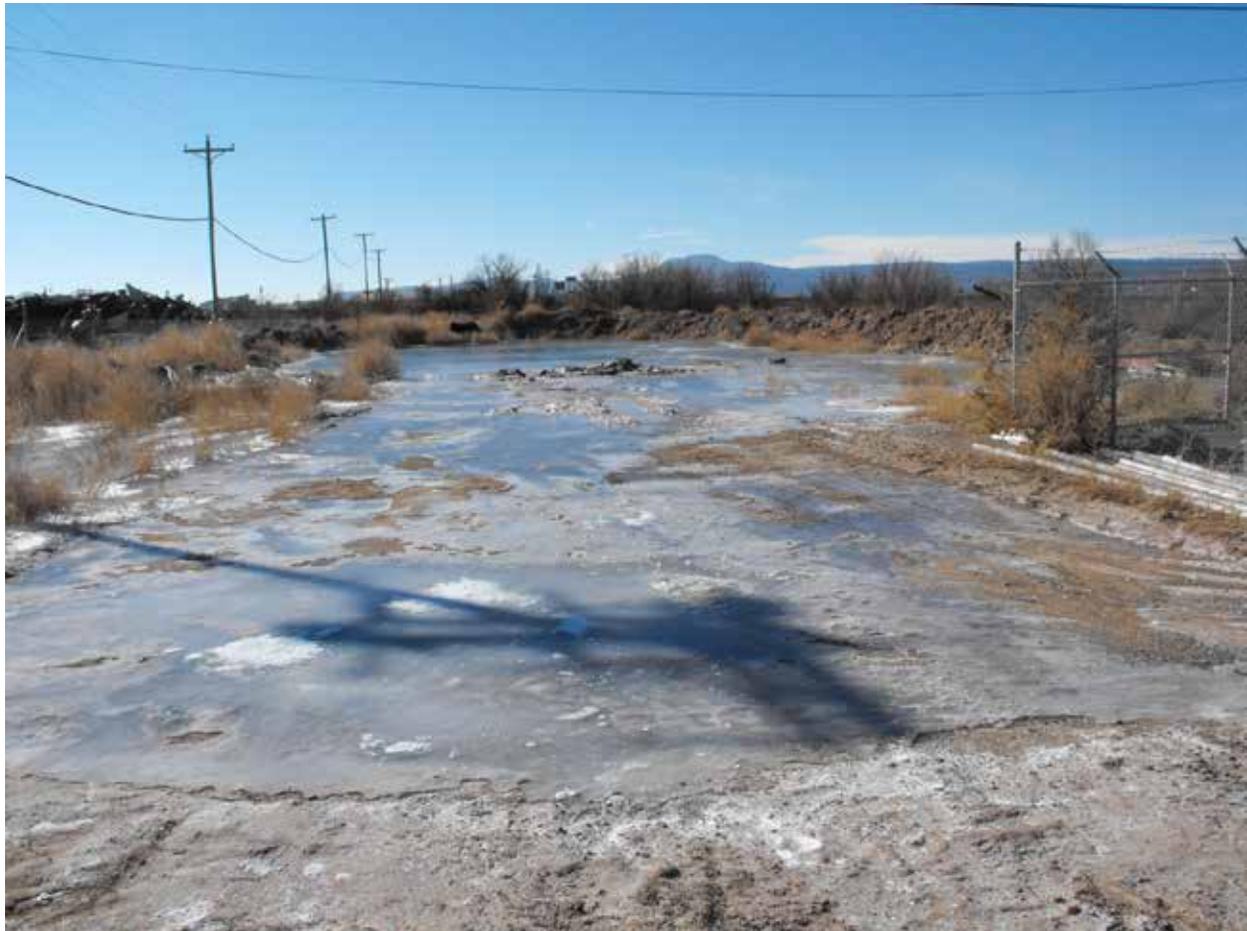
New Mexico Environment Department/Surface Water Quality Bureau
Official Photo Log
Photo #3

At the time of this inspection, the force main was fixed, the lift station was functional. The gravel pit where the majority of the sewage traveled is frozen over and appeared to be a pond of frozen ice. The containment area to the south of the lift station was also a frozen pond. The discharge location to the west of the lift station had no notable solid debris associated with raw sewage. Again, this inspection was done thirteen days after the sanitary sewer overflow.

Photographer: Daniel Valenta	Date: January 7, 2012	Time: 1134 hours
City/County: Grants/Cibola		
Location: #66 Lift Station; E. Santa Fe Avenue; Grants, NM		
Subject: Containment area on south side of lift station

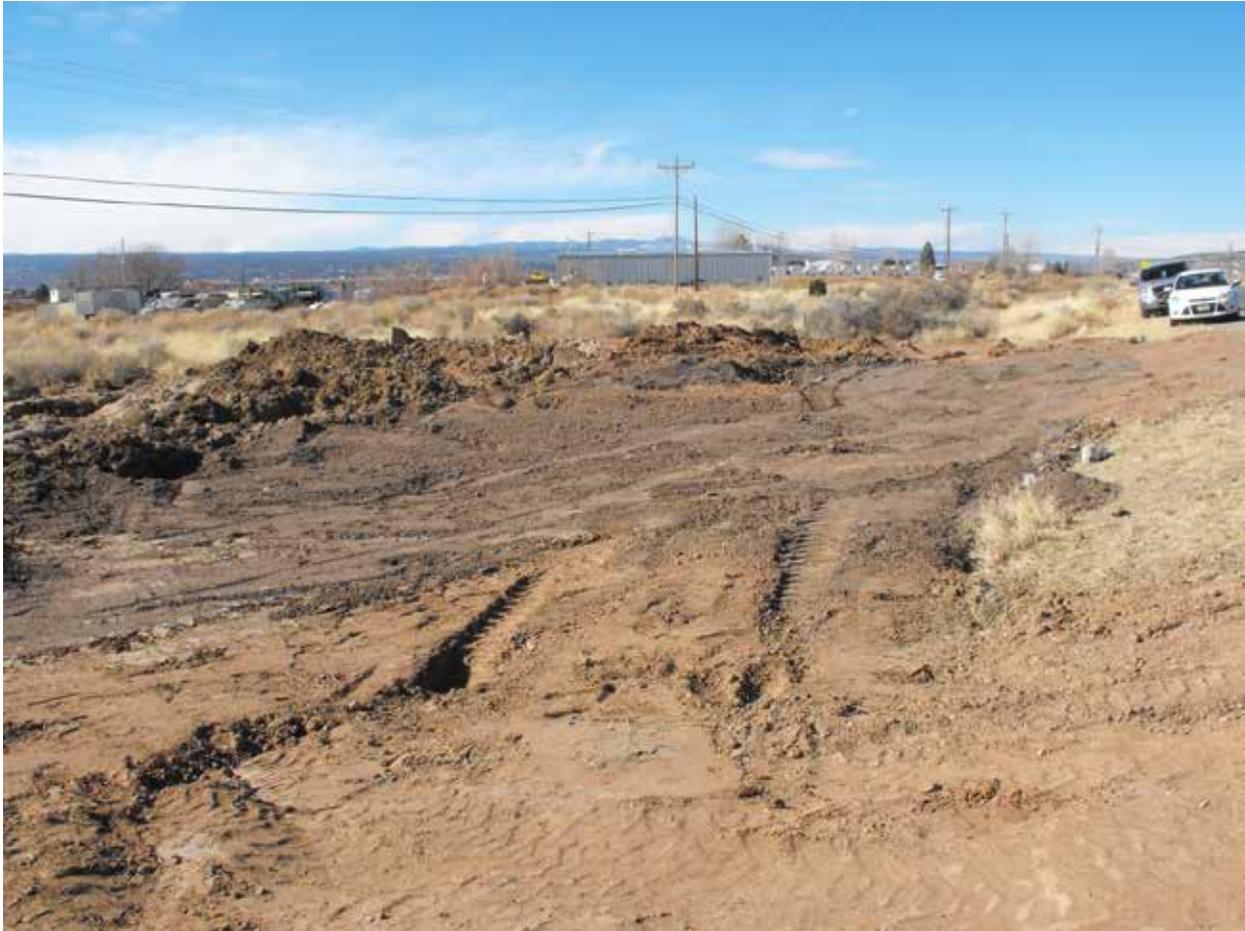
New Mexico Environment Department/Surface Water Quality Bureau
Official Photo Log
Photo #4

Photographer: Daniel Valenta	Date: January 7, 2012	Time: 1233 hours
City/County: Grants/Cibola		
Location: Force Main break; E. Santa Fe Avenue; Grants, NM		
Subject: Area where 16" force main break occurred

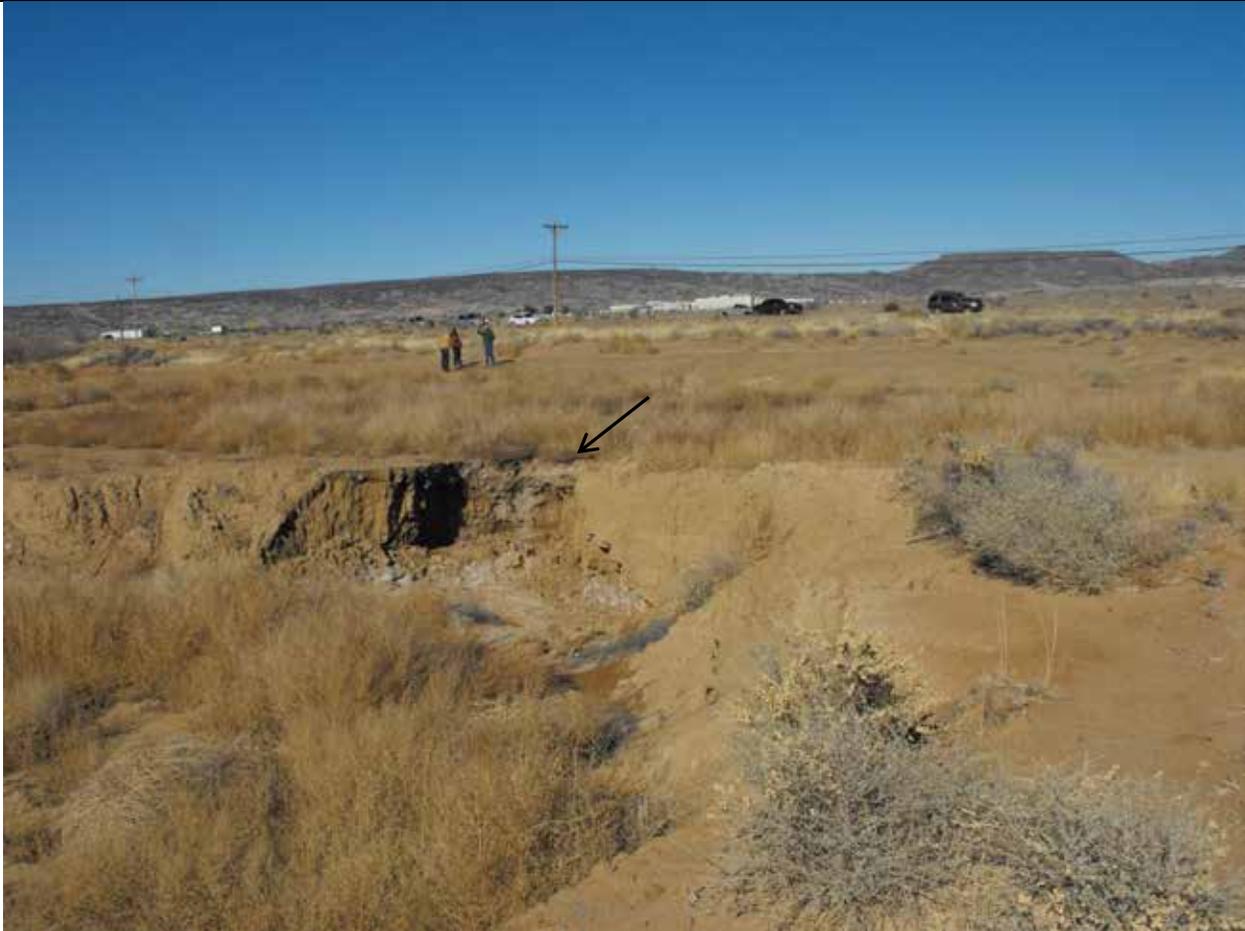
New Mexico Environment Department/Surface Water Quality Bureau
Official Photo Log
Photo #5

Photographer: Daniel Valenta	Date: January 7, 2012	Time: 1250 hours
City/County: Grants/Cibola		
Location: Force Main break; E. Santa Fe Avenue; Grants, NM		
Subject: Area where apparently raw effluent entered the gravel pit

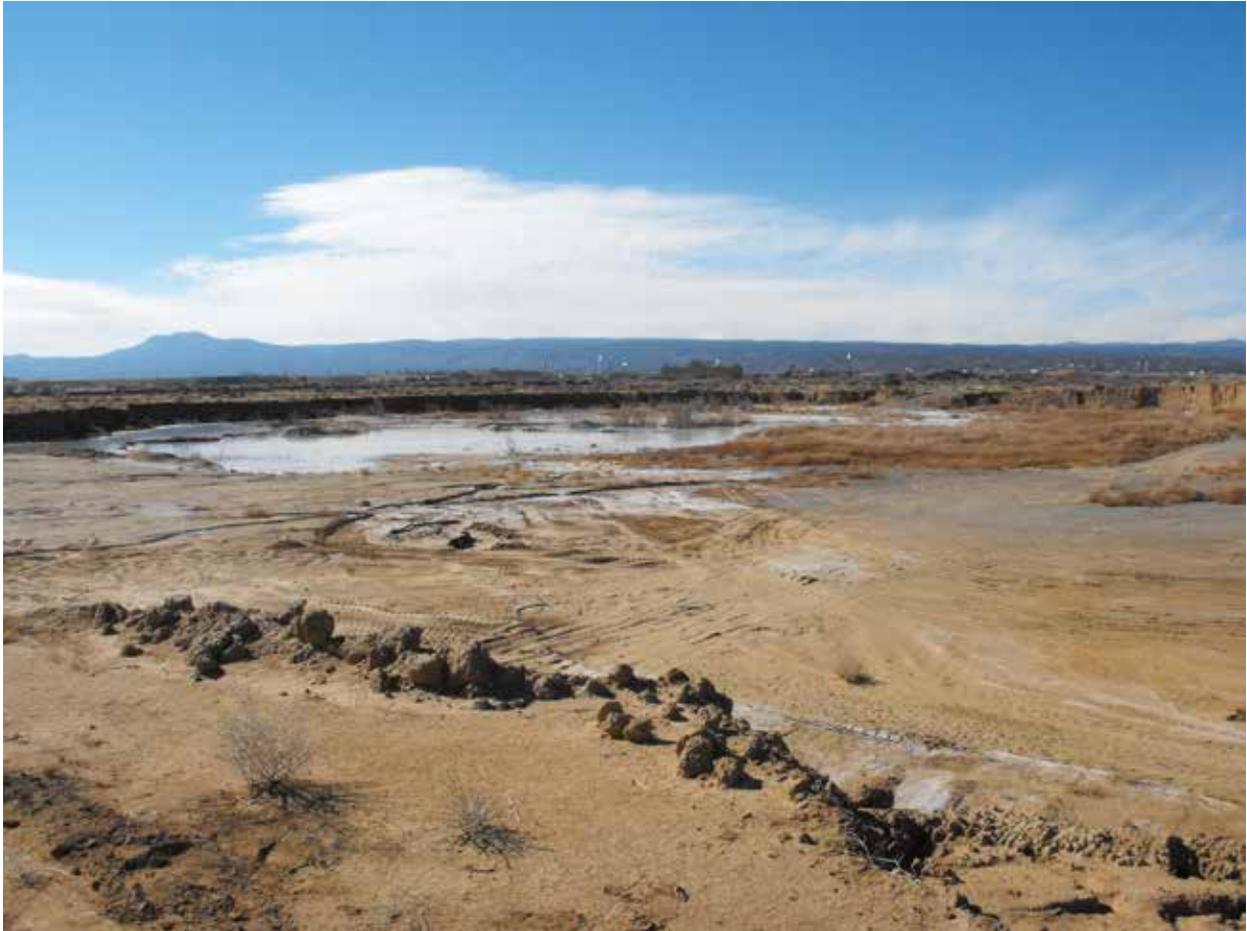
New Mexico Environment Department/Surface Water Quality Bureau
Official Photo Log
Photo #6

Photographer: Daniel Valenta	Date: January 7, 2012	Time: 1250 hours
City/County: Grants/Cibola		
Location: Force Main break, gravel pit; E. Santa Fe Avenue; Grants, NM		
Subject: Area where majority of raw sewage was contained
