Re: **Major Municipal; SIC 4952; NPDES Compliance Evaluation Inspection; Village of Taos Ski Valley Wastewater Treatment Plant; NM0022101; February 2, 2012**

NPDES Compliance Inspection Report

Village of Taos Ski Valley
Wastewater Treatment Plant
Compliance Evaluation Inspection
NPDES Permit Number NM0022101
2 February 2012
Page - 2 - of 6

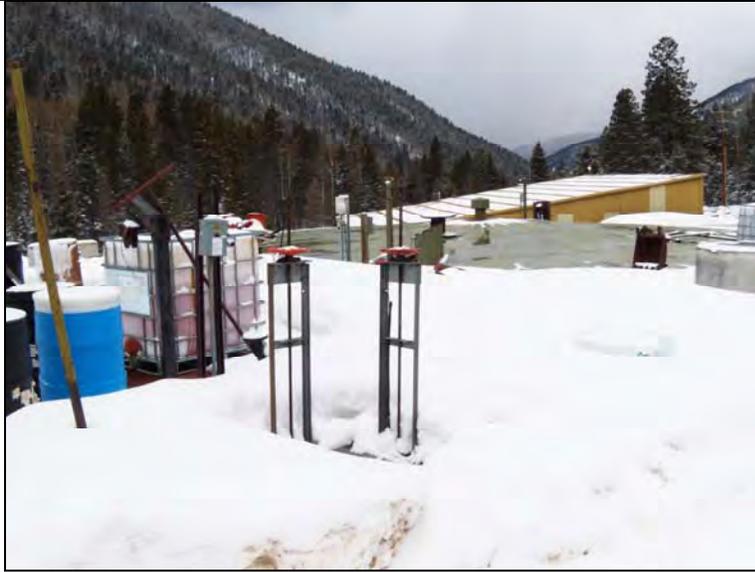
Subject: The Dome Top Of An Equalization Basin (EQ) At the Head of the Wastewater Treatment Plant

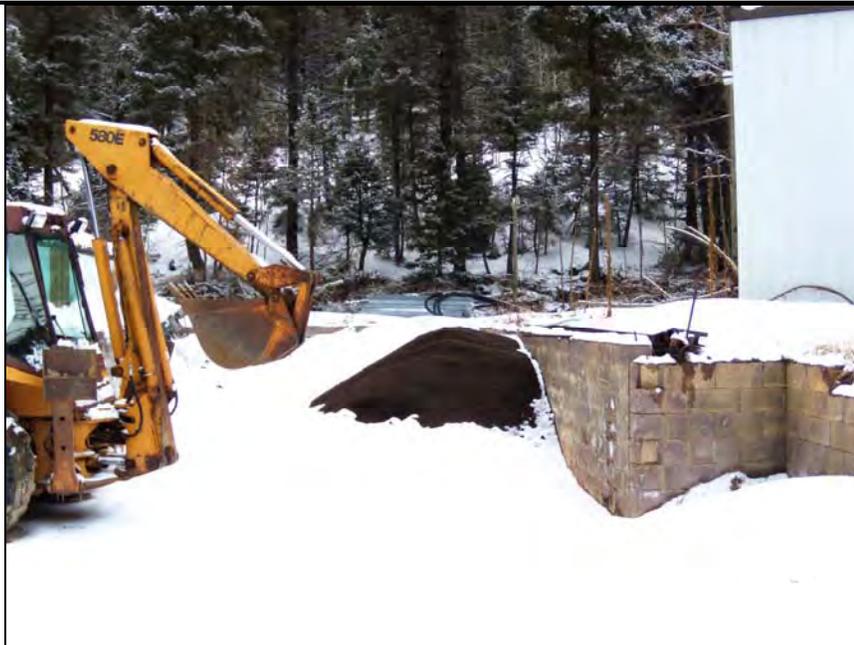
NMED/SWQB
Official Photograph Log
Photo # 2

Subject: Sludge bed. With so much snow it was not evident that the cement platform was sloped so there would be no run off. Some physical barrier may be necessary such as a berm, curb or other barrier to prevent run off from the sludge bed.

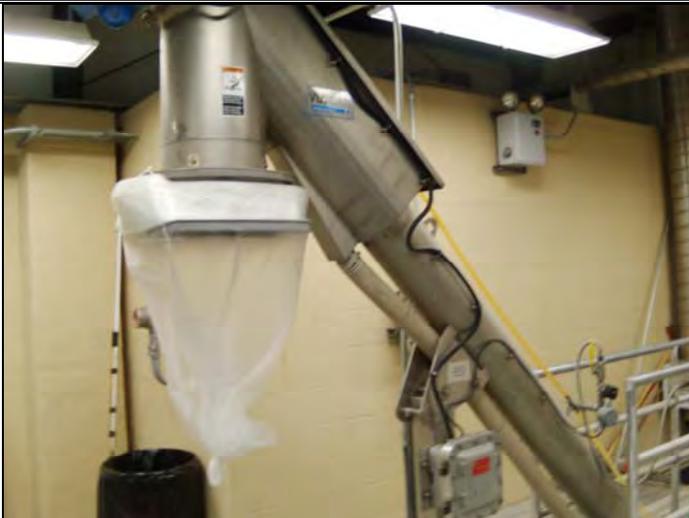
NMED/SWQB
Official Photograph Log
Photo #3

Subject: Influent Grit Removal Screw Pump at the head works. The solids are bagged, pass the paint filter test then are sent to the Rio Rancho landfill for final disposal.

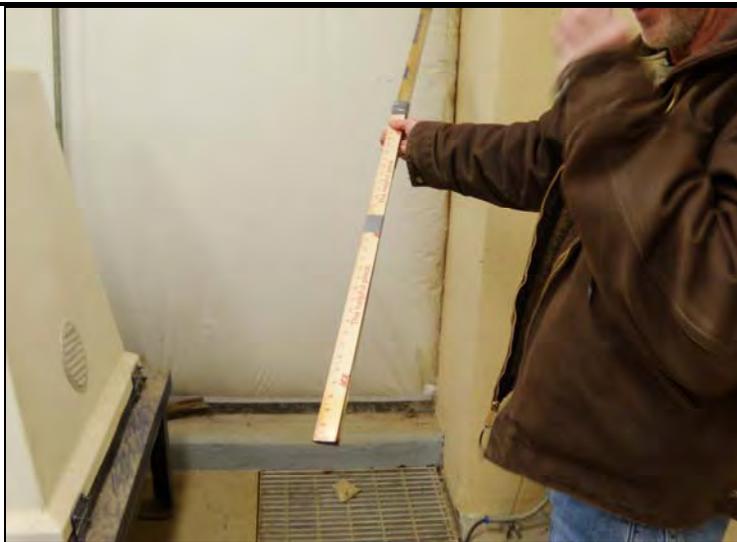
NMED/SWQB
Official Photograph Log
Photo #4

Subject: Influent flow measurement with a wooden yard stick at the influent Parshall flume.

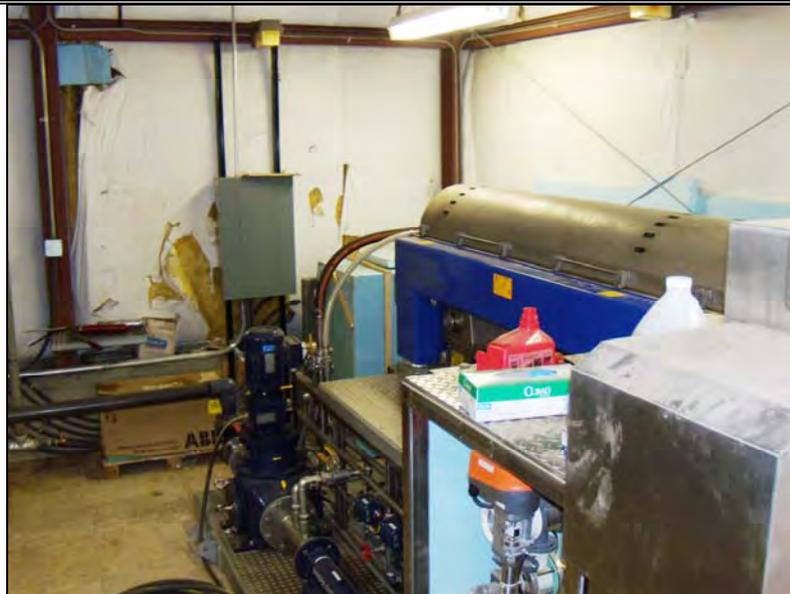
NMED/SWQB
Official Photograph Log
Photo # 5

Subject: solids de-watering system following the anaerobic digestion. The Circular Unit to the right is a centrifugal system that moves water to the outside of the cylinder where it is captured and sent to the head of the EQ basins. Solids left in the center of the unit are moved by a conveyor system (not seen in the photo) to the beds and/or hopper for transport to final disposal.

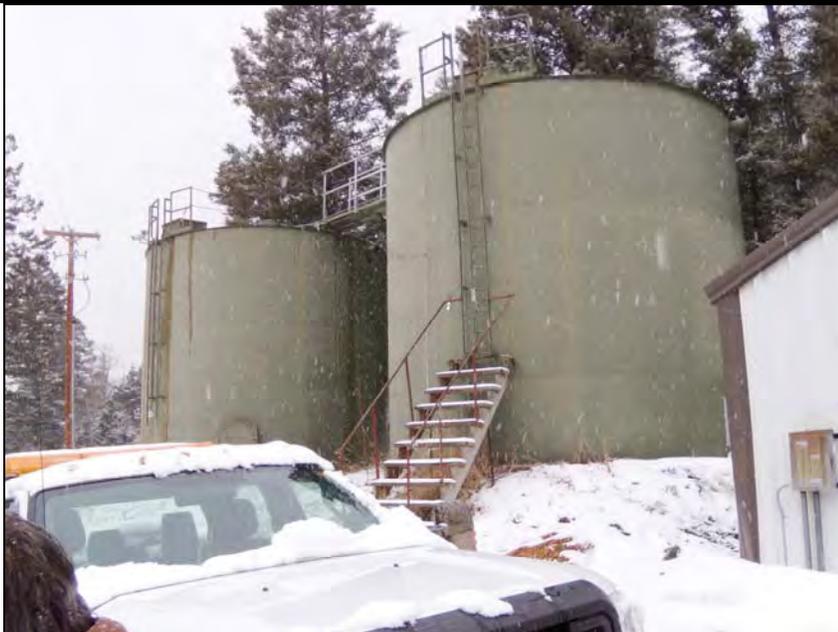
NMED/SWQB
Official Photograph Log
Photo # 6

Subject: Anaerobic Digesters for solids.

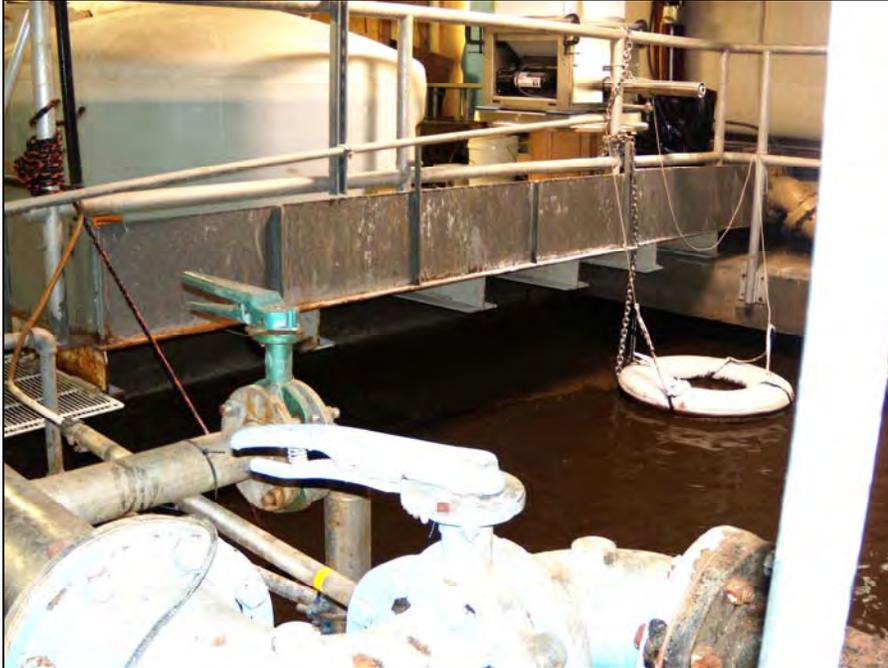
NMED/SWQB
Official Photograph Log
Photo # 7

Subject: First of Four basins that alternate aerobic and anaerobic process. In the first basin there is chemical addition of Soda Ash to normalize the pH to near 7.0 su. Polyaluminum Chloride or (PAC) is added to aid in the precipitation and removal of phosphorous.

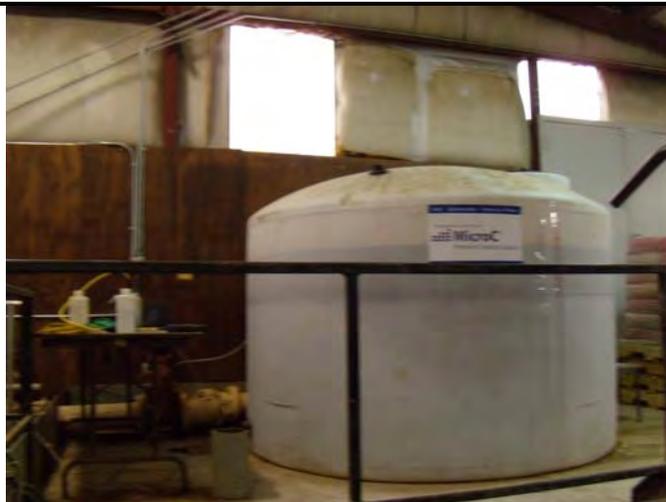
NMED/SWQB
Official Photograph Log
Photo # 8

Subject: In the anaerobic basin the addition of facultative and anaerobic microorganisms is used to aid in the de-nitrification process. Micro C adds a carbon source for microbiological feed - 5% Methanol solution.

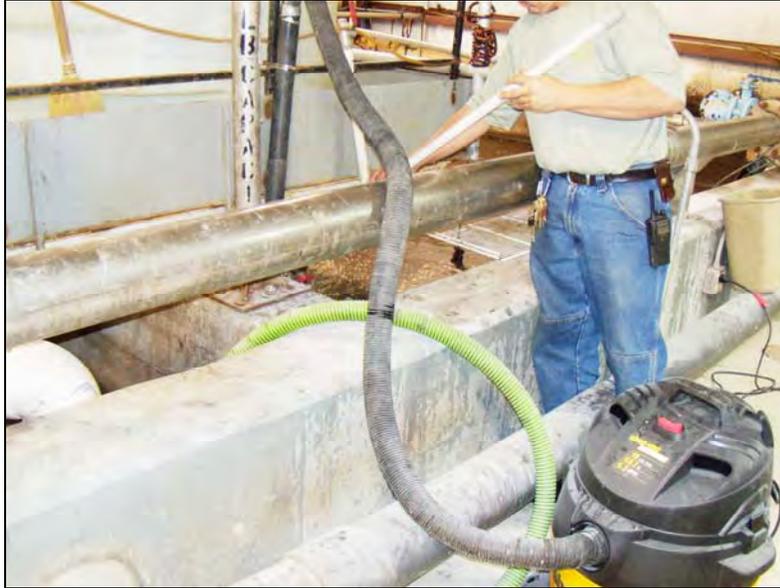
NMED/SWQB
Official Photograph Log
Photo # 9

Subject: Floating grease and scum is removal from the first basin with a wet vacuum. The grease waste is held in a septic tank then hauled to the Town of Taos WWTP for final disposal.

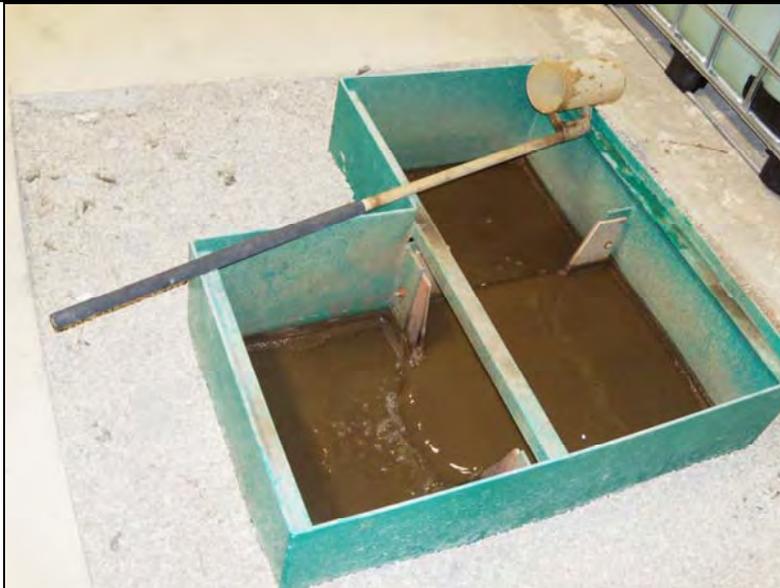
NMED/SWQB
Official Photograph Log
Photo # 10

Subject: Splitter box following the aerobic, anaerobic basins. The flow is divided between two clarifiers.

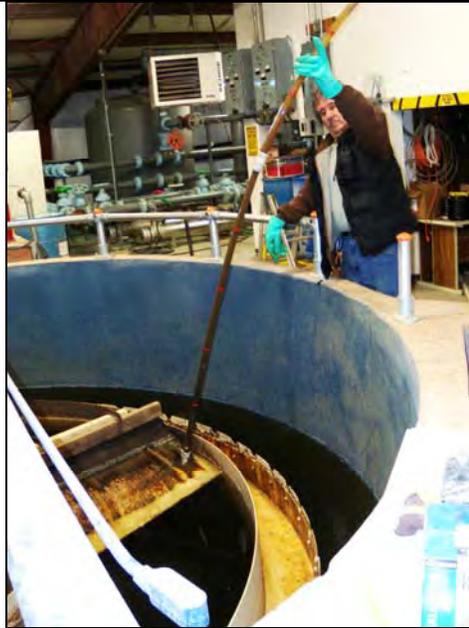
NMED/SWQB
Official Photograph Log
Photo # 11

Subject: The roughly 10 feet deep secondary clarifiers have between 5 and 7 feet deep sludge blankets (as seen with this sludge judge). The clarifiers are undersized for this treatment plant and become overwhelmed with solids quickly. The solids are wasted to maintain lower sludge blankets. Wasting is ongoing daily.

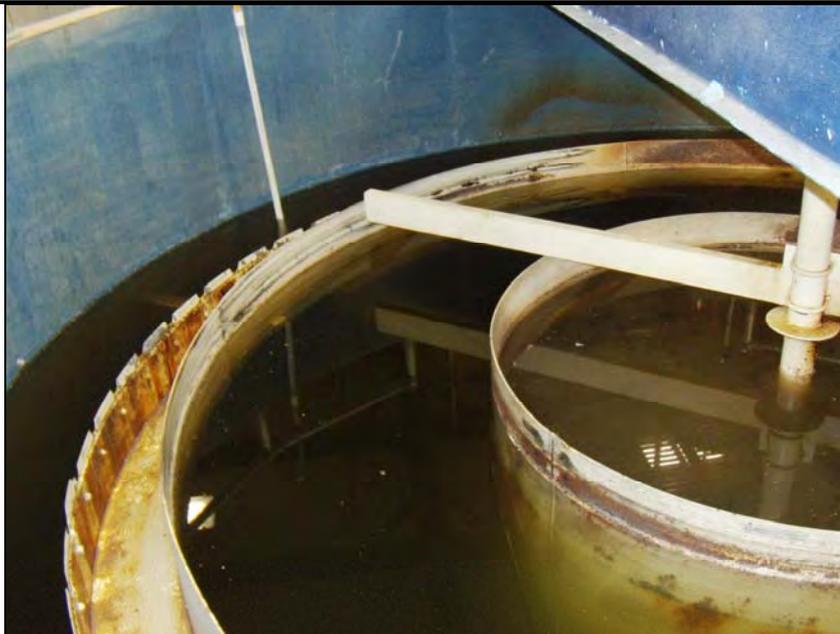
NMED/SWQB
Official Photograph Log
Photo # 12

Subject: Clarifier - weirs were balanced and no short circuiting was evident. No apparent floating solids were present in the clarifiers. Sludge blankets are kept high for the size of the units though. Because of the small land area available the size of these treatment units are limited.

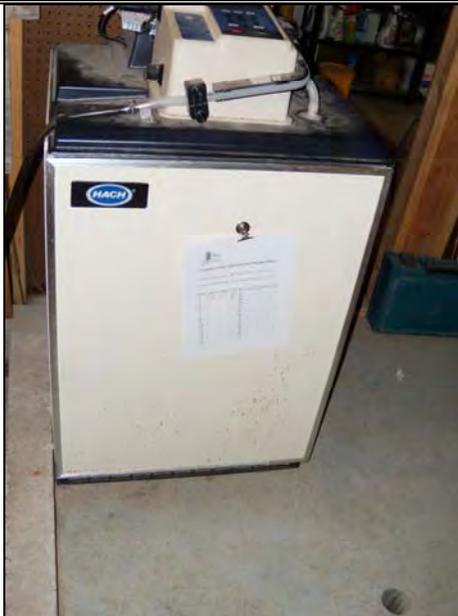
NMED/SWQB
Official Photograph Log
Photo #13

Subject: Effluent sampling and composting unit. Daily log of temperature reading is recorded on the sheet seen on the door in this photo.

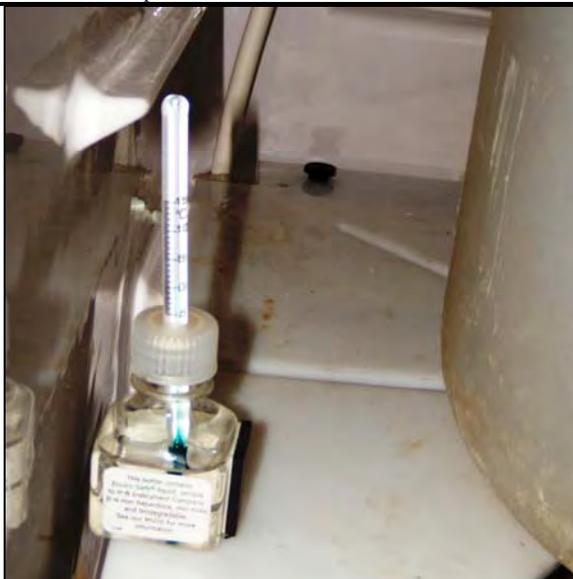
NMED/SWQB
Official Photograph Log
Photo # 14

Subject: Composting refrigerator thermometer reads 1° Centigrade. It's important to not let the temperature go any lower. If the samples freeze, they must be discarded and cannot be used for any of the analytical test required in the NPDES permit.

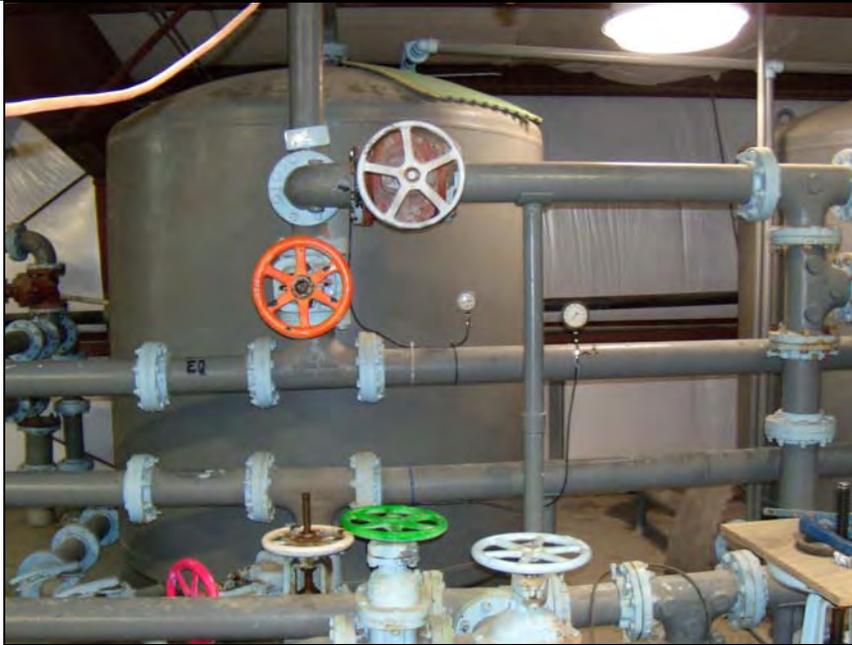
NMED/SWQB
Official Photograph Log
Photo # 15

Subject: One of two final sand filters

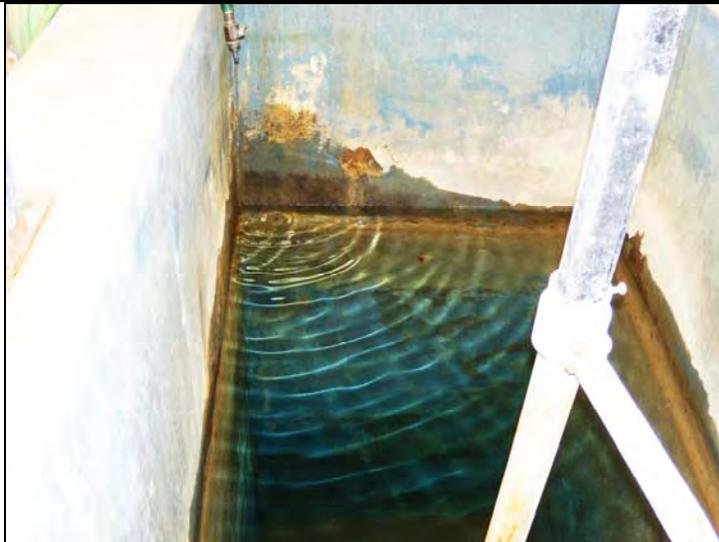
NMED/SWQB
Official Photograph Log
Photo # 16

Subject: Sand filter back wash water from this basin it is sent back to the head of the EQ basins.

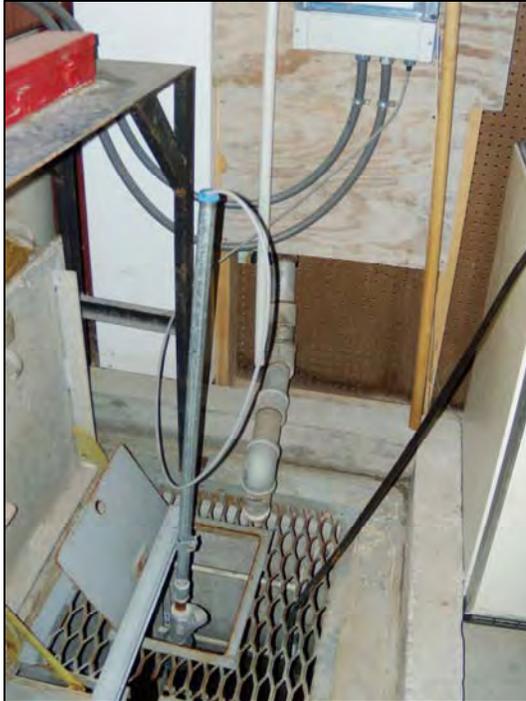
NMED/SWQB
Official Photograph Log
Photo # 17

Subject: Effluent flow meter and sample location.

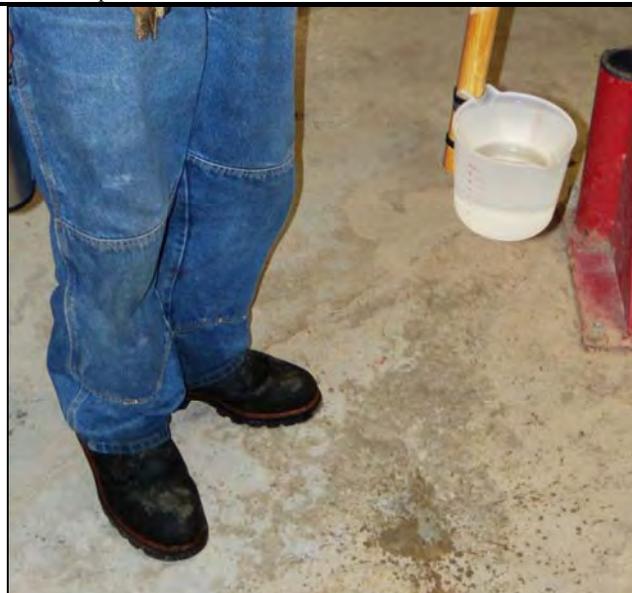
NMED/SWQB
Official Photograph Log
Photo #18

Subject: Effluent Water Sample is clear and free of any floating solids. - Sample taken at the end of the treatment works. - Fecal Coliform & E. coli samples are not taken w/ this dipper. Samples are collected directly into the sample bottles.
