**RE: Major Municipal, SIC 4952, NPDES Compliance Evaluation Inspection, Las Cruces –
Jacob Hands Wastewater Treatment Plant, NM0023311, July 26, 2012**

NPDES Compliance Inspection Report

LAS CRUCES – JACOB HANDS WASTEWATER TREATMENT PLANT

PERMIT NO. NM0023311

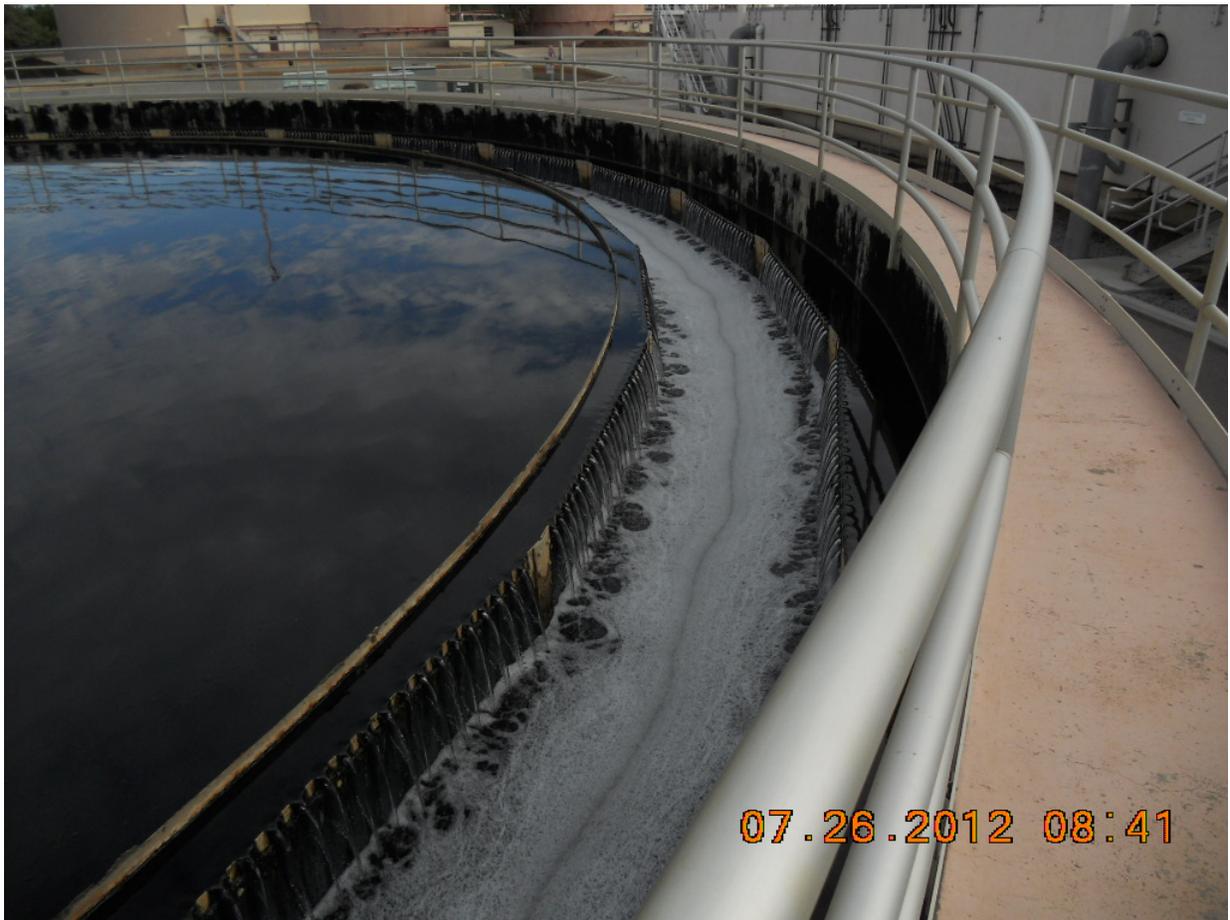
NMED/SWQB
Official Photograph Log
Photo # 1

Photographer: Sandra Gabaldón	Date: July 26, 2012	Time: 0841 Hours
City/County: Las Cruces / Doña Ana		State: New Mexico
Location: City of Las Cruces – Jacob Hands Wastewater Treatment Plant		
Subject: One of two clarifier.

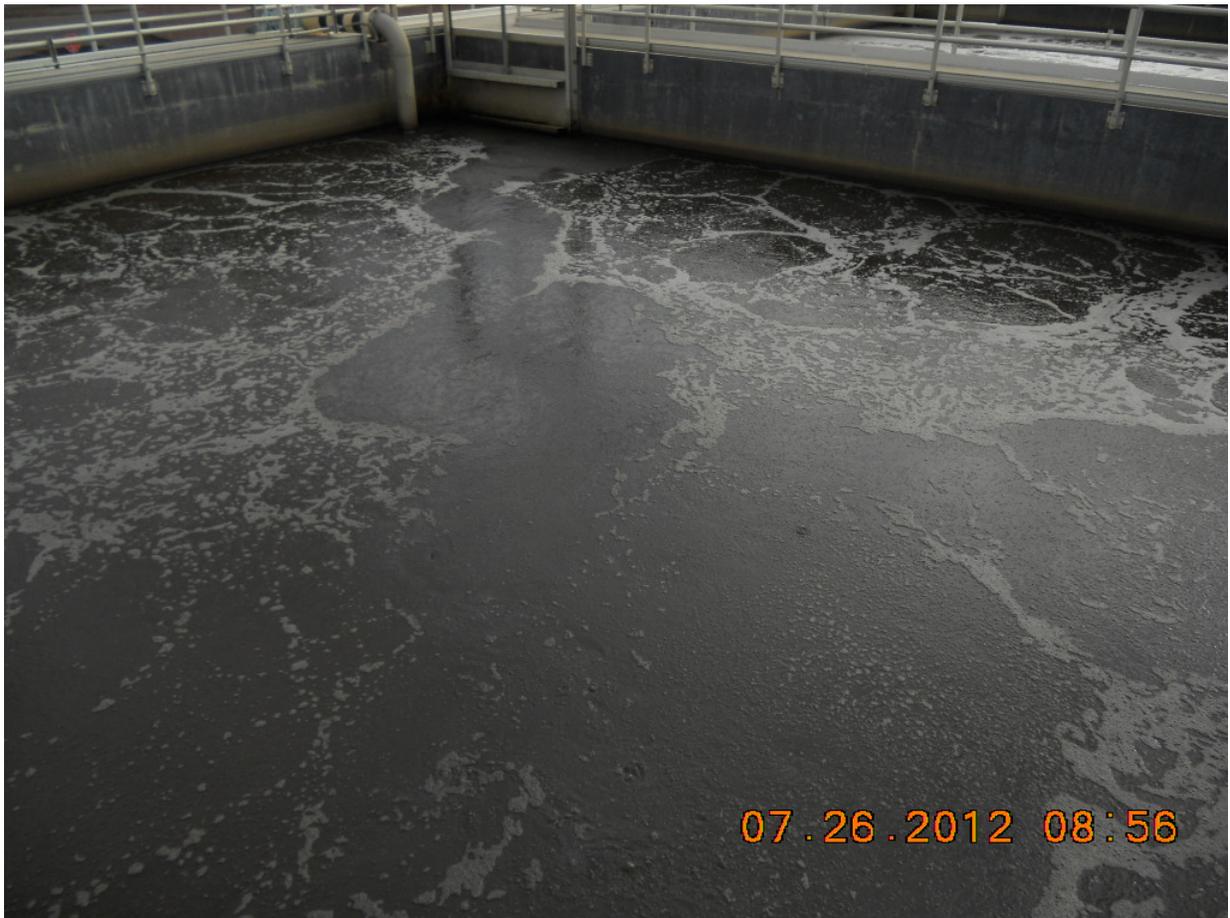
NMED/SWQB
Official Photograph Log
Photo # 2

During this inspection, denitrification was occurring. It was noted that the dissolved oxygen was at 0.81 mg/L. Although this is “low” by textbook standards, (average dissolved oxygen should be approximately 2.0 mg/L) it appears that this facility is running efficiently and is achieving compliance with the conditions of this permit. Therefore, this is just a comment rather than a finding.

Photographer: Sandra Gabaldón	Date: July 26, 2012	Time: 0856 Hours
City/County: Las Cruces / Doña Ana		State: New Mexico
Location: City of Las Cruces – Jacob Hands Wastewater Treatment Plant		
Subject: Aeration Basin

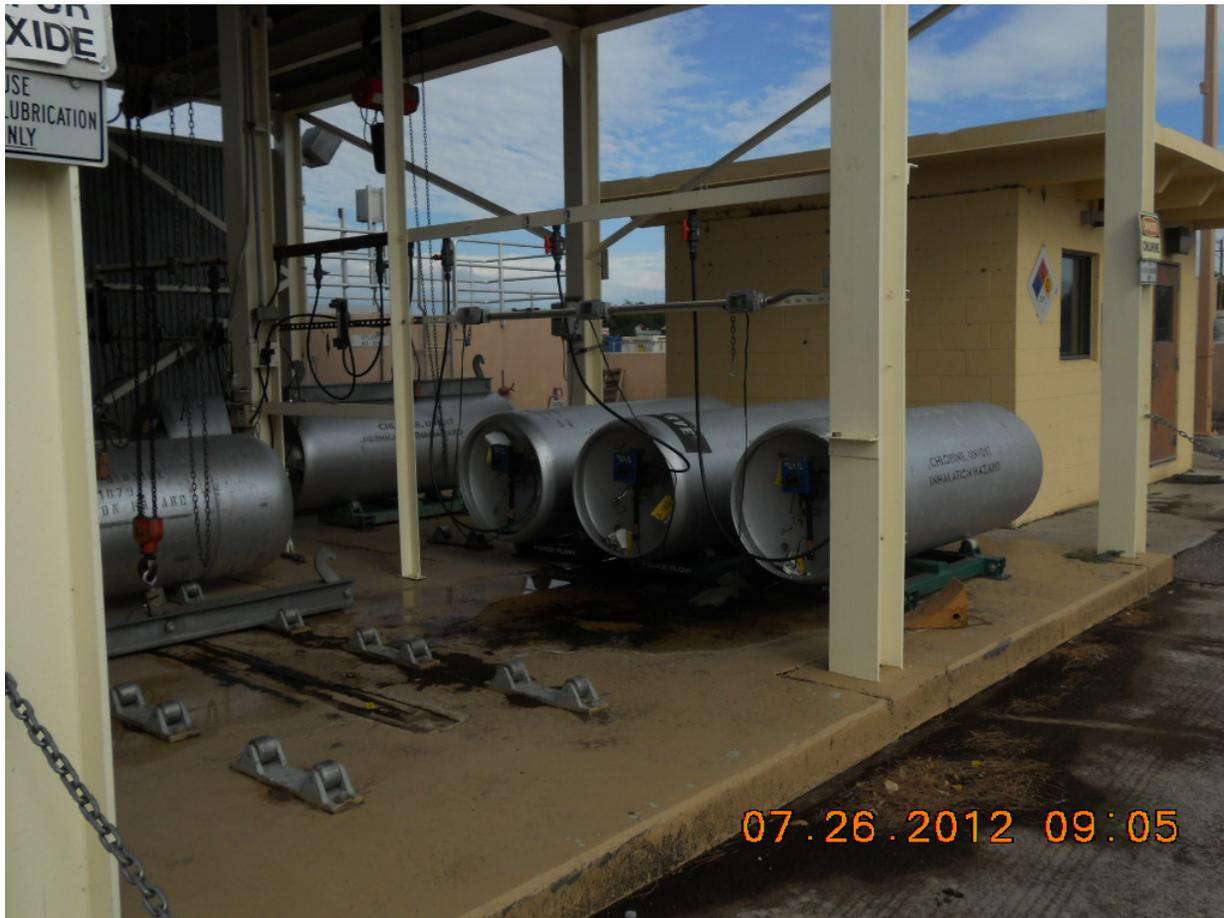
NMED/SWQB
Official Photograph Log
Photo # 3

Photographer: Sandra Gabaldón	Date: July 26, 2012	Time: 0905 Hours
City/County: Las Cruces / Doña Ana		State: New Mexico
Location: City of Las Cruces – Jacob Hands Wastewater Treatment Plant		
Subject: Chlorine gas in 1 ton cylinders.

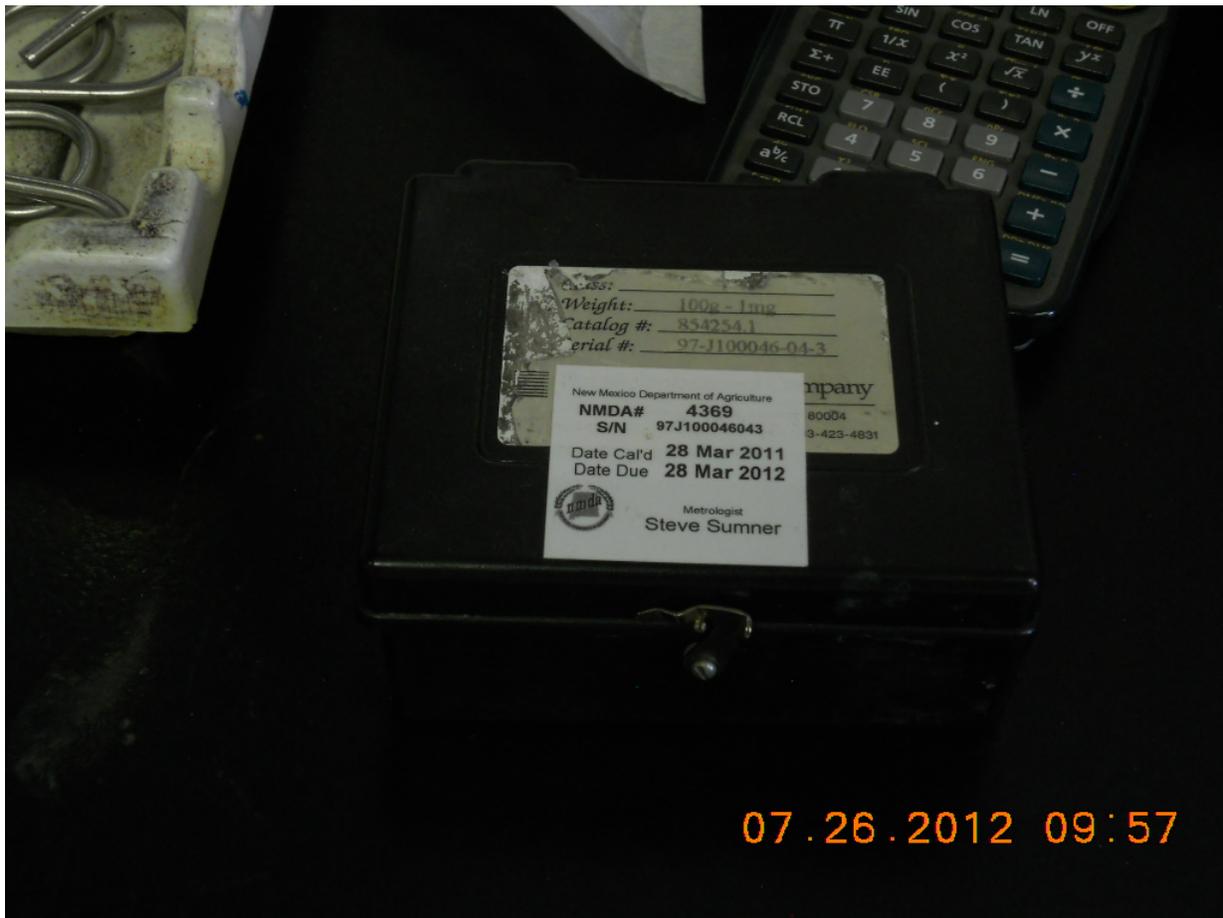
NMED/SWQB
Official Photograph Log
Photo # 4

- The dessicator contained pink dessicant indicating that there was moisture in the dessicant and it must be dried or replaced. The dessicant should be blue in color.
- The temperature of the drying oven for TSS was at 106° C. However, on further discussion with the laboratory manager, the temperature is +/- 1°. This would be within the 103° - 105° C range as required. All thermometers are NIST calibrated by New Mexico State Laboratory Department (SLD).
- During review of the analytical balance, the laboratory manager was asked if they calibrate the balance using “S weights” daily. The laboratory manager stated that they do. However, when asked to see the S weights used, the inspector noted that the calibration tag on the S weights were outdated. The S weights need to be re-calibrated.

Photographer: Sandra Gabaldón	Date: July 26, 2012	Time: 0957 Hours
City/County: Las Cruces / Doña Ana		State: New Mexico
Location: City of Las Cruces – Jacob Hands Wastewater Treatment Plant		
Subject: S-weights, used for daily calibration of analytical balance. Last calibration March, 2012

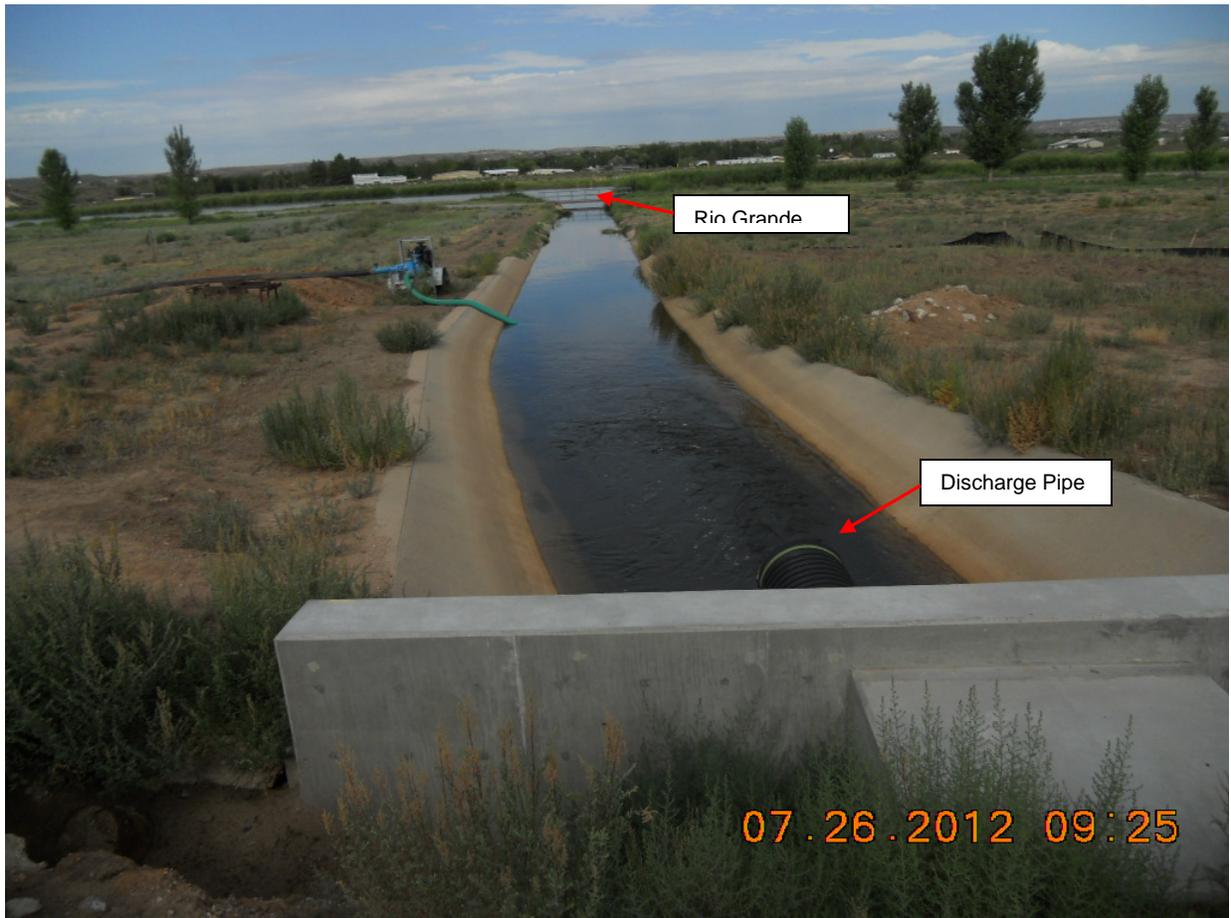
NMED/SWQB
Official Photograph Log
Photo # 5

RECEIVING WATER OBSERVATIONS Muddy brown – rain event night before inspection.

On the day of the inspection, however, the effluent was clear at the Parshall flume prior to discharge. No exceedance has been reported since April 2012.

Photographer: Sandra Gabaldón	Date: July 26, 2012	Time: 0925 Hours
City/County: Las Cruces / Doña Ana	State: New Mexico	
Location: City of Las Cruces – Jacob Hands Wastewater Treatment Plant		
Subject: Discharge to unnamed ditch, thence to Rio Grande. (GPS: N. 32.29134, W. -106.82413)
