**RE: Major Municipal; SIC 4952; NPDES Compliance Evaluation Inspection; Town of Taos Waste Water Treatment Plant; NM0024066; March 4, 2011**

### NPDES Compliance Inspection Report

Town of Taos Wastewater Treatment Plant  
Compliance Evaluation Inspection  
NPDES Permit Number NM0024066  
By New Mexico Environment Department, Surface Water Quality Bureau  
March 4, 2011

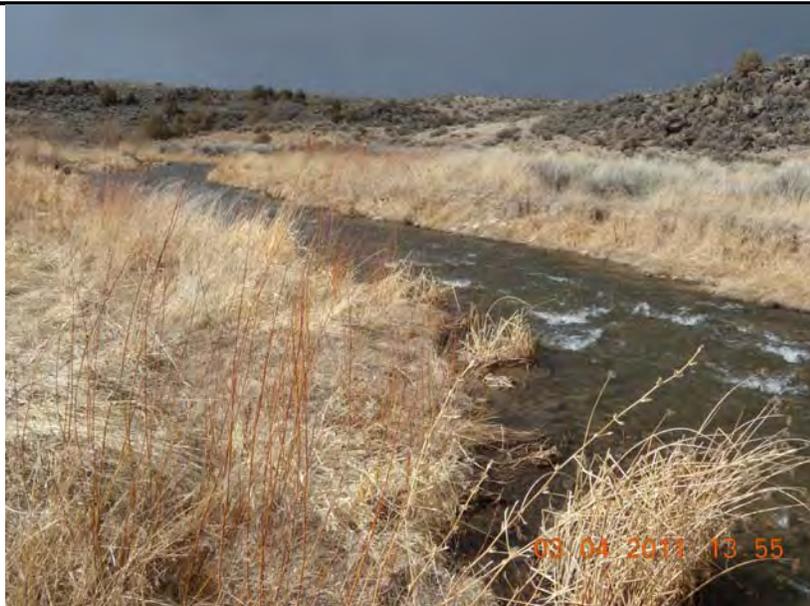
NMED/SWQB  
Official Photograph Log  
Photo # 2

Location: Taos WWTP effluent ditch confluence with the Rio Pueblo de Taos

Subject: Confluence

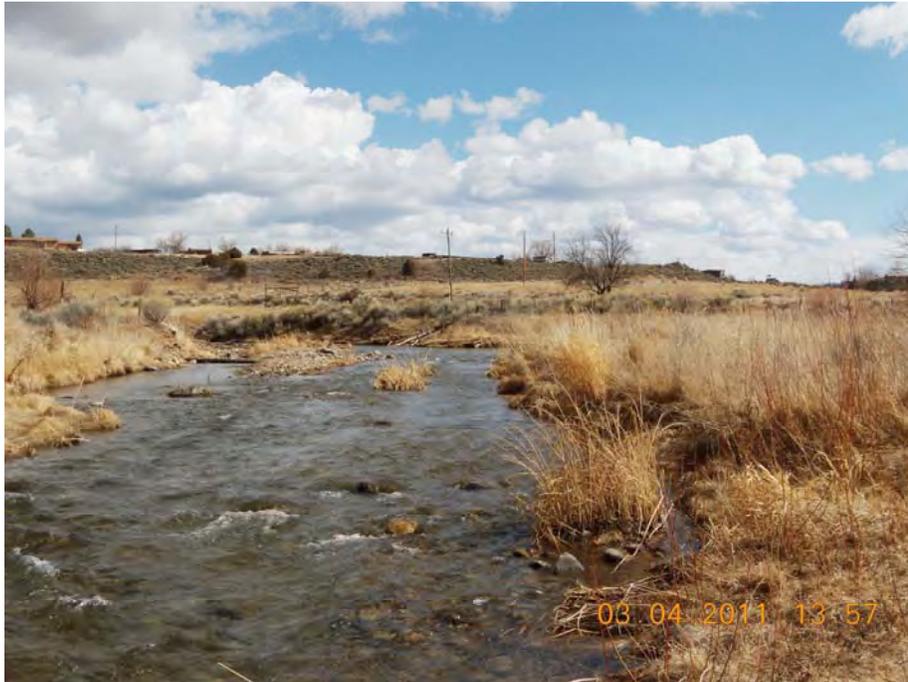
NMED/SWQB  
Official Photograph Log  
Photo #3

Location: Rio Pueblo de Taos below the confluence with the Taos WWTP Effluent Ditch

Subject: Down Stream looking up to the Confluence of the Taos WWTP Effluent Ditch and the Rio Pueblo de Taos

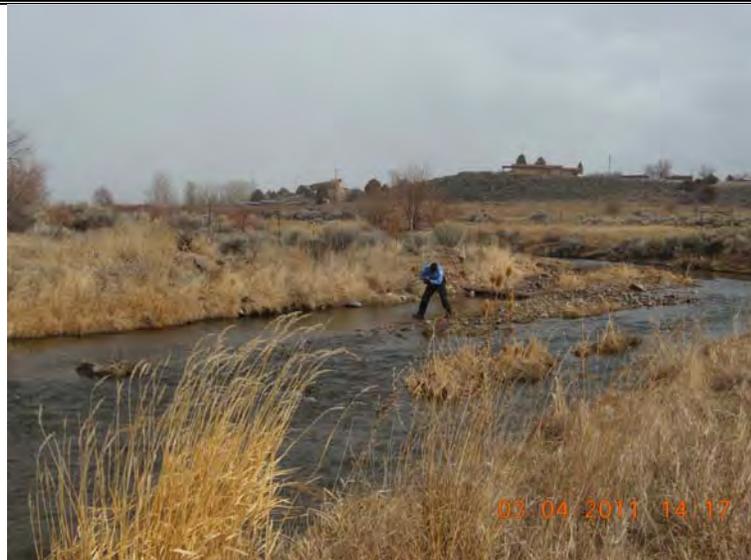
NMED/SWQB  
Official Photograph Log  
Photo # 4

Location: Rio Pueblo de Taos

Subject: Manuel Overby, DGF collecting a river sample in the eddy across from the confluence of the WWTP effluent ditch with the Rio Pueblo de Taos.

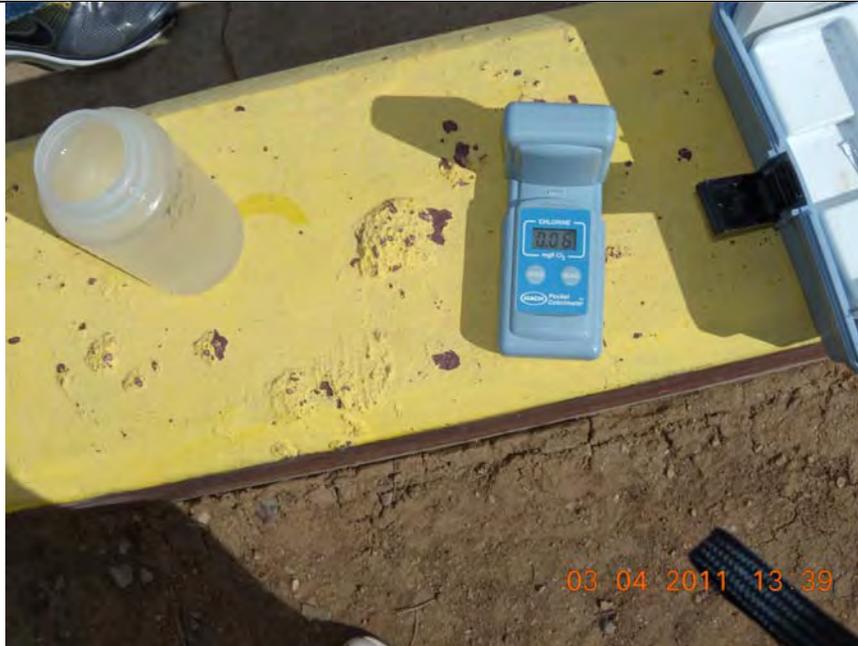
NMED/SWQB  
Official Photograph Log  
Photo # 5

Location: Taos WWTP

Subject: Chlorine meter reading of 0.06 mg/L Total Residual Chlorine at the Taos WWTP effluent channel.

TRC samples were analyzed by the Inspector and levels above the permit limit were found in the effluent. The effluent sample being tested for TRC was split with Mr. Burkett, who also analyzed the sample. Mr. Burkett reported that the concentration found was 0.00 µg/L.

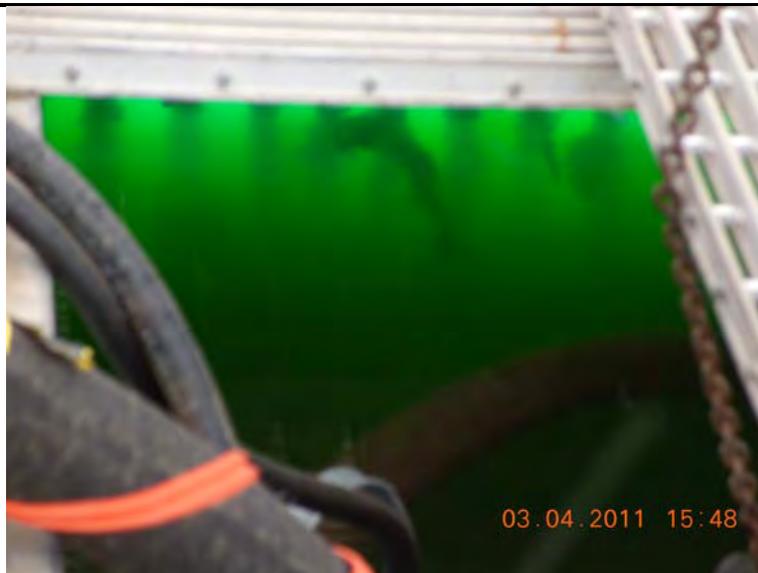
NMED/SWQB  
Official Photograph Log  
Photo #6

Location: Taos WWTP

Subject: WWTP U V disinfection Chamber, Very Turbid effluent water, with algal growth stringing off the light bulbs.

The facility's effluent exceeded the permit limits for E.coli bacteria, and for Fecal Coliform bacteria in recent months. It was observed that the effluent water was a very turbid green-brown and the effluent flow channel had visible algal growth on the walls and floor of the chamber. The UV lights were heavily coated with algae.

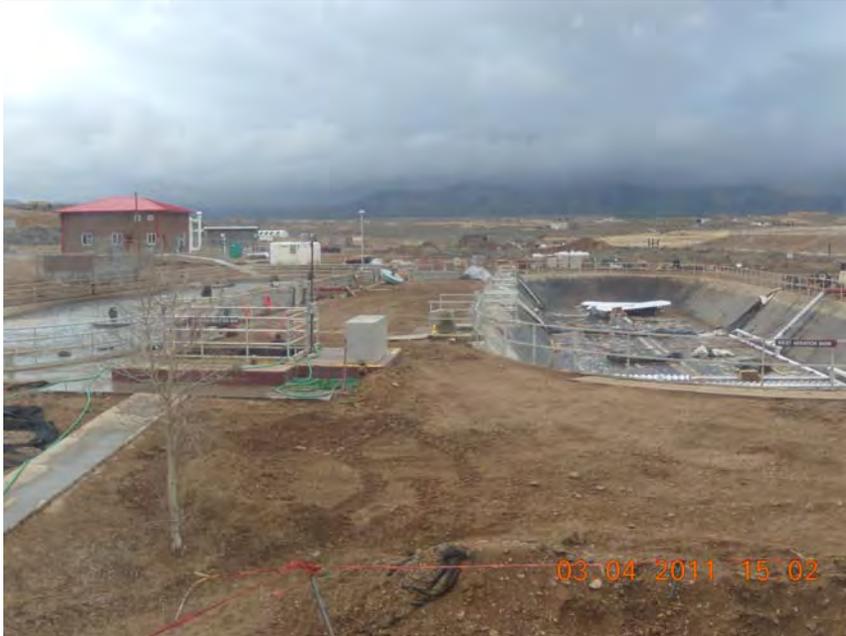
NMED/SWQB  
Official Photograph Log  
Photo # 7

Location: Taos WWTP

Subject: West Aeration basin off line for construction.

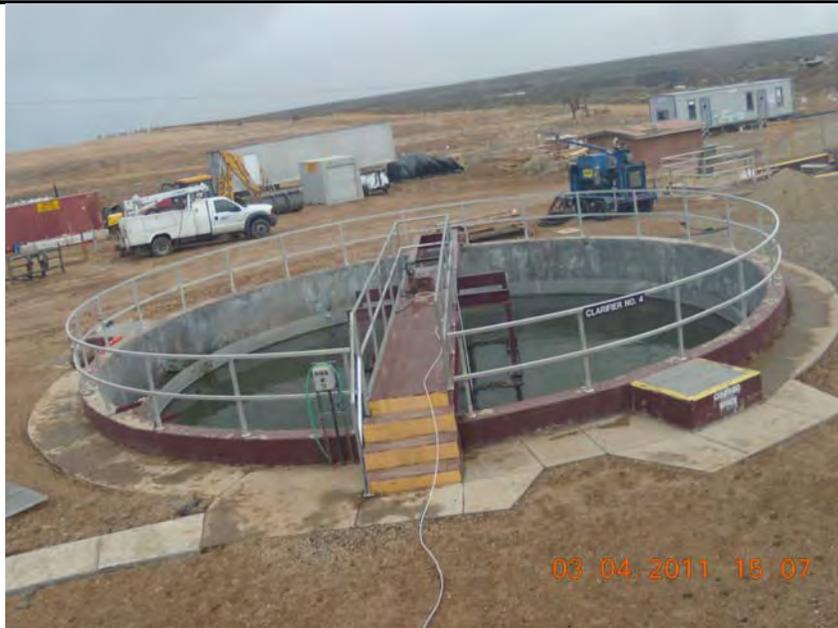
NMED/SWQB  
Official Photograph Log  
Photo # 8

Location: Taos WWTP

Subject: Secondary Clarifier with chlorine feed line. Note the white tubing in the center bottom of the photo.

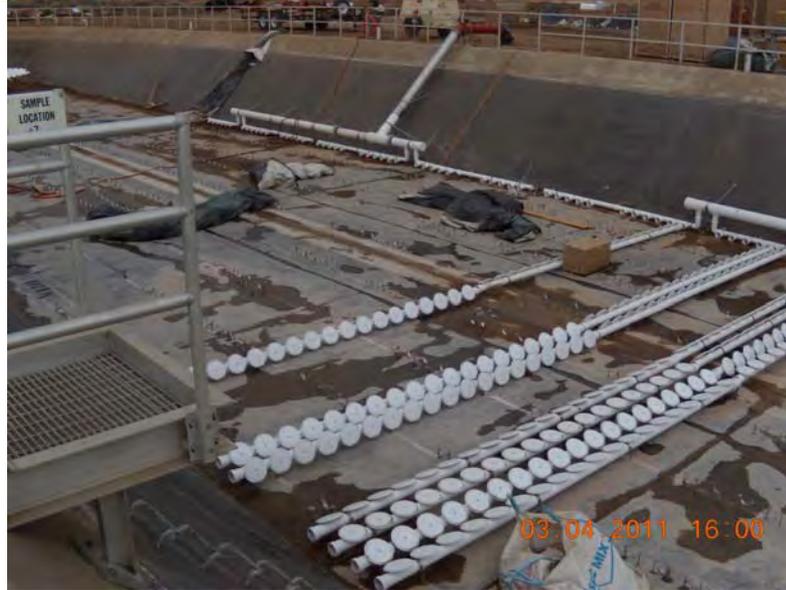
NMED/SWQB  
Official Photograph Log  
Photo # 9

Location: Taos WWTP

Subject: West Aeration Basin being fitted with fine bubble diffuse aerators

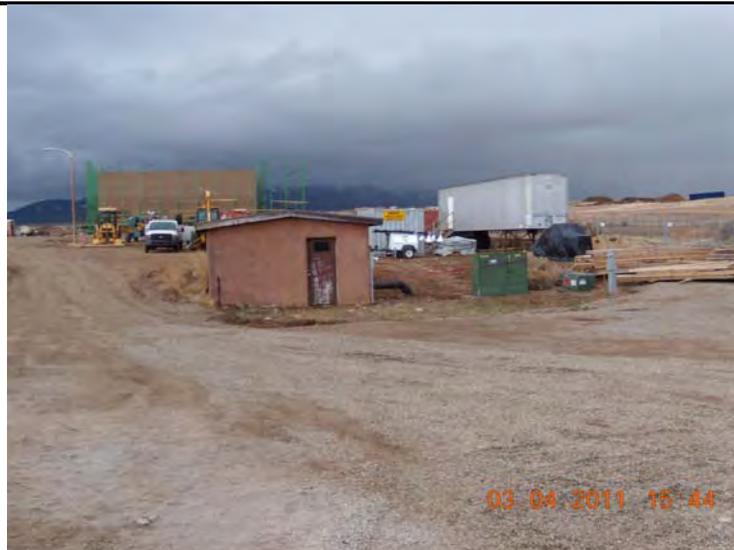
NMED/SWQB  
Official Photograph Log  
Photo # 10

Location: Taos WWTP

Subject: New building in the background under construction. Note in the far right of the picture are the composting piles for the solids at the WWTP.

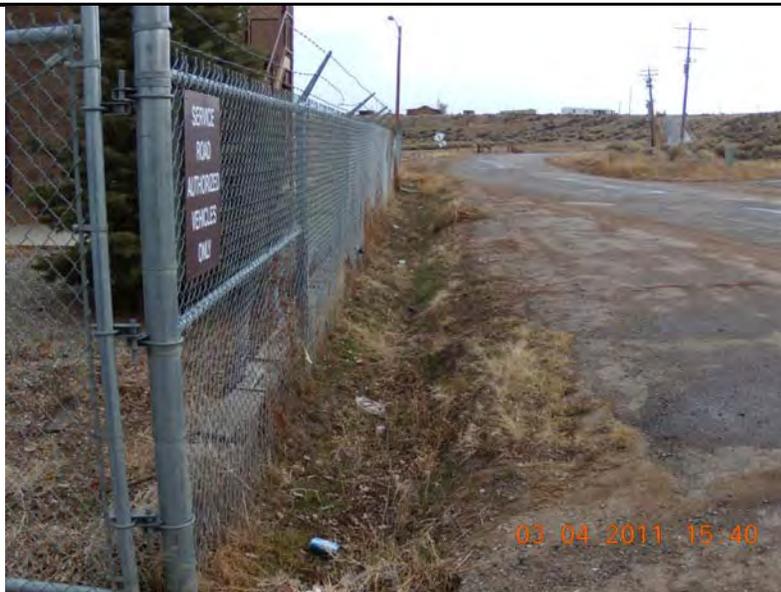
NMED/SWQB  
Official Photograph Log  
Photo # 11

Location: Taos WWTP

Subject: Ditch along Cordova Road at WWTP does not show recent discharges or flow at the time of the inspection. However the site does not have any berm or physical containment in place.

4. The downhill perimeter of the WWTP was observed for any evidence of recent runoff or potential dumping of any material and/or substances that could make it's way to the Rio Pueblo de Taos. The WWTP does not have any constructed berms or containment around the WWTP to prevent runoff. Indications of recent flows of liquid and/or material off site were not evident.

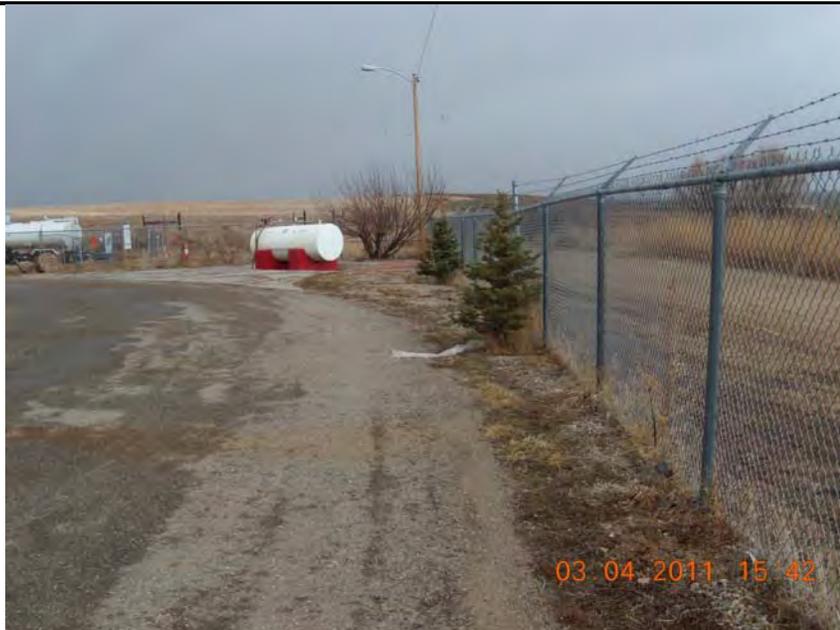
NMED/SWQB  
Official Photograph Log  
Photo # 12

Location: Taos WWTP

Subject: Ditch along down grade side of WWTP does not show recent discharges or flow at the time of the inspection. However the site does not have any berm or physical containment in place.

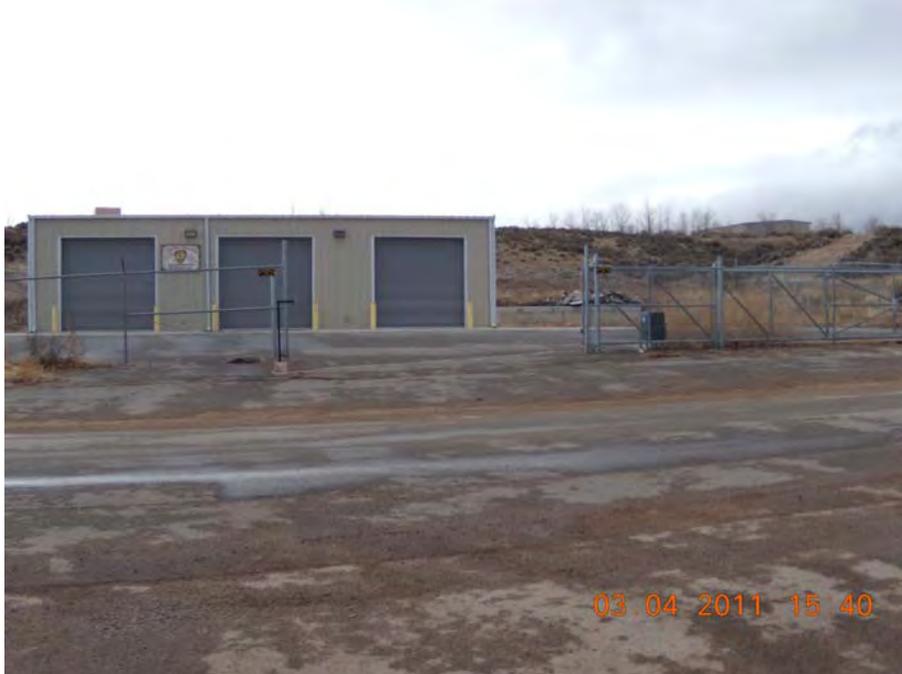
NMED/SWQB  
Official Photograph Log  
Photo # 13

Location: Taos WWTP

Subject: Town of Taos Drinking Water Chlorination and Distribution Station. Located across Cordova Road from WWTP. Processes water from Well by river.

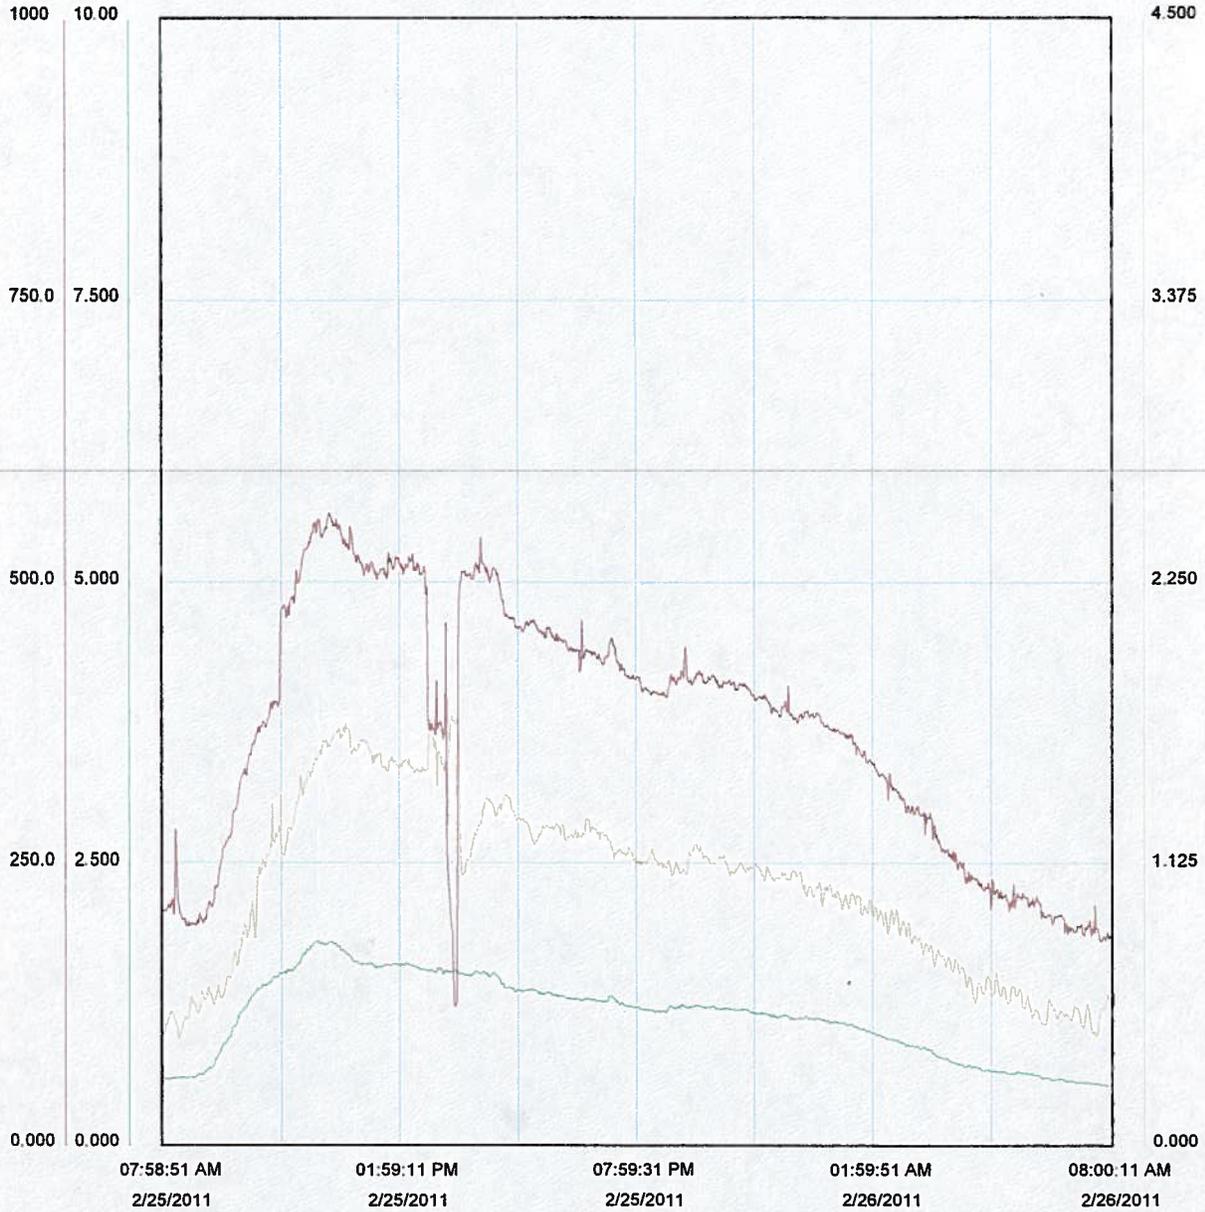
# OMI TAOS WWTP FLOW TREND

Legend	Trend Name	Comment	Min.	Max.	Avg.	Min. Scale	Max. Scale	Eng. Units
<span style="color: green;">—</span>	INFLUENTFL OW	Influent flow	0.528	1.803	1.144	0.000	10.00	MGD
<span style="color: grey;">—</span>	EFFLUENTFL OW	Effluent flow	0.424	1.719	1.051	0.000	4.500	MGD
<span style="color: brown;">—</span>	RASFLOW	RAS flow	122.2	562.1	370.7	0.000	1000	GPM

*All flows on + running  
CGS 2/25/11*

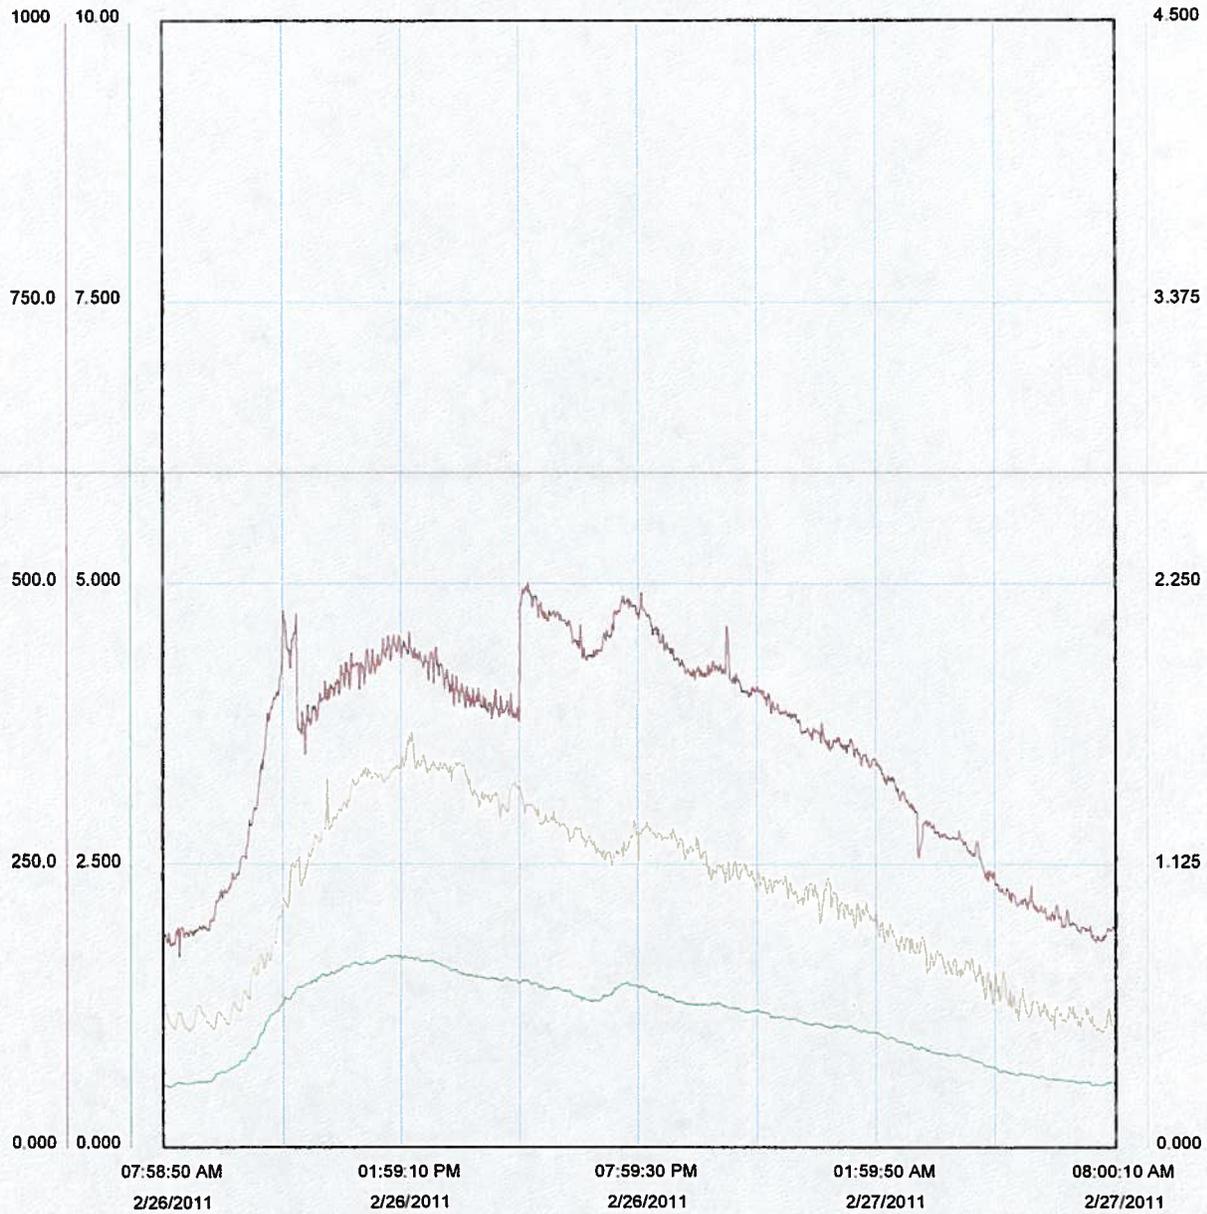
# OMI TAOS WWTP FLOW TREND

Legend	Trend Name	Comment	Min.	Max.	Avg.	Min. Scale	Max. Scale	Eng. Units
<span style="color: green;">—</span>	INFLUENTFL OW	Influent flow	0.524	1.694	1.128	0.000	10.00	MGD
<span style="color: yellow;">—</span>	EFFLUENTFL OW	Effluent flow	0.455	1.664	1.014	0.000	4.500	MGD
<span style="color: red;">—</span>	RASFLOW	RAS flow	167.7	501.3	355.0	0.000	1000	GPM

*All flows on + running  
CGL 2/28/11*

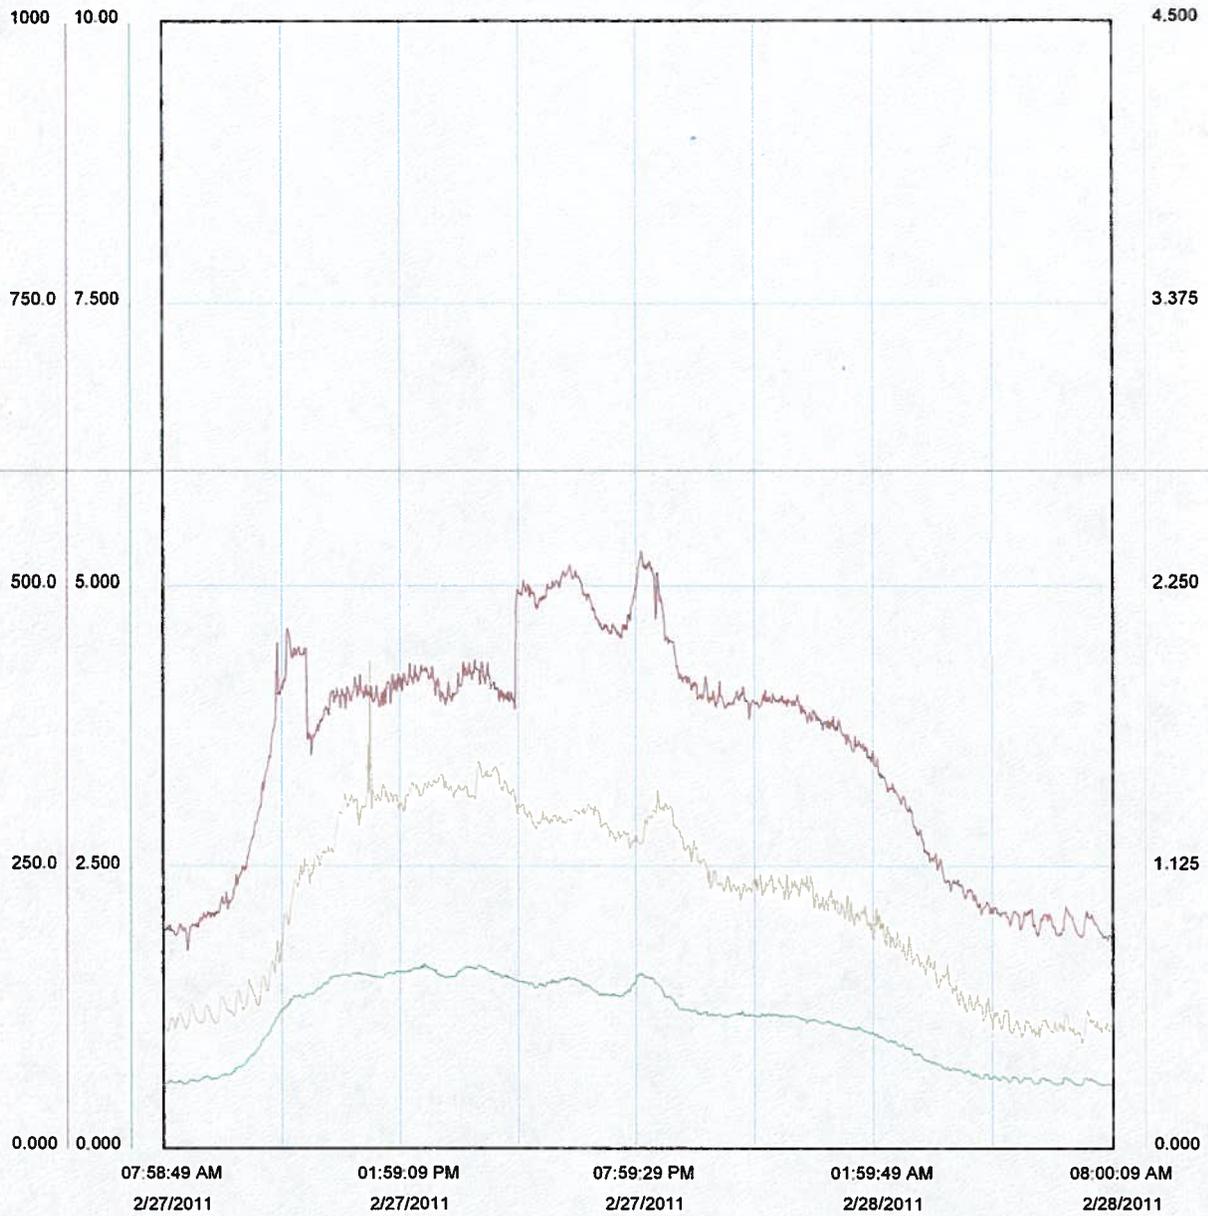
# OMI TAOS WWTP FLOW TREND

Legend	Trend Name	Comment	Min.	Max.	Avg.	Min. Scale	Max. Scale	Eng. Units
<span style="color: green;">—</span>	INFLUENTFL OW	Influent flow	0.550	1.635	1.120	0.000	10.00	MGD
<span style="color: yellow;">—</span>	EFFLUENTFL OW	Effluent flow	0.419	1.951	0.994	0.000	4.500	MGD
<span style="color: red;">—</span>	RASFLOW	RAS flow	175.9	531.4	354.7	0.000	1000	GPM

*all flows out running  
CBV 2/28/11*

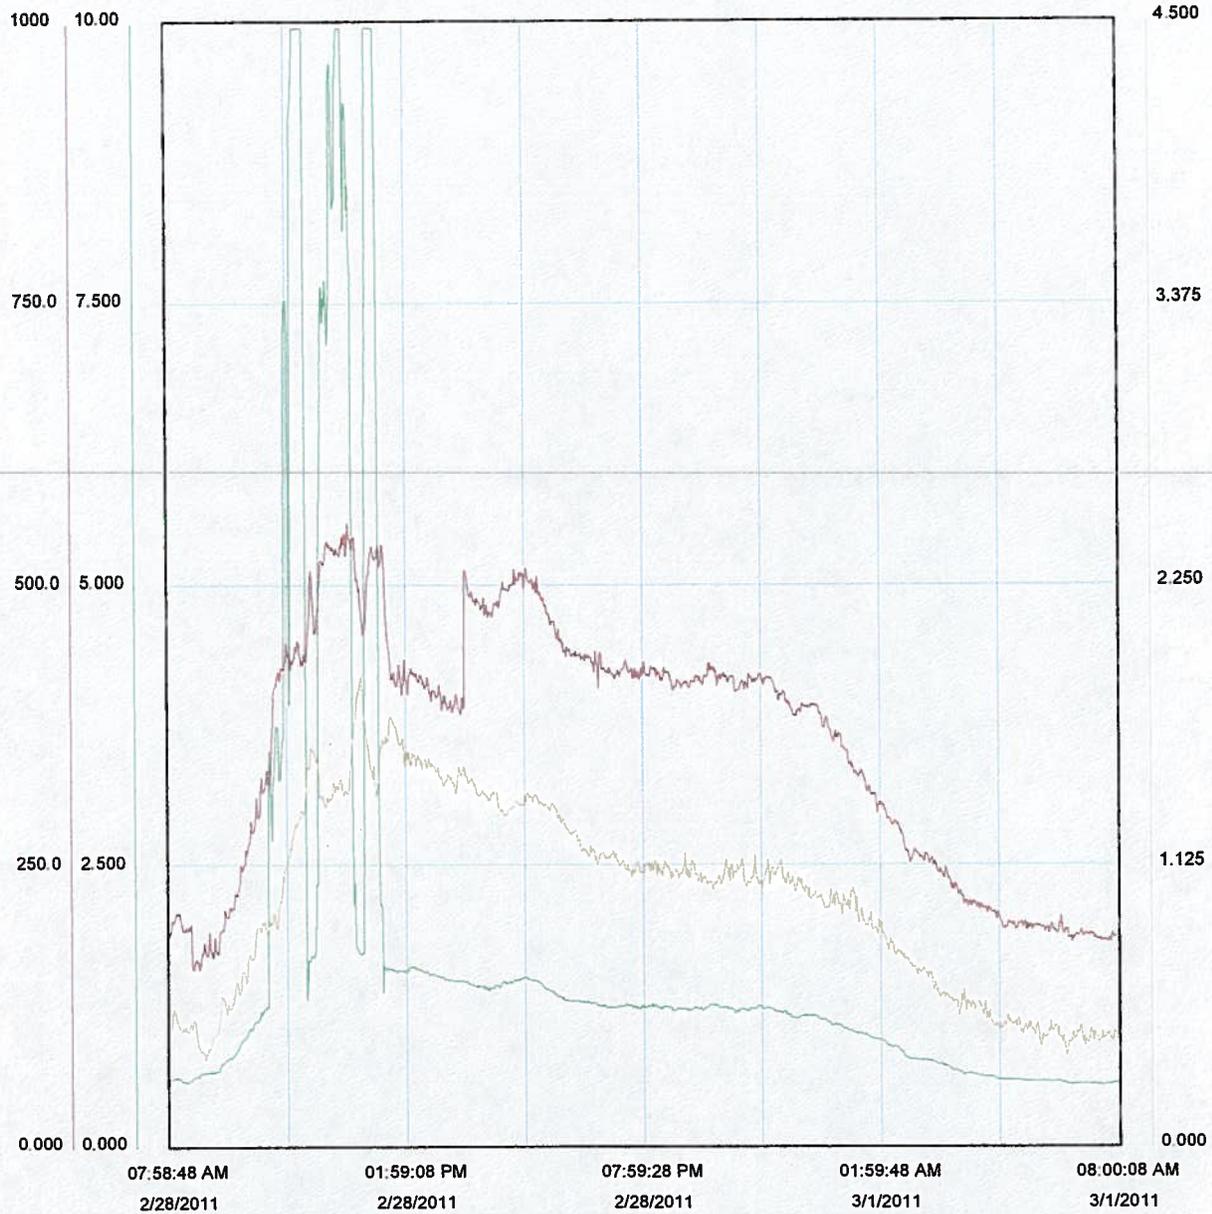
# OMI TAOS WWTP FLOW TREND

Legend	Trend Name	Comment	Min.	Max.	Avg.	Min. Scale	Max. Scale	Eng. Units
<span style="color: green;">—</span>	INFLUENTFL OW	Influent flow	0.541	9.95	1.671	0.000	10.00	MGD
<span style="color: brown;">—</span>	EFFLUENTFL OW	Effluent flow	0.344	1.882	1.005	0.000	4.500	MGD
<span style="color: red;">—</span>	RASFLOW	RAS flow	157.8	554.9	356.8	0.000	1000	GPM

*All flows are running  
CB 3/1/11*

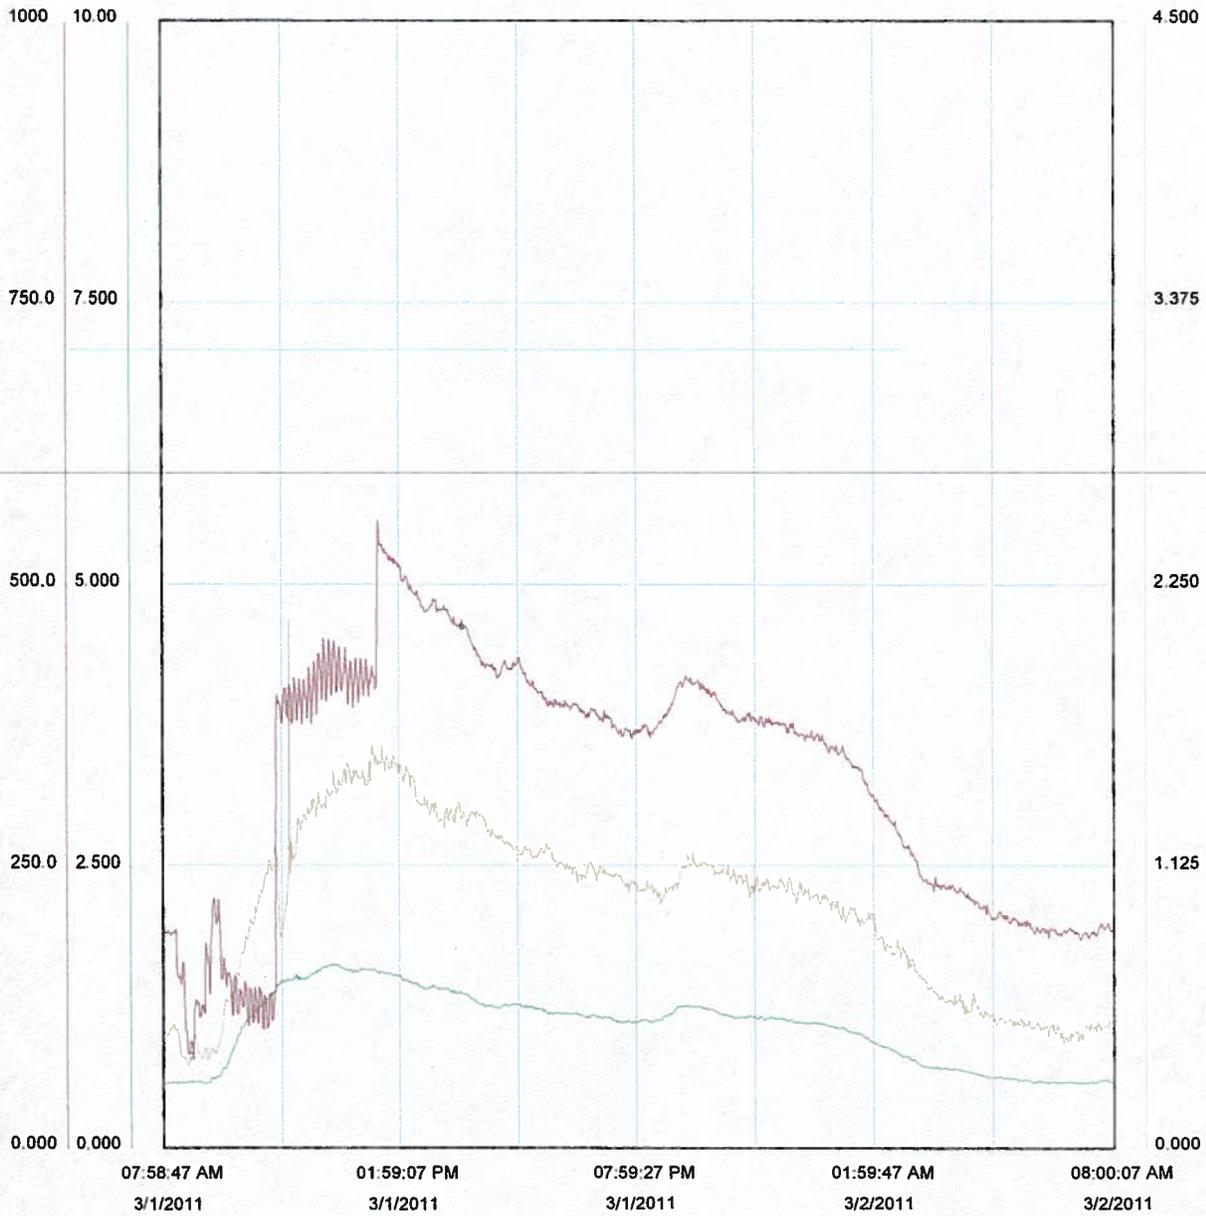
# OMI TAOS WWTP FLOW TREND

Legend	Trend Name	Comment	Min.	Max.	Avg.	Min. Scale	Max. Scale	Eng. Units
<span style="color: green;">—</span>	INFLUENTFL OW	Influent flow	0.556	1.631	1.070	0.000	10.00	MGD
<span style="color: brown;">—</span>	EFFLUENTFL OW	Effluent flow	0.326	2.114	0.964	0.000	4.500	MGD
<span style="color: red;">—</span>	RASFLOW	RAS flow	77.56	556.6	329.8	0.000	1000	GPM

*all flows on + running  
CMT 3/2/11*

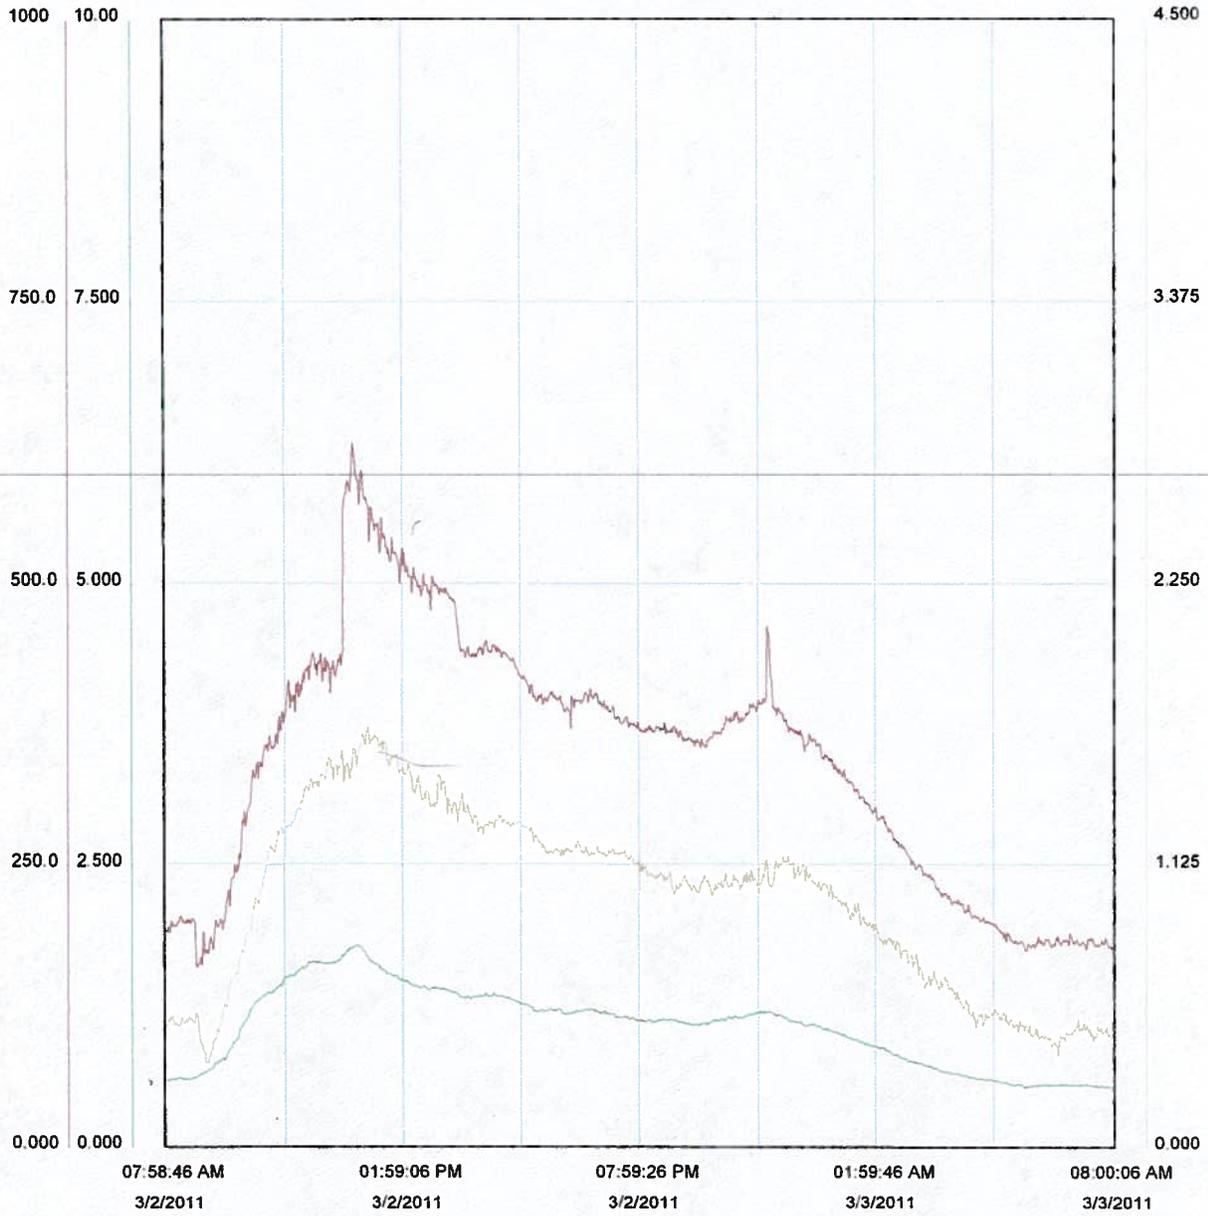
# OMI TAOS WWTP FLOW TREND

Legend	Trend Name	Comment	Min.	Max.	Avg.	Min. Scale	Max. Scale	Eng. Units
	INFLUENTFL OW	Influent flow	0.524	1.785	1.067	0.000	10.00	MGD
	EFFLUENTFL OW	Effluent flow	0.333	1.681	0.998	0.000	4.500	MGD
	RASFLOW	RAS flow	159.0	624.9	343.2	0.000	1000	GPM

*All flows on + going  
CAY 3/3/11*

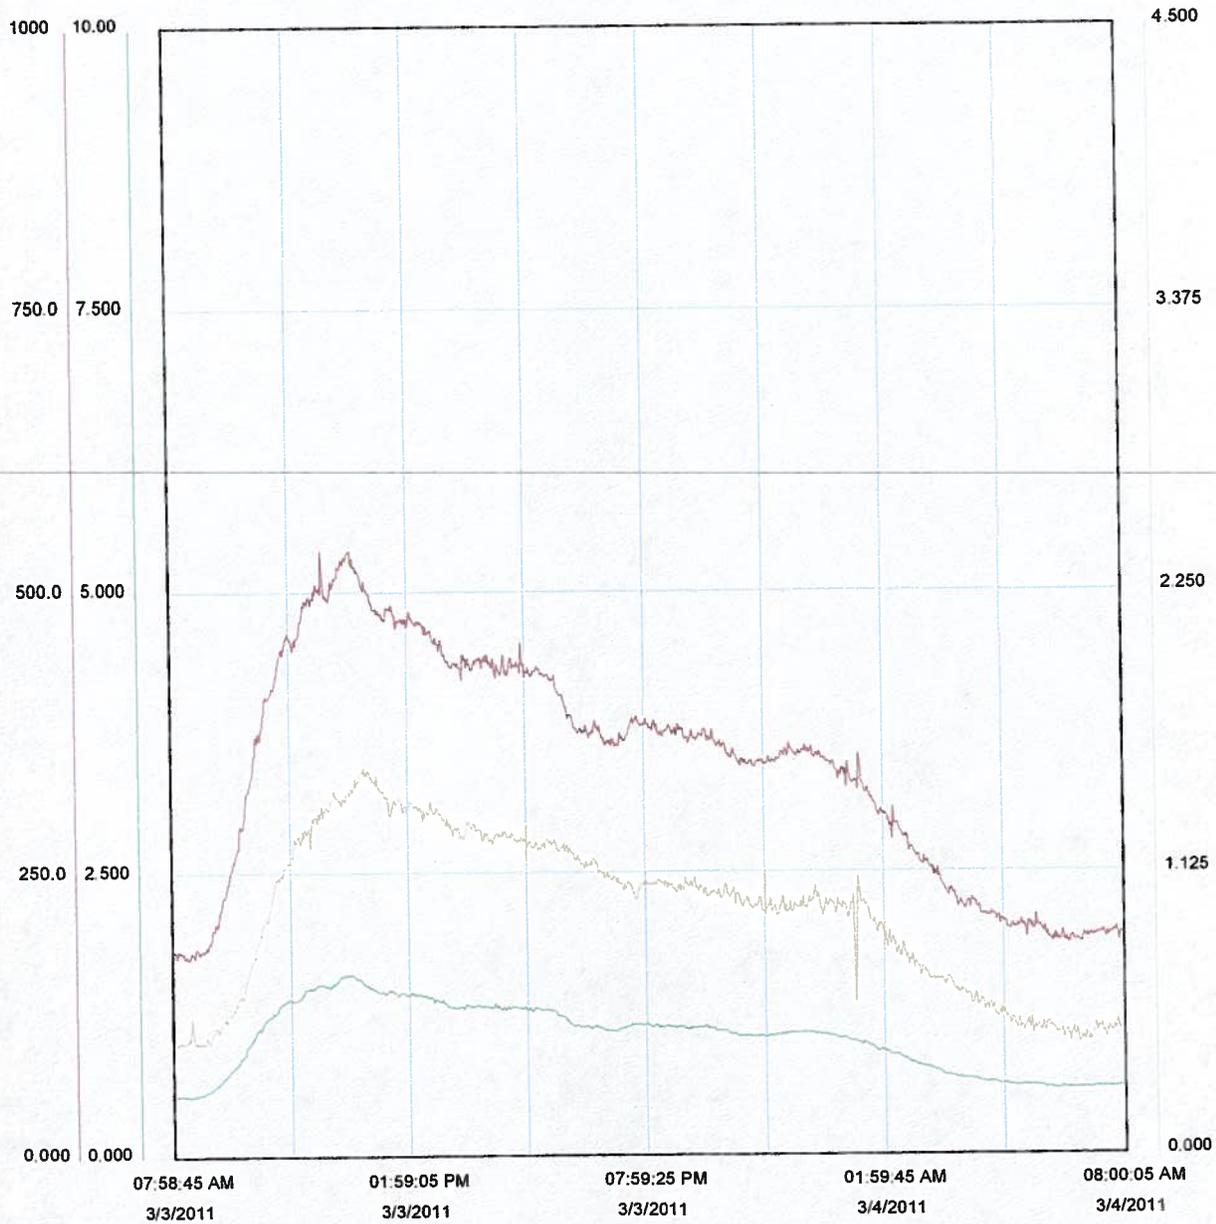
# OMI TAOS WWTP FLOW TREND

Legend	Trend Name	Comment	Min.	Max.	Avg.	Min. Scale	Max. Scale	Eng. Units
<span style="color: green;">—</span>	INFLUENTFL OW	Influent flow	0.518	1.610	1.040	0.000	10.00	MGD
<span style="color: yellow;">—</span>	EFFLUENTFL OW	Effluent flow	0.441	1.557	0.971	0.000	4.500	MGD
<span style="color: red;">—</span>	RASFLOW	RAS flow	173.4	537.1	345.7	0.000	1000	GPM

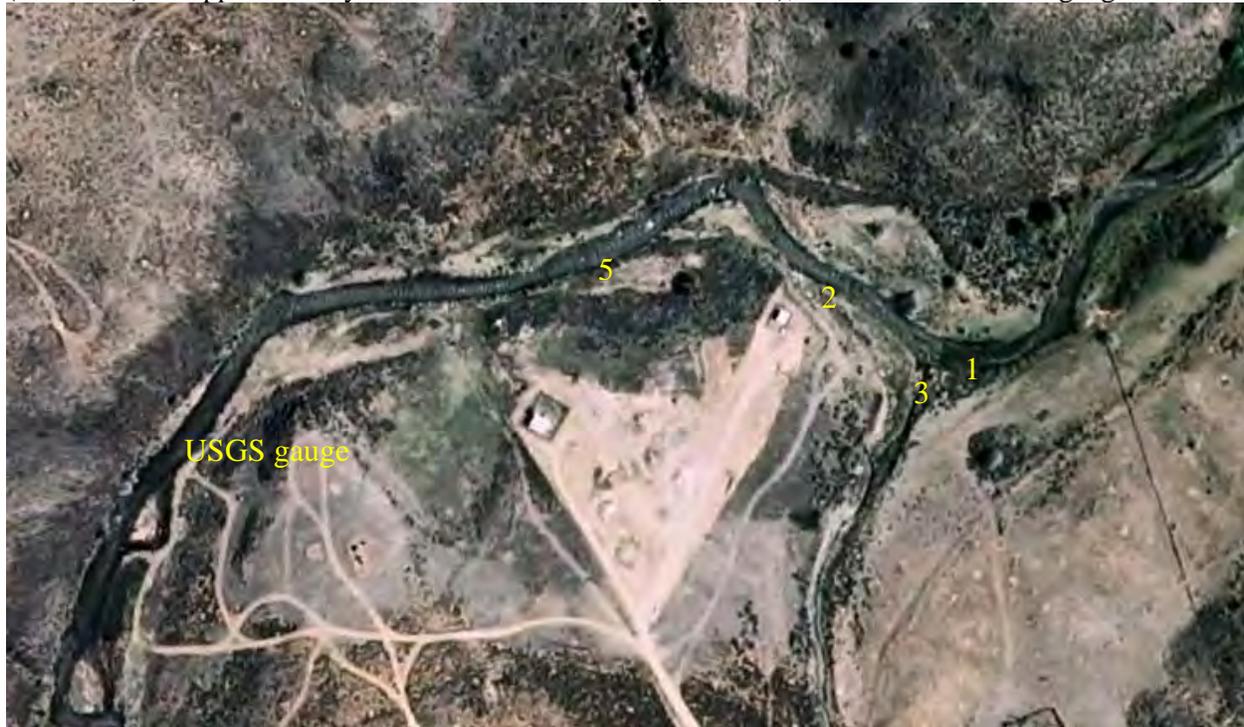
1. Rio Pueblo de Taos above the effluent channel
2. Rio Pueblo de Taos below the effluent channel
3. Taos WWTP effluent channel immediately above the Rio Pueblo de Taos
4. WWTP flume (not shown in photo)

Additionally, we performed a visual inspection for dead fish from below the effluent channel (location 2) for approximately 200 meters downstream (location 5), and also at the USGS gauge station.

Preliminary ammonia results from the Scientific Laboratory Division are at location 1: 0.00 mg/L as N; at location 2: 0.55 mg/L as N; at location 3: 21.8 mg/L as N; location 4: 20.8 mg/L as N. Nitrate values were all below detection. These data, if verified and finalized by the laboratory, indicate that the Taos WWTP does input ammonia to the Rio Pueblo de Taos. The concentration at the downstream site is consistent with the mixing of this effluent with stream water and this sample having been collected below the mixing zone. The downstream concentration (0.55 mg/L) is less than the applicable water quality standards (acute (salmonids present) = 1.6 mg/L; chronic (early life stages present) = 0.85 mg/L) at the stream temperature (11.06°C) and pH (8.66).

*E coli* results at location 1 were 7.4 cfu/100 mL; at location 2, 7.5cfu/100 mL; at location 3, 52.8 cfu/100 mL; at location 4, 37.9 cfu/100 mL. All values are below the applicable water quality standard of 126 cfu/100mL (monthly geometric mean).

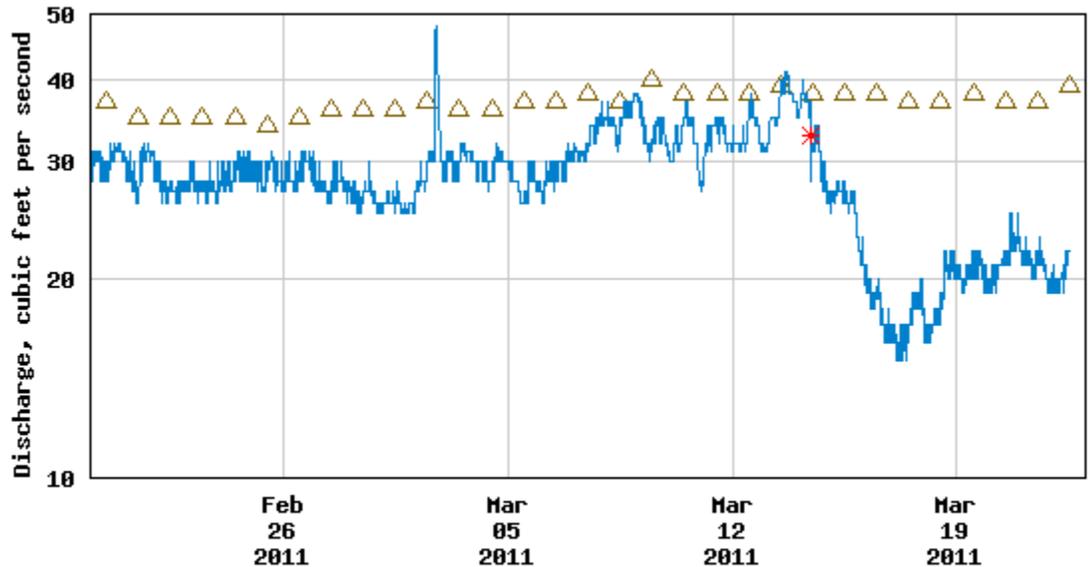
USGS 08276300 RIO PUEBLO DE TAOS BELOW LOS CORDOVAS, NM

A review of USGS stream flow data from the gauge shown on the above photo (Rio Pueblo de Taos below Los Cordovas) indicated a spike in stream flow from about 18:00 to 20:00 on 2 March, the evening before the fish kill was originally reported. No such spike is indicated in the data from the next upstream gauge, Rio Pueblo de Taos near Taos (which is in the canyon above the Taos Pueblo). The spike in flow brought the river from about 30 cfs to 48 cfs for a brief time.

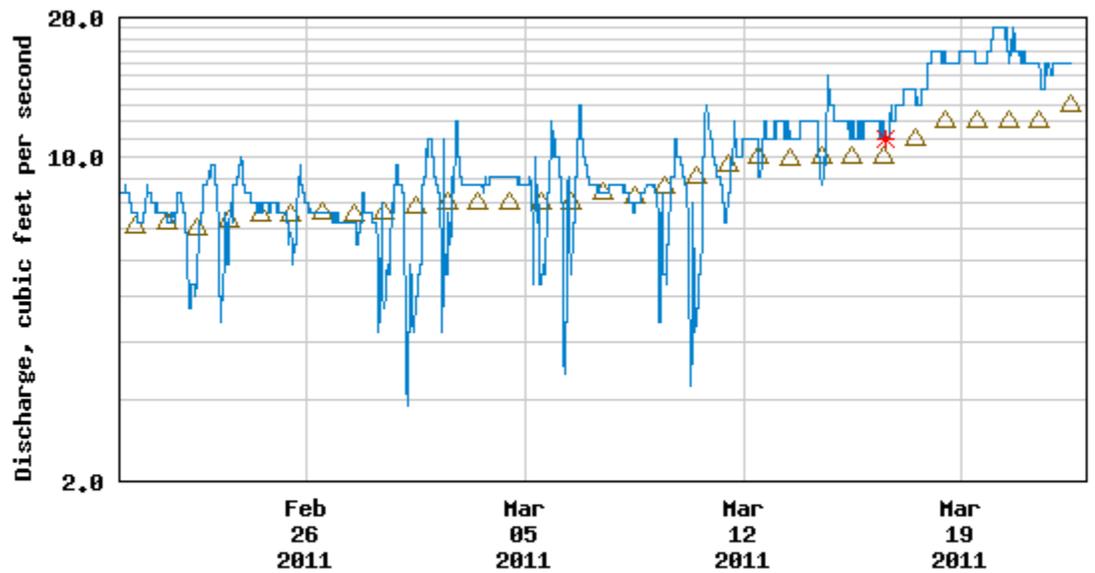
USGS 08269000 RIO PUEBLO DE TAOS NEAR TAOS, NM

△ Median daily statistic (62 years) \* Measured discharge  
— Discharge
