**RE: Major Municipal, SIC 4952, NPDES Compliance Evaluation Inspection, Town of Taos
Wastewater Treatment Plant, NM0024066, July 12, 2012**

NPDES Compliance Inspection Report

**Compliance Evaluation Inspection
Town of Taos Wastewater Treatment Plant
NPDES Permit No. NM0024066
Date of Inspection: July 12, 2012**

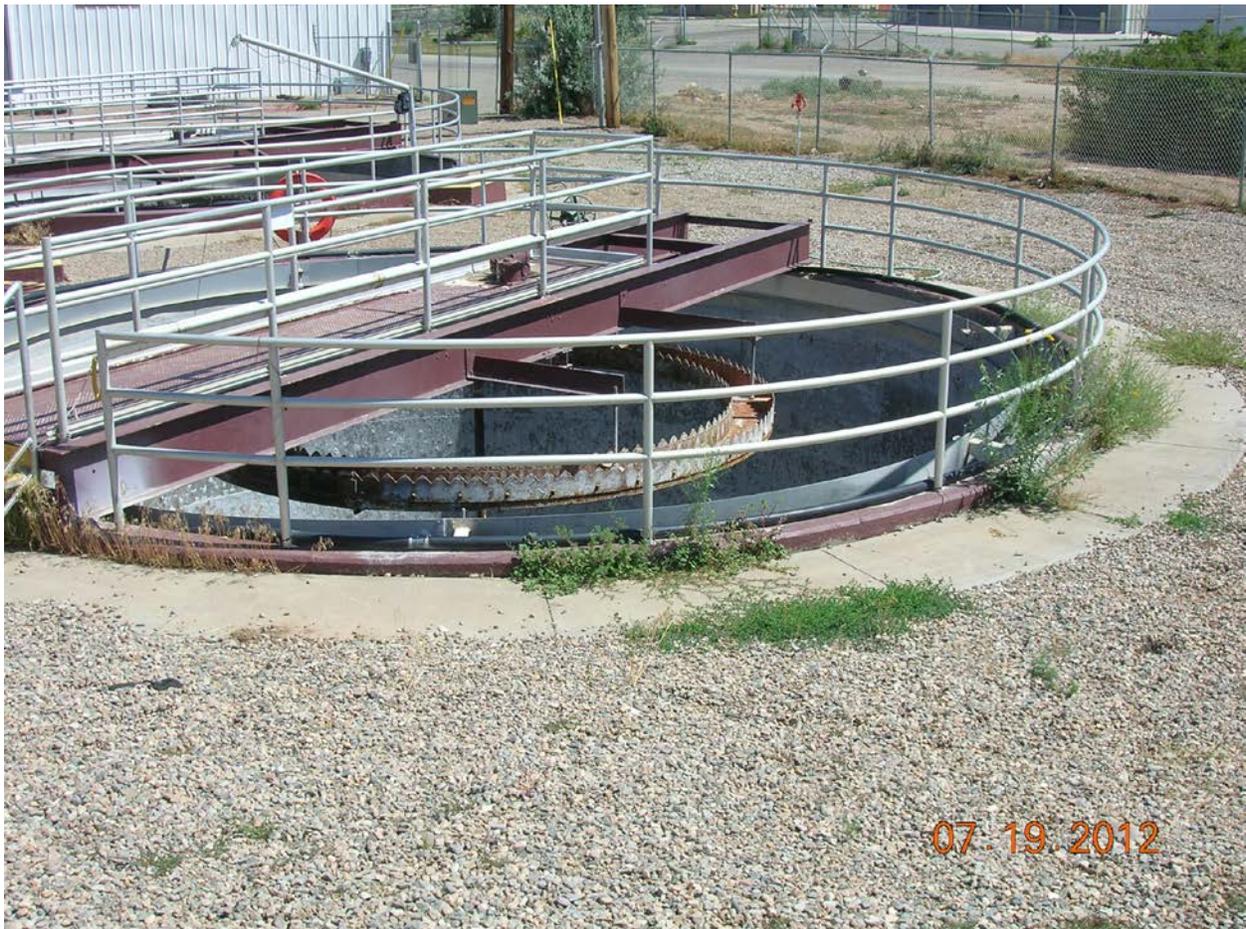
NMED/SWQB
Official Photograph Log
(Photos taken by Project Manager – Inspector’s camera malfunctioned)
Photo # 1

Photographer: Anthony Martinez, Project Manager	Date: 07-19-2012	
City/County: Town of Taos / Taos		State: New Mexico
Location: Taos Wastewater Treatment Plant		
Subject: Decommissioned clarifiers

Previously, four clarifiers were used in treatment. These units have since been decommissioned. The lines have been closed and capped and no further flows are allowed to enter any clarifier.

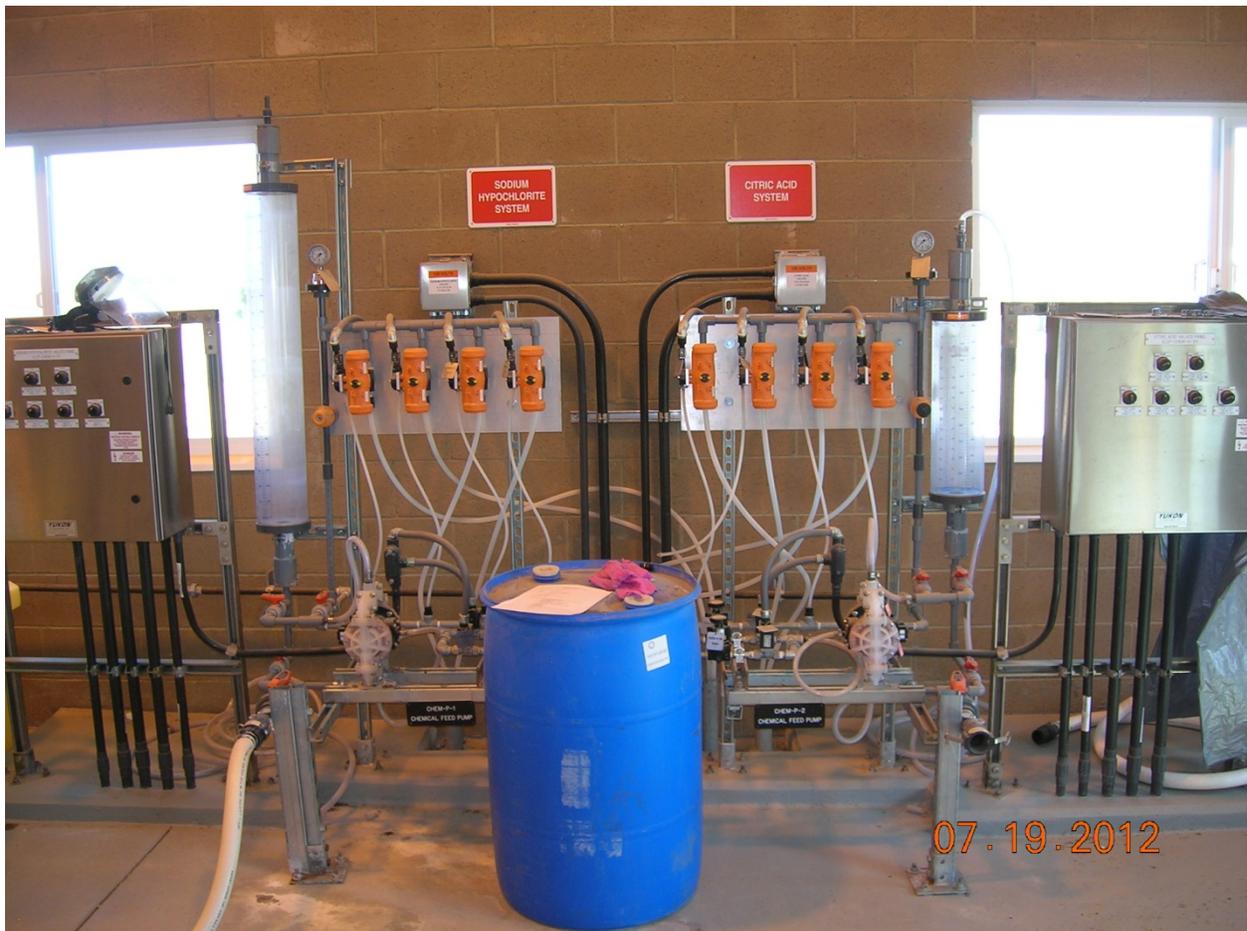
**NMED/SWQB
Official Photograph Log
Photo # 2**

Photographer: Anthony Martinez, Project Manager.	Date: 07-19-2012	
City/County: Town of Taos / Taos	State: New Mexico	
Location: Taos Wastewater Treatment Plant		
Subject: Chemical cleaning system for MBR

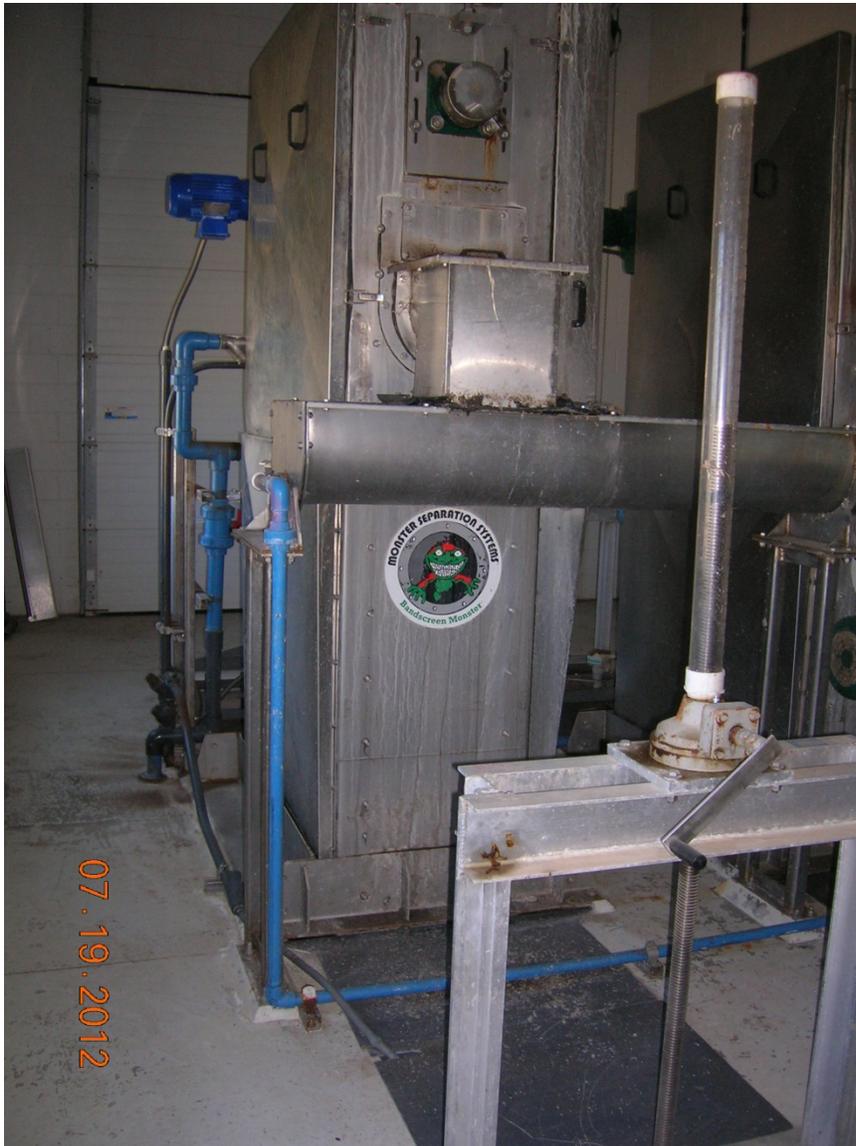
**NMED/SWQB
Official Photograph Log
Photo # 3**

Photographer: Anthony Martinez, Project Manager.	Date: 07-19-2012	
City/County: Town of Taos / Taos	State: New Mexico	
Location: Taos Wastewater Treatment Plant		
Subject: Headworks
