NEW MEXICO  
ENVIRONMENT DEPARTMENT

*Surface Water Quality Bureau*

Re: **Minor Non-Municipal; SIC 4952; NPDES Compliance Evaluation Inspection; Elephant Butte State Park; NM0024937; June 13, 2012**

**Compliance Evaluation Inspection**  
**Elephant Butte State Park Wastewater Treatment Facility**  
**NPDES Permit No. NM0024937**  
**June 13, 2012**

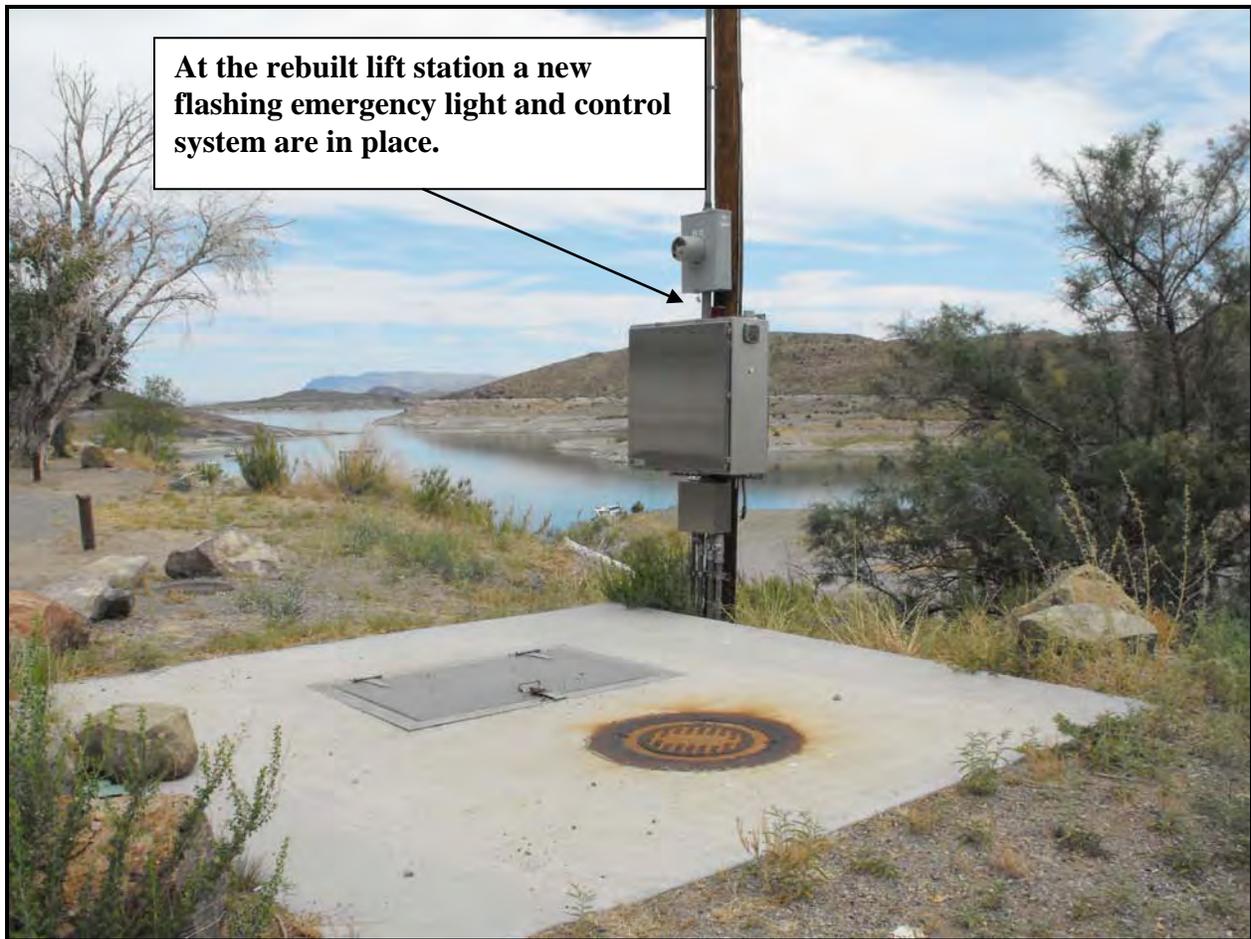
Photo # 1

Photographer: Daniel Valenta	Date: 6/13/2012	Time: 1139
City/County: Elephant Butte State Park/Sierra County		
Location: Elephant Butte State Park, New Mexico, lift station at the trailer park, facing northwest.		
Subject: Lift station

The lift station has been rebuilt with new pumps, level meters and alarm system put in place. Influent flow enters the aeration chamber through a manually cleaned bar screen with 1 inch gaps between the bars.

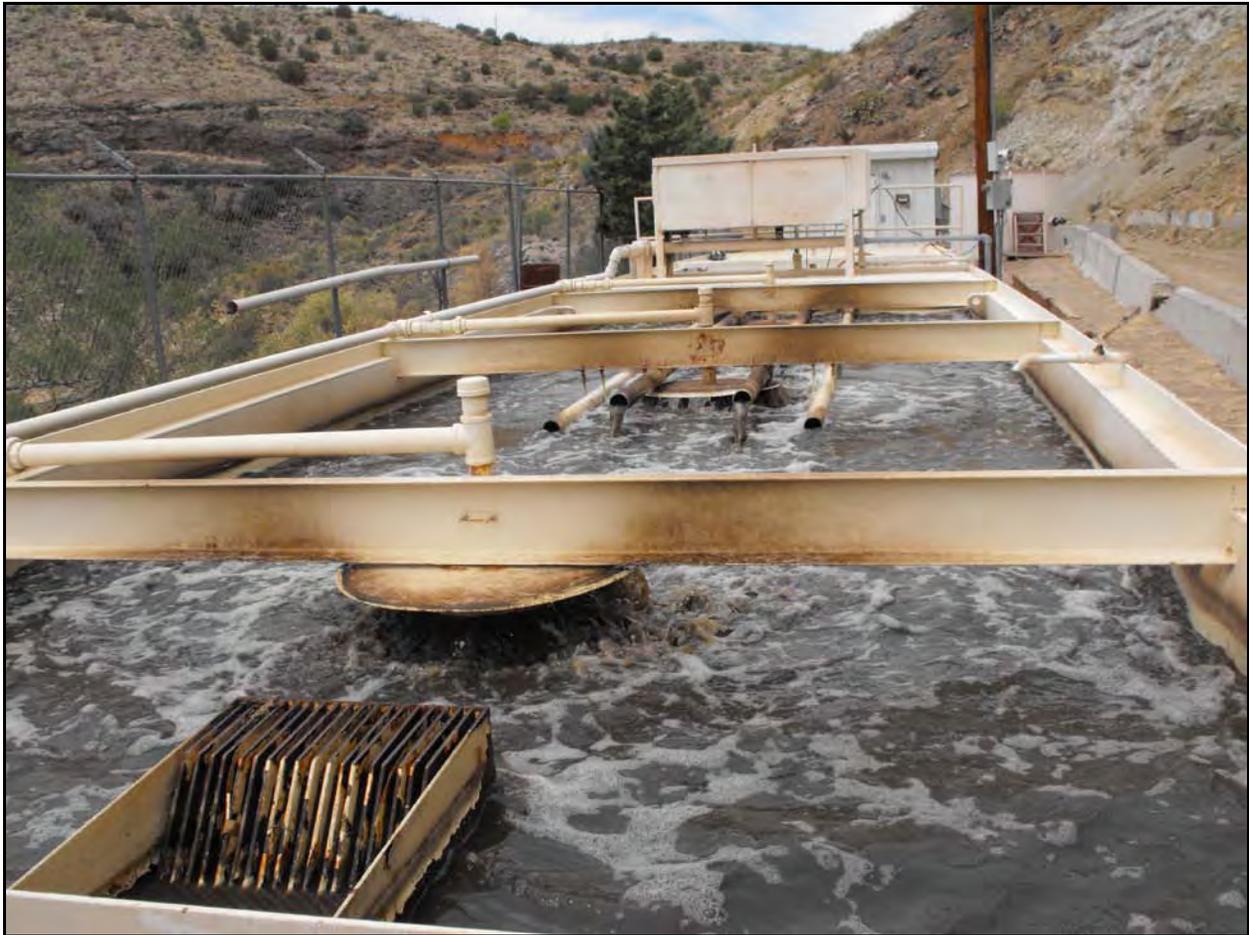
Photo # 2

Photographer: Daniel Valenta	Date: 6/13/2012	Time: 1148
City/County: Elephant Butte State Park/Sierra County		
Location: Elephant Butte State Park, New Mexico, waste water treatment facility, facing south.		
Subject: Waste water treatment facility, aeration unit.

The aeration basin is continuously aerated using fixed surface aerators. The aerators force air down a cone shaped injection port. The air flow can be regulated manually depending on the depth of wastewater in the aeration basin. The volume of influent varies due to the time of year visitor's use the park. When flow is very low dog food is added to the aeration basin in order to keep the biological elements of the process viable. Return activated sludge (RAS) is brought back to the aeration basin from the clarifier via two lines which are suspended above the aeration basin contents. The secondary clarifier is rectangular in configuration. The effluent weirs from this unit are on the end of the tank next to what was the chlorine contact chamber. The effluent then enters a cement evaporation lagoon.

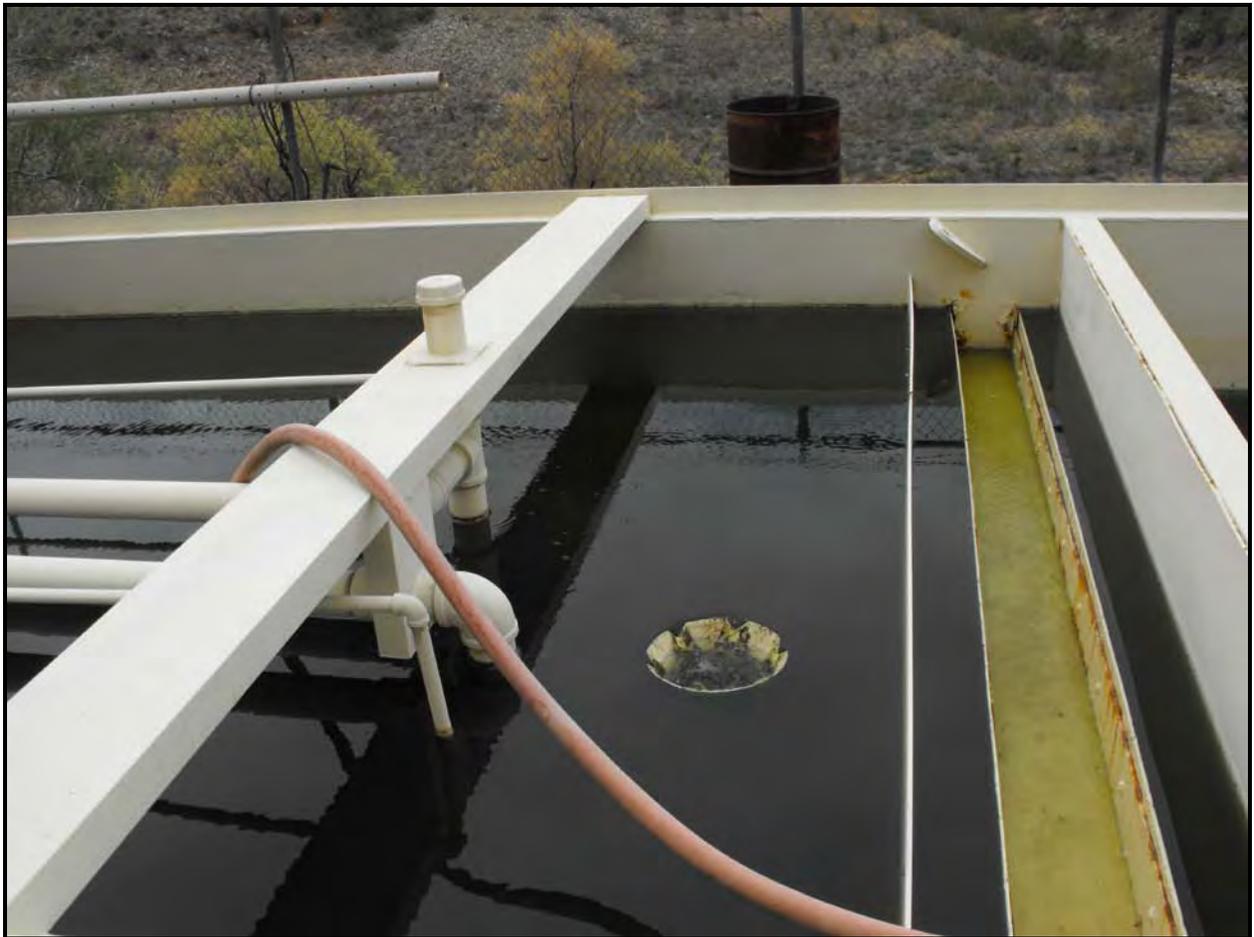
Photo # 3

Photographer: Daniel Valenta	Date: 6/13/2012	Time: 1153
City/County: Elephant Butte State Park/Sierra County		
Location: Elephant Butte State Park, New Mexico, waste water treatment facility, facing west.		
Subject: Waste water treatment facility, clarifier unit.

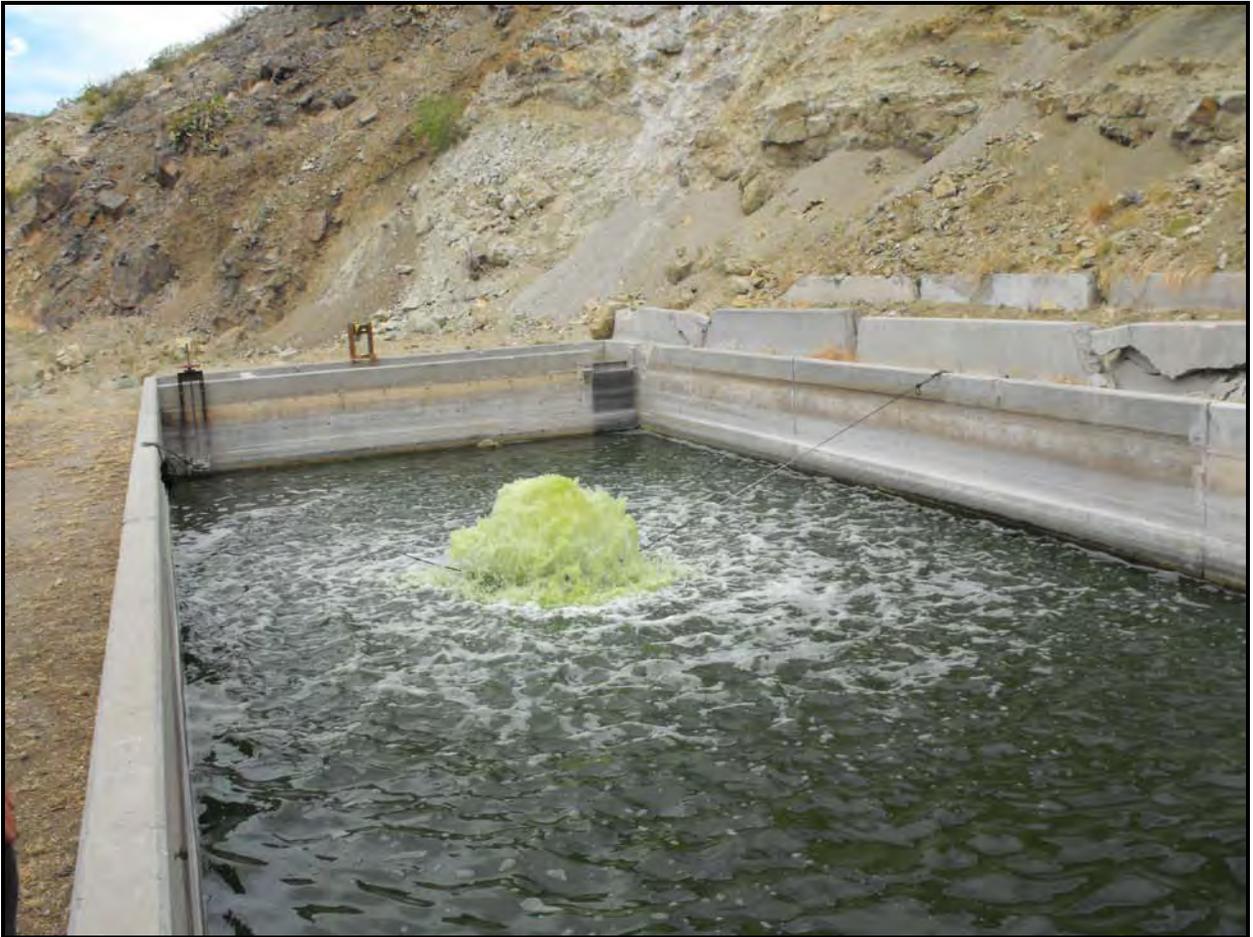
Photo # 4

Photographer: Daniel Valenta	Date: 6/13/2012	Time: 1155
City/County: Elephant Butte State Park/Sierra County		
Location: Elephant Butte State Park, New Mexico, waste water treatment facility, facing south.		
Subject: Waste water treatment facility, evaporation unit.

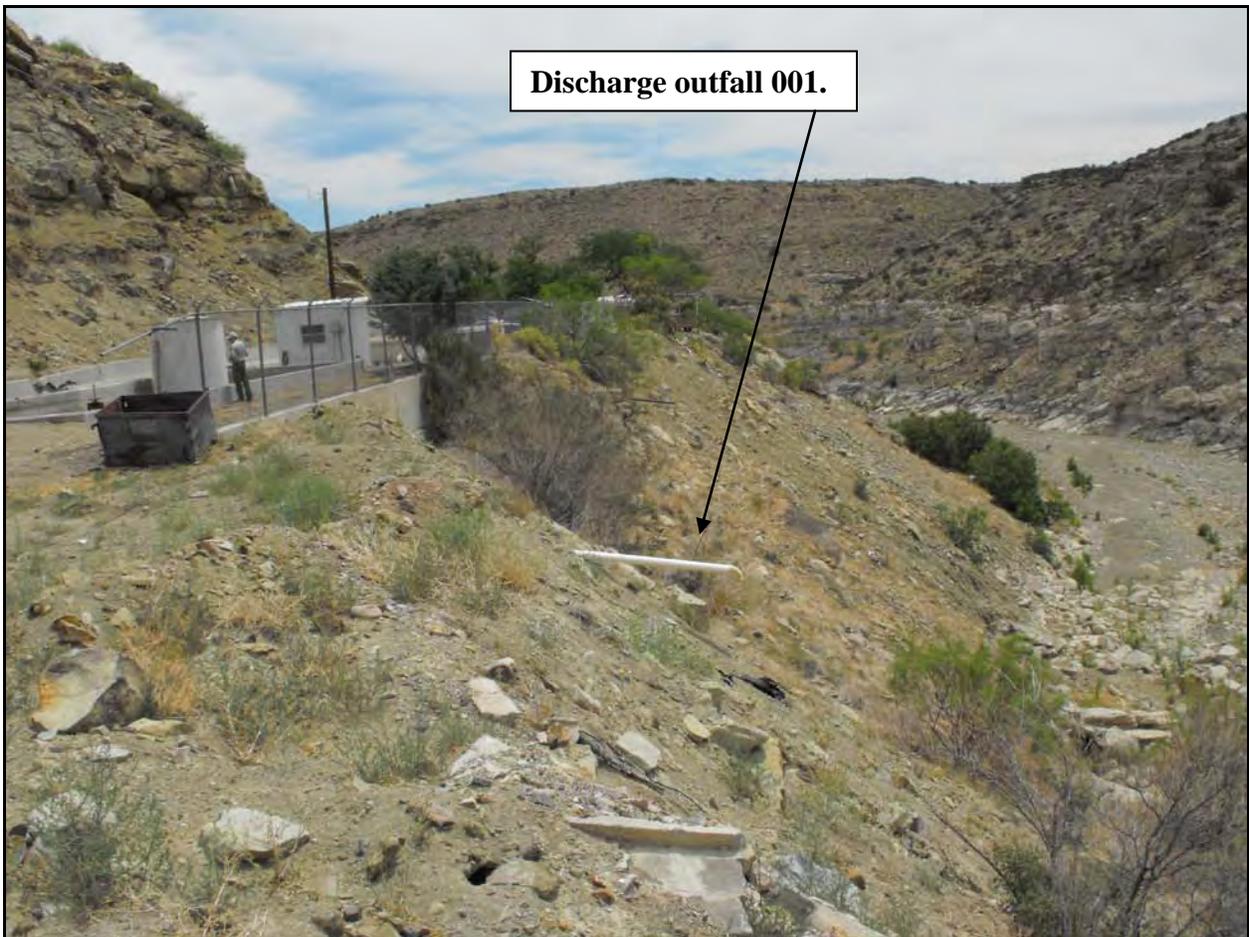
Photo # 5

Photographer: Daniel Valenta	Date: 6/13/2012	Time: 1203
City/County: Elephant Butte State Park/Sierra County		
Location: Elephant Butte State Park, New Mexico, waste water treatment facility, facing south.		
Subject: Waste water treatment facility, discharge outfall.

The facility does not have in place a method of final disinfection or of measuring the discharge, the facility has not discharged since 2003. No changes have occurred at the site that would increase the volume of raw effluent flowing to the facility. The facility appeared well managed with needed units on line and functioning as needed.
