RE: Minor Municipal, SIC 4952, NPDES Compliance Evaluation Inspection, Santa Rosa Wastewater Treatment Plant (WWTP), NPDES Permit No. NM0024988, June 28, 2013

NPDES Compliance Inspection Report

On May 31, 2013 a Compliance Evaluation Inspection (CEI) was conducted at the City of Santa Rosa Wastewater Treatment Plant (WWTP) by Barbara Cooney of the State of New Mexico Environment Department (NMED), Surface Water Quality Bureau (SWQB). The inspection was conducted by NMED for the US Environmental Protection Agency (USEPA), Region VI, under the National Pollutant Discharge Elimination System (NPDES) permit program, in accordance with the Federal Clean Water Act. These inspections are conducted under contract with the USEPA and are used by USEPA to evaluate compliance with the NPDES permit program. This inspection report is based on information supplied by the City of Santa Rosa representatives (the permittee), observations made by the NMED inspectors, reports and records kept by the permittee and/or NMED.

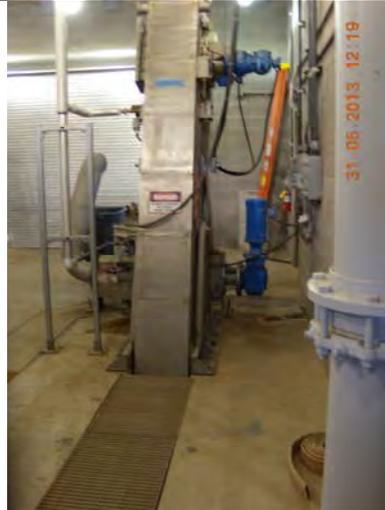
Subject: Influent automatic bar screen with a grinder unit to remove large solids from entering the treatment works.

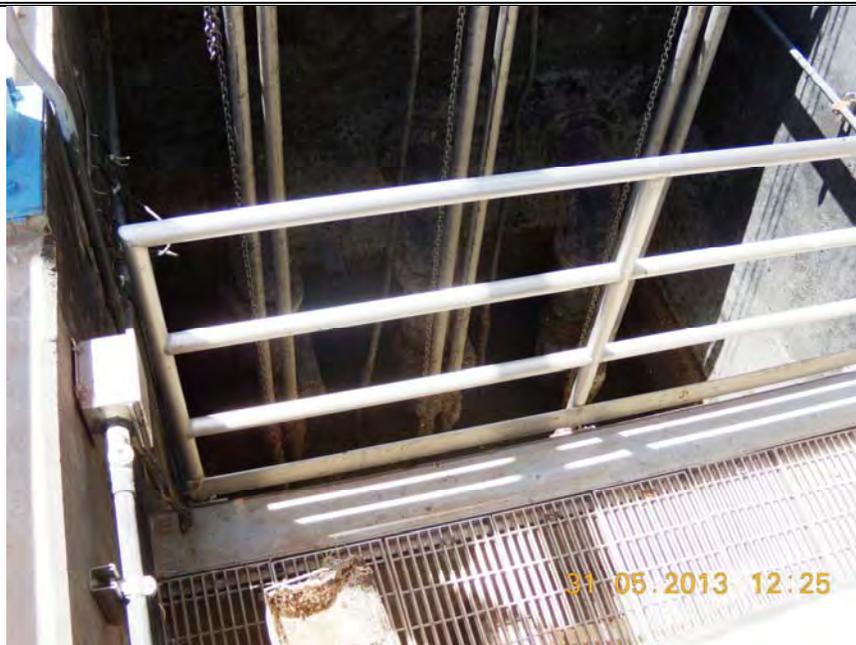
NMED/SWQB
Official Photograph Log
Photo # 2

Subject: Lift station at head works of WWTP with 3 Flygt pumps, activated by floats that detect the height of the water level.

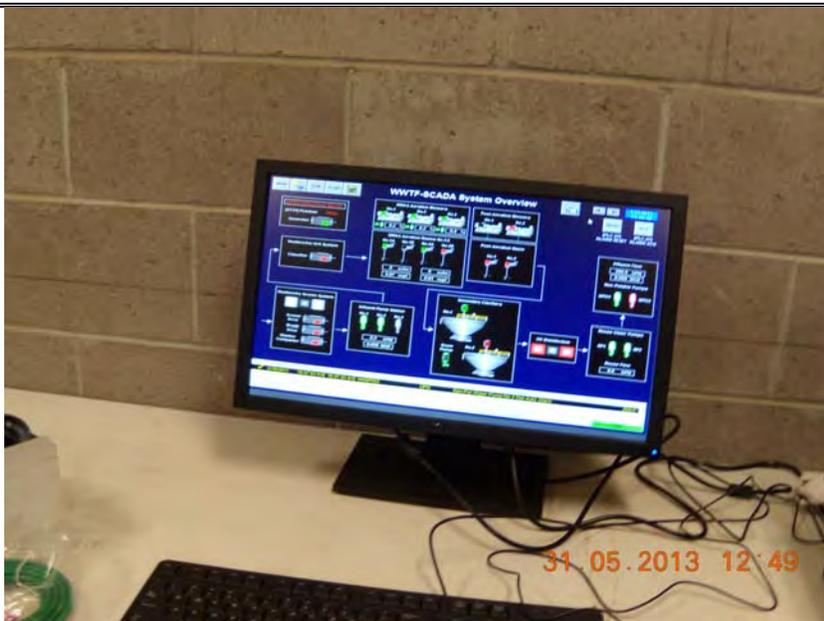
**NMED/SWQB
Official Photograph Log
Photo # 3**

Subject: SCADA – WWTP control system

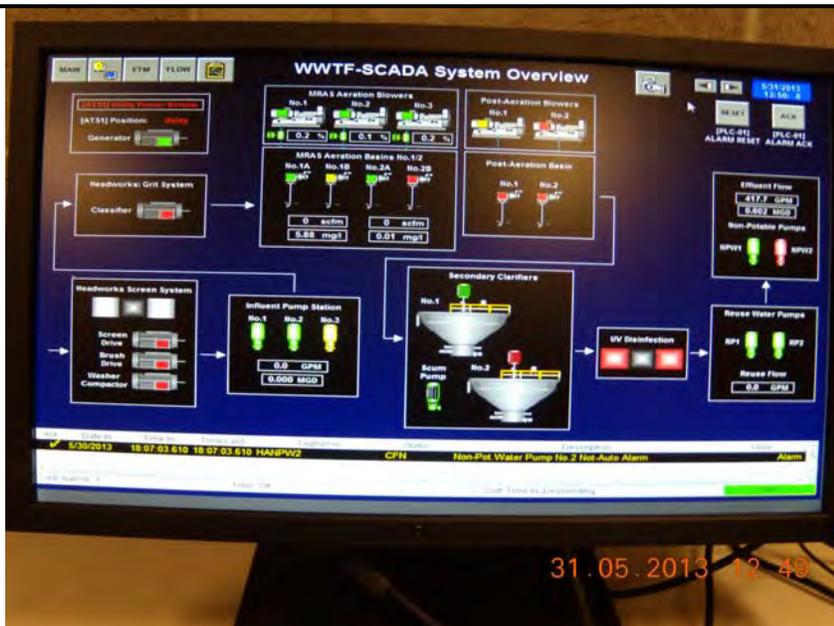
**NMED/SWQB
Official Photograph Log
Photo # 4**

Subject: SCADA WWTP control system shows every treatment unit and the phase of operation for each.

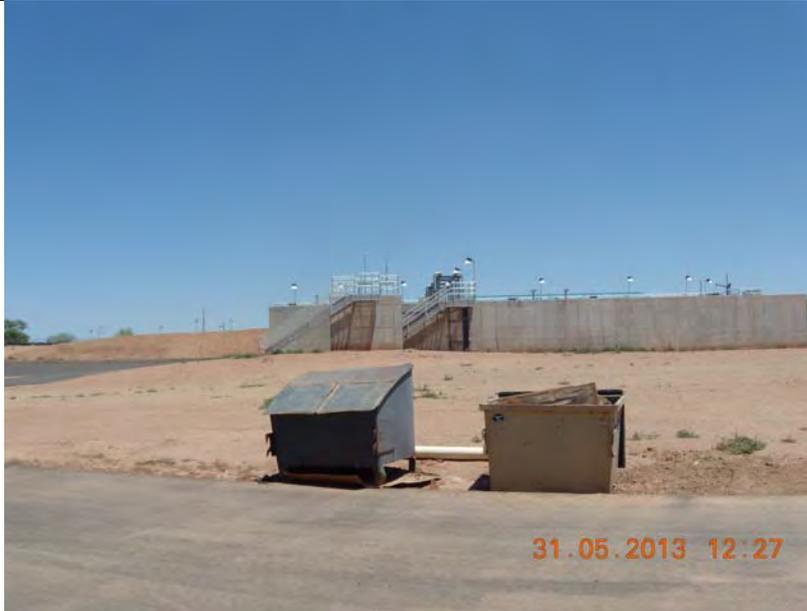
NMED/SWQB
Official Photograph Log
Photo # 5

Subject: View from the head works towards the aeration basins, in the background of the photo. The basins are above ground due to the high groundwater level at this site.

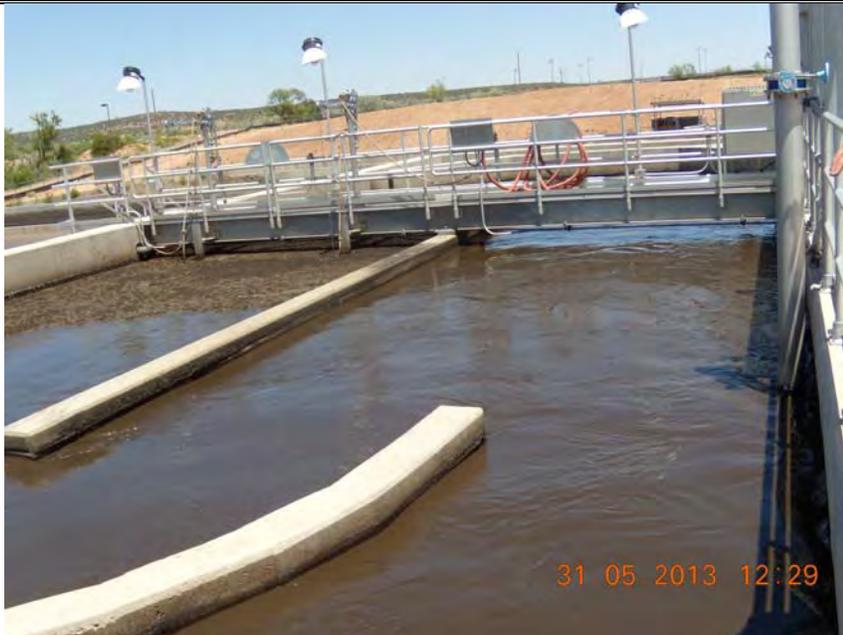
NMED/SWQB
Official Photograph Log
Photo # 6

Subject: Oxidation ditch. The basin is 30 feet deep. Fine bubble diffusers at the bottom of the basin, aerate the units on a cyclic basis. The color of the water being treated in the basin was a healthy, rich brown. Operators indicated that they did not know the MLSS of the basin. Operators said, a three foot sludge blanket is maintained. Solids are wasted to the aerobic digester every other day for 1 hour.

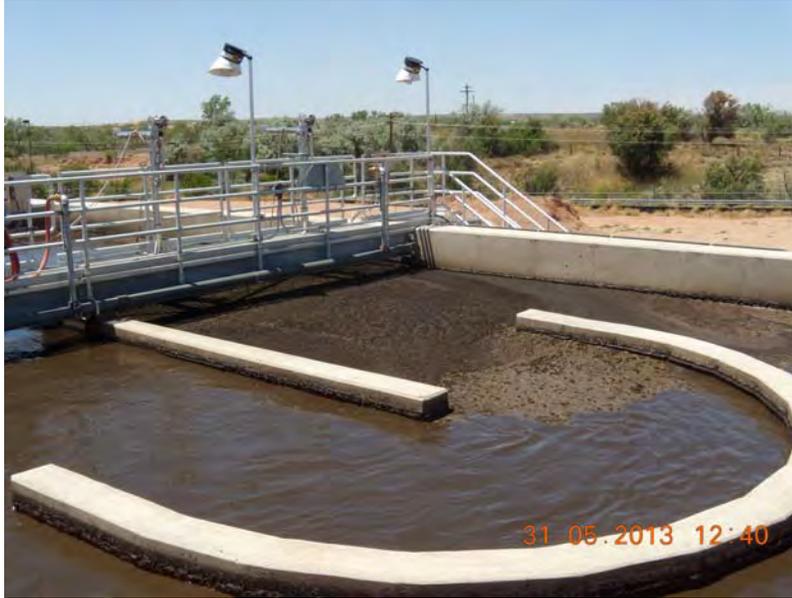
NMED/SWQB
Official Photograph Log
Photo # 7

Subject: Another view of the aeration basin. The basin is cycled through an aerated phase (120minutes) and an anoxic phase (120 minutes). Mixers are located approximately five feet from the bottom of the 30 foot basin.

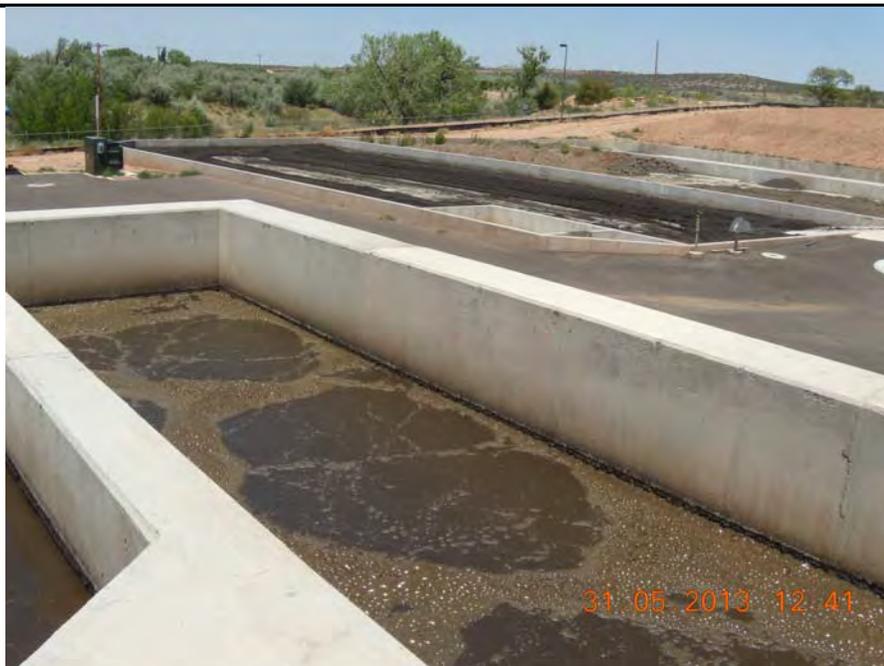
NMED/SWQB
Official Photograph Log
Photo # 8

Subject: Post aeration basin in the foreground of the photo and three sludge drying beds in the mid ground of the photo.

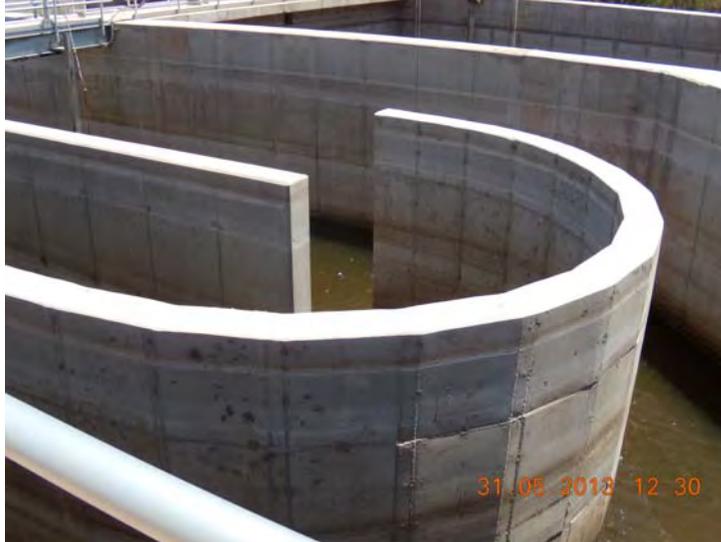
NMED/SWQB
Official Photograph Log
Photo # 9

Subject: The second aeration basin is offline. The mixer in the basin is being worked on. The treatment units are still under warranty. Additionally, the volume of the water being treated at the time only requires the use of one basin.

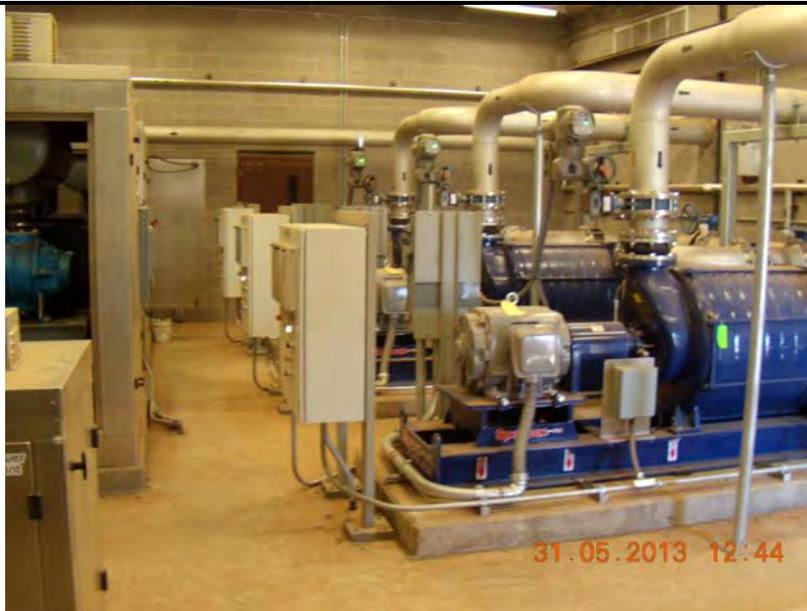
NMED/SWQB
Official Photograph Log
Photo # 10

Subject: Blowers

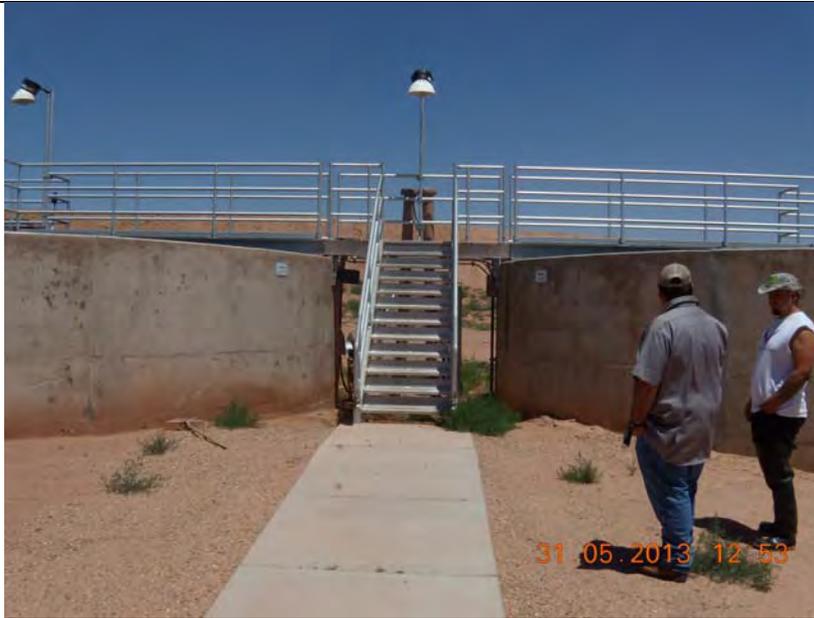
NMED/SWQB
Official Photograph Log
Photo # 11

Subject: Parallel Clarifiers following the oxidation ditches -

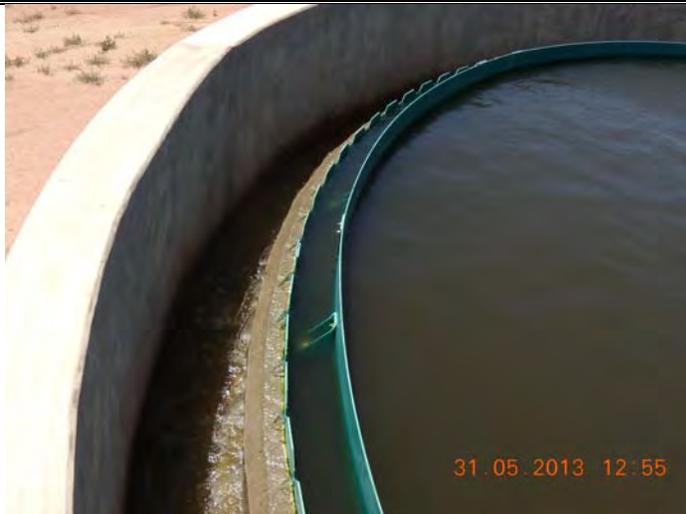
NMED/SWQB
Official Photograph Log
Photo # 12

Subject: Clarifier. The day of the inspection was windy and the water surface was blowing. It was not possible to evaluate the potential for short circuiting in the unit. The weirs had been cleaned earlier in the day and were, for the most part free of algae, or solids that could cause interference with the flow. Operators indicated that the weirs are cleaned as needed weekly or more frequently during the hot summer when algae growth accelerates. The sludge judge was broken at the time of the inspection, so operators could not show the solids blanket level to the inspector. The Operators stated that they intend to maintain a three foot sludge blanket. The location is frequently windy and holding the sludge judge up to test, results in the wind snapping the equipment. The clarifier basin is 30 feet deep.

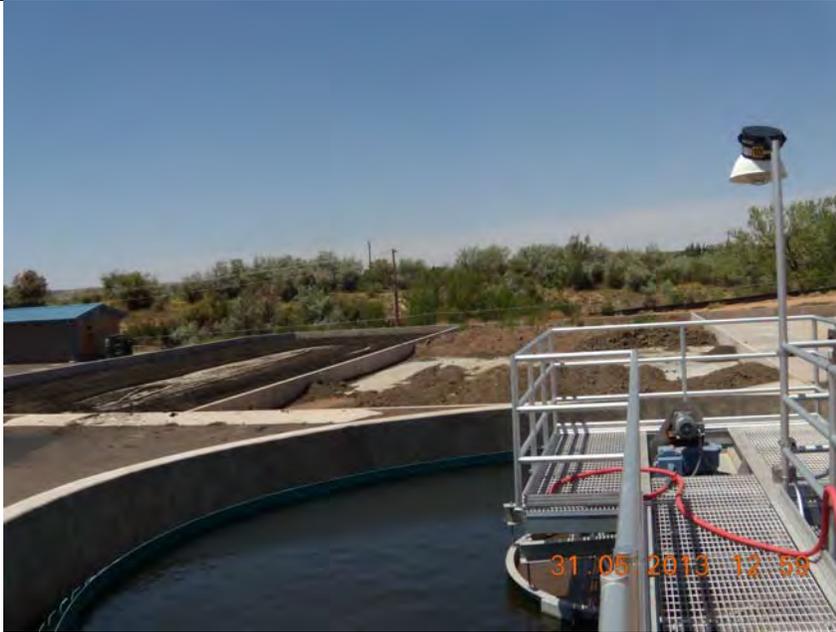
NMED/SWQB
Official Photograph Log
Photo # 13

Subject: Clarifier and sludge drying beds

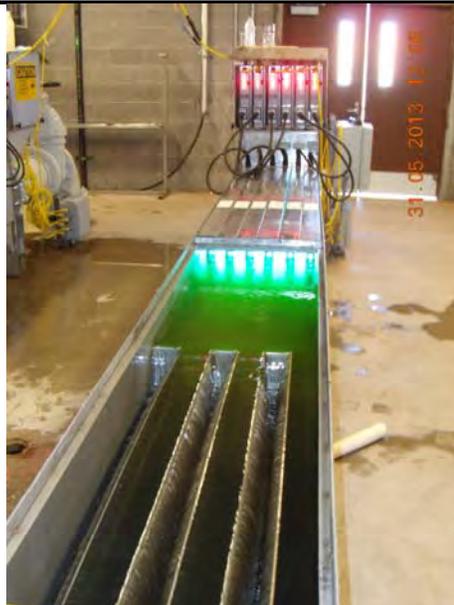
NMED/SWQB
Official Photograph Log
Photo # 14

Subject: Ultra Violet disinfection unit – one of two trains run parallel. UV lights cleaned two times per week.

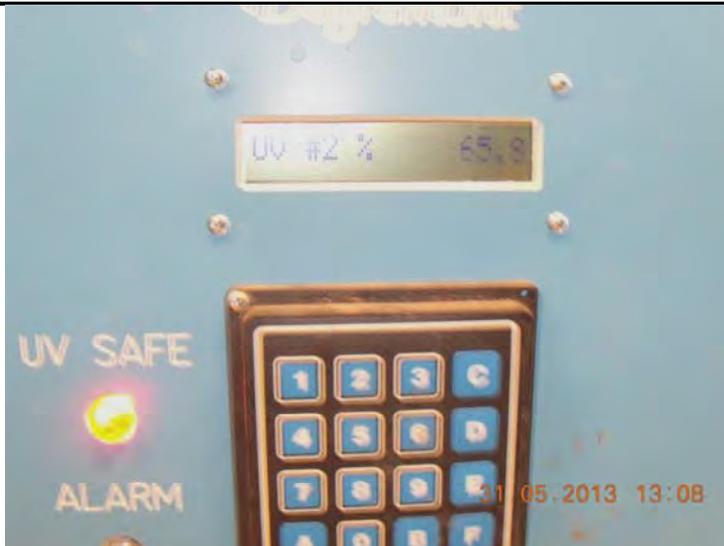
NMED/SWQB
Official Photograph Log
Photo # 15

Subject: Light transmittance in the Ultra Violet Disinfection Chamber is 65.8% - the water is very slightly turbid because the secondary clarifiers were just scrubbed and some floating algae is passing through the treatment unit. Operators had clean the light bulbs twice weekly or more frequently as needed.

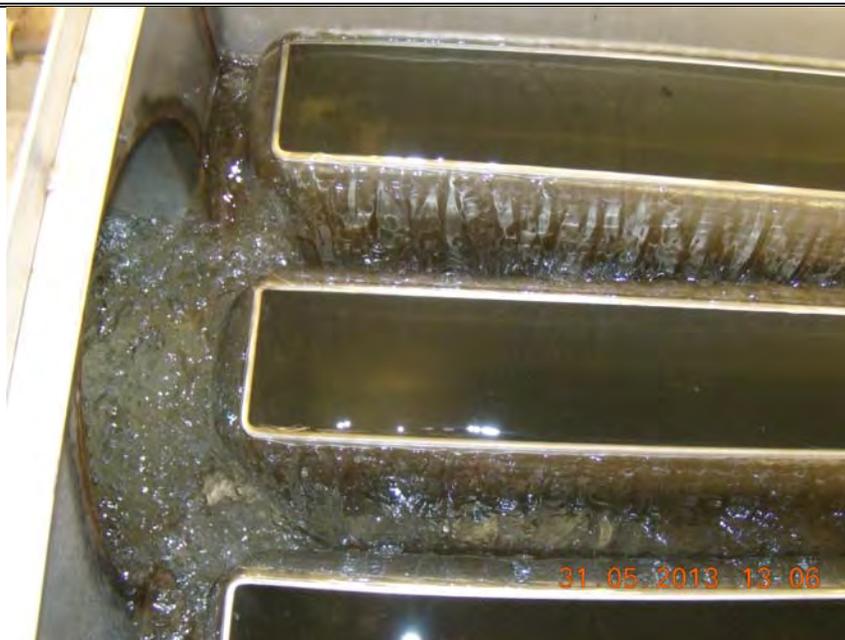
NMED/SWQB
Official Photograph Log
Photo # 16

Subject: End of the Ultra Violet Disinfection Chamber. Effluent is clear. Turbidity from the cleaned secondary clarifiers is only slightly visible to the eye.

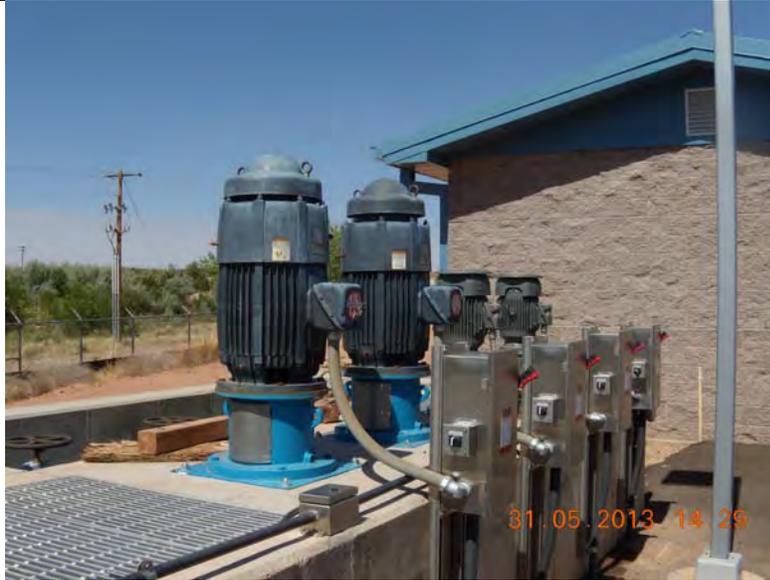
NMED/SWQB
Official Photograph Log
Photo # 17

Subject: Reuse pumps at effluent flow channel are located before the place where final effluent flow reading are taken at the Parshall Flume.

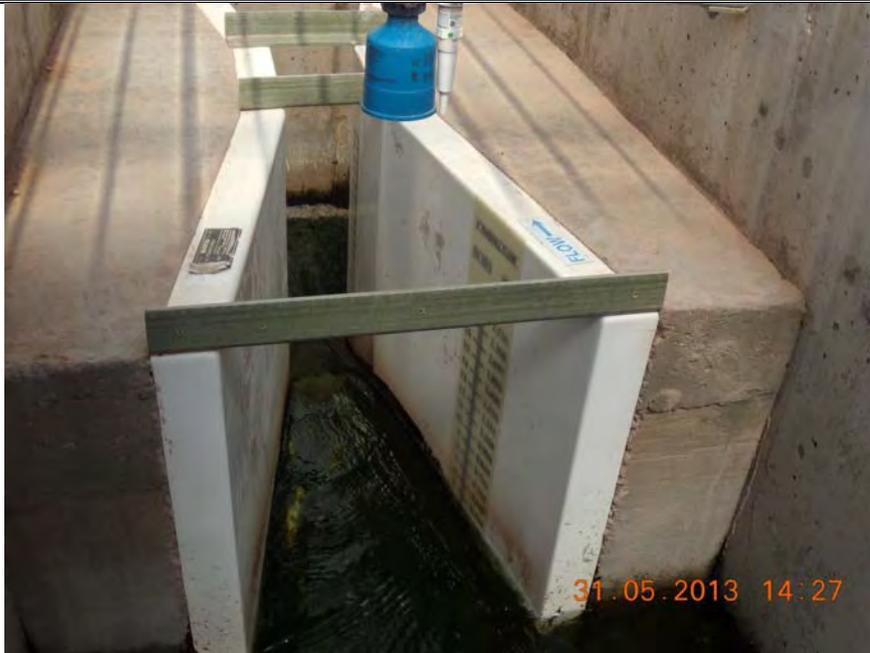
NMED/SWQB
Official Photograph Log
Photo # 18

Subject: Flow Measurement at the Parshall Flume w/ Staff Gauge and Ultrasonic Flow Meter. The flow is free of turbulence and is a good representation of laminar flow.

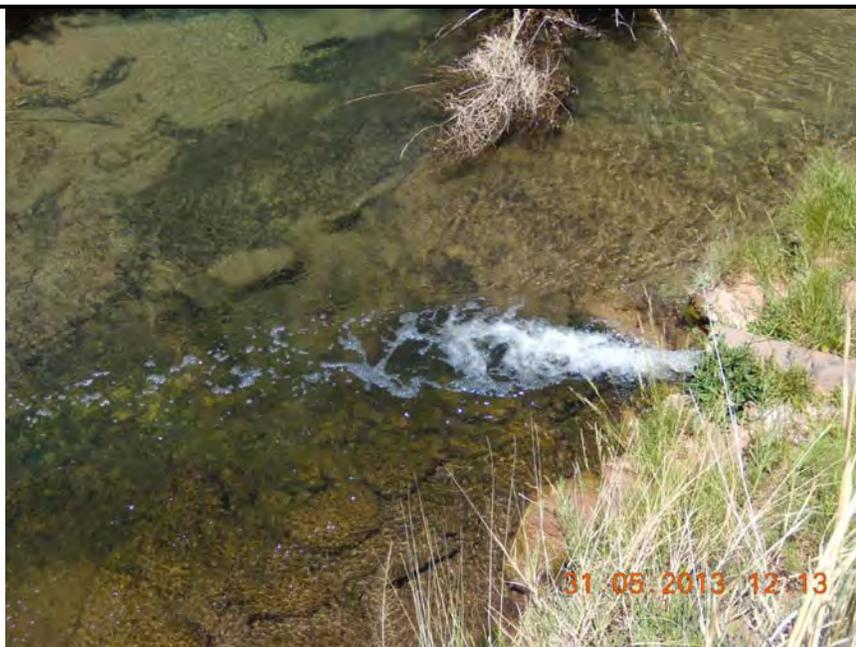
NMED/SWQB
Official Photograph Log
Photo # 19

Subject: WWTP outfall pipe to El Rito Creek. Effluent is clear and free of floating solids. Some algae mats were observed upstream and downstream of the outfall.

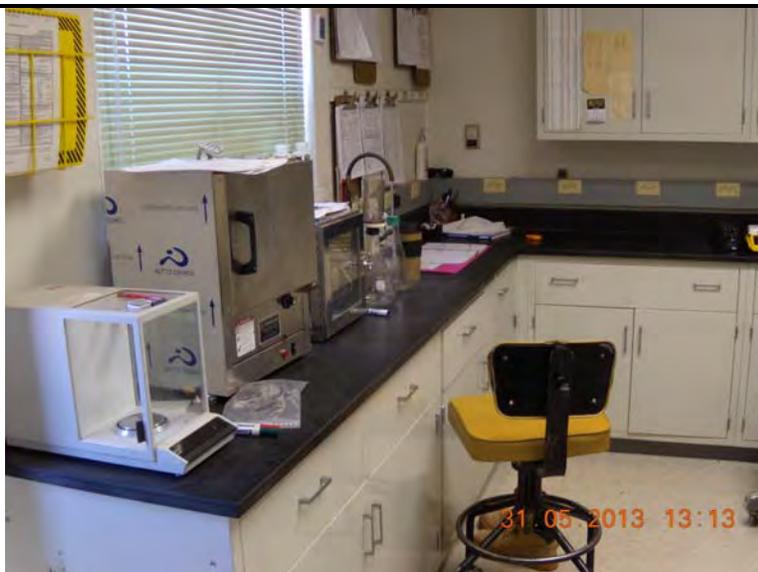
NMED/SWQB
Official Photograph Log
Photo # 20

Subject: Onsite Laboratory, pH, settleable solids, and TRC (when used) are tested on site. The other permit samples are sent to the City of Tucumcari WWTP Laboratory or to Bio Aquatic
