Re: Minor Non Municipal; SIC 6515; NPDES Compliance Evaluation Inspection; Rio de Arenas Mobile Home Manor; Waste Water Treatment Plant; NM0027375, Arenas Valley, New Mexico; July 25, 2012

NPDES Compliance Inspection Report

**Rio de Arenas Mobile Home Park
Compliance Evaluation Inspection
WWTP – NM0027375
July 25, 2012**

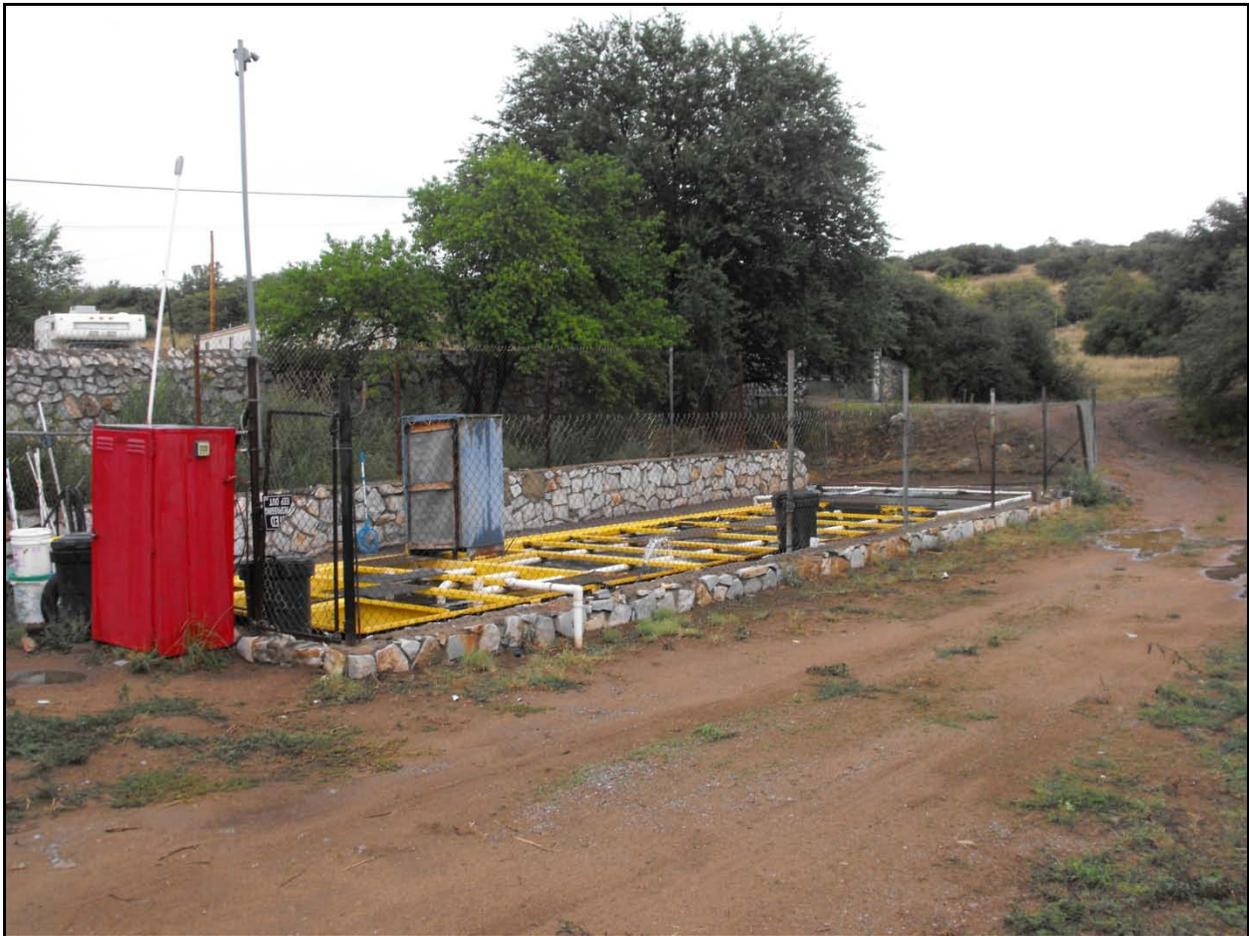
Photo # 1

Photographer: Daniel Valenta	Date: 7/25/2012	Time: 1611 hours
City/County: Arenas Valley/Grant County		
Location: Rio De Arenas Mobile Home Park, Hwy 180 E, Arenas Valley, Silver City, NM 88061, facing north east.		
Subject: Waste Water Treatment Plant at the Rio De Arenas Mobile Home Park

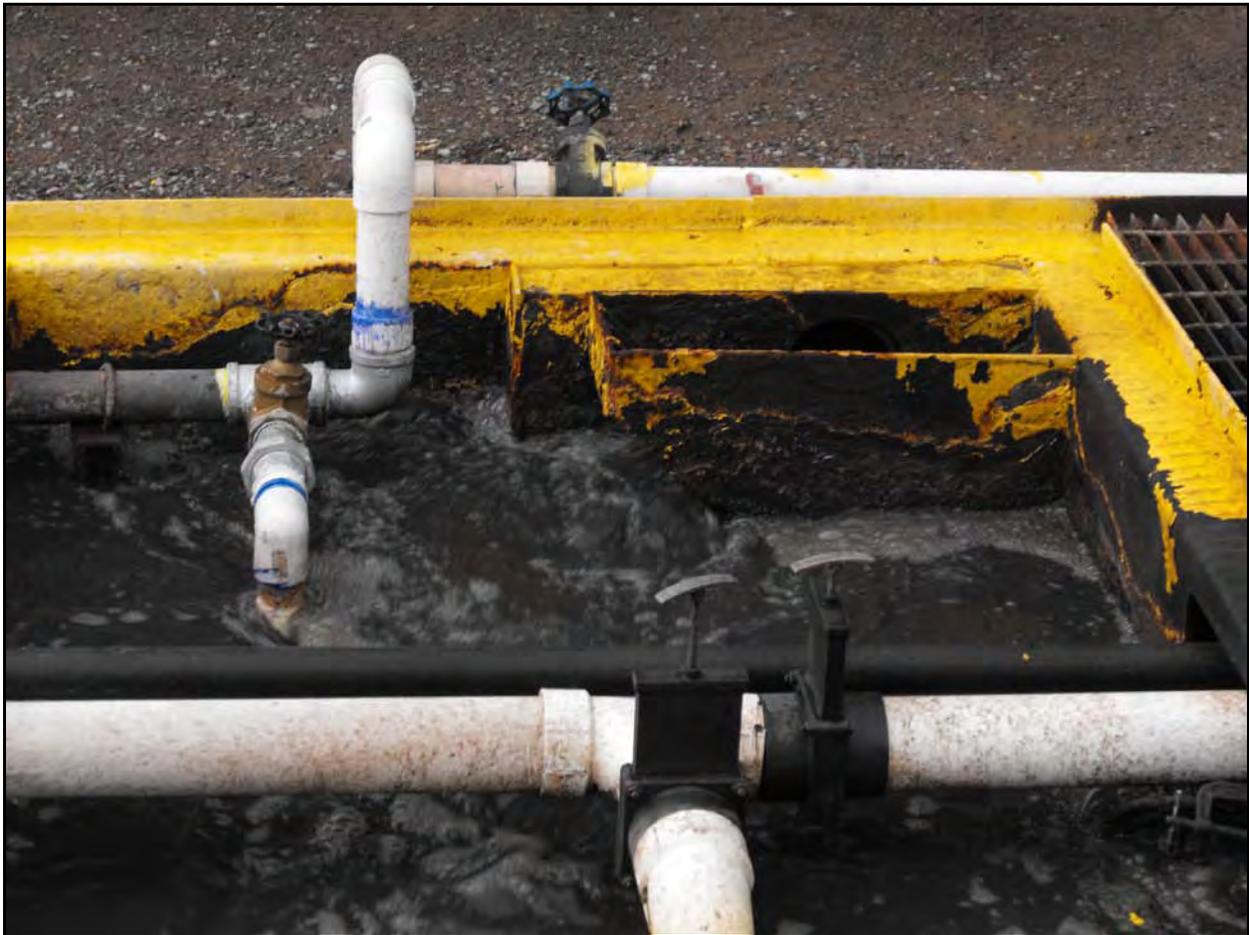
Photo # 2

- The facility has large areas that have rusted through the paint with metal flaking off, (see photo 2). The plant is showing its age, manufactured in 1974, with most piping converted to PVC pipe. Any preventative aid in stopping or slowing down the rusting of the containment/treatment sections will extend the life of the facility.

Photographer: Daniel Valenta	Date: 7/25/2012	Time: 1622 hours
City/County: Arenas Valley/Grant County		
Location: Rio De Arenas Mobile Home Park, Hwy 180 E, Arenas Valley, Silver City, NM 88061, facing north.		
Subject: Facility has rusted through the paint in many areas, metal is flaking off.

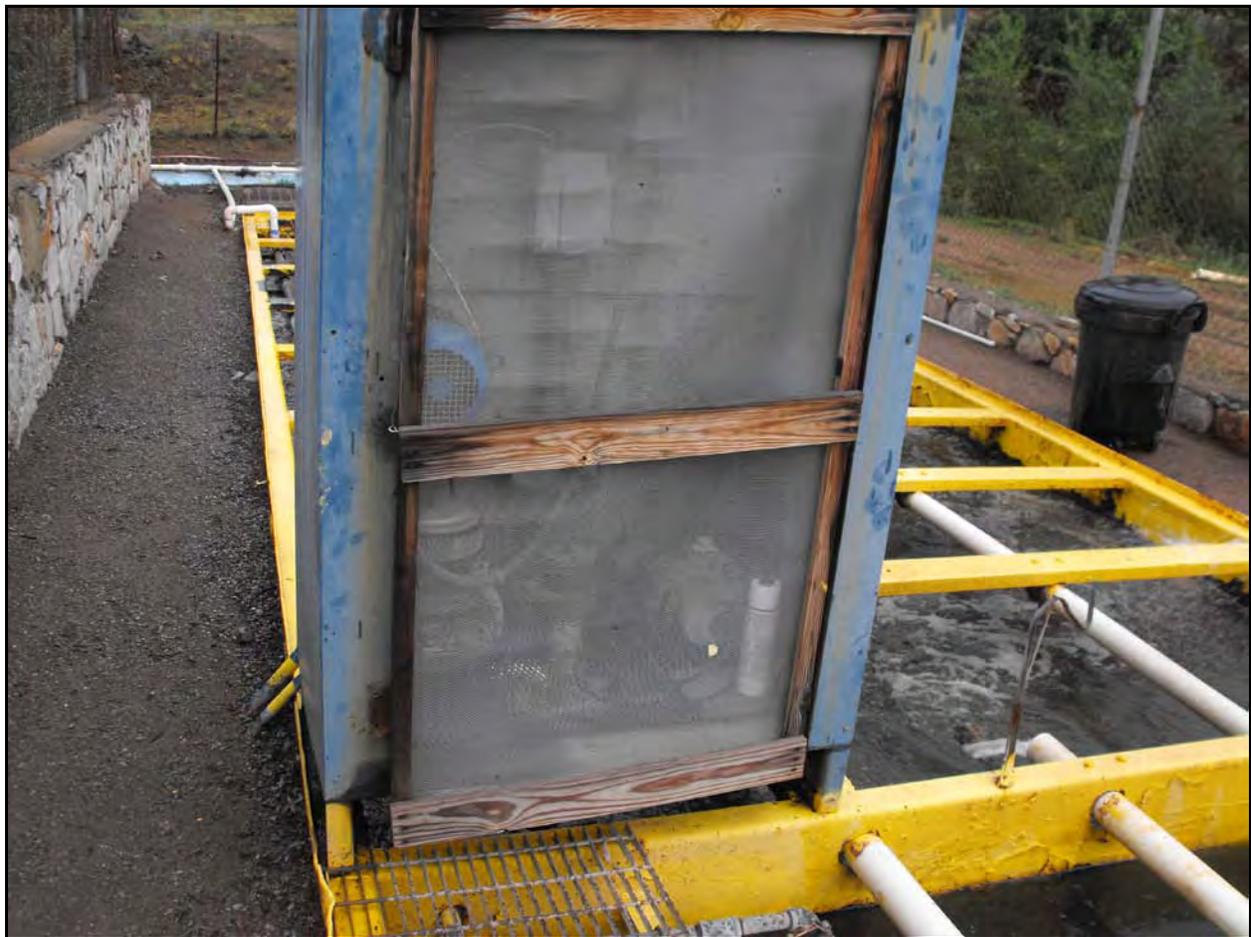
Photo # 3

- The facility has no standby power or alarm system. Because this is a small facility and staff is not present onsite for long periods of time, it is important to have some sort of an alarm system for notification of power failures or other problems at the plant. The aeration pump on/off switch is located in an unlocked shelter, (see photo 3). If someone was to turn the switch off with the low oxygen levels and no alarm system the plant could lose its biological organisms. The facility is responsible for any non-compliance, even if it is caused by outside influences.

Photographer: Daniel Valenta	Date: 7/25/2012	Time: 1633 hours
City/County: Arenas Valley/Grant County		
Location: Rio De Arenas Mobile Home Park, Hwy 180 E, Arenas Valley, Silver City, NM 88061, facing east.		
Subject: Open pump shelter, on/off switch for the plant.

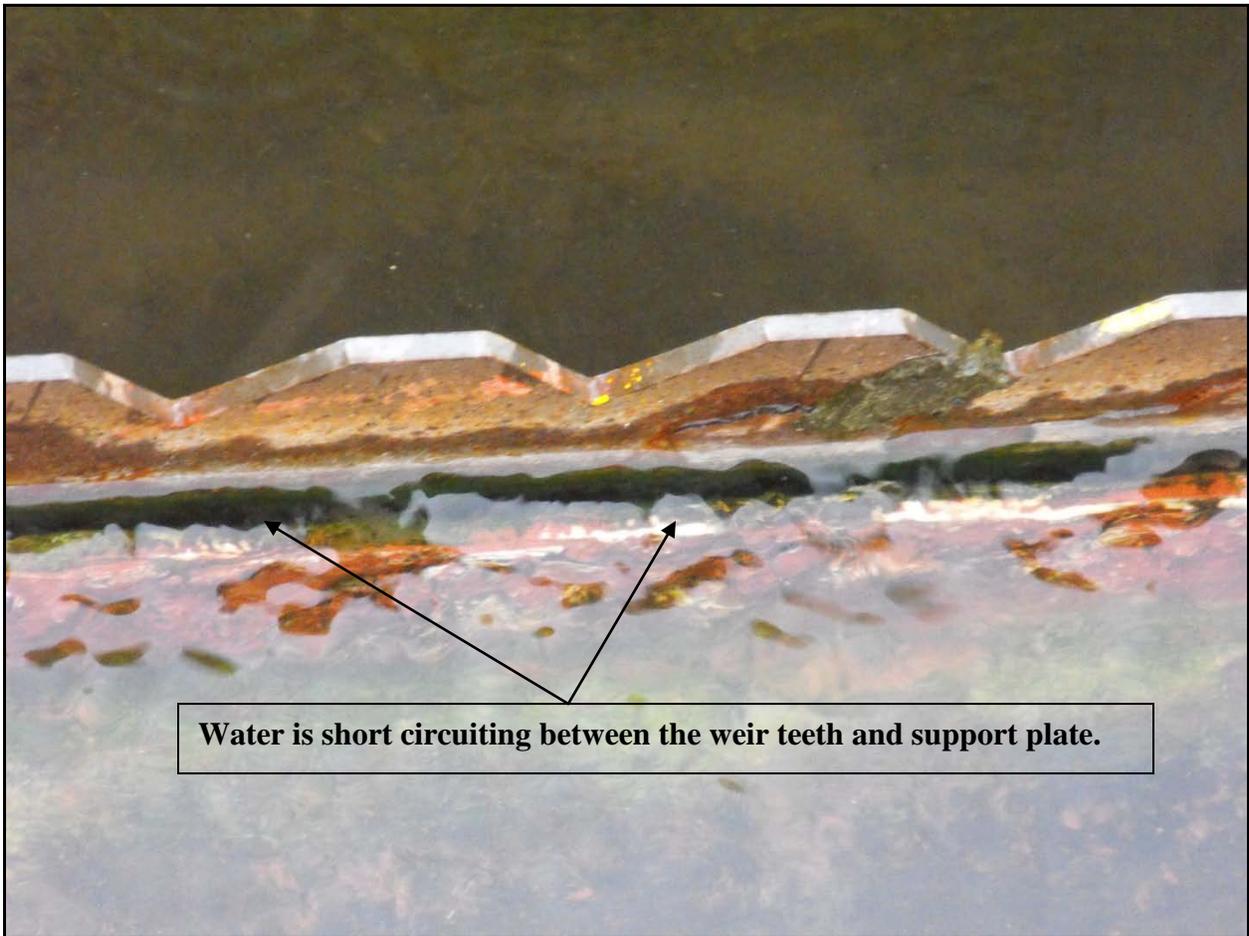
Photo # 4

- The clarifier has developed a substantial short circuiting around the weir teeth on one bank. One side of weir plate appears even with smooth flow. The other side has a gap between the teeth and the support beam. The weir teeth on this side also appear to be higher than the level of the water (see photo 4). Short circuiting will result in reduced retention time thus reducing the treatment capacity of the unit.

Photographer: Daniel Valenta	Date: 7/25/2012	Time: 1637 hours
City/County: Arenas Valley/Grant County		
Location: Rio De Arenas Mobile Home Park, Hwy 180 E, Arenas Valley, Silver City, NM 88061, facing west.		
Subject: Toothed weir plate on the clarifier.

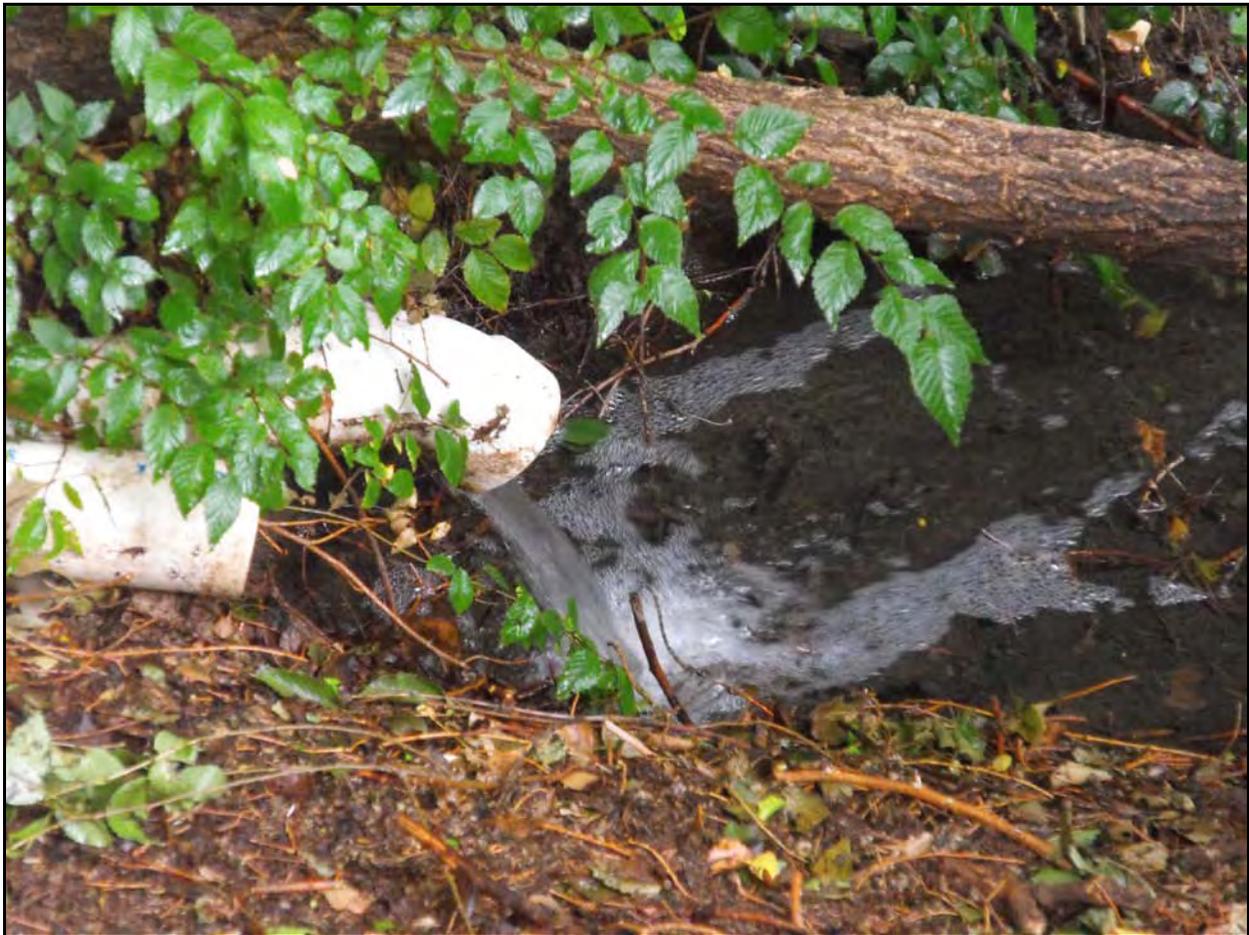
Photo # 4

A new in-line GPI TM Series Electronic meter has been purchased and was awaiting installation. The treatment facility had at one time a v-weir at the discharge point at the treatment facility for taking flow measurements. This was removed and is no longer functional. If failures occur with the new meter a secondary measurement device or method should be available.

Photographer: Daniel Valenta	Date: 7/25/2012	Time: 1652 hours
City/County: Arenas Valley/Grant County		
Location: Rio De Arenas Mobile Home Park, Hwy 180 E, Arenas Valley, Silver City, NM 88061, facing south.		
Subject: Discharge point for the facility.
