**NEW MEXICO
ENVIRONMENT DEPARTMENT**

Re: Minor Industrial SIC 4952, NPDES Compliance Evaluation Inspection, Jemez Valley Schools, NM0028479, Sandoval County, New Mexico January 9, 2013.

Jemez Valley Public Schools
NPDES Permit NM0028479
Compliance Evaluation Inspection
January 9, 2013
Page 1 of 6

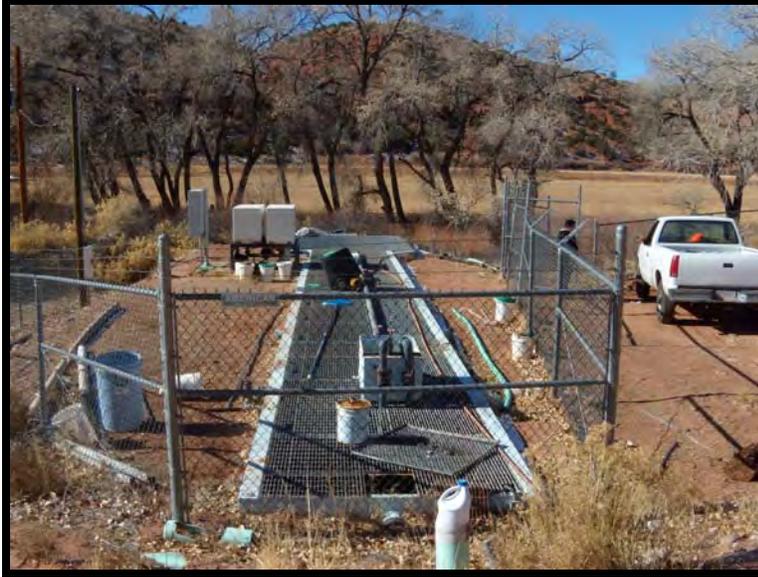
NMED/SWQB
Official Photograph Log
Photo # 1

Subject: Package plant from the head works to the Chlorine Contact Chamber. Contained within the fenced area.

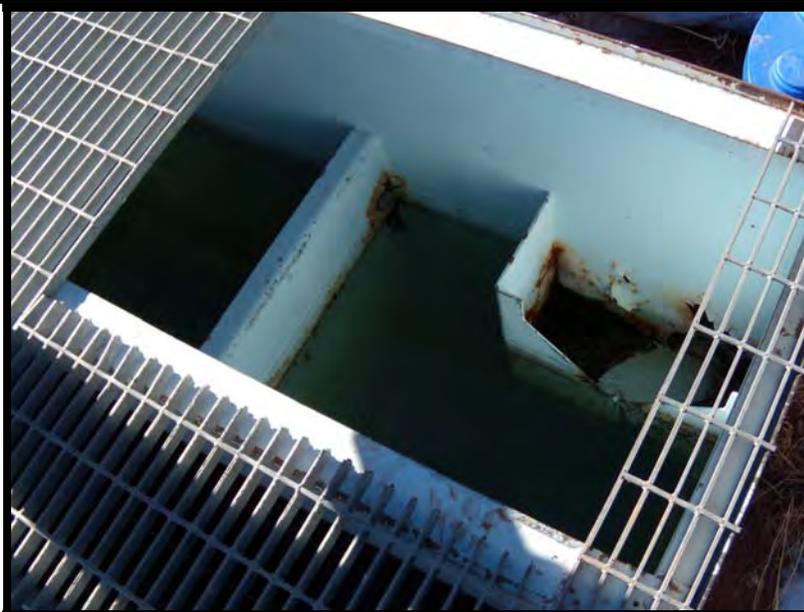
NMED/SWQB
Official Photograph Log
Photo # 2

Subject: Chlorine contact chamber and effluent weir.

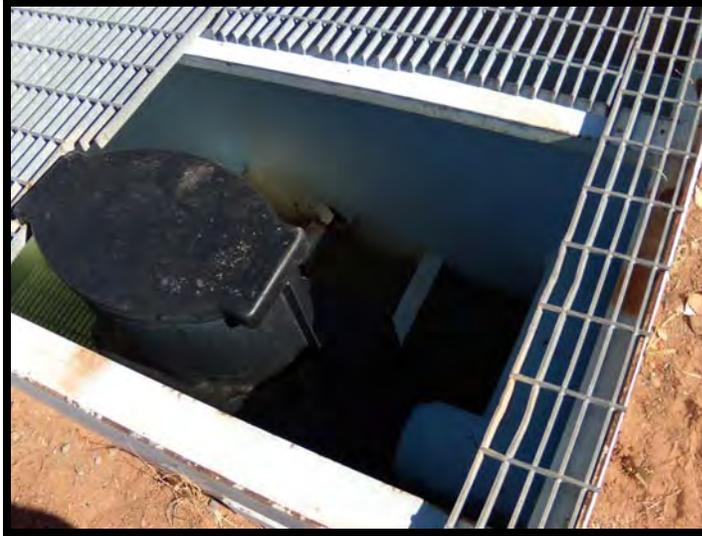
NMED/SWQB
Official Photograph Log
Photo #3

- 2) The chlorine contact chamber dispenser has 4 tablet tubes. A new tablet was added the day of the inspection. Two of the four tubes had dissolving tablets and two were empty. The operator stated that as a standard practice, he added tablets only after there has been an E. coli effluent exceedences. He stated that he would be more attentive to maintaining the chlorine levels in the future.

Subject: Chlorine Tablet Dispenser – In the Chlorine Contact Chamber.

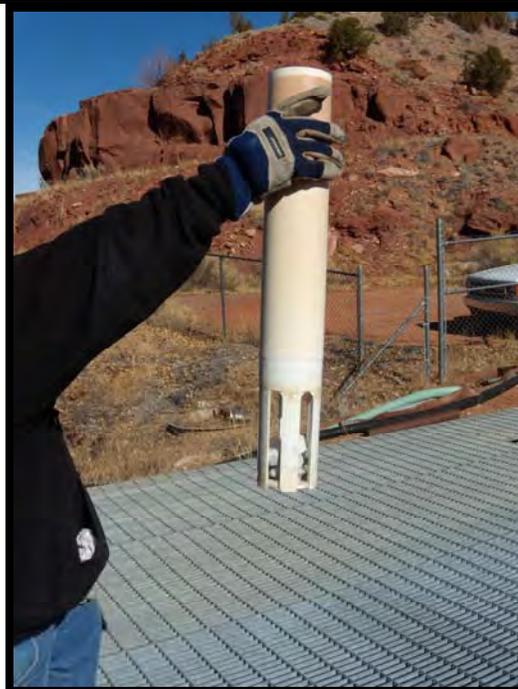
NMED/SWQB
Official Photograph Log
Photo #4

Subject: Chlorine tablet dispenser 1 of 4 – a new tablet was added the same day.

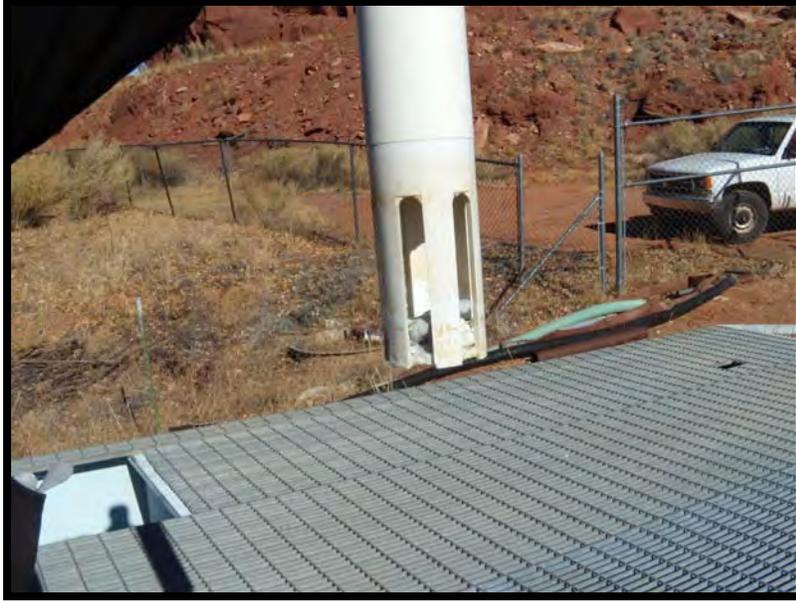
NMED/SWQB
Official Photograph Log
Photo # 5

Subject: Chlorine tablet dispenser 2 of 4 with dissolving tablets.

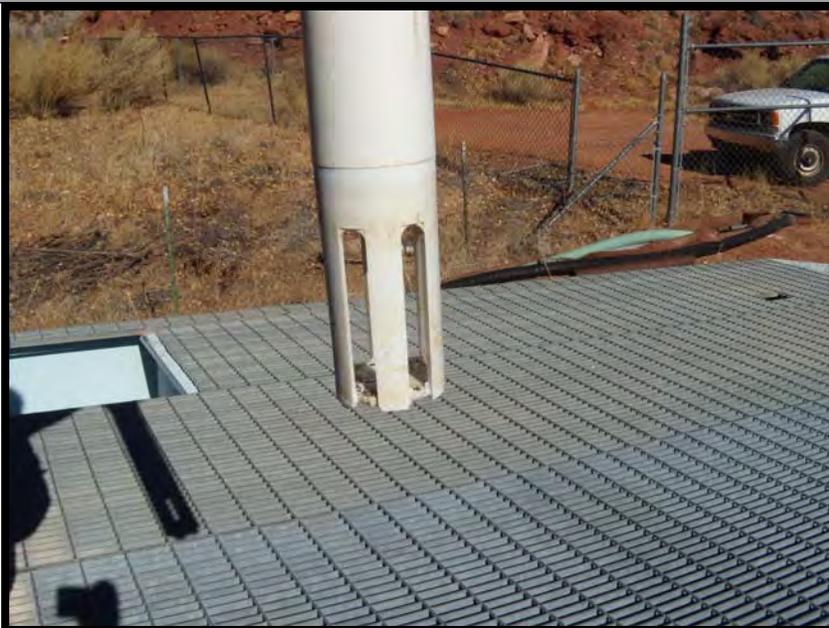
NMED/SWQB
Official Photograph Log
Photo # 6

Subject: Chlorine Tablet Dispenser 3 of 4 - no tablets.

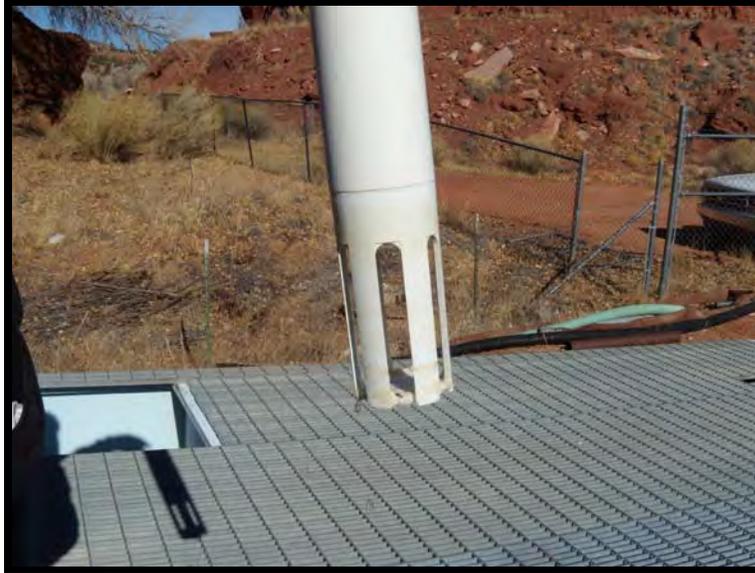
NMED/SWQB
Official Photograph Log
Photo # 7

Subject: Chlorine tablet dispenser 4 of 4 no tablets.

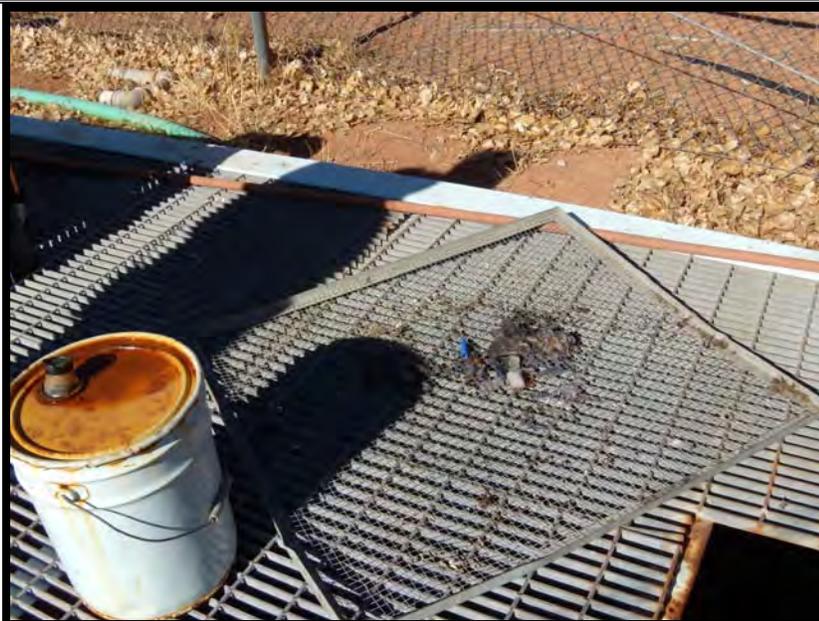
NMED/SWQB
Official Photograph Log
Photo # 8

Subject: Influent bar screen scrapings. The large solids are dried and disposed of at the Sandoval County Landfill.

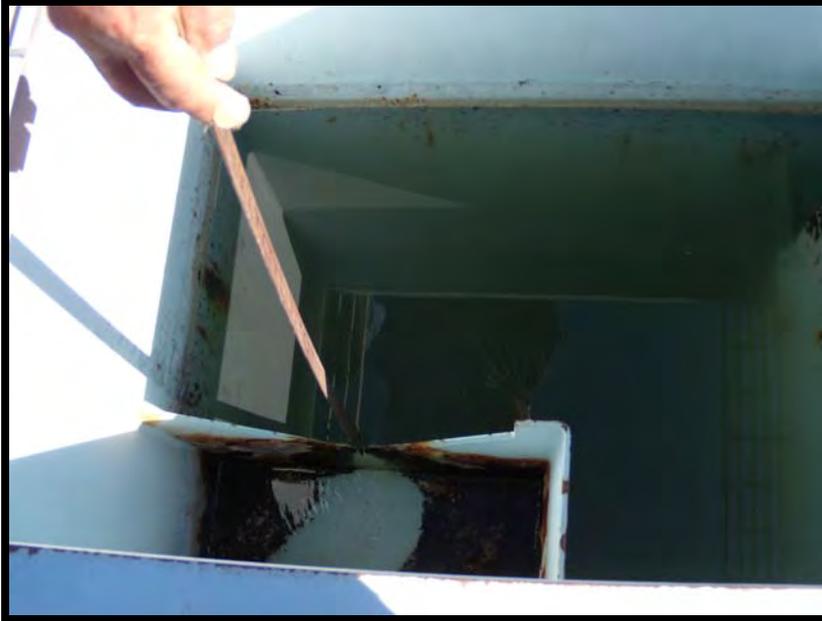
NMED/SWQB
Official Photograph Log
Photo # 9

Due to the design of the weir box, the lack of a fixed measuring device, the uneven flow, and no records of flow conversion factors, this device does not produce a reliable flow reading.

Subject:
Subject: Flow Measurement Yardstick is placed in the center of the notch of the effluent weir box.

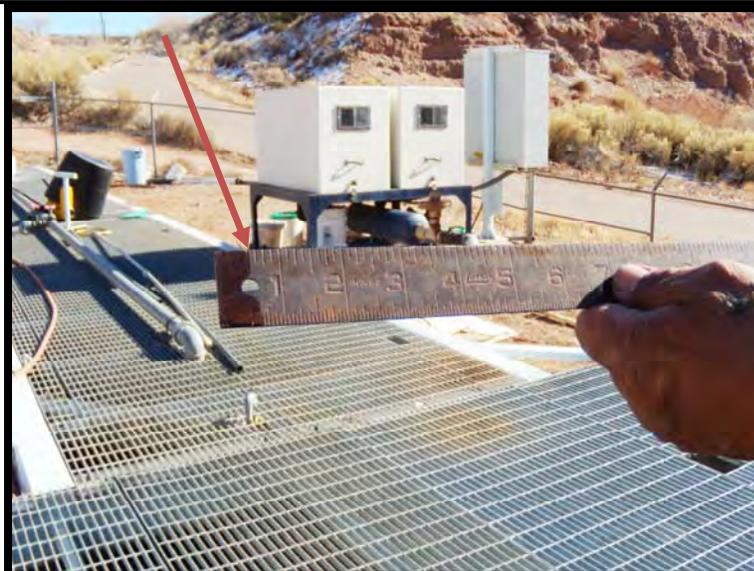
NMED/SWQB
Official Photograph Log
Photo # 10

Flow readings are estimated.

Subject: Flow Measurement Yardstick –According to the Operator, $\frac{1}{2}$ inch = 0.01 mgd. - The operator stated that he does not need to use the yardstick regularly. He can estimate the flow most days.

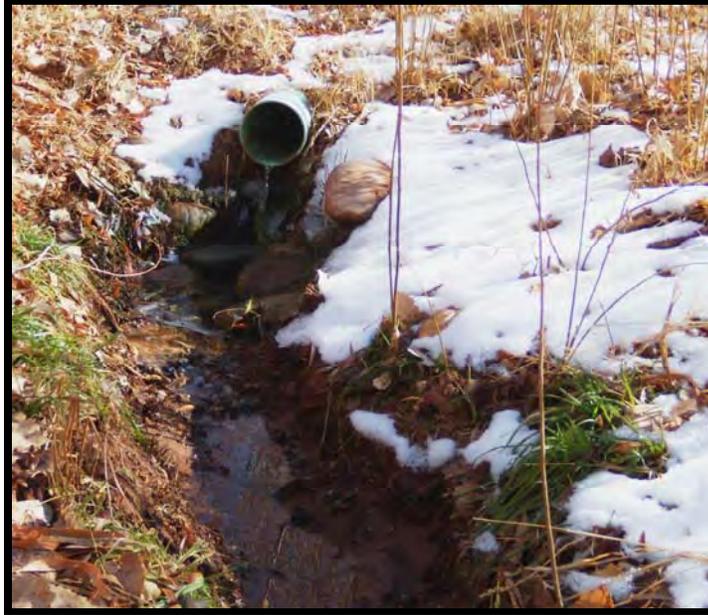
NMED/SWQB
Official Photograph Log
Photo # 11

Subject: Effluent Pipe to the Jemez River.

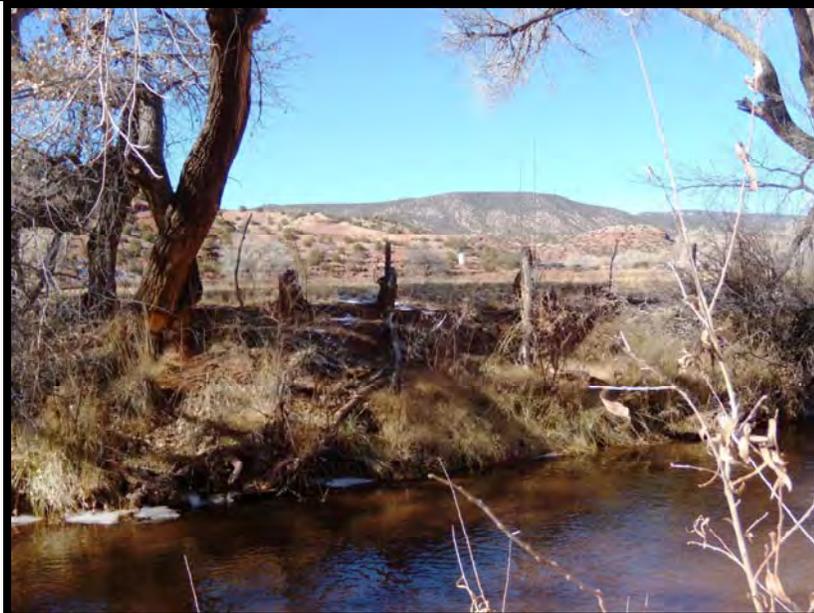
NMED/SWQB
Official Photograph Log
Photo # 12

Subject: Jemez River at the Effluent Outfall of the WWTP.
