**RE: Major-Municipal, SIC 4952, NPDES Compliance Sanitary Sewer Overflow (SSO) Inspection,  
Las Vegas Wastewater Treatment Plant, NM0028827, December 7, 2010**

### NPDES Compliance Inspection Report

**City of Las Vegas Waste Water Treatment Plant**  
**NPDES Permit No NM0028827**  
**Sanitary Sewer Overflow Inspection**  
**December 7, 2010**

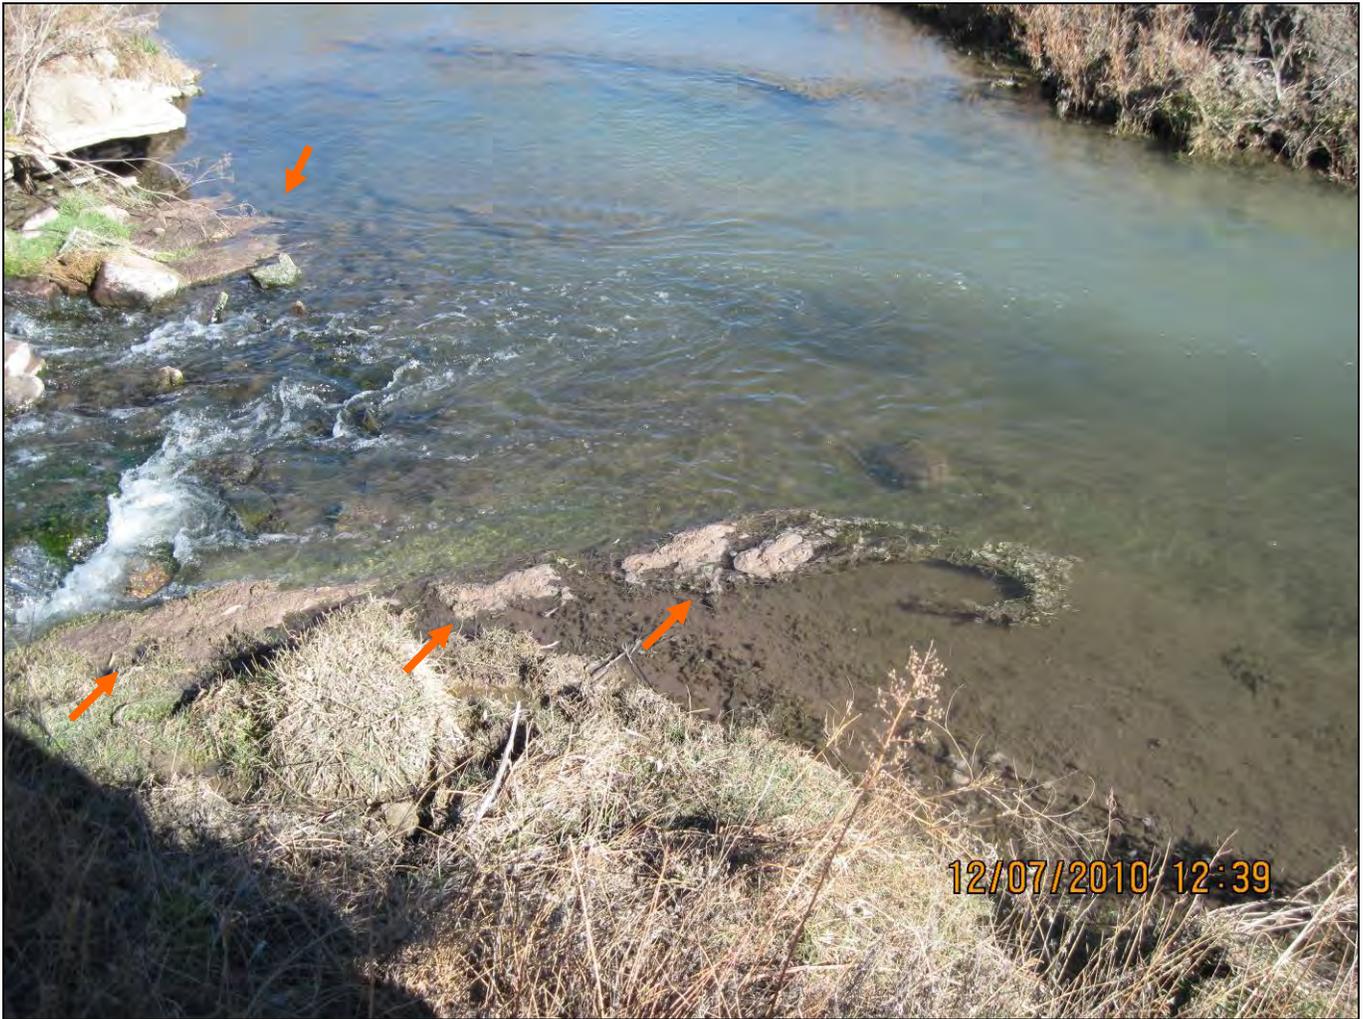
NMED/SWQB  
Official Photograph Log  
Photo # 1

Photographer: Erin S. Trujillo	Time: 12/07/2010	Time: 1239 hours
City/County: Las Vegas / San Miguel County		State: New Mexico
Location: City of Las Vegas Wastewater Treatment Plant, NPDES Permit No. NM0028827		
Subject: Arrows point to floating solids in Gallinas River where effluent discharge from Outfall 001 enters the receiving stream.

During this inspection, the effluent was clear and did not have noticeable oil sheen, grease, turbidity, visible foam, float solids or color. However, immediately below the outfall and in some locations along the bank of the receiving stream, floating solids had accumulated. Mr. Medina stated he would re-inspect the receiving water banks below the outfall to see if the remaining solids could be removed.

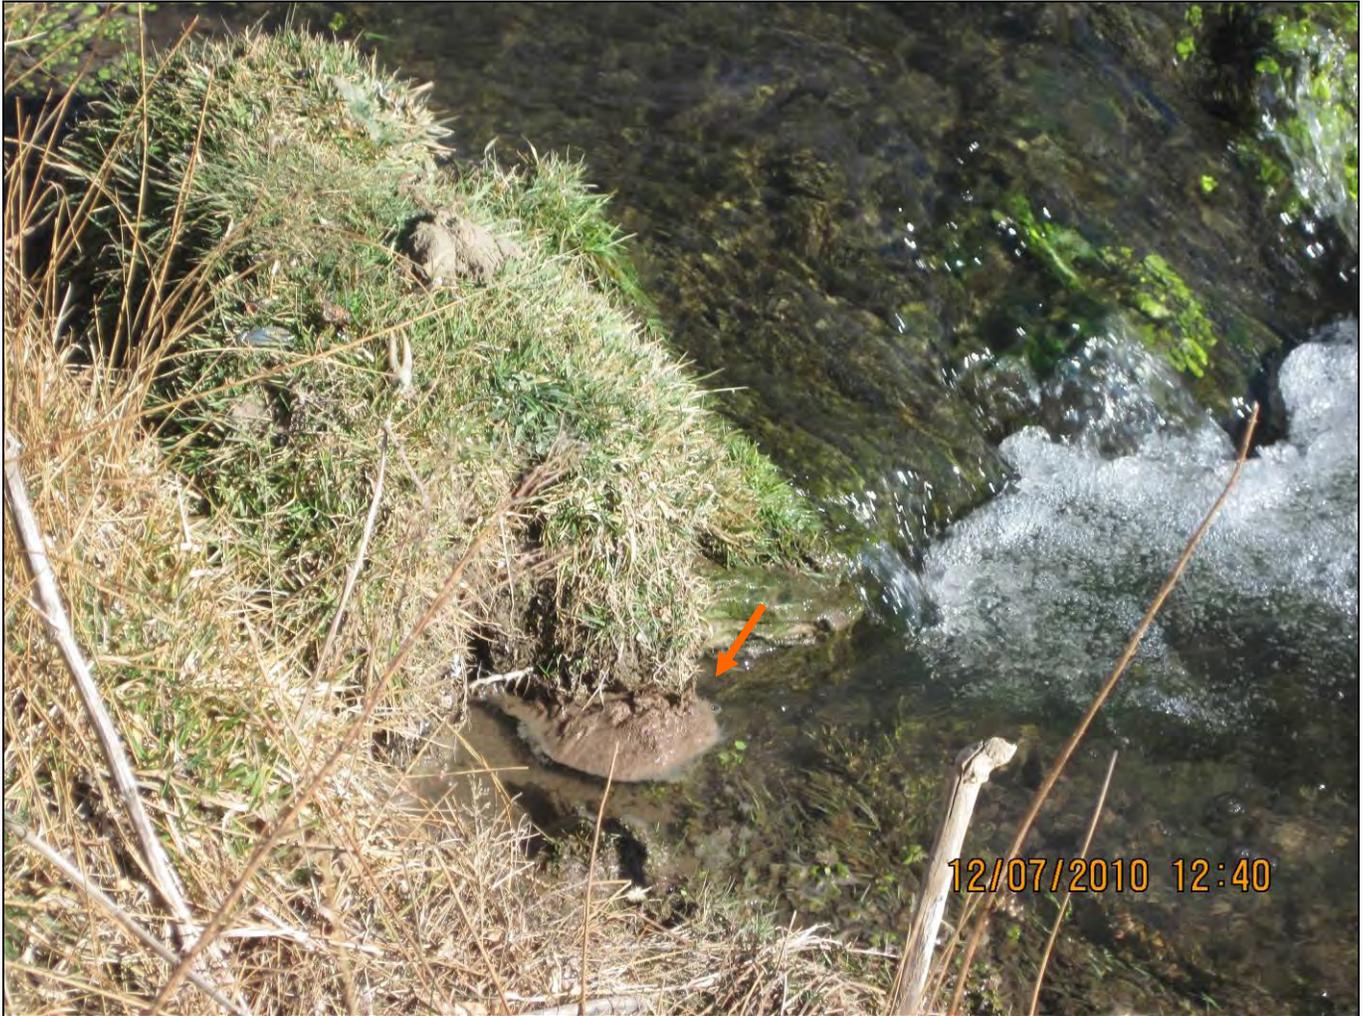
NMED/SWQB  
Official Photograph Log  
Photo # 2

Photographer: Erin S. Trujillo	Time: 12/07/2010	Time: 1240 hours
City/County: Las Vegas / San Miguel County	State: New Mexico	
Location: City of Las Vegas Wastewater Treatment Plant, NPDES Permit No. NM0028827		
Subject: Arrow points to an example of floating solids along bank of Gallinas River downstream of Outfall 001.

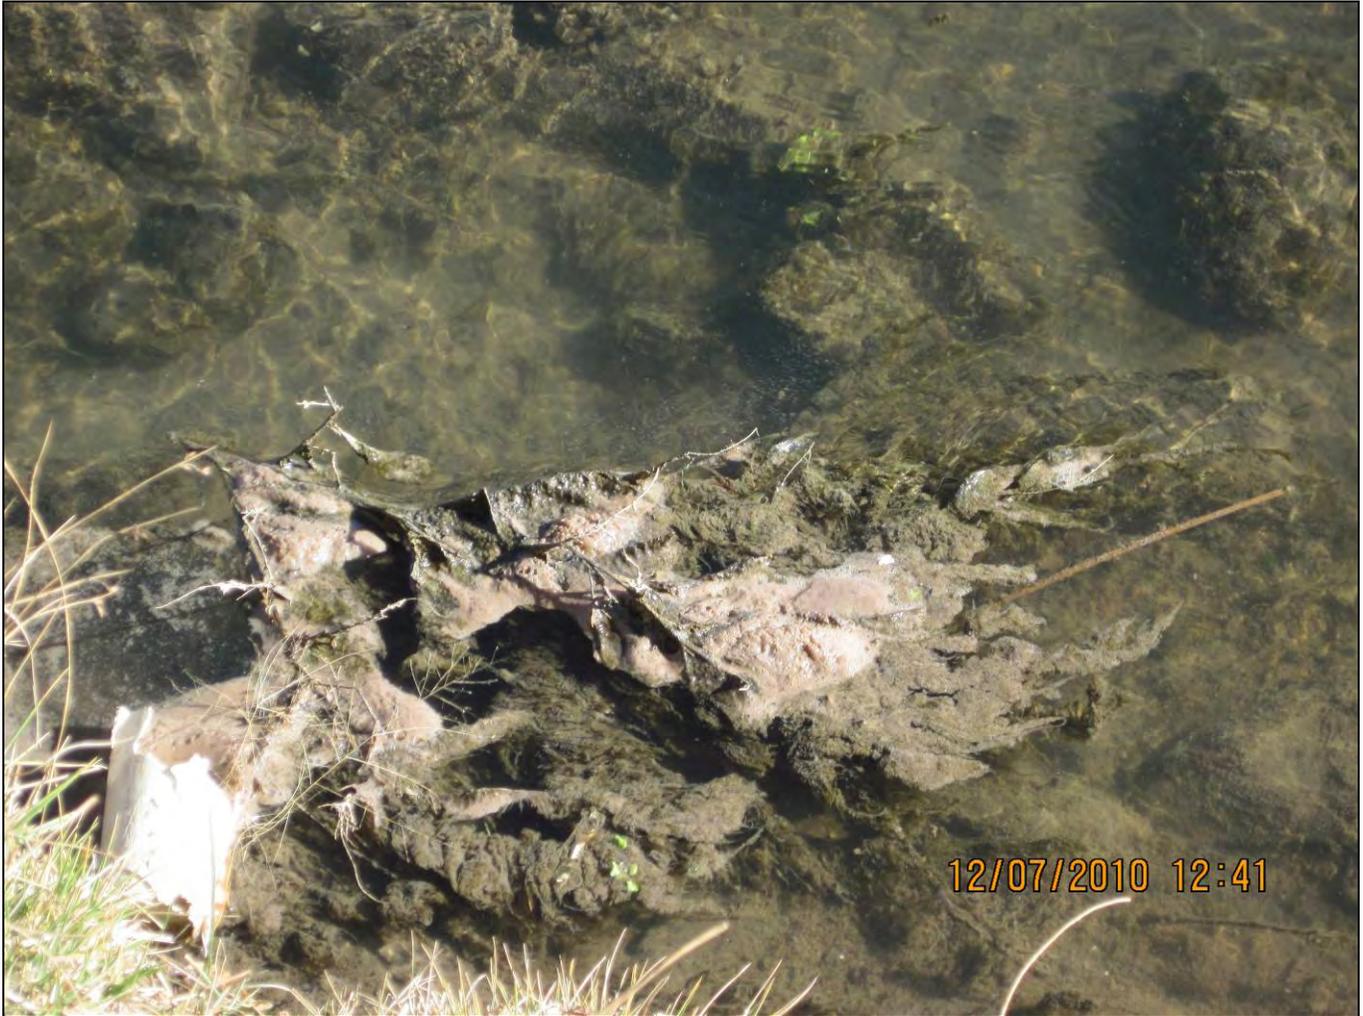
NMED/SWQB  
Official Photograph Log  
Photo # 3

Photographer: Erin S. Trujillo	Time: 12/07/2010	Time: 1241 hours
City/County: Las Vegas / San Miguel County		State: New Mexico
Location: City of Las Vegas Wastewater Treatment Plant, NPDES Permit No. NM0028827		
Subject: Another example of floating solids in Gallinas River downstream of Outfall 001.

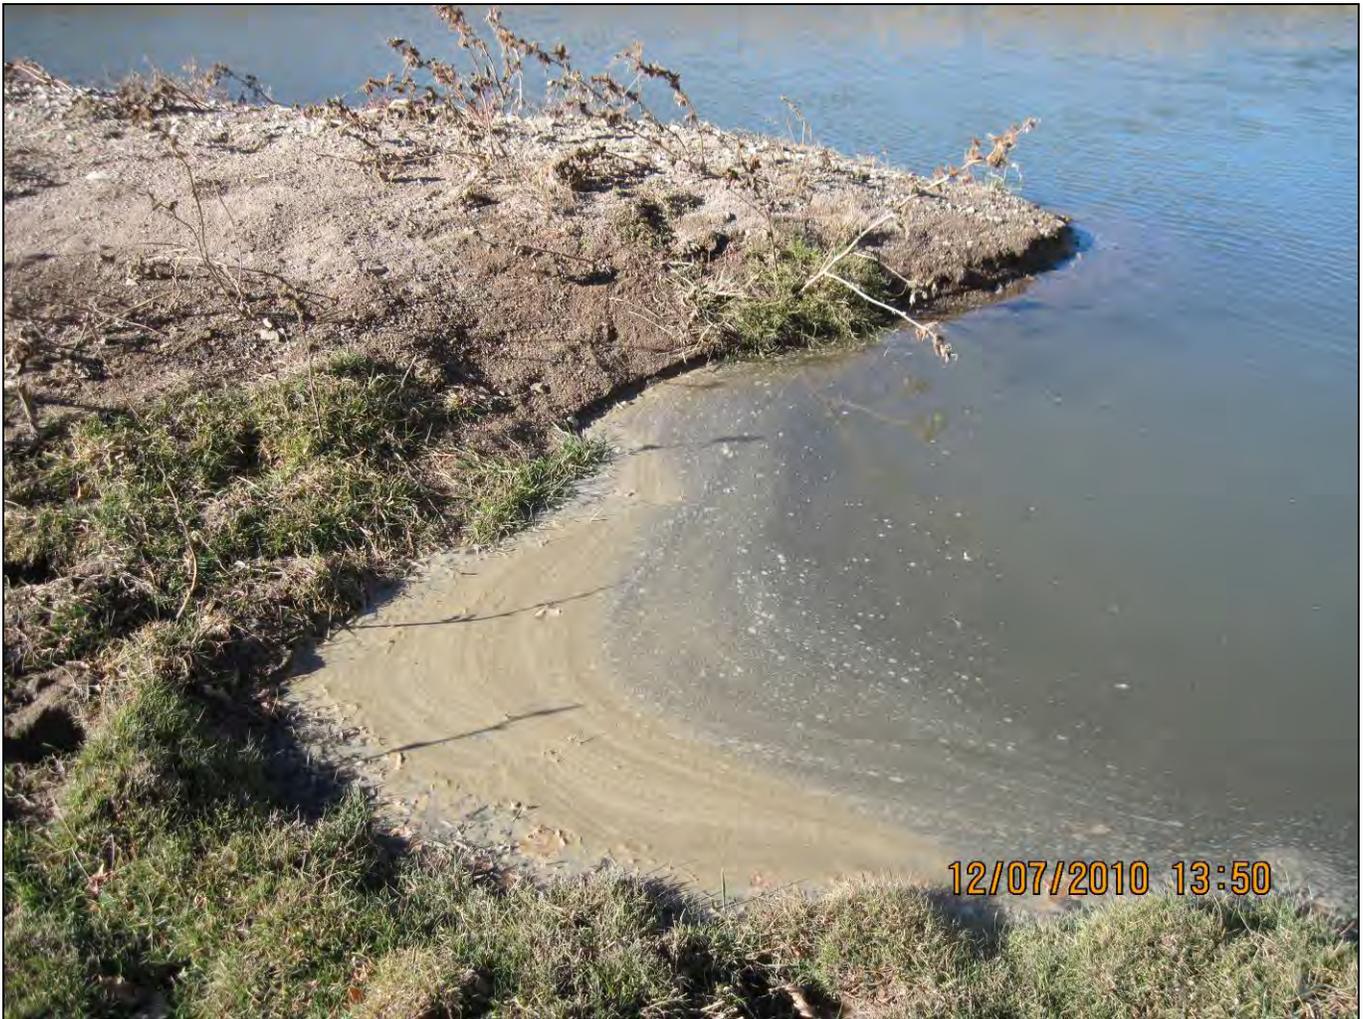
**NMED/SWQB  
Official Photograph Log  
Photo # 4**

Photographer: Erin S. Trujillo	Time: 12/07/2010	Time: 1350 hours
City/County: Las Vegas / San Miguel County		State: New Mexico
Location: Gallinas River near San Augustin		
Subject: Brown foam observed along bank approximately 8 miles downstream of the Las Vegas WWTP that had a faint ammonia odor. As discussed above, it cannot be determined if the foam and odor is attributed to the WWTP's overflow.

Downstream of the WWTP, public access to the Gallinas River is limited. Approximately 8 miles downstream near San Agustin, white foam was observed in the Gallinas River and had accumulated in some locations along the bank. The white foam easily dissipated when disturbed. A faint ammonia odor was noticeable while walking along the stream banks. One location of brown foam accumulated at the edge of the river also had a faint ammonia odor. Due to the distance below the WWTP's outfall and that no floating solids were observed, it cannot be determined if the foam and odor is attributed to the WWTP's overflow.

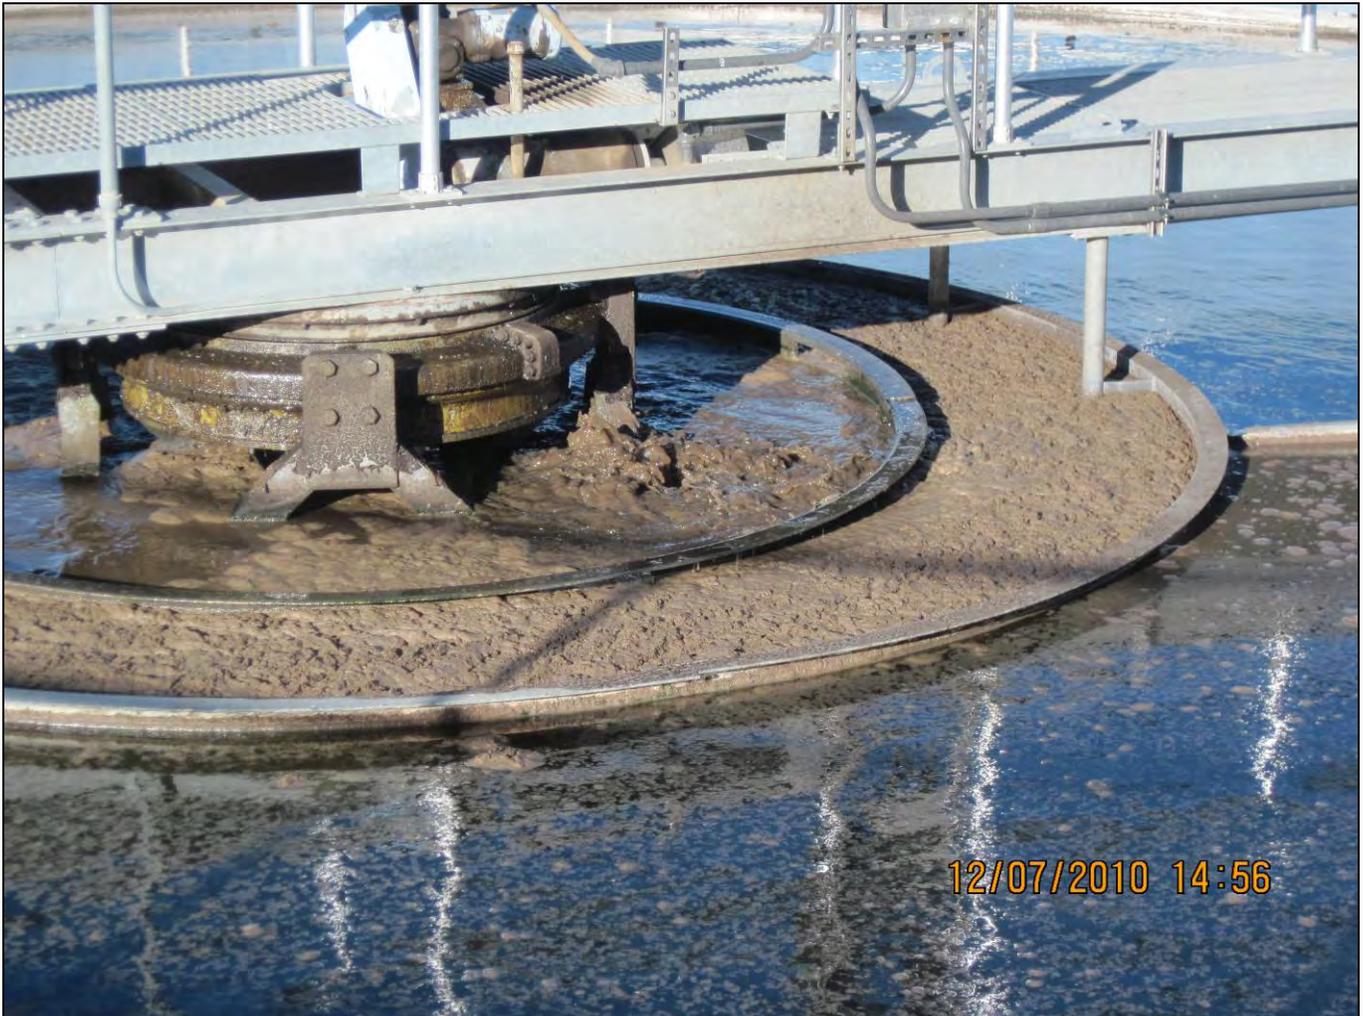
NMED/SWQB  
Official Photograph Log  
Photo # 5

Photographer: Erin S. Trujillo	Time: 12/07/2010	Time: 1456 hours
City/County: Las Vegas / San Miguel County		State: New Mexico
Location: City of Las Vegas Wastewater Treatment Plant, NPDES Permit No. NM0028827		
Subject: Foam and floating solids in west clarifier—example of additional action (skimming and cleaning of the clarifiers) still needed as a result of the overflow on the day of the inspection.

During this inspection, both clarifiers were discharging during this inspection. Substantial foam and floating solids were observed in both clarifiers. Sheens, possibly from oil, were also observed. Dark gray coated filamentous bacteria was observed below the outer effluent weir of the clarifier that had lifted the night before. Additional skimming and cleaning of the clarifiers was needed as a result of the overflow. The Permittee's on-site representative stated he would follow up to see if additional cleaning of the clarifiers could be done before the maintenance typically conducted on Mondays.

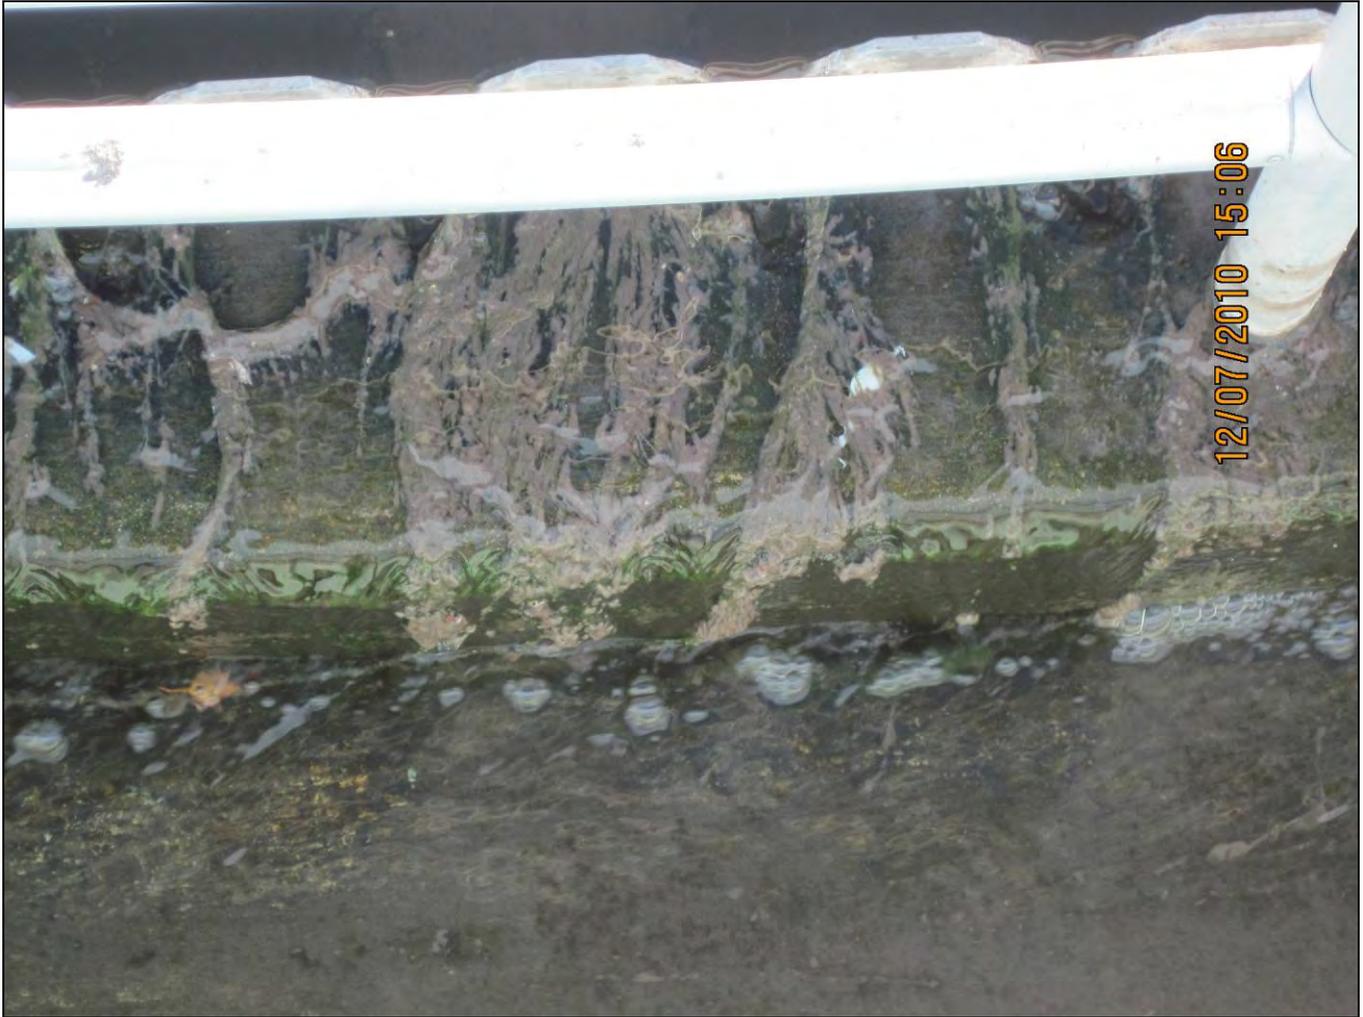
NMED/SWQB  
Official Photograph Log  
Photo # 6

Photographer: Erin S. Trujillo	Time: 12/07/2010	Time: 1506 hours
City/County: Las Vegas / San Miguel County		State: New Mexico
Location: City of Las Vegas Wastewater Treatment Plant, NPDES Permit No. NM0028827		
Subject: Coated filamentous algae below effluent weirs in west clarifier—example of additional action (skimming and cleaning of the clarifiers) still needed as a result of the overflow on the day of the inspection.

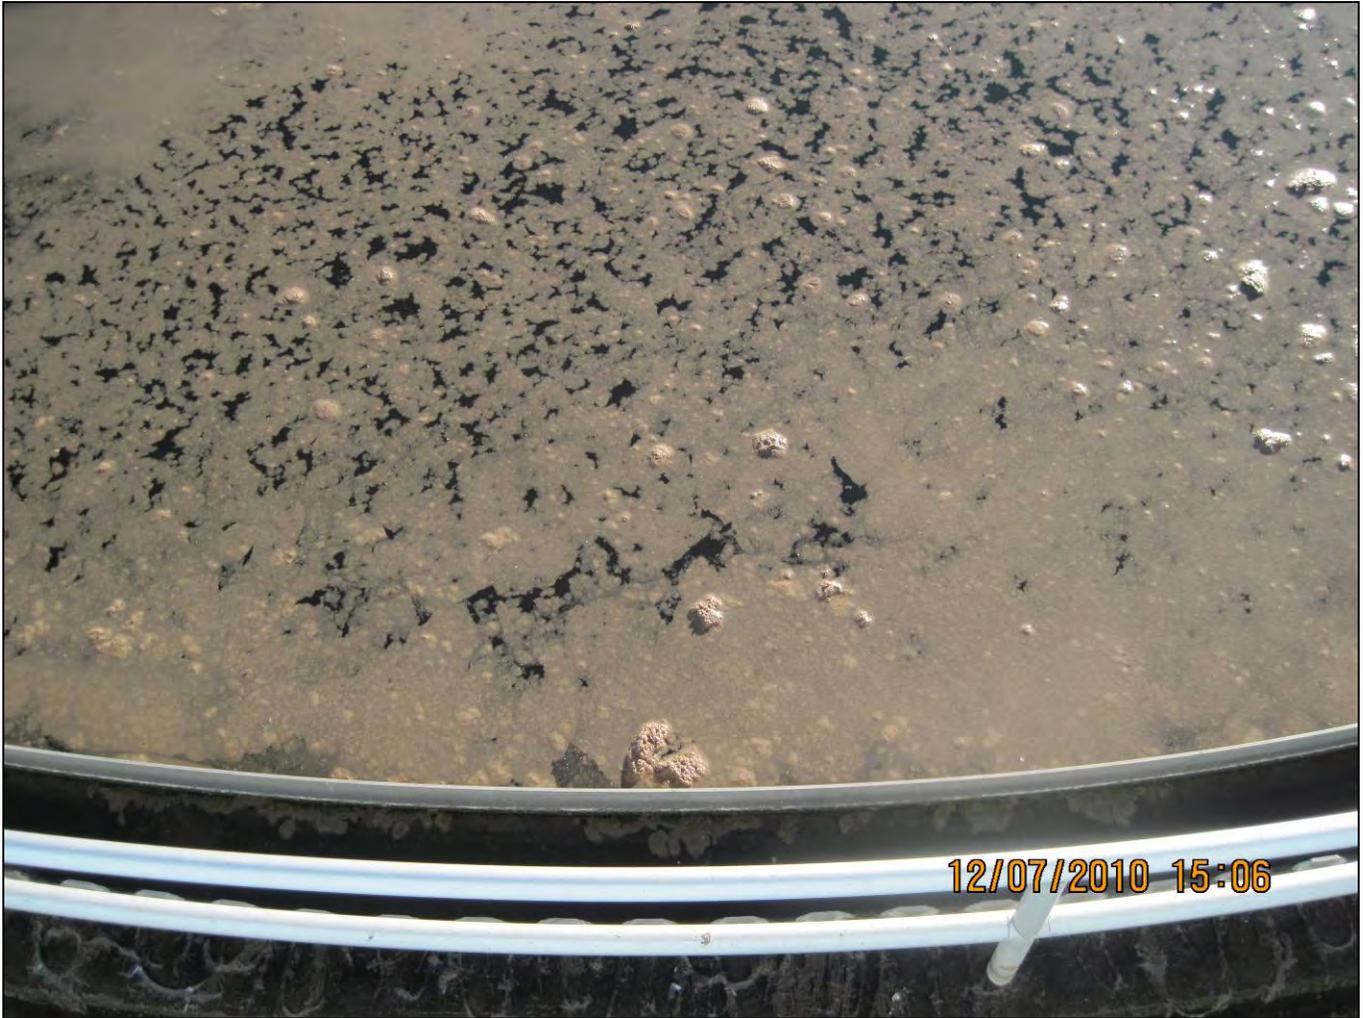
NMED/SWQB  
Official Photograph Log  
Photo # 7

Photographer: Erin S. Trujillo	Time: 12/07/2010	Time: 1506 hours
City/County: Las Vegas / San Miguel County		State: New Mexico
Location: City of Las Vegas Wastewater Treatment Plant, NPDES Permit No. NM0028827		
Subject: Floating solids in west clarifier—example of additional action (skimming and cleaning of the clarifiers) still needed as a result of the overflow on the day of the inspection.
