Re: **Minor Non-Municipal; SIC 4952; NPDES Compliance Evaluation Inspection; Central Consolidated Schools Wastewater Treatment Plant; NM0029319; August 01, 2012**

NPDES Compliance Inspection Report

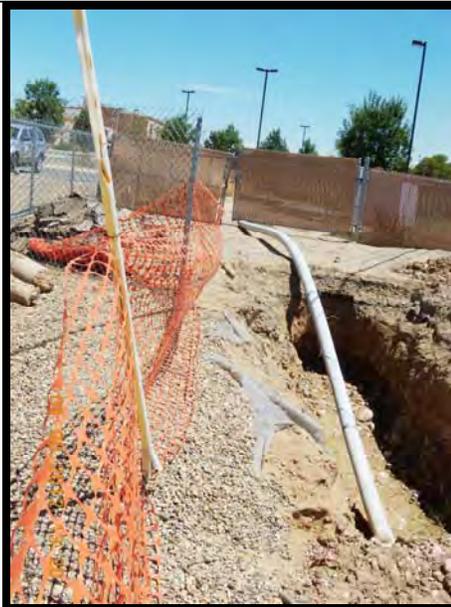
Subject: New 6 inch piping being laid from the main lift station in front of the schools to the collection line from the City of Farmington WWTP.

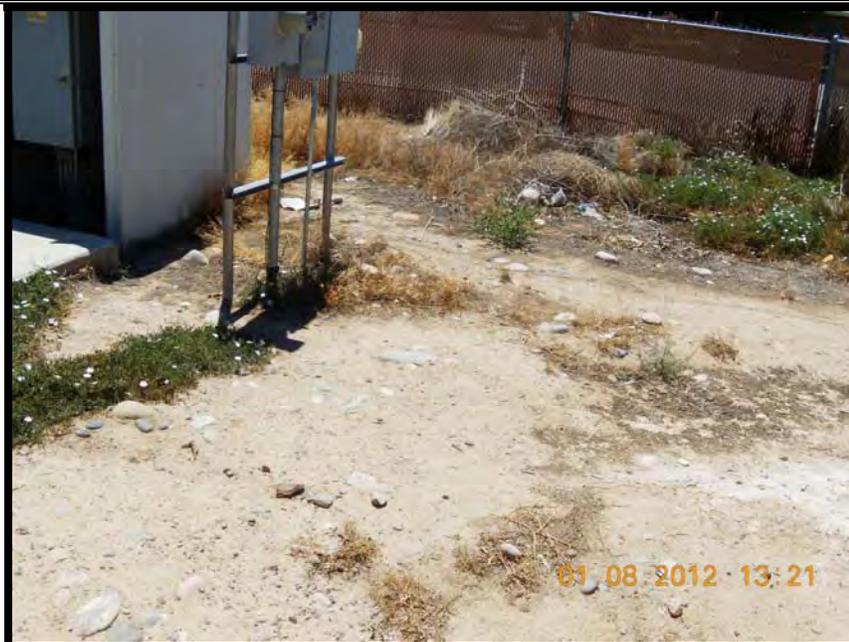
**NMED/SWQB
Official Photograph Log
Photo #2**

Subject: Lift Station - ground shows evidence of overflows and dried raw sewage debris.

9. Numerous overflows from the lift station in front of the junior high school have occurred. These failures have resulted in raw sewage flowing across the road, into a storm drain, to a holding pond, past houses and a residential area and potentially to the San Juan River. No preventive measures have been taken to stop future overflows. Debris on the ground near the lift station shows dried sewage solids (see attached photo).

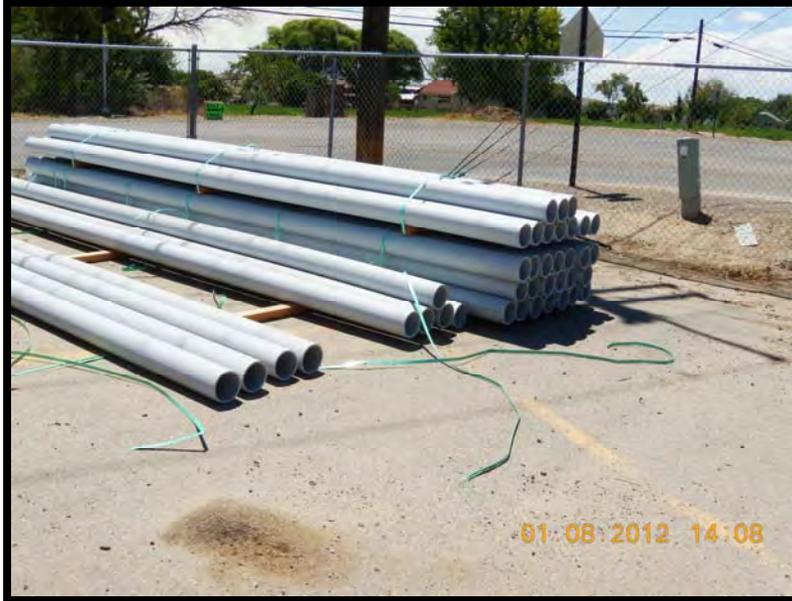
NMED/SWQB
Official Photograph Log
Photo #3

Subject: 6 inch pipe to be laid for the sewer line connecting to the Farmington WWTP collection system. This pipe is being stored in the parking lot of the high school. Completion of the sewer line is expected to be the end of September 2012.

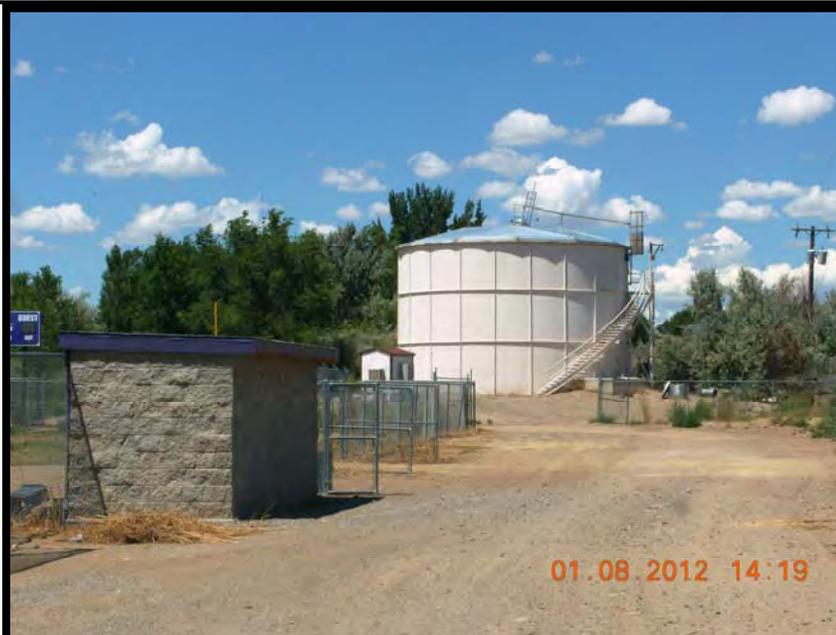
NMED/SWQB
Official Photograph Log
Photo #4

Subject: The Enclosed WWTP - Schreiber Activated Sludge Treatment System.

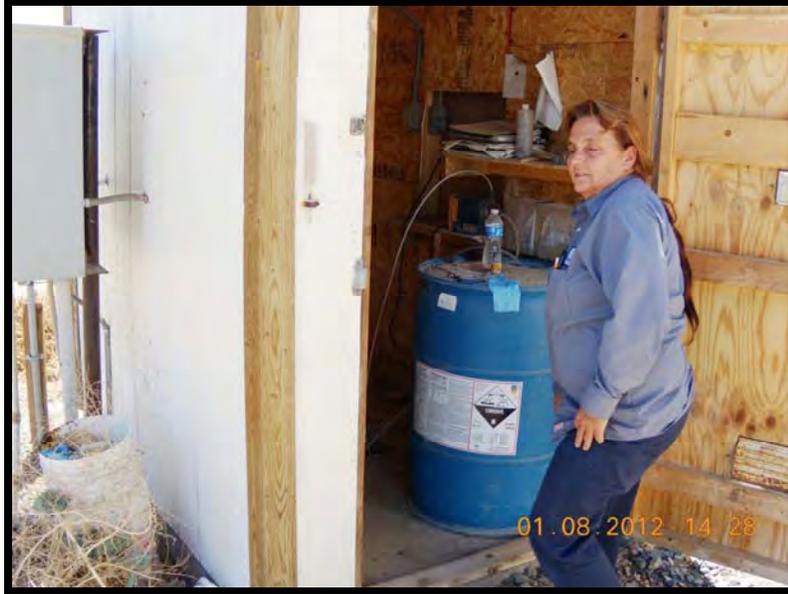
**NMED/SWQB
Official Photograph Log
Photo #5**

Subject: The chlorine building.

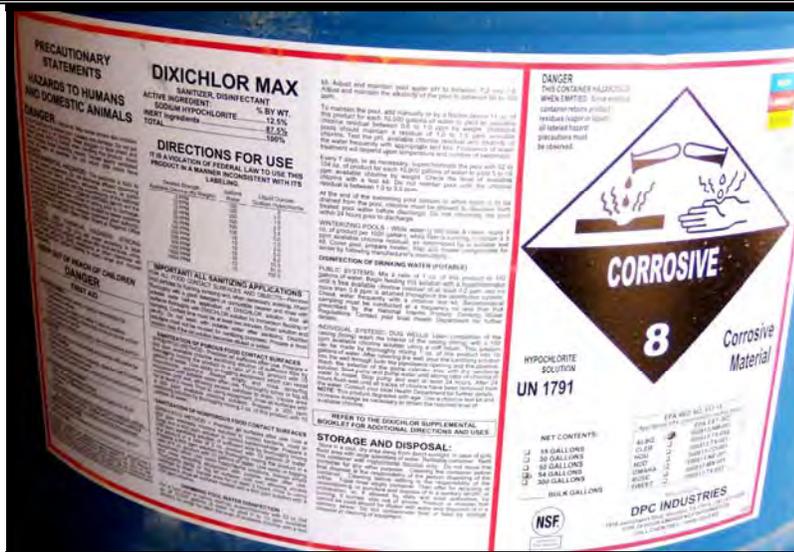
**NMED/SWQB
Official Photograph Log
Photo # 6**

Subject: Chlorine barrel - Sodium Hypochlorite.

7. Chlorination and de-chlorination systems are poorly maintained. The Chlorine (see photos) is stored in 50 gallon drums; the pump is attached to a 1/4 inch tube stuck into a 4 inch opening of the drum. There is no other covering for the 4inch opening. The tubes were heavily coated with dried chlorine salts. The tubes should be cleaned or replaced. The 4 inch opening should be covered and sealed around the tubing. Chlorine salts were splattered all over the wall, floor and drum. The chlorine vapors were extremely strong in the building. The same conditions were also found with the de-chlorination System.

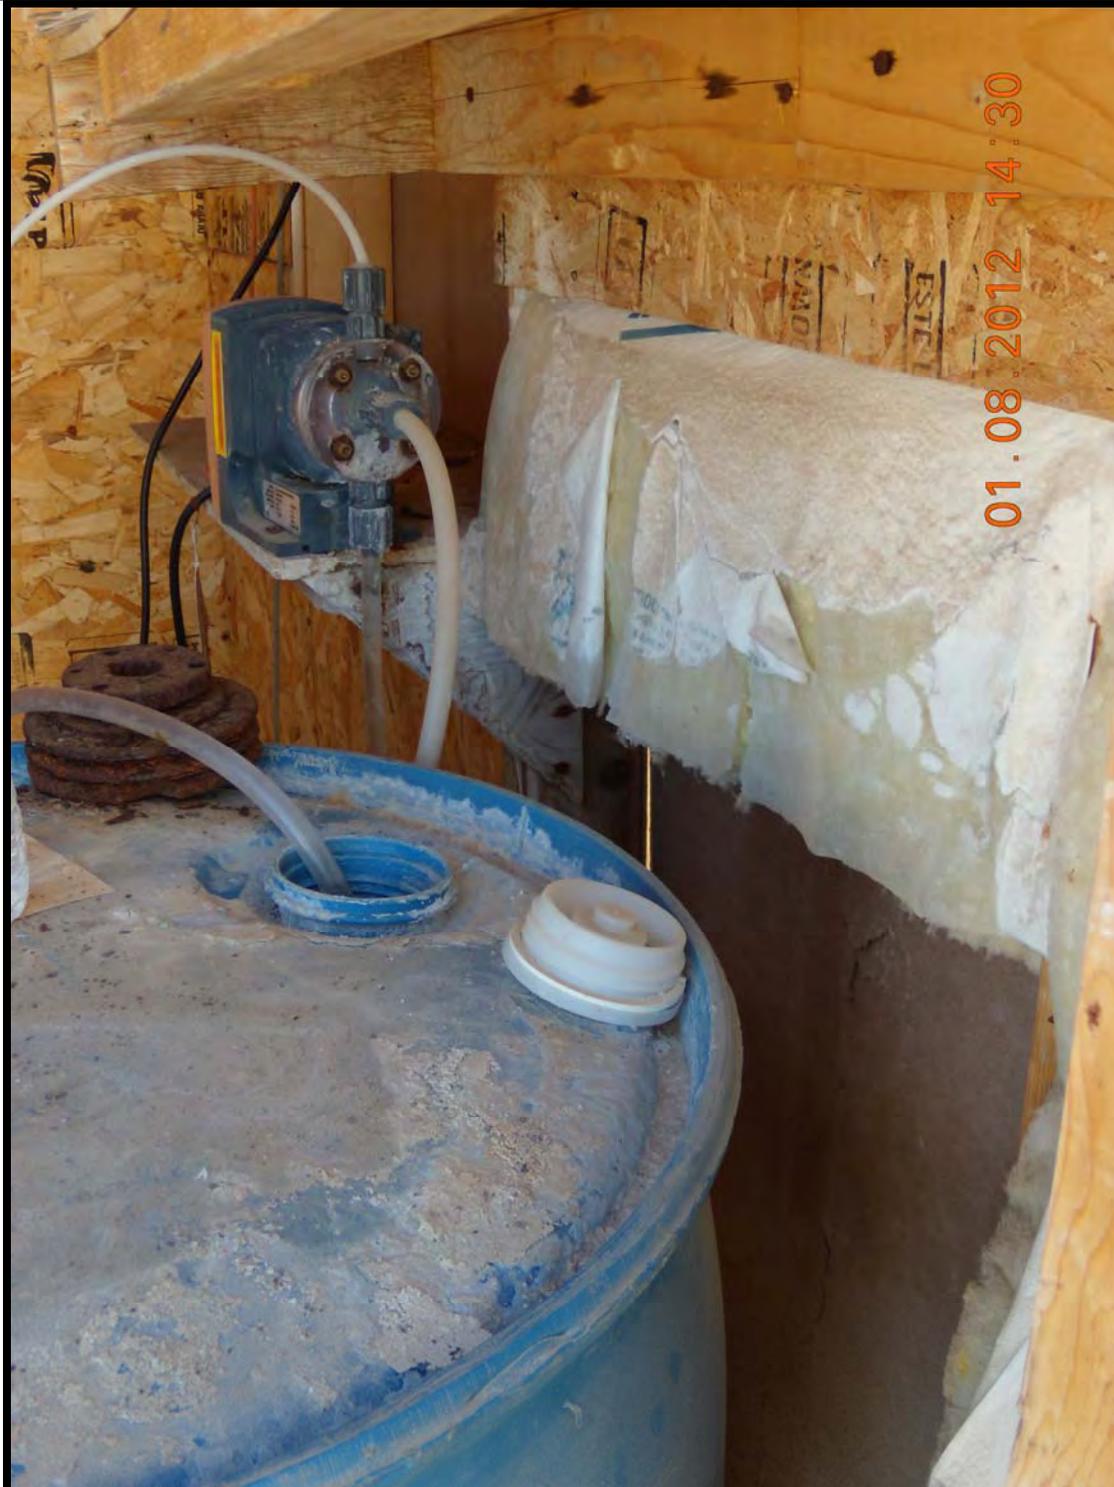
NMED/SWQB
Official Photograph Log
Photo # 7

Subject: Chlorine pumps, tubing, storage container. The container is not sealed and chlorine vapors are leaking, coating the walls. The tubing is caked and coated, not maintained nor clean. There is potential for this to leak to outside of the building. Also, the area is not always kept securely locked posing a potential danger to school children. Strong odors of Chlorine were evident in this storage area.

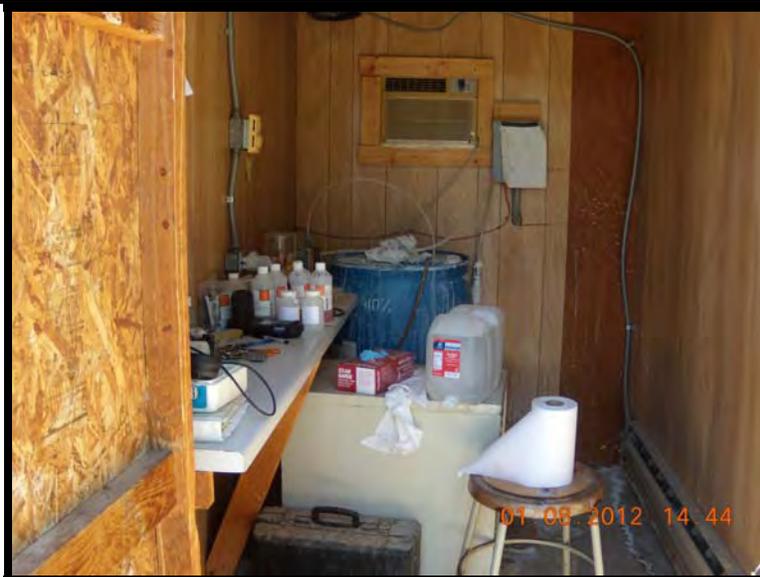
NMED/SWQB
Official Photograph Log
Photo # 8

Subject: Onsite laboratory and de-chlorination system.

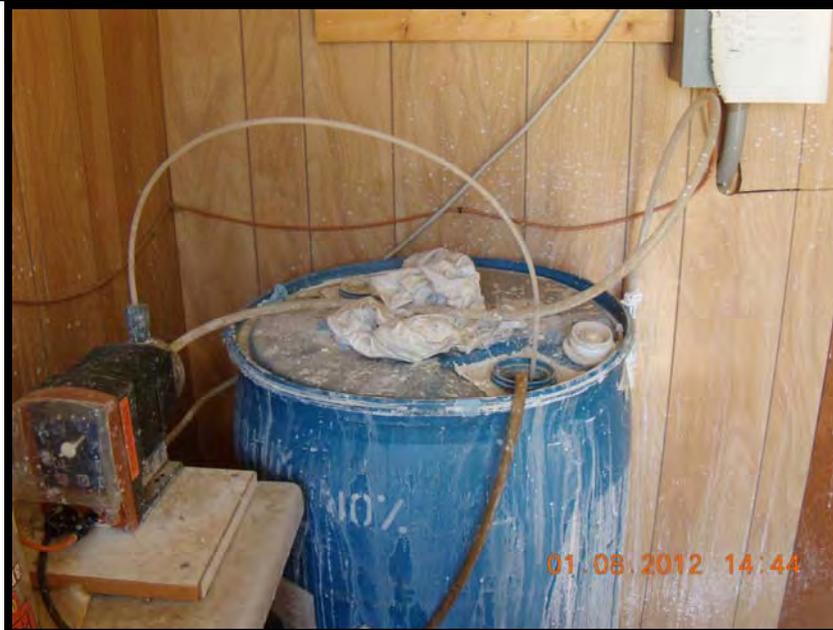
NMED/SWQB
Official Photograph Log
Photo # 9

Subject: De-chlorination is achieved by using Sodium Sulfite. The tubing from the storage tank through the pump to the effluent is not being cleaned and maintained. There is a large amount of splatter coating the barrel and the walls. The poor cleaning and maintenance can result in unreliable dosing volumes. Additionally- like the chlorine storage building there are high amounts of vapors.

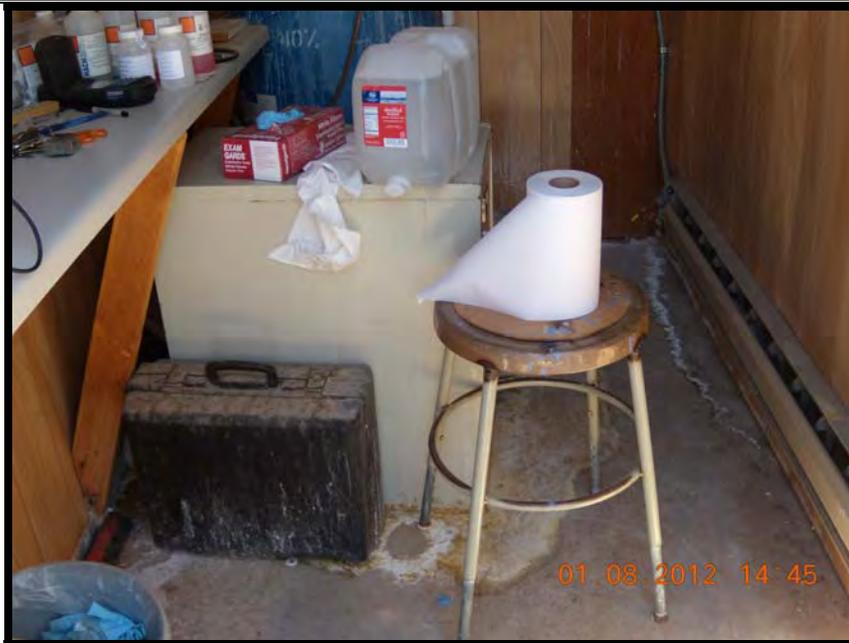
NMED/SWQB
Official Photograph Log
Photo # 10

Subject: The De-chlorination system is leaking, coating the ground and walls and the other equipment. It is possible for this to leak out of the building to bare ground. Note the stains on the floor and coated equipment box.

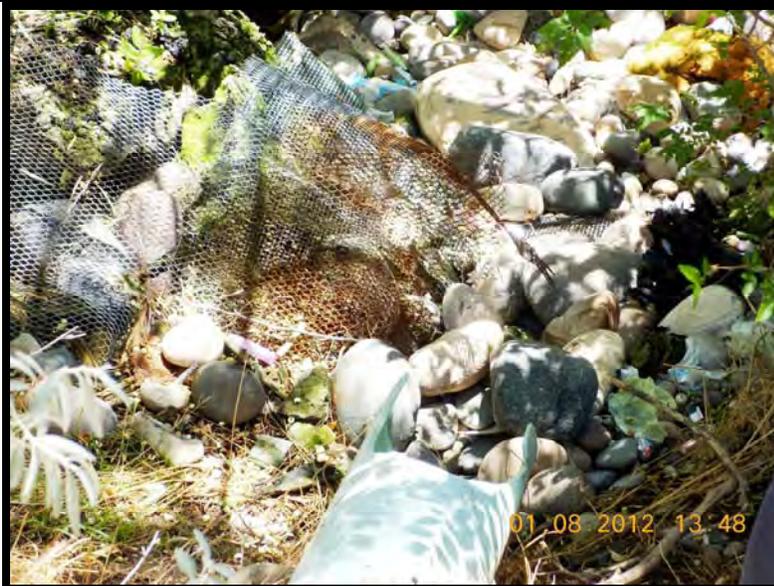
NMED/SWQB
Official Photograph Log
Photo # 11

Subject: Plastic and solid debris, trash that has gone through the WWTP to the outfall. The wire basket intended to catch solids has not been maintained. Large solids are being discharged to the San Juan River.

1. The outfall pipe on previous inspections had a wire basket in place to catch any large solids being discharged from the facility. At the time of this inspection the wire basket has fallen to the rocks below the outfall pipe and appeared to have been there for a considerable amount of time. There were numerous items that littered the ground at the outfall location including plastic hygiene applicators, rags and other debris.
