RE: **Major-Municipal; SIC 4952; NPDES Compliance Evaluation; CRRUA - Sunland Park Waste Water Treatment Plant; NM0029483; July 18, 2013**

NPDES Compliance Inspection Report

On July 18, 2013 a Compliance Evaluation Inspection (CEI) was conducted at the Camino Real Regional Utility Authority (CRRUA) Sunland Park Wastewater Treatment Plant (WWTP) by Barbara Cooney of the State of New Mexico Environment Department (NMED), Surface Water Quality Bureau (SWQB). The inspection was conducted by NMED for the US Environmental Protection Agency (USEPA), Region VI, under the National Pollutant Discharge Elimination System (NPDES) permit program, in accordance with the Federal Clean Water Act. These inspections are conducted under contract with the USEPA and are used by USEPA to evaluate compliance with the NPDES permit program. This inspection report is based on information supplied by the City of Santa Rosa representatives (the permittee), observations made by the NMED inspectors, reports and records kept by the permittee and/or NMED.

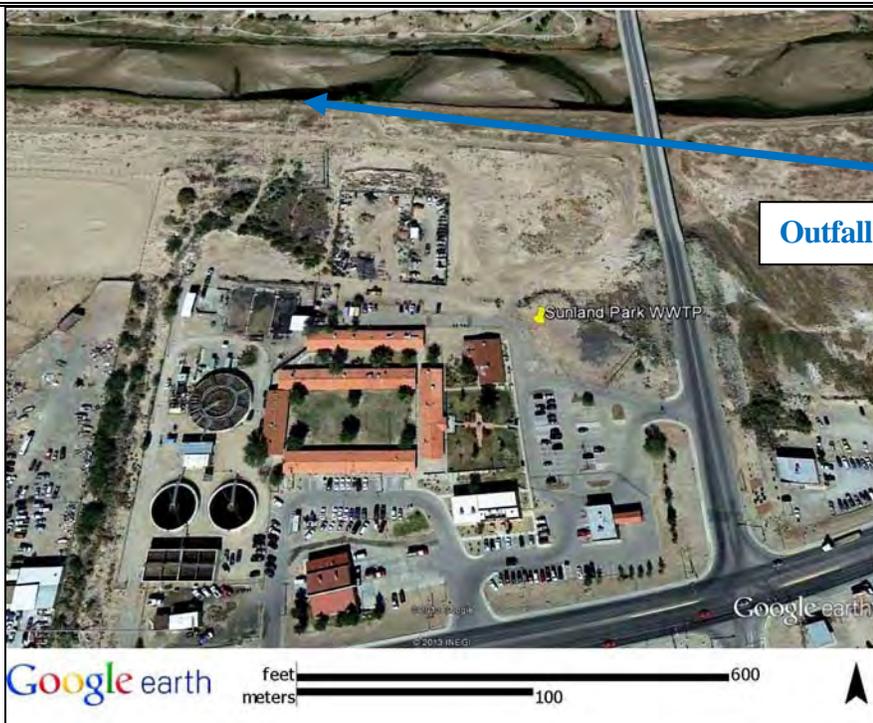
NMED/SWQB
Official Photograph Log
Photo # 1

Subject: Aerial View

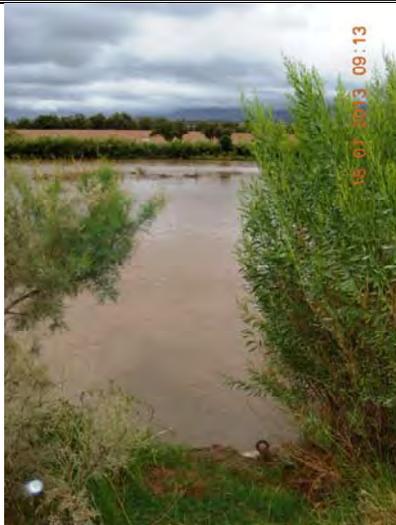
NMED/SWQB
Official Photograph Log
Photo # 2

Subject: Outfall at the Rio Grande. The outfall pipe is below the river water surface. A large volume of water was being released from Caballo Reservoir upstream.

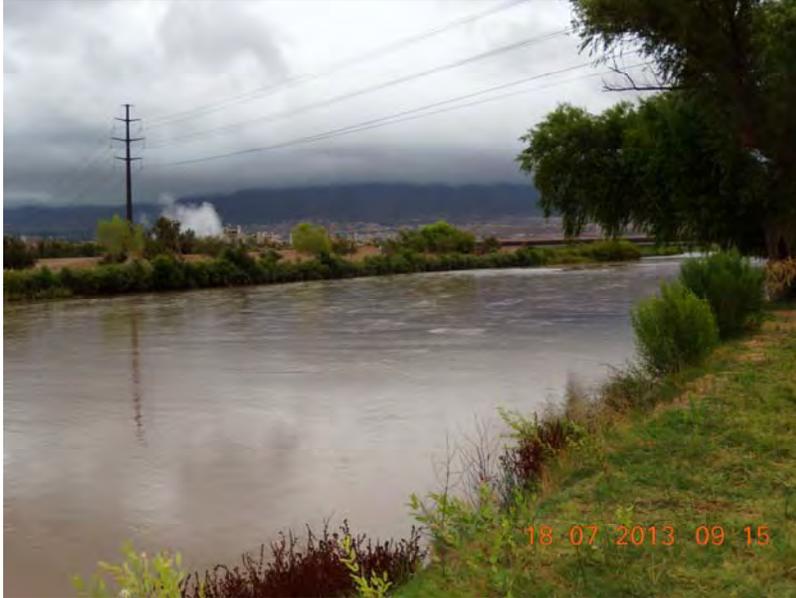
NMED/SWQB
Official Photograph Log
Photo #3

Subject: Rio Grande at the Outfall – looking downstream towards Texas.

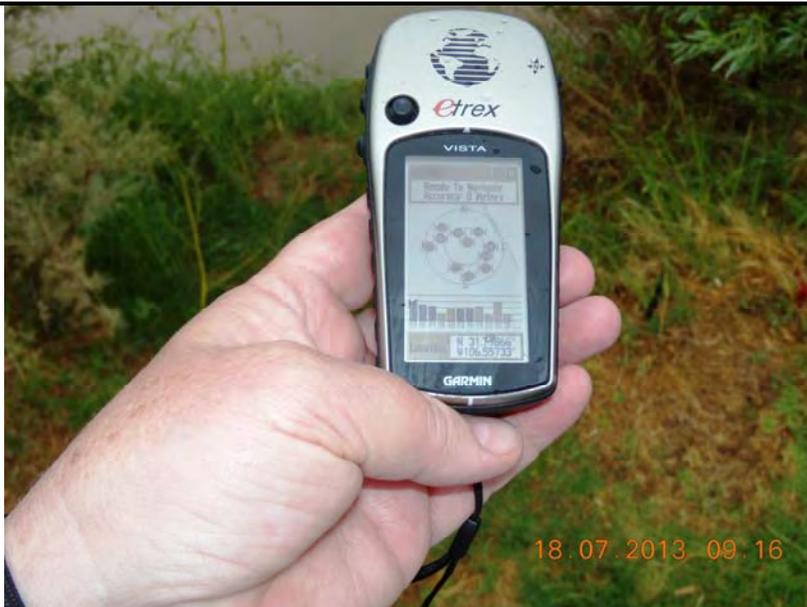
NMED/SWQB
Official Photograph Log
Photo #4

Subject: Outfall Coordinates N31.79866 W106.55733 Decimal Degrees

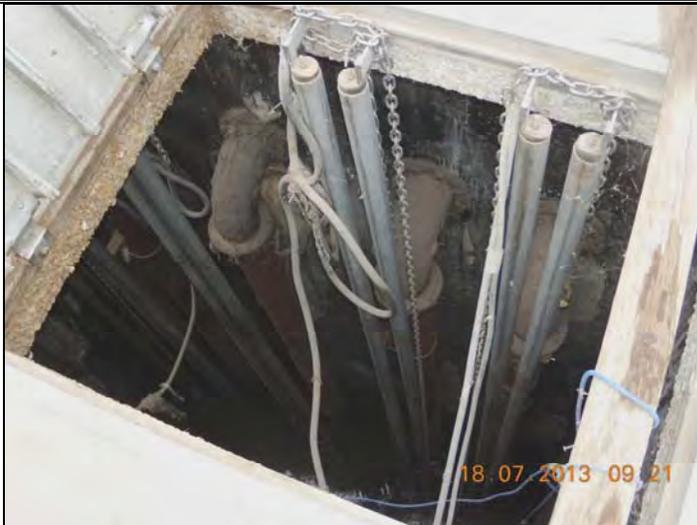
NMED/SWQB
Official Photograph Log
Photo # 5

Subject: Influent lift station with Flygt pumps – located before the bar screen and any solids removal.

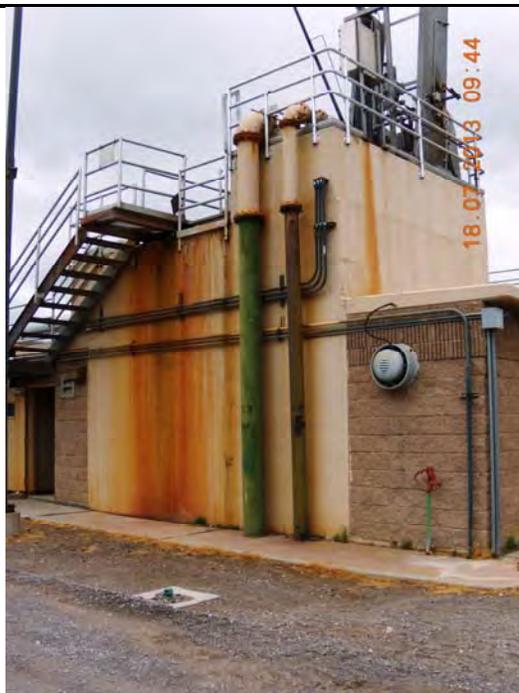
NMED/SWQB
Official Photograph Log
Photo # 6

Subject: Influent pipes from the Racetrack and town. The mechanical bar screen is at the top right of the photo.

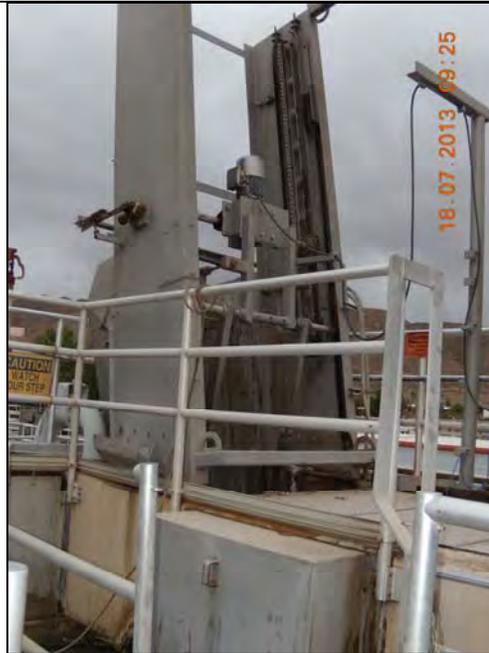
NMED/SWQB
Official Photograph Log
Photo # 7

Subject: Influent mechanical bar screen.

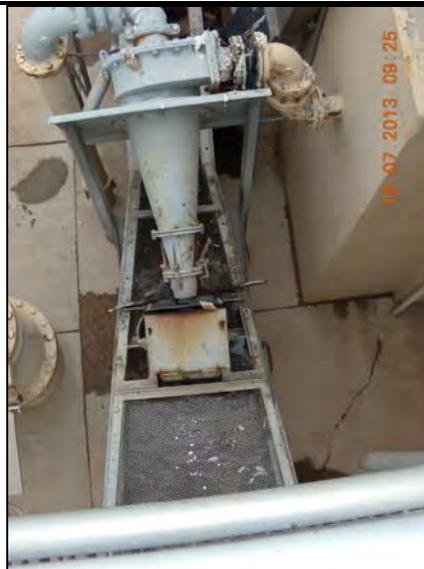
NMED/SWQB
Official Photograph Log
Photo # 8

Subject: Influent grit removal system below the bar screen at the headworks.

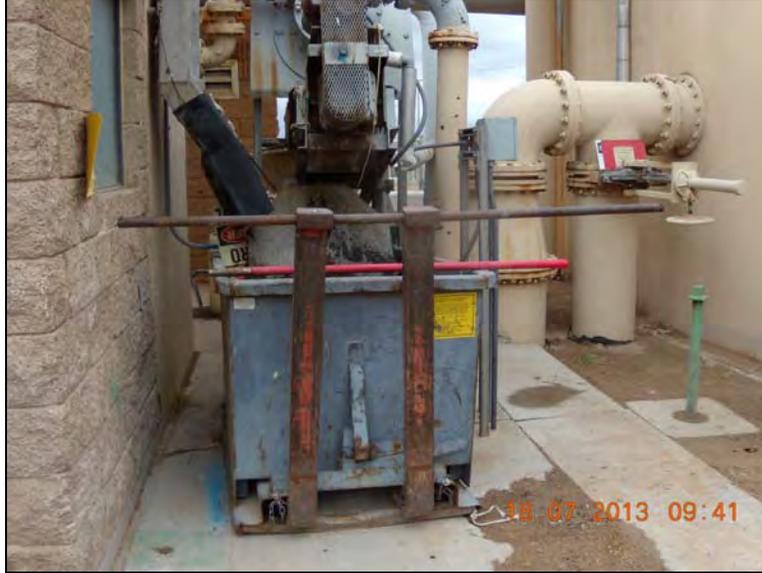
NMED/SWQB
Official Photograph Log
Photo # 9

Subject: Another view of the grit removal system. Grit collected in the hopper is disposed of at the landfill after passing the paint filter test.

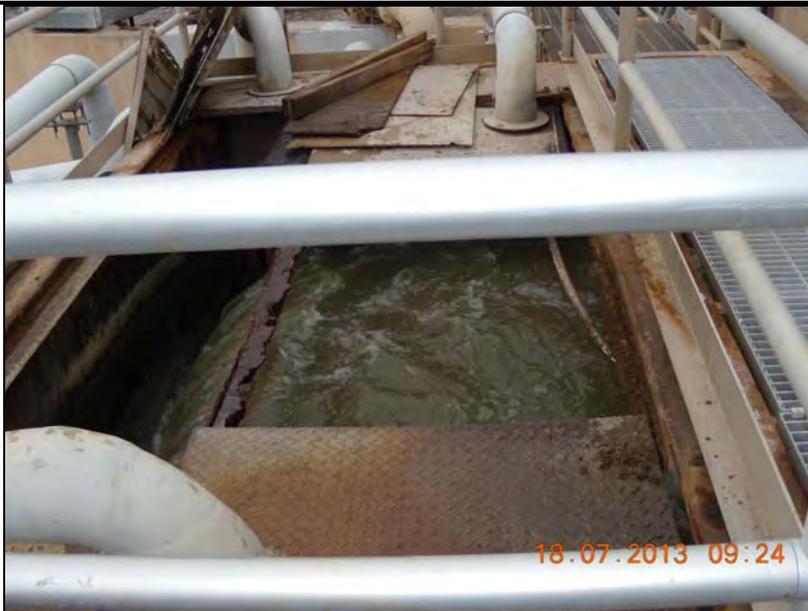
NMED/SWQB
Official Photograph Log
Photo # 10

Subject: Influent grit removal.

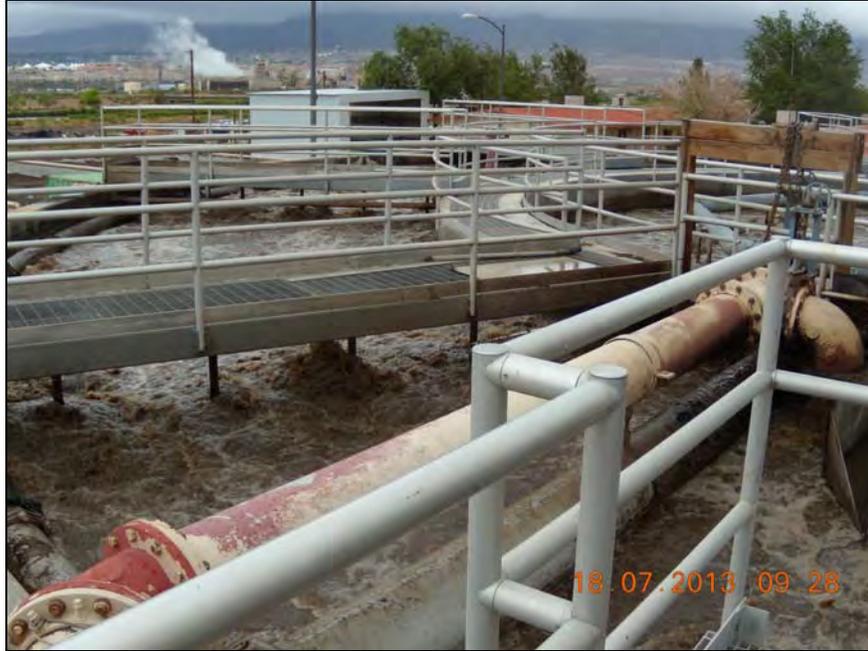
NMED/SWQB
Official Photograph Log
Photo # 11

Subject: Aeration basins

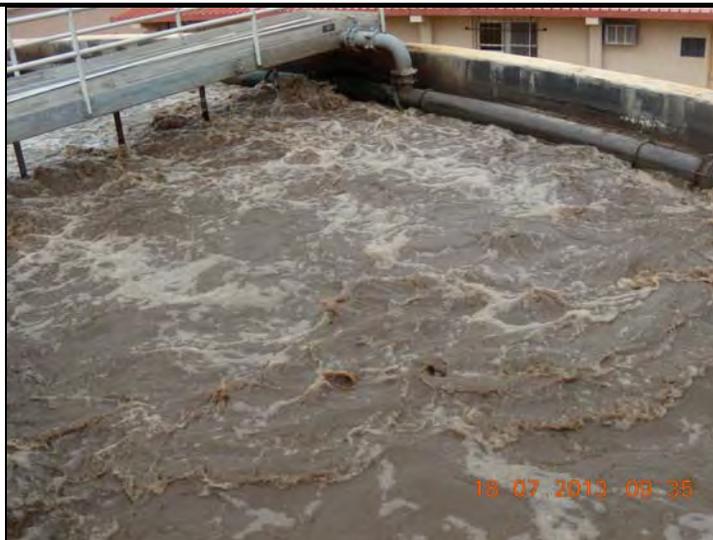
NMED/SWQB
Official Photograph Log
Photo # 12

Subject: Aeration basins – The basins were mostly free of accumulated foam. The diffusers appeared to adequately aerate the basins. Significant dead spots were not observed.

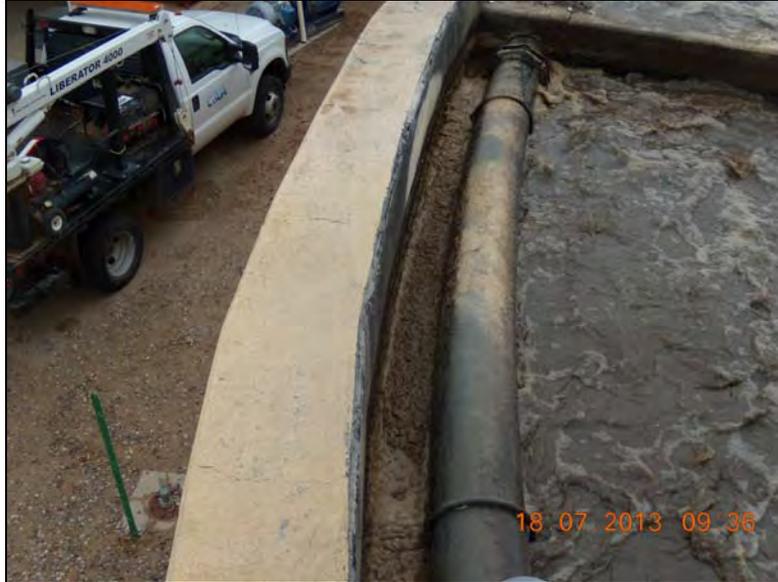
NMED/SWQB
Official Photograph Log
Photo # 13

Subject: Aeration basins – Solids and foam along the outer wall.

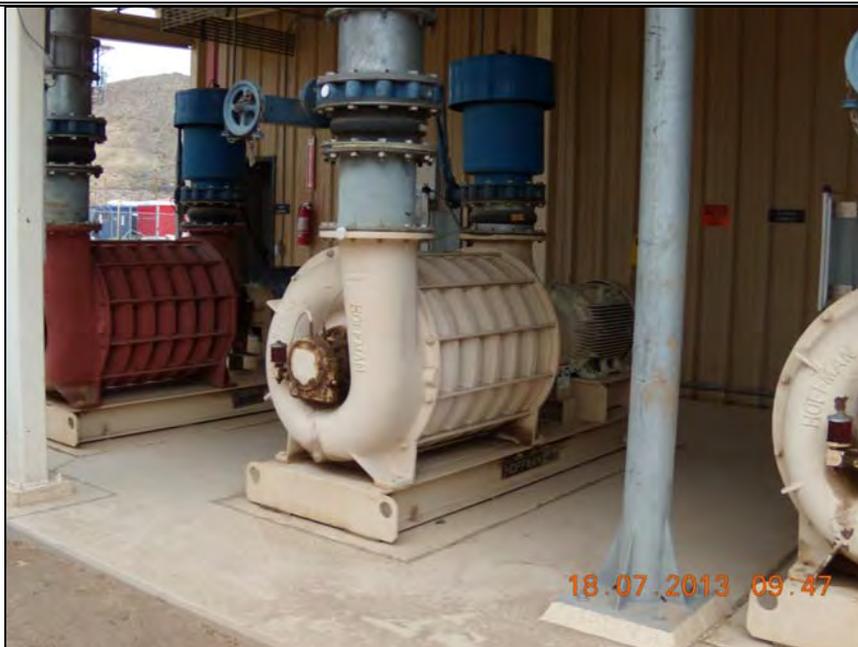
NMED/SWQB
Official Photograph Log
Photo # 14

3. The blowers that provide aeration appeared to be well maintained. Some small amount of leaking oil was observed.
4. The operational staff were knowledgeable and the overall maintenance at the WWTP indicated that adequate operational staffing was present.

Subject: Blowers that provide aeration appear to be well maintained. Some small amount oil leaking was observed.

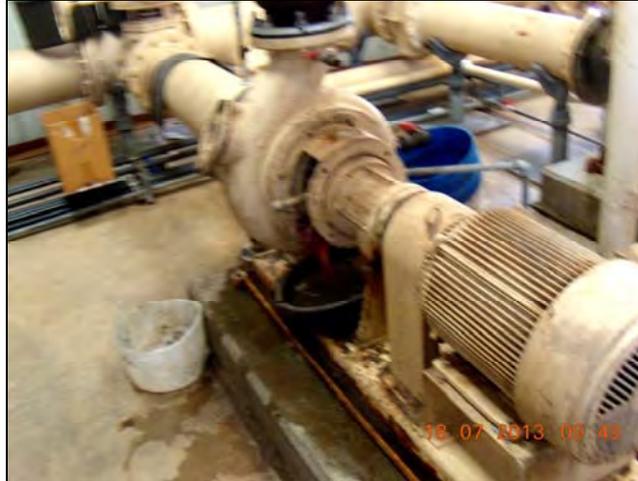
NMED/SWQB
Official Photograph Log
Photo # 15

2. The RAS and WAS pumps were leaking fluids and appeared to require extra maintenance due to age. One pump was offline for repairs.

Subject: RAS and WAS pumps were leaking fluids and were under repair.

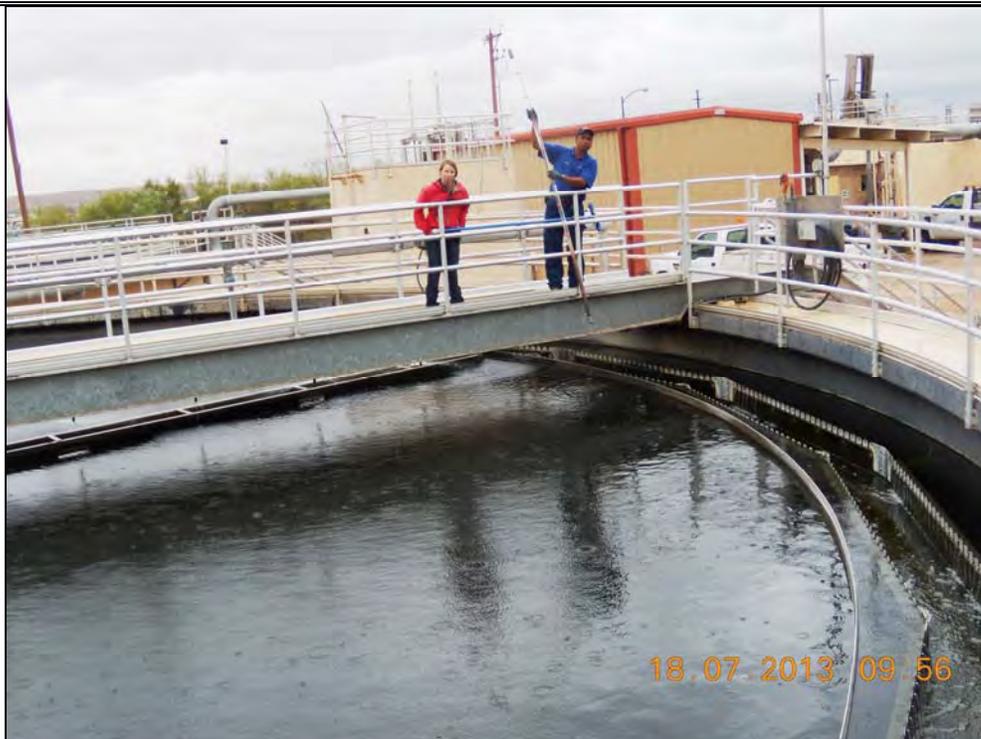
NMED/SWQB
Official Photograph Log
Photo # 16

1. Some uneven flow and short circuiting was observed in the secondary clarifiers. This is likely the result of the units settling into the ground over the years. However the weirs were clean and free of debris and excessive algae build up.

Subject: Clarifier with two foot sludge blanket. Some uneven flow and short circuiting was observed. The weirs were clean and free of debris and algae accumulation.

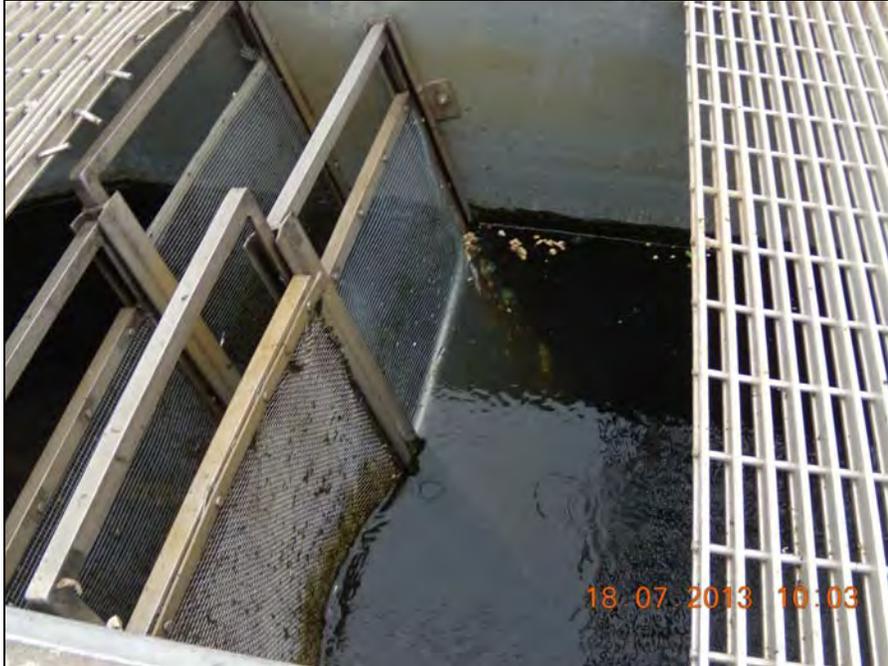
NMED/SWQB
Official Photograph Log
Photo # 17

Subject: Screens to catch floating solids before Ultraviolet Disinfection and discharge to the Rio Grande.

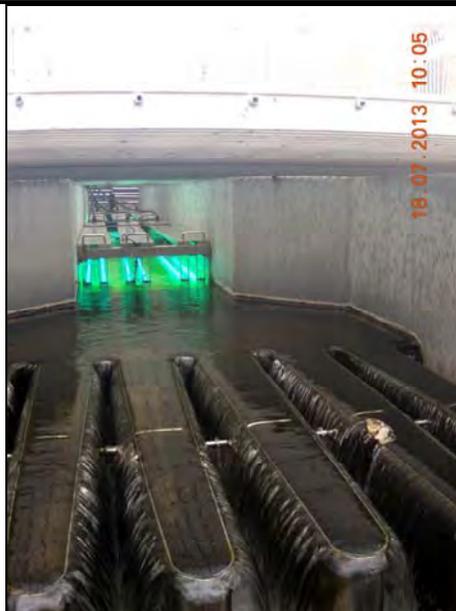
NMED/SWQB
Official Photograph Log
Photo # 18

Subject: Ultraviolet Disinfection System. Bulbs were clean and free of debris and algae.

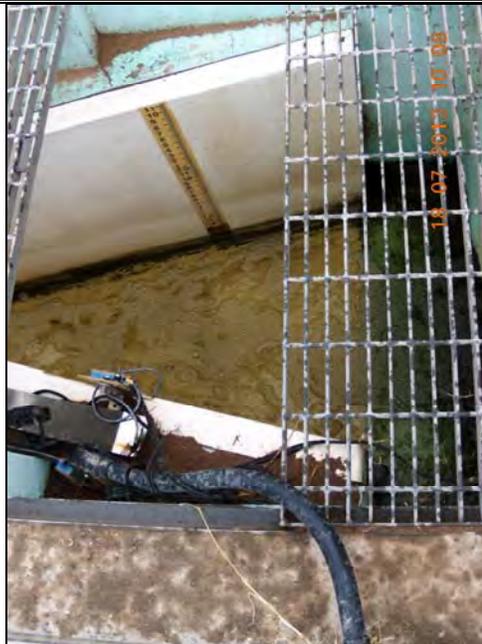
NMED/SWQB
Official Photograph Log
Photo # 19

Subject: Effluent flow meter staff gauge – a backup pressure sensor gauge is also in place for flow reading. Effluent was clear and free of foam and floating solids.

1. The permittee does not do self calibration checks. To conduct these checks, the staff gauge should be read at the same time another person reads the pressure gauge readout in the laboratory. This should be recorded. The flow meter is calibrated annually by a contractor.

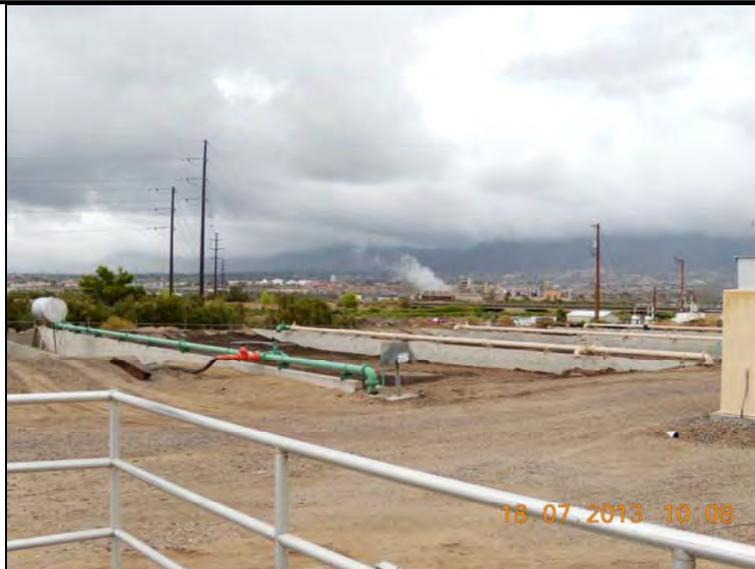
NMED/SWQB
Official Photograph Log
Photo # 20

Subject: Sludge Drying Beds. – The beds are cement lined. Some track out was observed.

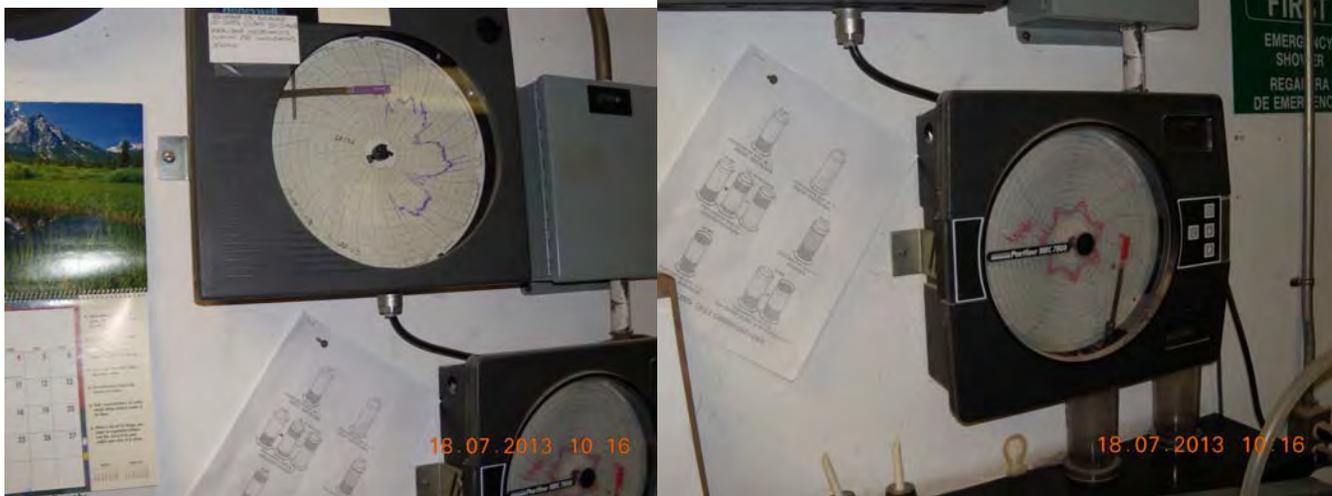
NMED/SWQB
Official Photograph Log
Photo # 21

Subject: Influent and Effluent Flow meters

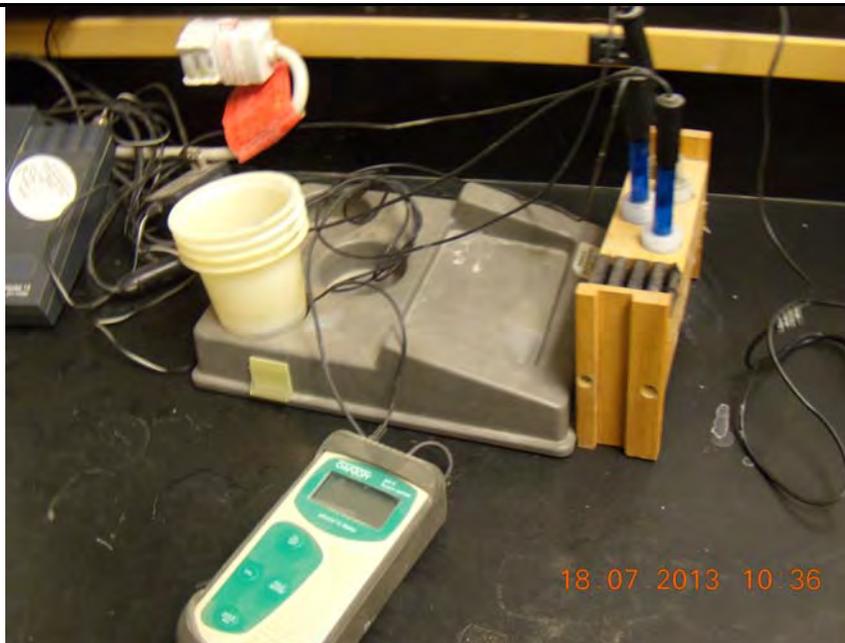
NMED/SWQB
Official Photograph Log
Photo # 22

1. Samples collected are not properly stored and re Fridgerated before and during transport to the laboratory.
2. The pH meter probe was not stored properly in either a storage solution or a buffer.
3. Duplicate samples were not analyzed for quality control at the onsite laboratory.
4. Bench Sheet for E.coli Bacteria for the sample date 5/15/2013 does not list the analysis date. The times of sampling and the time of analysis are listed.

Subject: On-site Laboratory: pH meter. Electrode is stored in distilled water. For proper care store in pH storage or buffer solution.

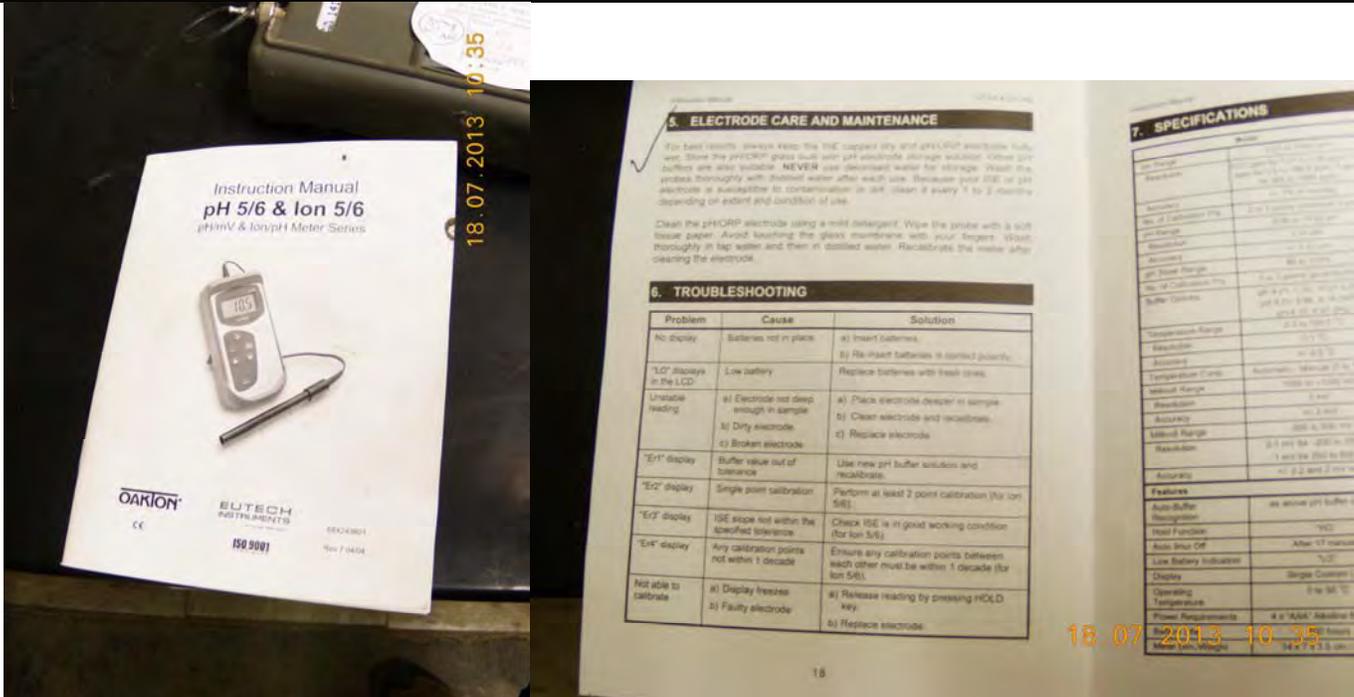
**NMED/SWQB
Official Photograph Log
Photo # 23**

Subject: pH meter manual instruction for electrode care: "Store the pH/ORP glass bulb with pH electrode storage solution. Other pH buffers are also suitable. NEVER use deionized water for storage"

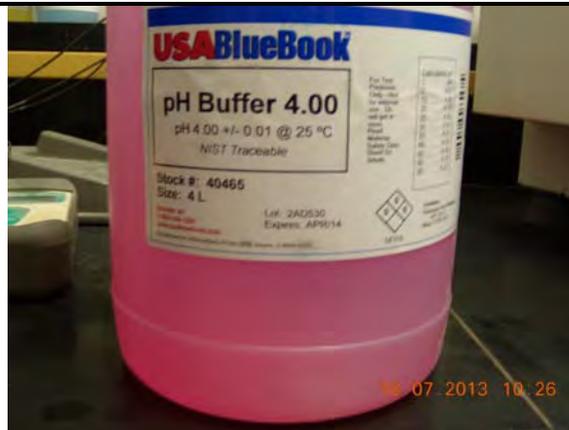
**NMED/SWQB
Official Photograph Log
Photo # 24**

Subject: pH buffers did not have the date when it was opened written on the bottles or recorded anywhere.
