Re: Minor Municipal, SIC 4952, NPDES Compliance Evaluation Inspection, Rio Rancho Number 3
Wastewater Treatment Plant, NM0029602, Sandoval County, New Mexico, January 10, 2013

NPDES Compliance Inspection Report

Rio Rancho Wastewater Treatment Plant Number 3
NPDES Permit NM0029602
Compliance Evaluation Inspection
2013 January 10

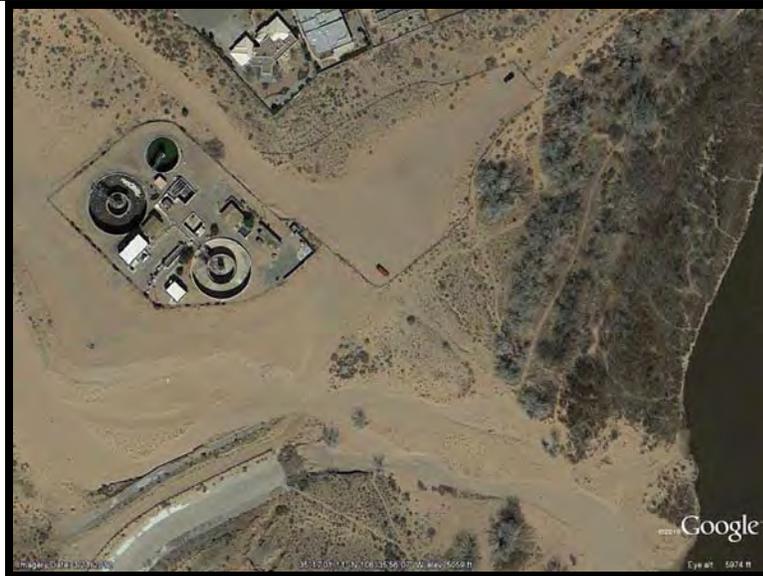
NMED/SWQB
Official Photograph Log
Photo # 1

Subject: Wide view of the WWTP and the proximity to the Rio Grande.

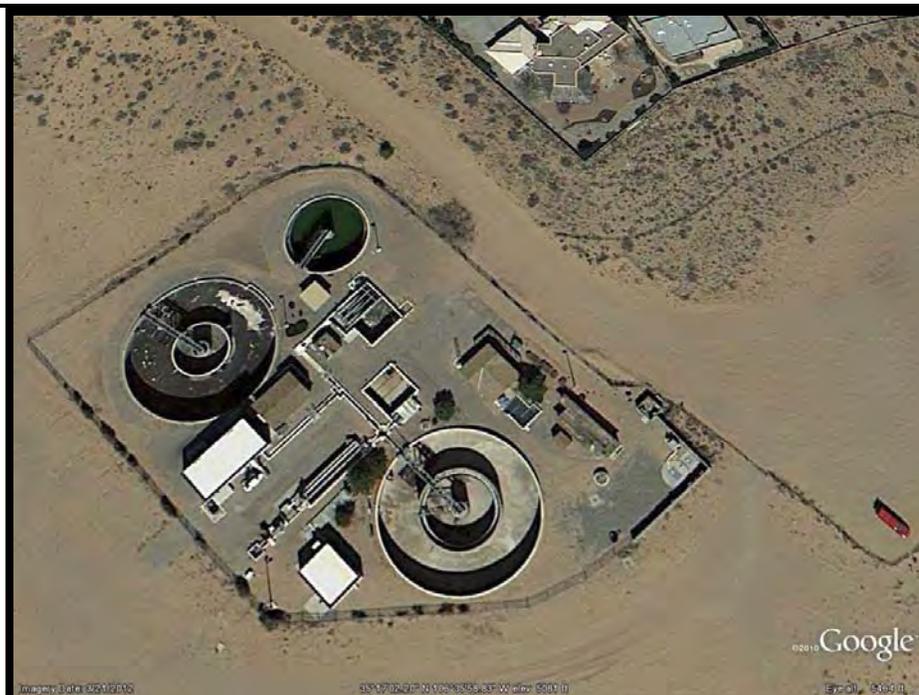
NMED/SWQB
Official Photograph Log
Photo # 2

Subject: Closer aerial view of the WWTP. Showing the Schreiber treatment systems.

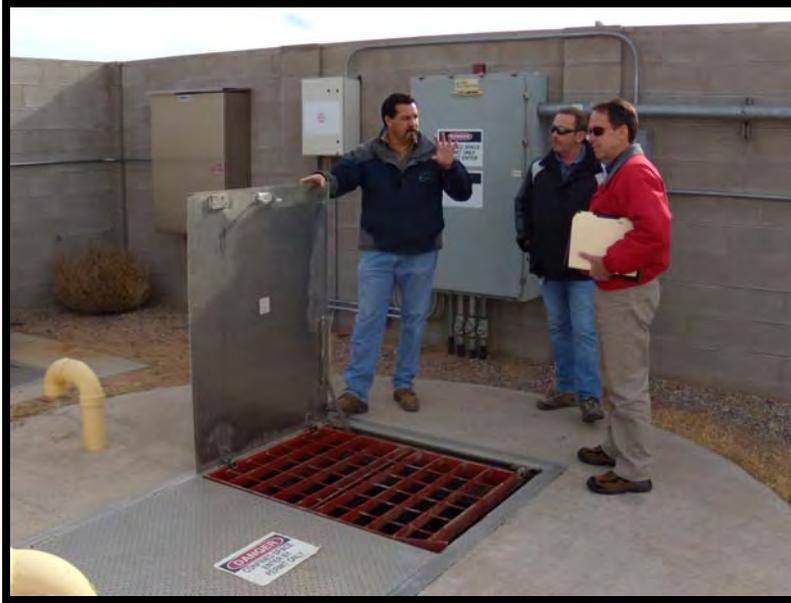
NMED/SWQB
Official Photograph Log
Photo #3

Subject: Rio Rancho Plant Managers and NMED Inspector at lift station number 21, that sends raw sewage through a forced main line to the Rio Rancho #2 WWTP for treatment. The entire flow entering the lift stations for plant #3 are sent directly to plant #2.

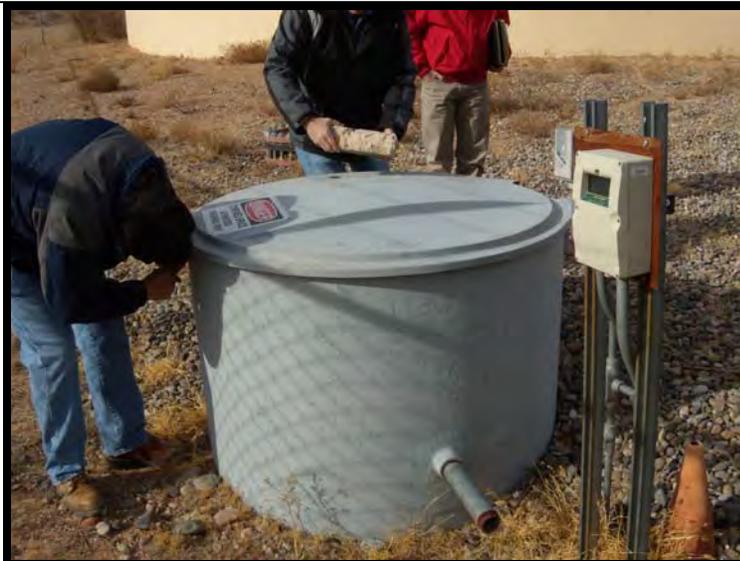
NMED/SWQB
Official Photograph Log
Photo #4

Subject: Manhole cover for the effluent flow measurement devices.

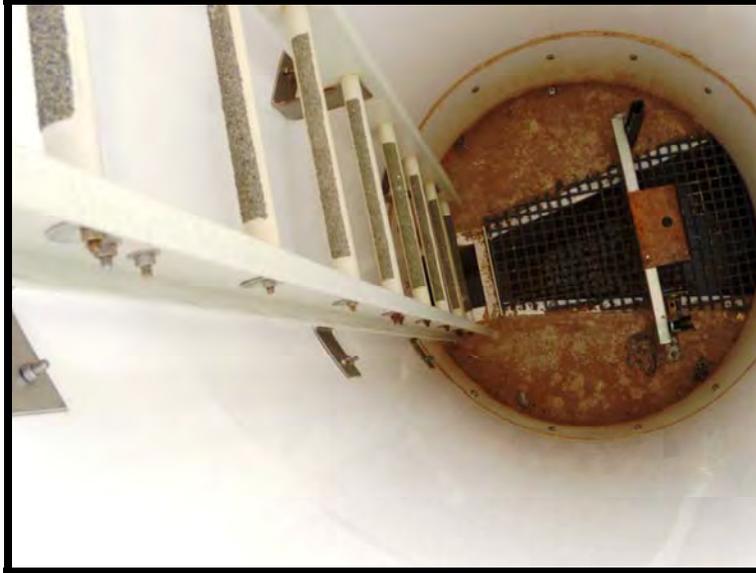
NMED/SWQB
Official Photograph Log
Photo # 5

Subject: Effluent Flow Chanel Parshall Flume flow monitoring location. No flow at the time of the inspection.

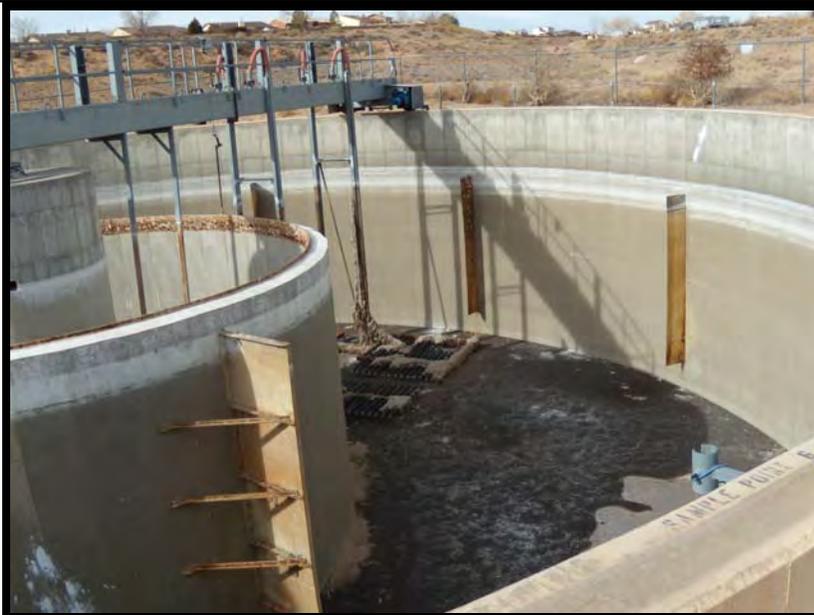
NMED/SWQB
Official Photograph Log
Photo # 6

Subject: Schreiber System that was not in operation at the time of the Inspection. All wastewater is diverted through the collection system away from this WWTP and directly to Rio Rancho #2 for treatment.

According to Mr. De Lara, plans are underway to upgrade the WWTP. Some of the considered upgrades are to install fixed aeration in the Schreiber systems, replacing the circulating bridge diffused air system currently in place. There are no dates specified for the upgrades to occur or to restart of operations at the WWTP.

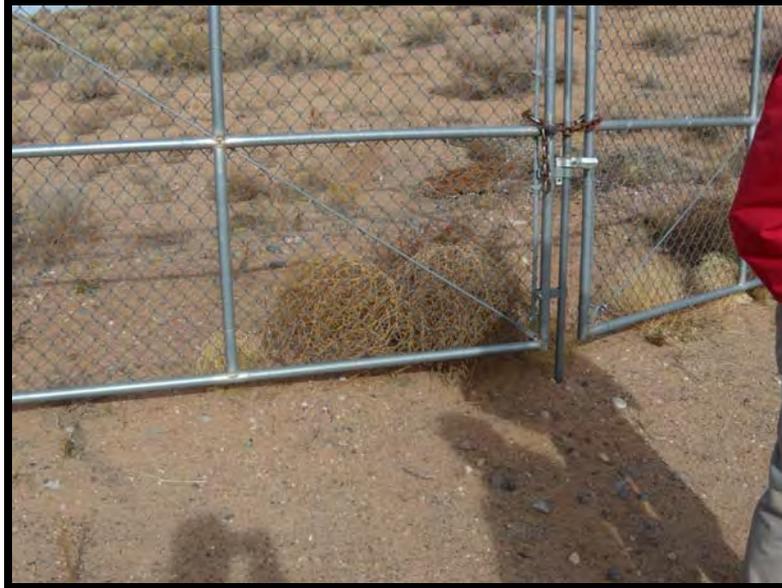
NMED/SWQB
Official Photograph Log
Photo # 7

Subject: Fenced area. There is evidence of animals digging under the fence. The area should be more secure to prevent access from animals such as dogs and coyotes, as well as from unauthorized humans.
